# Performance Monitoring of Mechanistically-Designed Pavements

## 2010 Data Collection

PHYSICAL RESEARCH REPORT NO. 159  
MARCH 2011

**Illinois Department of Transportation**

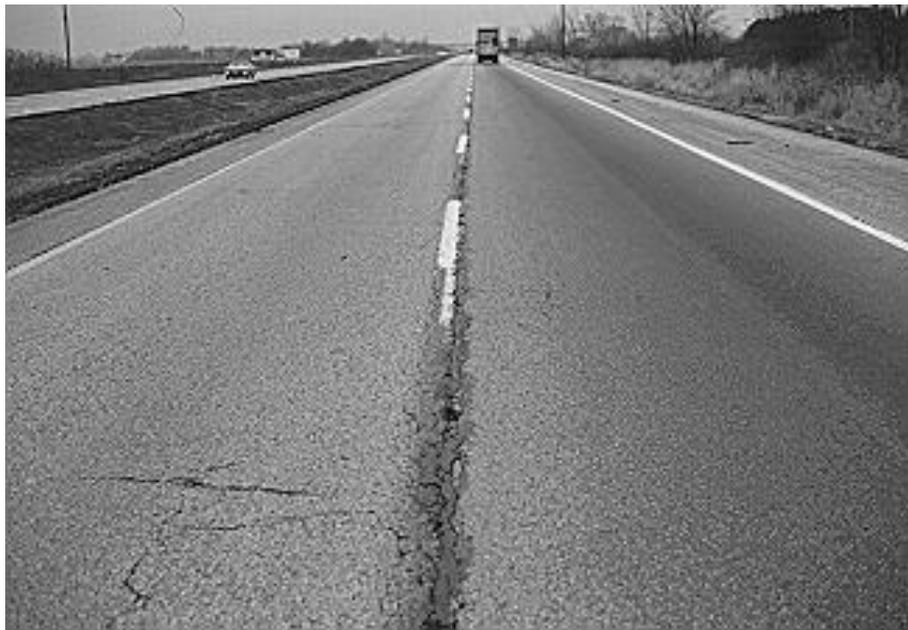
- L - Cracks are tight (mean width less than or equal to 1/4") with minor or no spalling present.
- M - Crack width is between 1/4" and 1/2". Cracks may be moderately spalled. Low severity random parallel cracking may exist near the crack or at the intersection of cracks.
- H - One or more of the following conditions exist: (1) crack width is greater than 1/2", (2) crack is severely spalled, (3) medium or severe random parallel cracking exists near the crack or at the intersection of cracks, (4) major sealing or other major maintenance activity has been performed.

High Severity Centerline Cracking

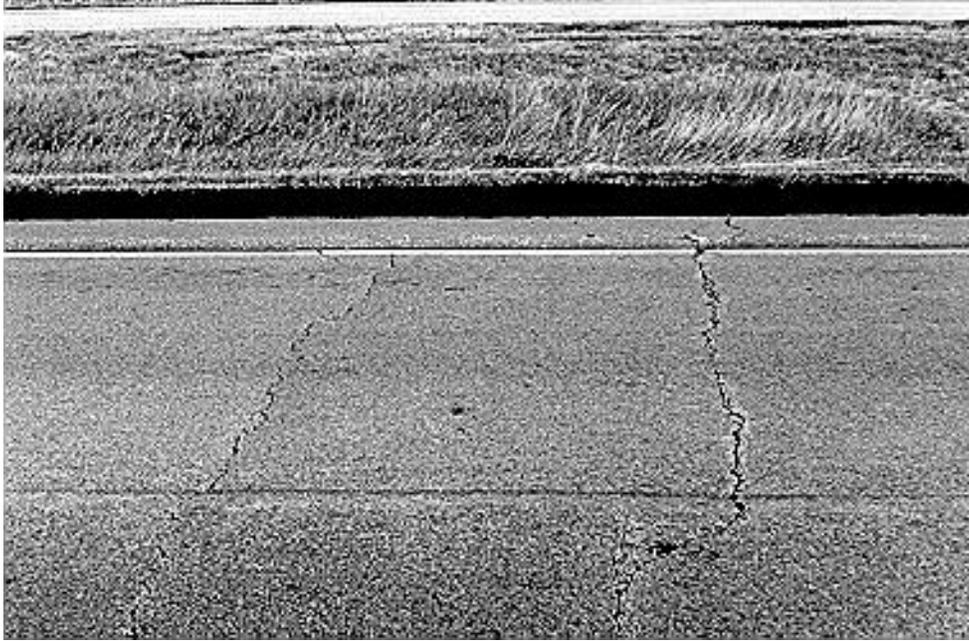
- L - Cracks are tight and the bituminous overlay is in very good condition in the vicinity of the cracks.
- M - The bituminous overlay is somewhat deteriorated, having medium level of severity for any type of distress described in this manual.
- H - The bituminous overlay is badly deteriorated in the area of the patch and in need of maintenance.

Low Severity Overlaid Patch Deterioration

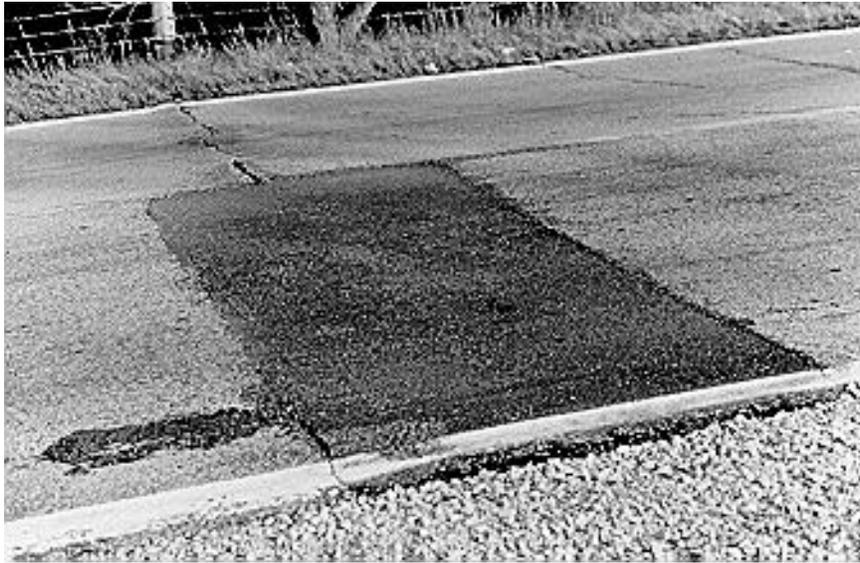
L - Patch is in very good condition and is performing satisfactorily.

Low Severity Permanent Patch Deterioration

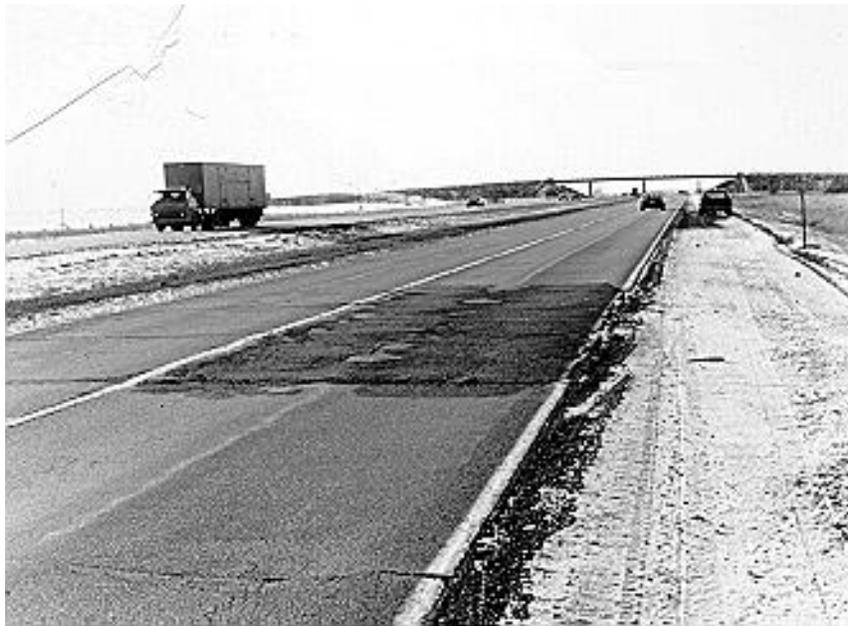
H - Patch is badly deteriorated and soon needs replacement.

High Severity Permanent Patch Deterioration

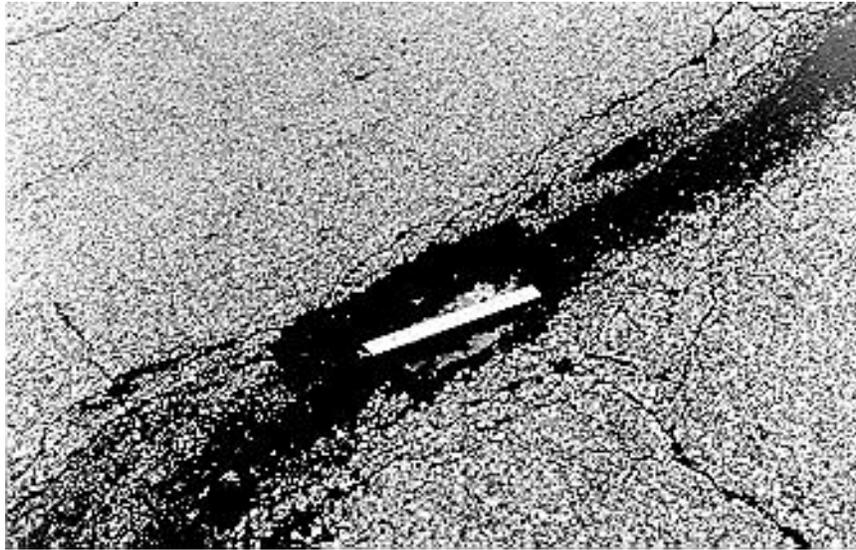
Medium Severity Pothole

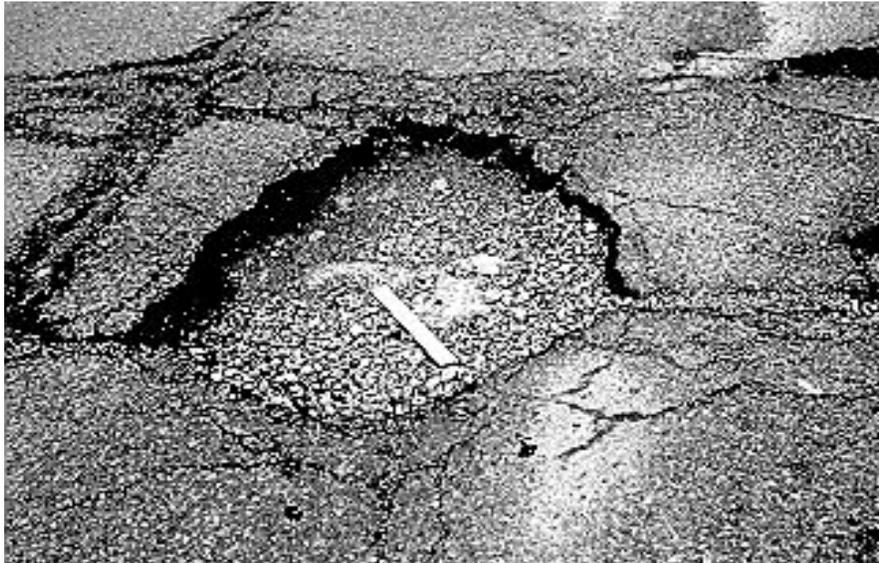
High Severity Pothole

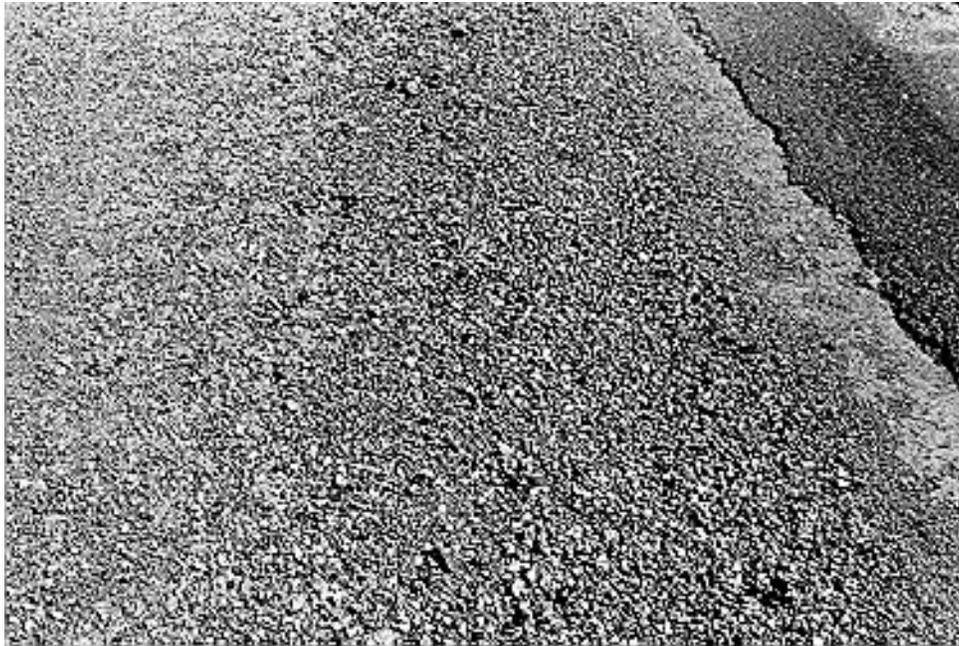
- L - Wearing away of the aggregate or binder has started but has not progressed significantly.
- M - Aggregate and/or binder has worn away and the surface texture is becoming rough and pitted; loose particles generally exist.
- H - Aggregate and/or binder has worn away and the surface texture is very rough and pitted.

High Severity Raveling and Weathering

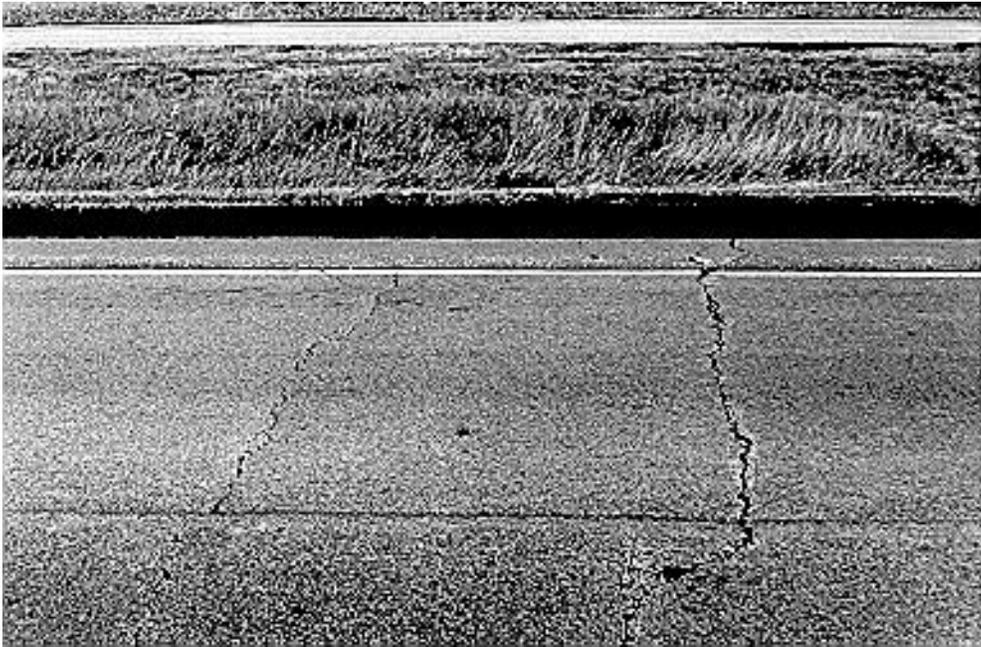
- L - Cracks are tight (mean width less than or equal to 1/4") with minor or no spalling present.
- M - Crack width is between 1/4" and 1/2". Cracks may be moderately spalled. Low severity random parallel cracking may exist near the crack or at the intersection of cracks.
- H - One or more of the following conditions exist: (1) crack width is greater than 1/2", (2) crack is severely spalled, (3) medium or severe random parallel cracking exists near the crack or at the intersection of cracks, (4) major sealing or other major maintenance activity has been performed.

Low Severity Reflected Patch Joint Cracking

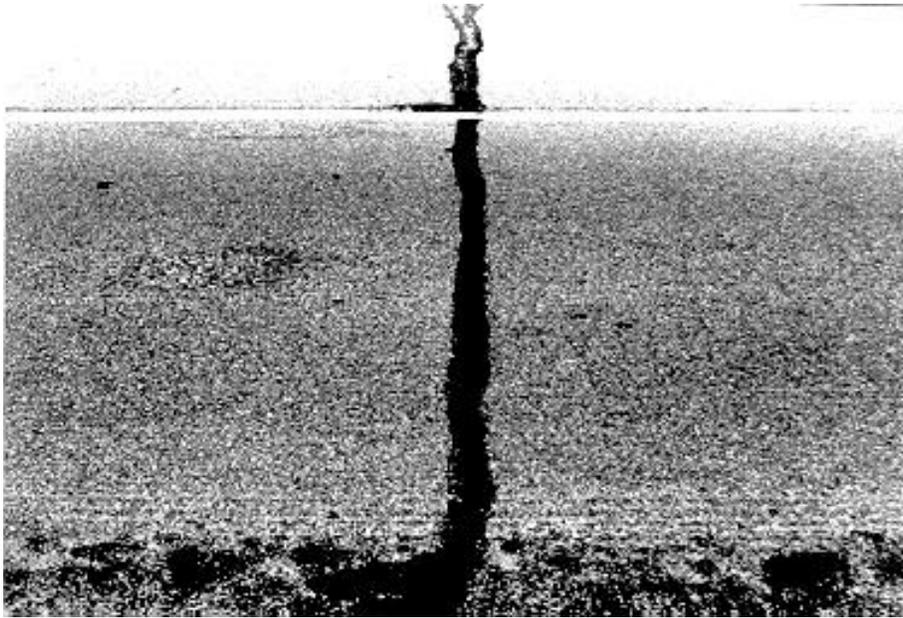
Medium Severity Reflection Cracking of Transverse Joints  
(sealed for preventive maintenance)

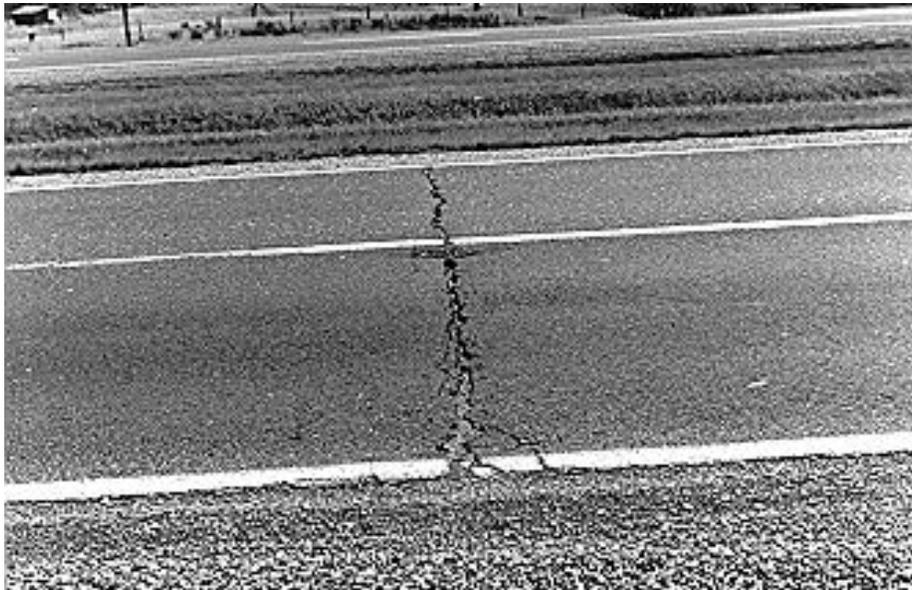
High Severity Reflection Cracking of Transverse Joints

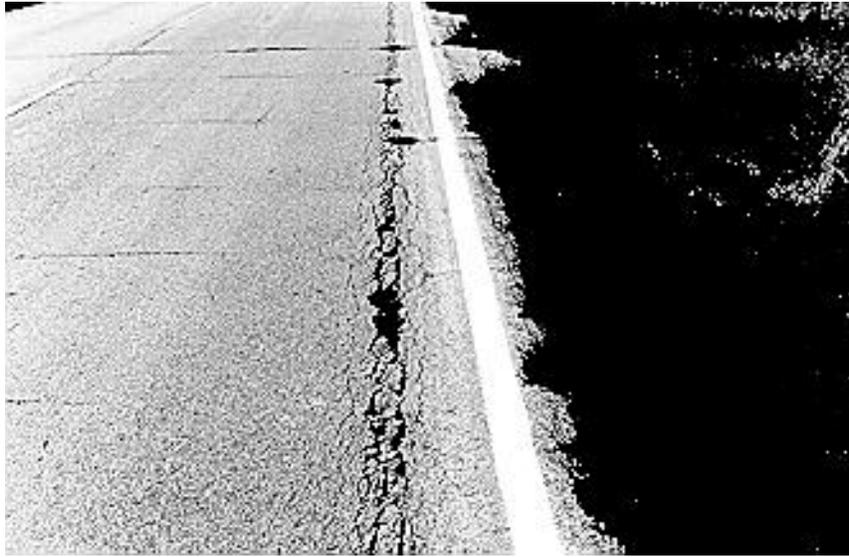
High Severity Widening Cracking

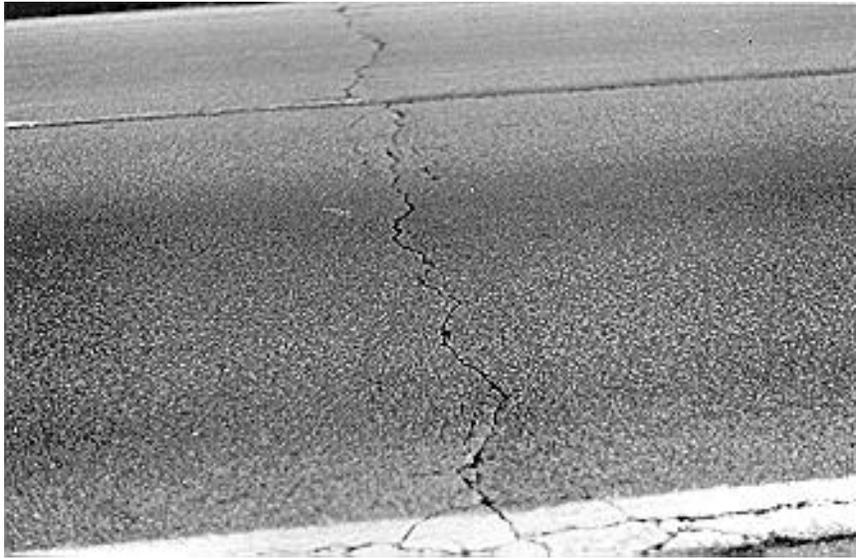
Low Severity Transverse Cracking

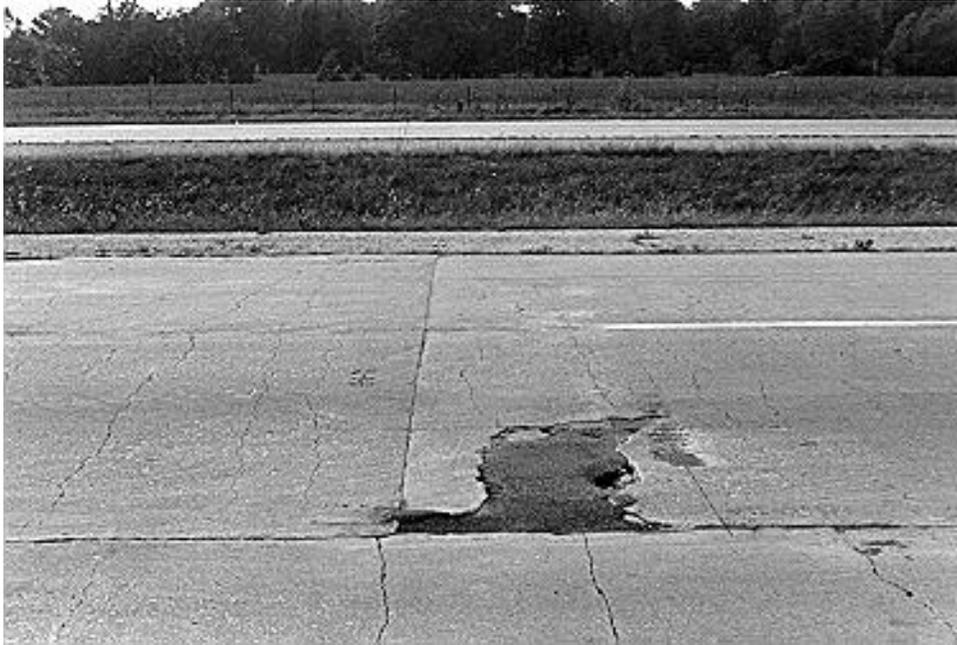
High Severity Construction Joint Deterioration

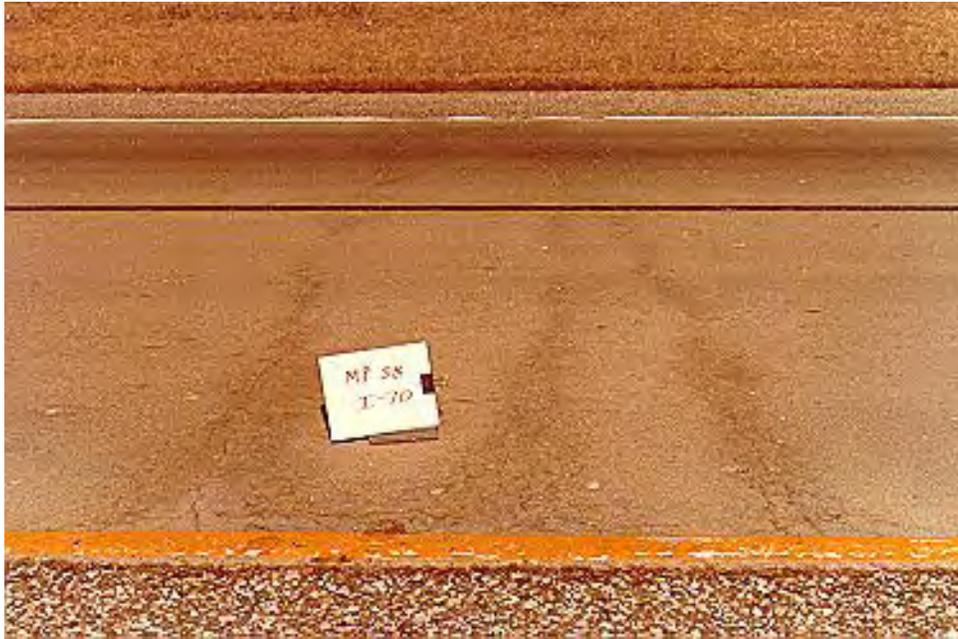
Low Severity D-Cracking

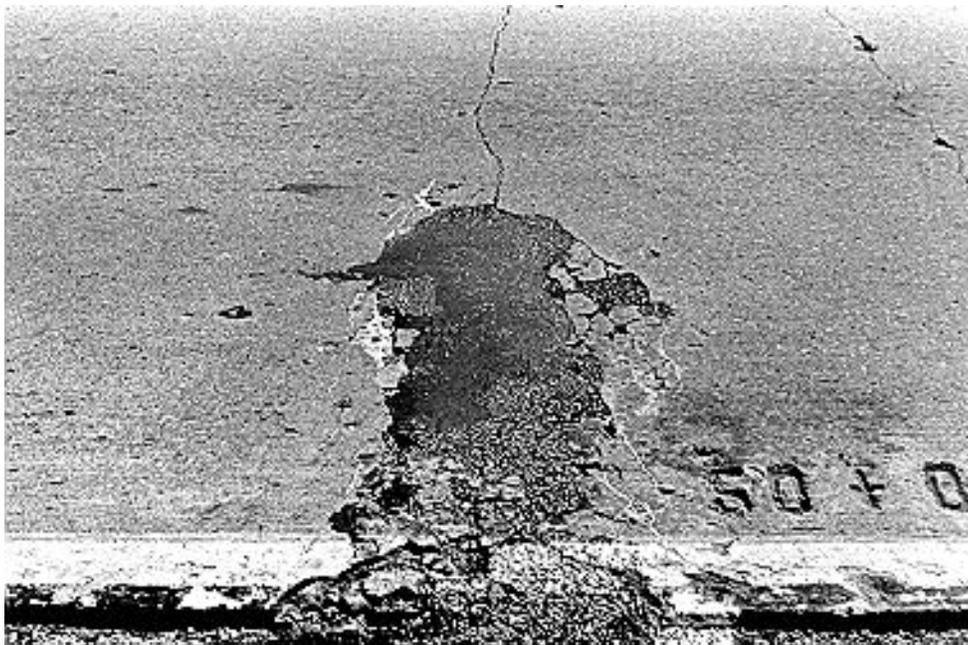
High Severity D-Cracking

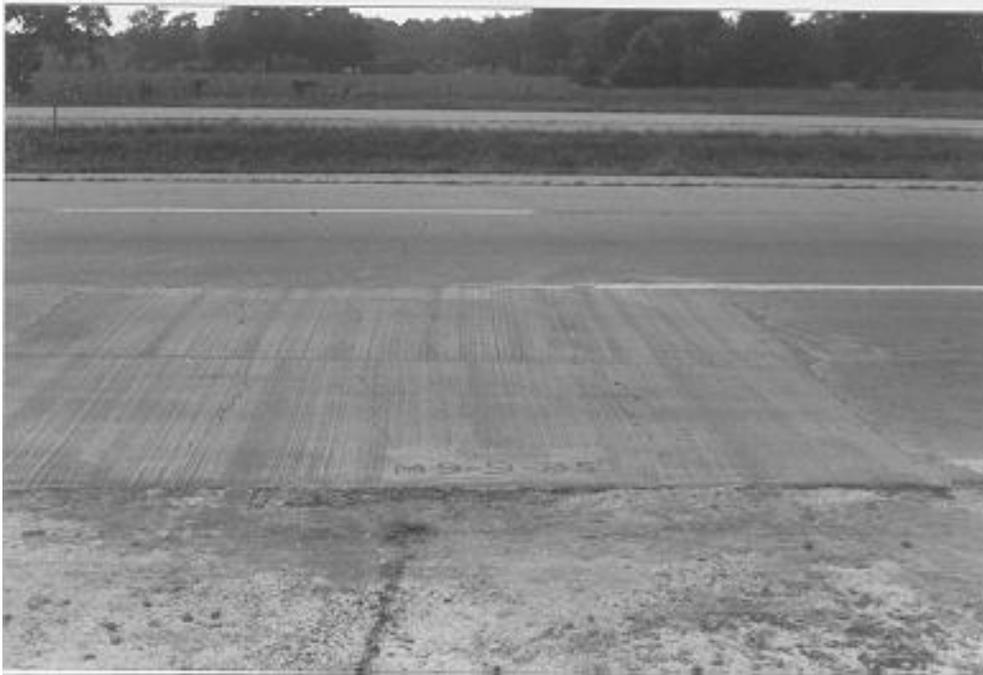
Low Severity Permanent Patch Deterioration

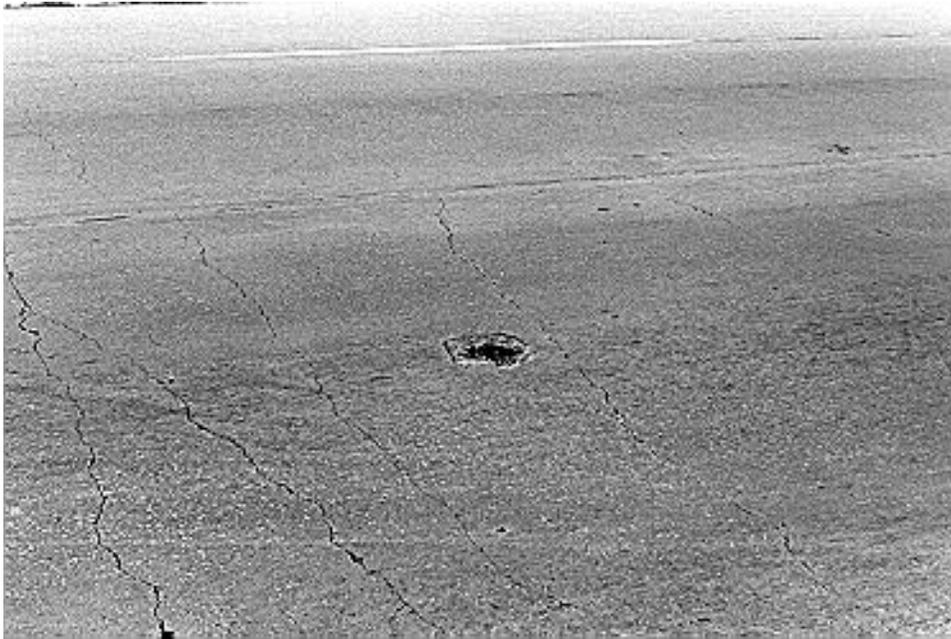
Low Severity Localized Distress

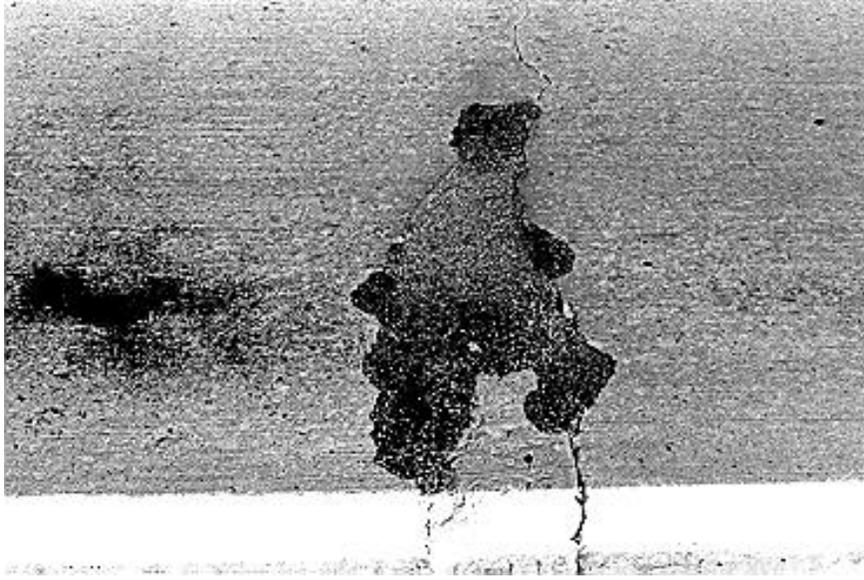
High Severity Punchout

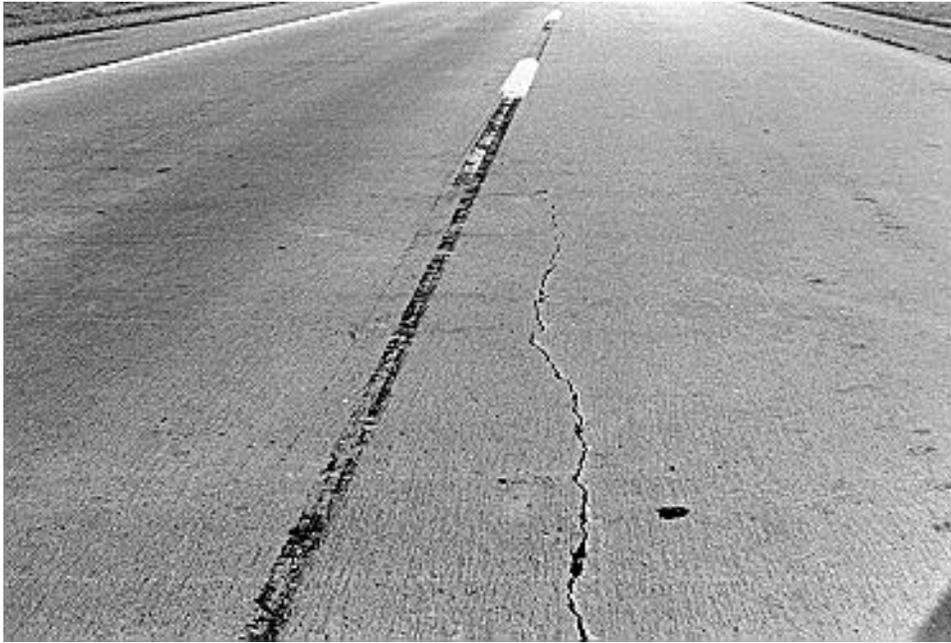
Low Severity Random Longitudinal Cracking

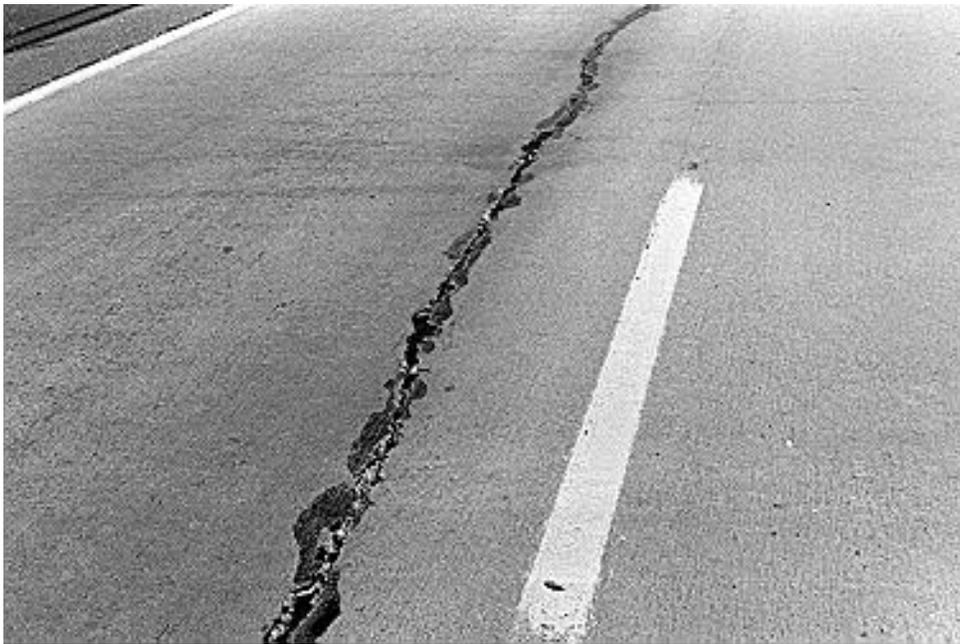
Medium Severity Random Longitudinal Cracking

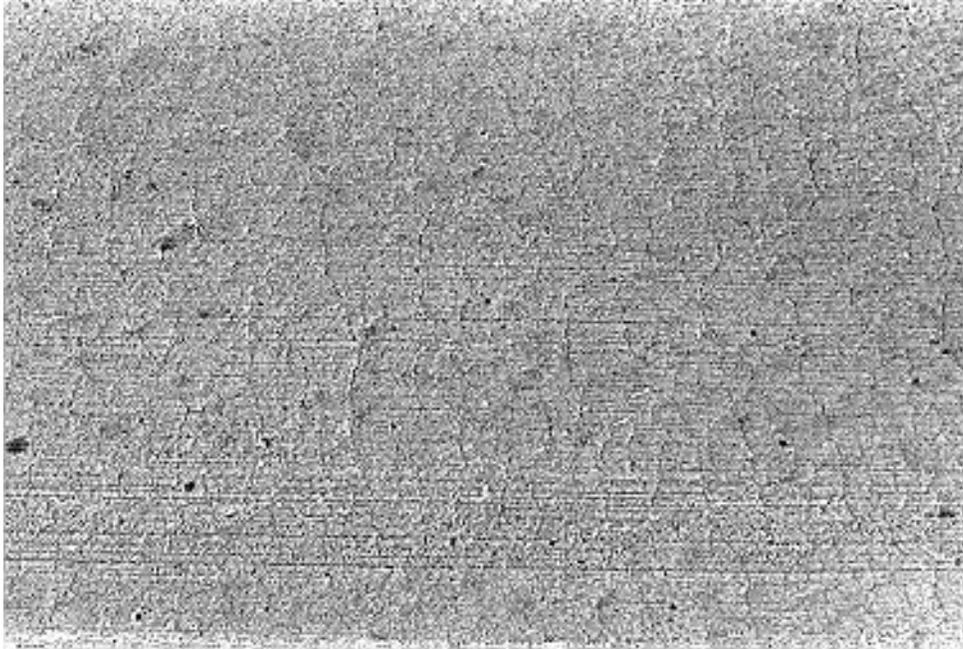
Low Severity Map Cracking

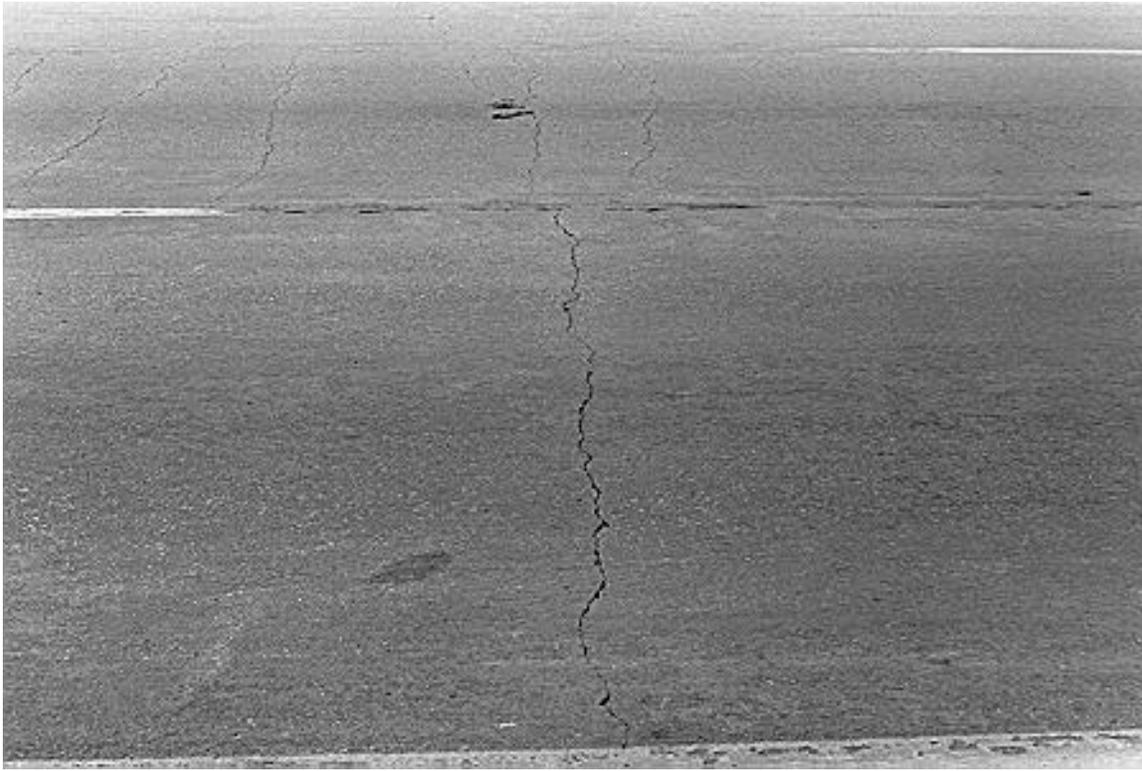
Low Severity Transverse Crack

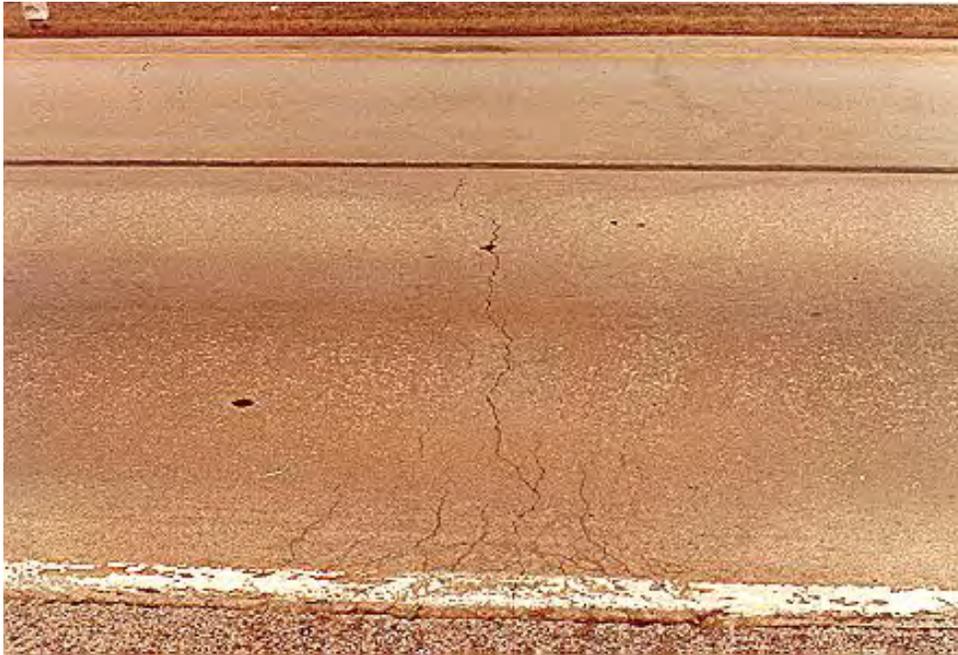
Low Severity D-Cracking

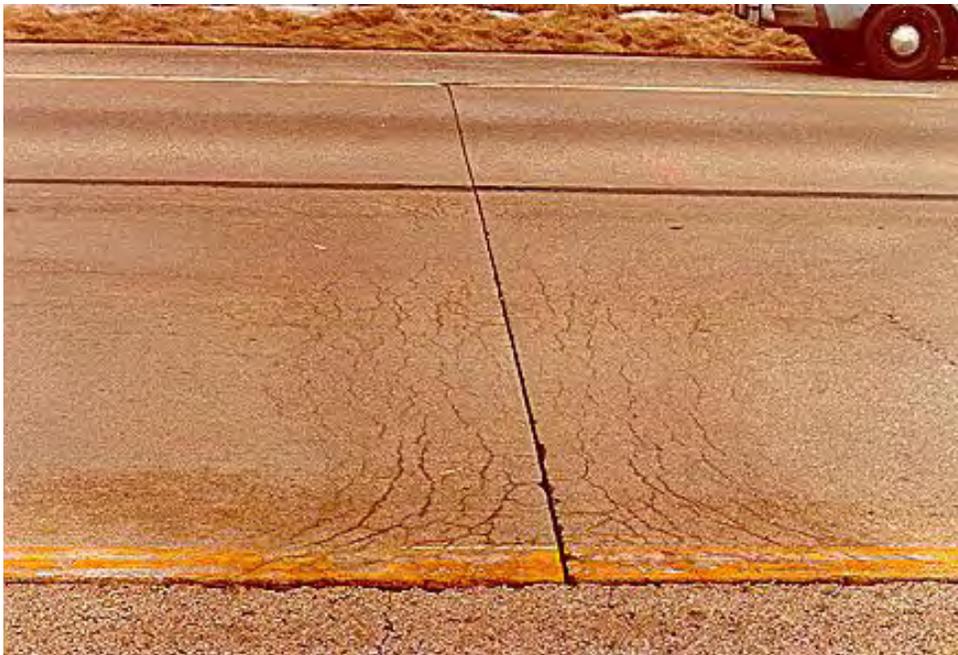
Medium Severity D-Cracking

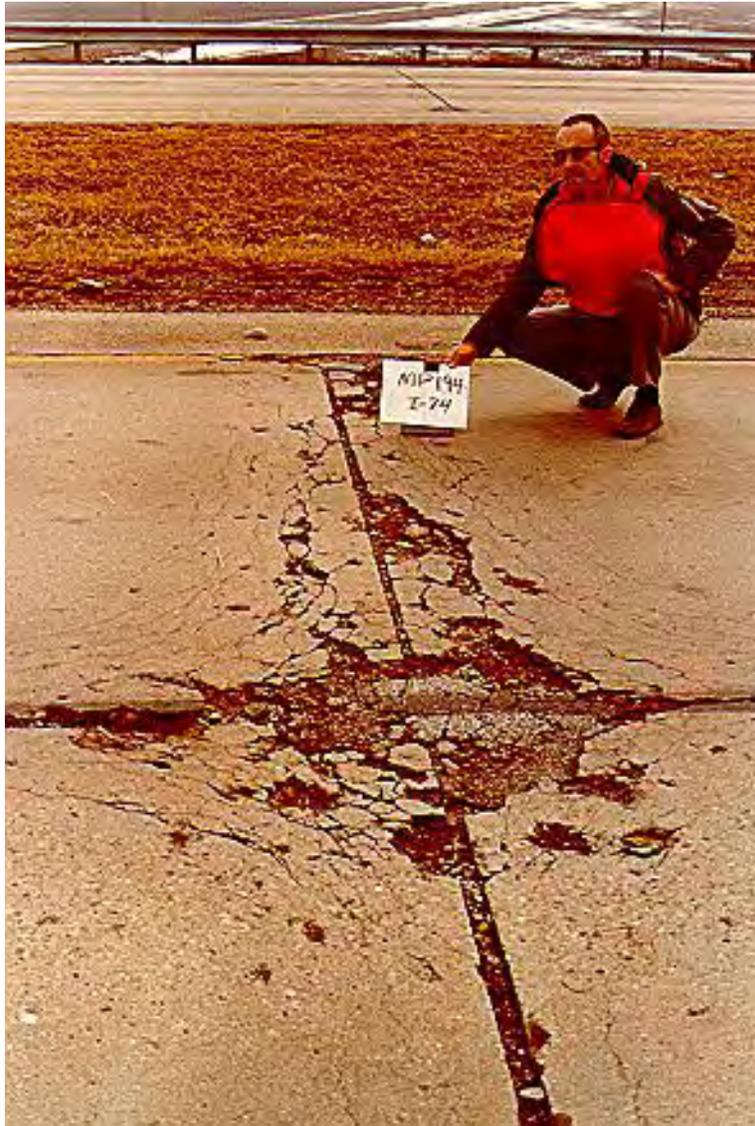
High Severity D-Cracking

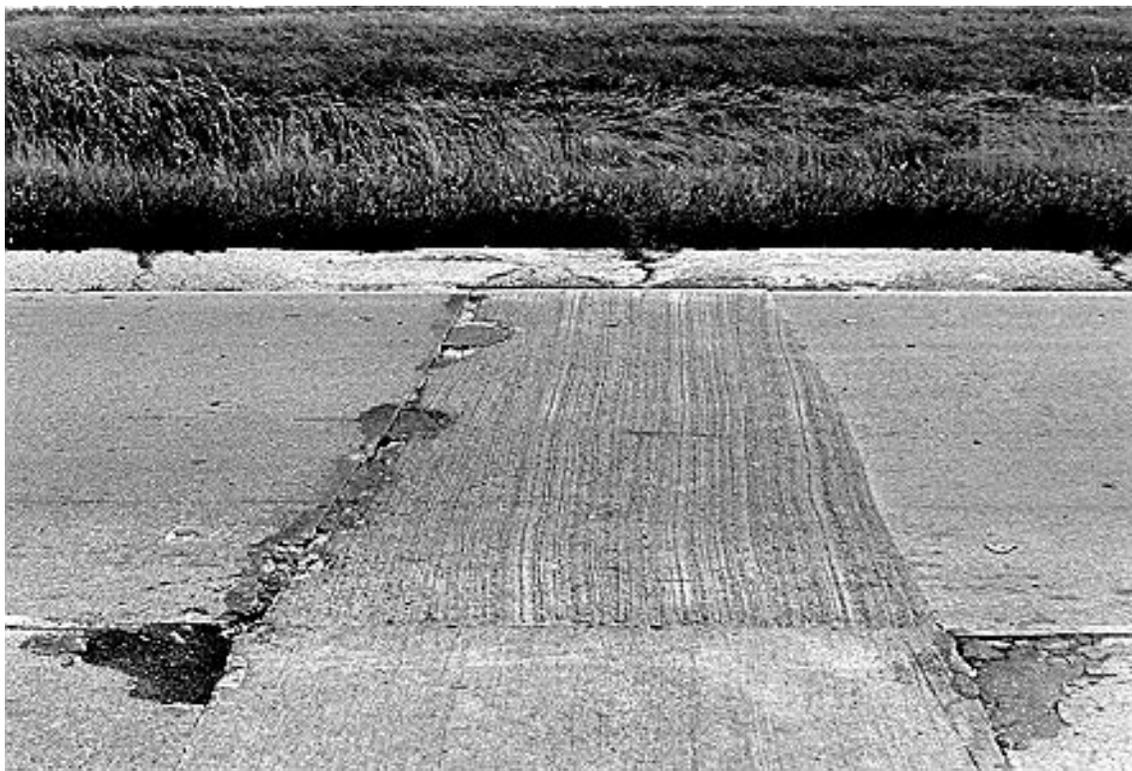
Medium Severity Permanent Patch Deterioration

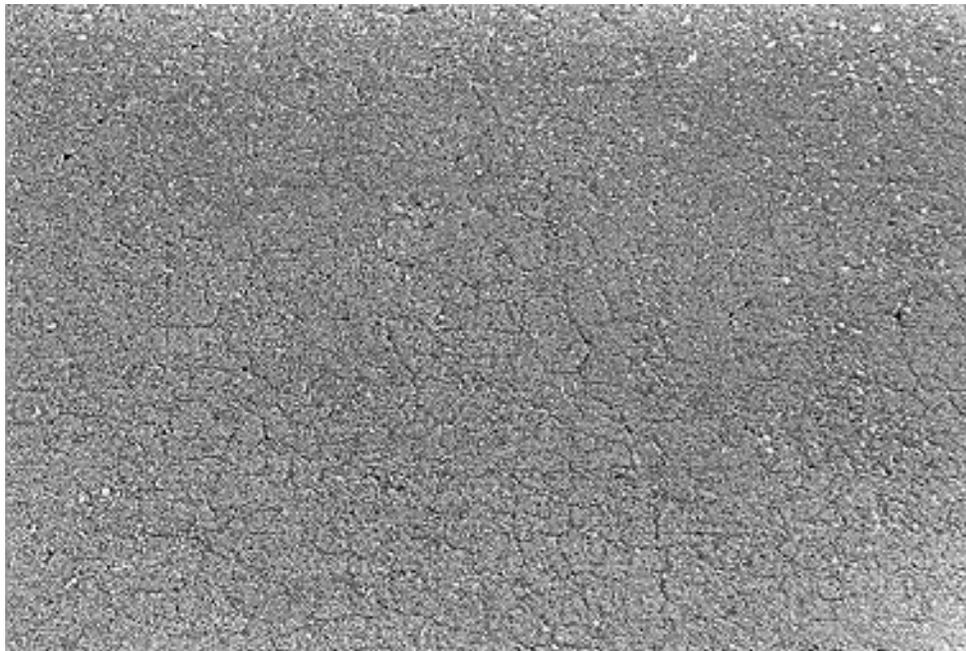
Low Severity Map Cracking

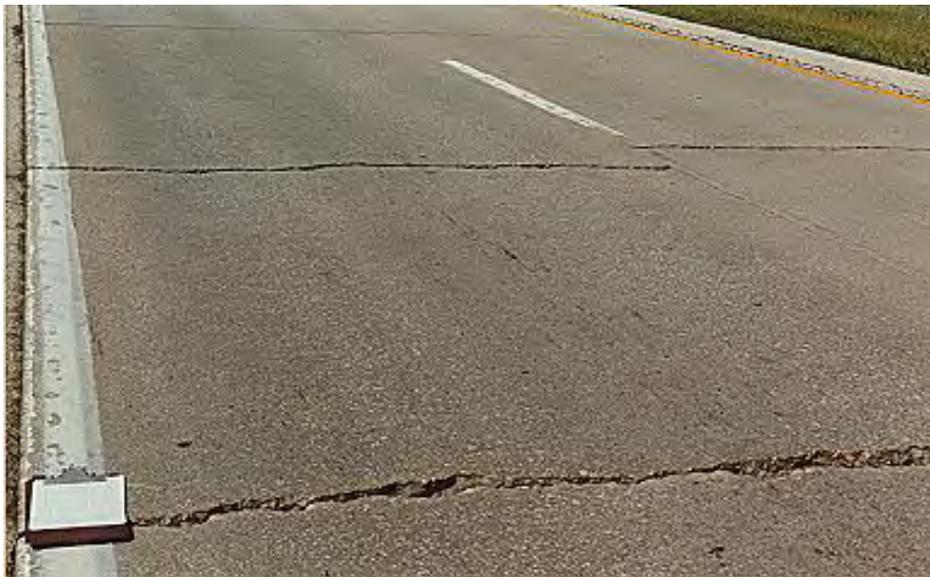
High Severity Transverse Crack (foreground) and  
Medium Severity Transverse Crack (background)
