# Tech Brief

## Guardrail Installations at Intersections or Other Access Points

**CATEGORY:** Design

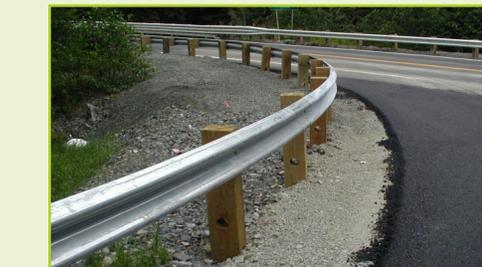
**Situation 2 (Photo B):** Weak post radius treatment. Because the situation was so pervasive, a design was developed – in the 1980's - that successfully sustained the direct hit – although only at 50 mph. The design, which can go from an 8.5 foot to a 35 foot radius, used weakened wood posts (CRT) through the radius; on impact the rail wrapped around the vehicle, safely decelerating it. The design requires a special anchor to develop adequate tension and a large clear area behind the rail (though it could have a 2:1 slope). This design has not met NCHRP 350 or MASH testing.

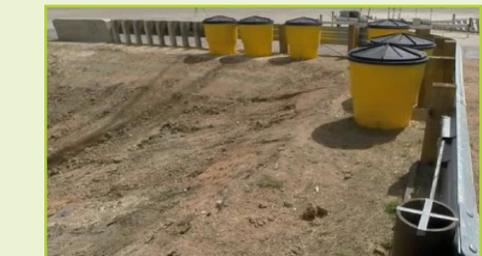
With the movement to MASH, and with the continued need to have an acceptable design to address this common situation (with or without a nearby bridge), there is ongoing research to develop a practical treatment. One recent design shown in Photo C has successfully passed MASH TL-3 testing but it is a complicated installation; it has been tested with a 3:1 slope behind the radius beyond the shelf necessary to support the sand barrels. Further testing is being conducted to develop less involved designs.

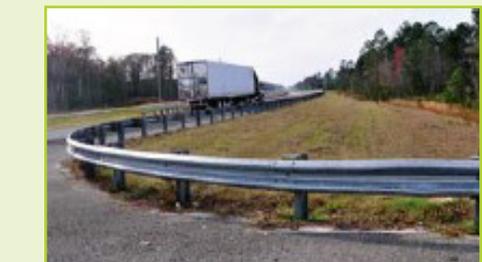
Although any successful radius designs may seem to be the panacea for the access problem, they need to be used appropriately. In Photo D, it appears the designer may have become too enamored with the design. Providing a very minor amount of grading (if any) would have allowed the guardrail to be flared and terminated with a crashworthy terminal, easily satisfying LON criteria. For Photo E, the designer did not understand how the system worked (need for a large deflection area), resulting in this failure.
