# Introduction to Element-Level Bridge Inspection

## Participant Workbook (1-Day Version)

U.S. Department of Transportation  
Federal Highway Administration

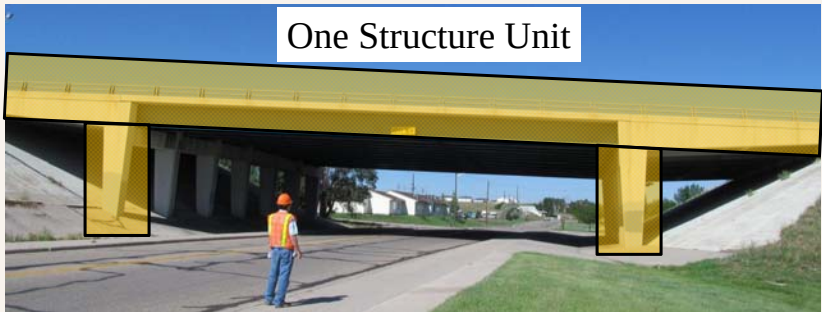
One Structure Unit

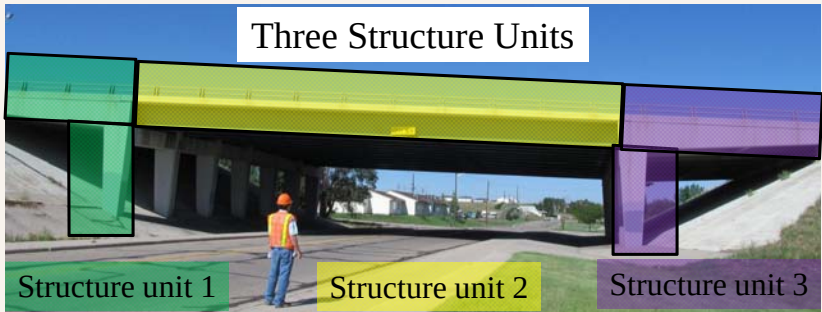
Three Structure Units

Structure unit 1      Structure unit 2      Structure unit 3

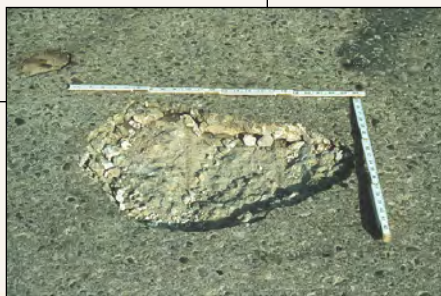
| CS 1 - Good | CS 2 - Fair | CS 3 - Poor | CS 4 - Severe |
|---|---|---|---|
| None | Delaminated. Spall 1 in. or less deep or 6 in. or less in diameter. Patched area that is sound. | Spall greater than 1 in. deep or greater than 6 in. diameter. Patched area that is unsound or showing distress. Does not warrant structural review. | The condition warrants a structural review to determine the effect on strength or serviceability of the element or bridge; OR a structural review has been completed and the defects impact strength or serviceability of the element or bridge. |

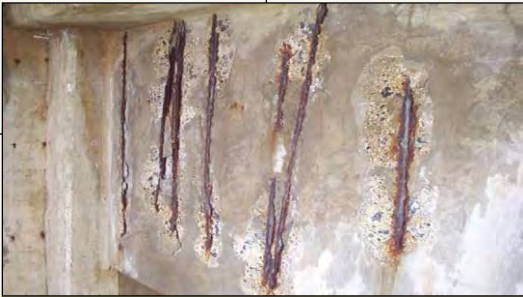
| CS 1 - Good | CS 2 - Fair | CS 3 - Poor | CS 4 - Severe |
|---|---|---|---|
| None | Present without measurable section loss. | Present with measurable section loss, but does not warrant structural review. | The condition warrants a structural review to determine the effect on strength or serviceability of the element or bridge; OR a structural review has been completed and the defects impact strength or serviceability of the element or bridge. |

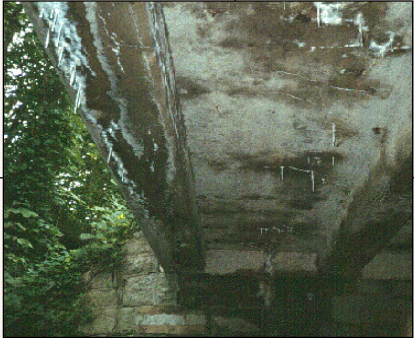
| CS 1 - Good | CS 2 - Fair | CS 3 - Poor | CS 4 - Severe |
|---|---|---|---|
| None | Surface white without build-up or leaching without rust staining. | Heavy build-up with rust staining. | The condition warrants a structural review to determine the effect on strength or serviceability of the element or bridge; OR a structural review has been completed and the defects impact strength or serviceability of the element or bridge. |

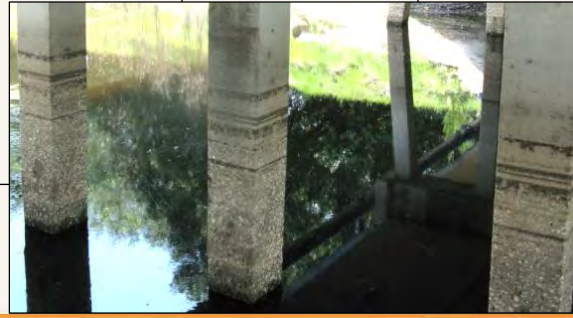
| CS 1 - Good | CS 2 - Fair | CS 3 - Poor | CS 4 - Severe |
|---|---|---|---|
| No abrasion or wearing | Abrasion or wearing has exposed coarse aggregate but the aggregate remains secure in the concrete. | Coarse aggregate is loose or has popped out of the concrete matrix due to abrasion or wear. | The condition warrants a structural review to determine the effect on strength or serviceability of the element or bridge; OR a structural review has been completed and the defects impact strength or serviceability of the element or bridge. |

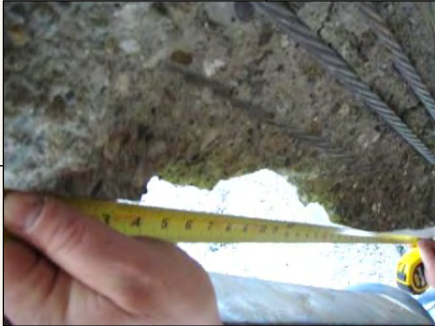
| CS 1 - Good | CS 2 - Fair | CS 3 - Poor | CS 4 - Severe |
|---|---|---|---|
| None. | Present without section loss. | Present with section loss, but does not warrant structural review. | The condition warrants a structural review to determine the effect on strength or serviceability of the element or bridge; OR a structural review has been completed and the defects impact strength or serviceability of the element or bridge. |

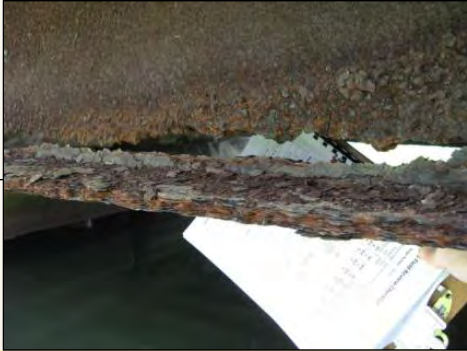
| CS 1 - Good | CS 2 - Fair | CS 3 - Poor | CS 4 - Severe |
|---|---|---|---|
| None | Freckled Rust. Corrosion of the steel has initiated. | Section loss is evident or pack rust is present but does not warrant structural review. | The condition warrants a structural review to determine the effect on strength or serviceability of the element or bridge; OR a structural review has been completed and the defects impact strength or serviceability of the element or bridge. |

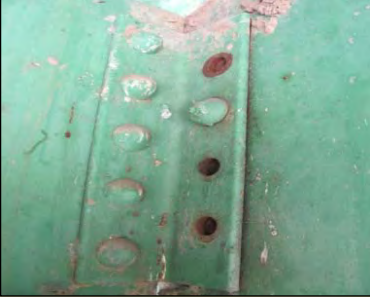
| CS 1 - Good | CS 2 - Fair | CS 3 - Poor | CS 4 - Severe |
|---|---|---|---|
| Connection is in place and functioning as intended. | Loose fasteners or pack rust without distortion is present but the connection is in place and functioning as intended. | Missing bolts, rivets, or fasteners; broken welds; or pack rust with distortion but does not warrant a structural review. | The condition warrants a structural review to determine the effect on strength or serviceability of the element or bridge; OR a structural review has been completed and the defects impact strength or serviceability of the element or bridge. |

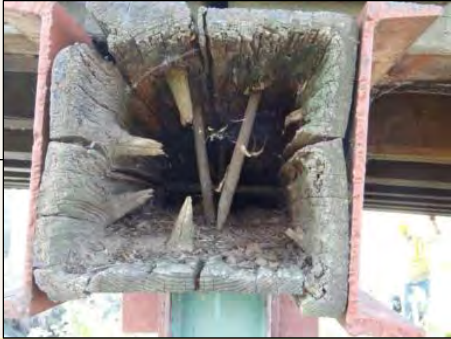
| CS 1 - Good | CS 2 - Fair | CS 3 - Poor | CS 4 - Severe |
|---|---|---|---|
| None. | Affects less than 10% of the member section. | Affects 10% or more of the member but does not warrant structural review. | The condition warrants a structural review to determine the effect on strength or serviceability of the element or bridge; OR a structural review has been completed and the defects impact strength or serviceability of the element or bridge. |

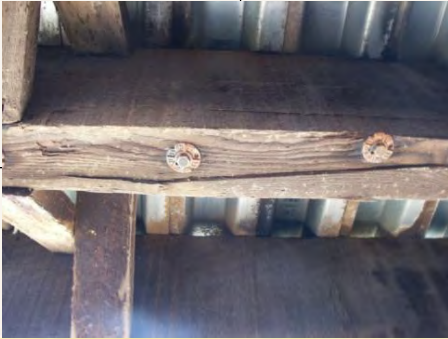
| CS 1 - Good | CS 2 - Fair | CS 3 - Poor | CS 4 - Severe |
|---|---|---|---|
| None. | Crack that has been arrested through effective measures. | Identified crack exists that is not arrested, but does not warrant structural review. | The condition warrants a structural review to determine the effect on strength or serviceability of the element or bridge; OR a structural review has been completed and the defects impact strength or serviceability of the element or bridge. |

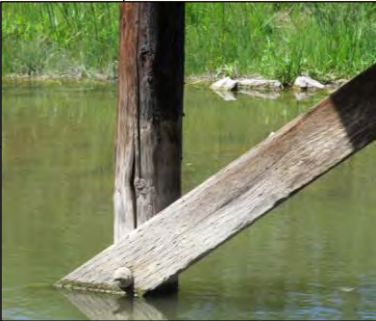
| CS 1 - Good | CS 2 - Fair | CS 3 - Poor | CS 4 - Severe |
|---|---|---|---|
| None. | Length less than the member depth or arrested with effective actions taken to mitigate. | Length equal to or greater than the member depth, but does not warrant structural review. | The condition warrants a structural review to determine the effect on strength or serviceability of the element or bridge; OR a structural review has been completed and the defects impact strength or serviceability of the element or bridge. |

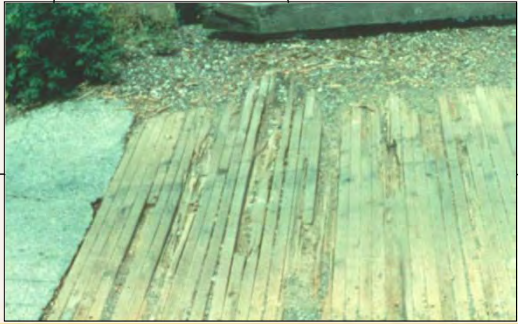
| CS 1 - Good | CS 2 - Fair | CS 3 - Poor | CS 4 - Severe |
|---|---|---|---|
| None or no measurable section loss. | Section loss less than 10% of the member thickness | Section loss 10% or more of the member thickness but does not warrant structural review. | The condition warrants a structural review to determine the effect on strength or serviceability of the element or bridge; OR a structural review has been completed and the defects impact strength or serviceability of the element or bridge. |

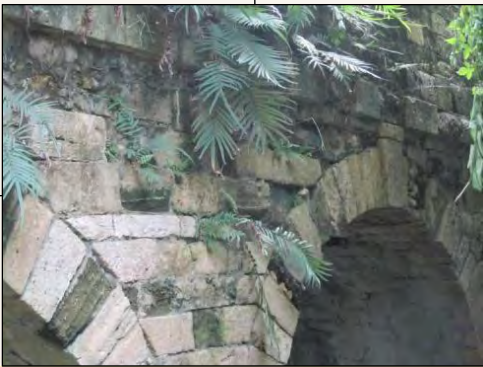
| CS 1 - Good | CS 2 - Fair | CS 3 - Poor | CS 4 - Severe |
|---|---|---|---|
| None | Cracking or voids in less than 10% of joints. | Cracking or voids in 10% or more of the of joints | The condition warrants a structural review to determine the effect on strength or serviceability of the element or bridge; OR a structural review has been completed and the defects impact strength or serviceability of the element or bridge. |

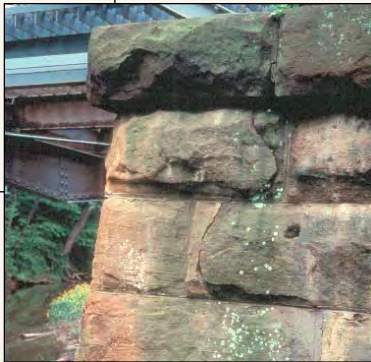
| CS 1 - Good | CS 2 - Fair | CS 3 - Poor | CS 4 - Severe |
|---|---|---|---|
| None | Block or stone has split or spalled with no shifting. | Block or stone has split or spalled with shifting but does not warrant a structural review. | The condition warrants a structural review to determine the effect on strength or serviceability of the element or bridge; OR a structural review has been completed and the defects impact strength or serviceability of the element or bridge. |

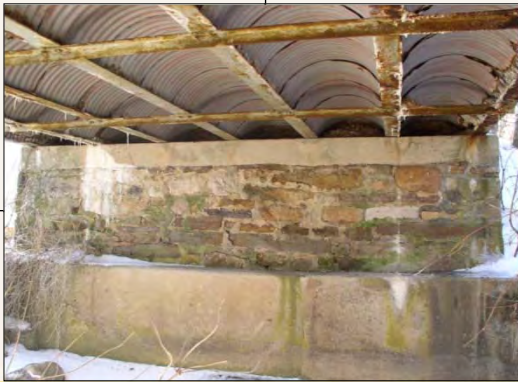
| CS 1 - Good | CS 2 - Fair | CS 3 - Poor | CS 4 - Severe |
|---|---|---|---|
| None. | Sound patch. | Unsound patch. | The condition warrants a structural review to determine the effect on strength or serviceability of the element or bridge; OR a structural review has been completed and the defects impact strength or serviceability of the element or bridge. |

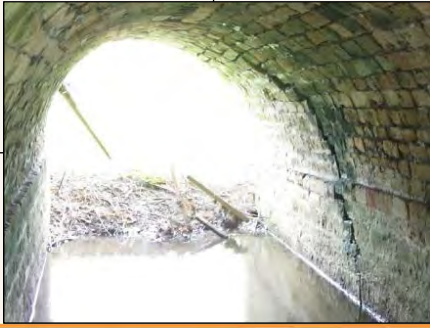
| CS 1 - Good | CS 2 - Fair | CS 3 - Poor | CS 4 - Severe |
|---|---|---|---|
| None. | Block or stone has shifted <u>slightly</u> out of alignment. | Block or stone has shifted <u>significantly</u> out of alignment or is missing but does not warrant structural review. | The condition warrants a structural review to determine the effect on strength or serviceability of the element or bridge; OR a structural review has been completed and the defects impact strength or serviceability of the element or bridge. |

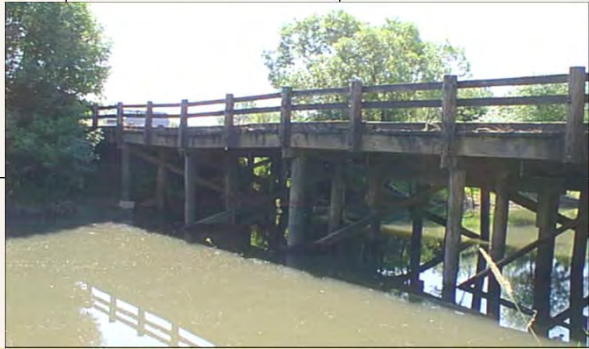
| CS 1 - Good | CS 2 - Fair | CS 3 - Poor | CS 4 - Severe |
|---|---|---|---|
| None. | Exists within tolerable limits or arrested with no observed structural distress. | Exceeds tolerable limits but does not warrant structural review. | The condition warrants a structural review to determine the effect on strength or serviceability of the element or bridge; OR a structural review has been completed and the defects impact strength or serviceability of the element or bridge. |

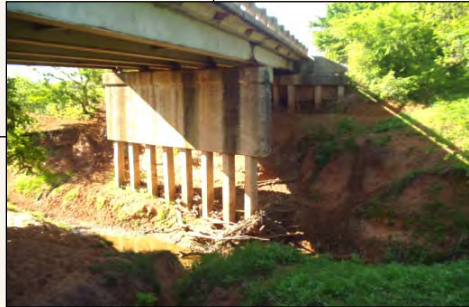
| CS 1 - Good | CS 2 - Fair | CS 3 - Poor | CS 4 - Severe |
|---|---|---|---|
| None. | Exists within tolerable limits or has been arrested with effective countermeasures. | Exceeds tolerable limits, but is less than the critical limits determined by scour evaluation and does not warrant structural review. | The condition warrants a structural review to determine the effect on strength or serviceability of the element or bridge; OR a structural review has been completed and the defects impact strength or serviceability of the element or bridge. |

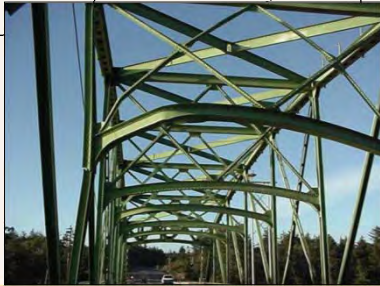
| CS 1 - Good | CS 2 - Fair | CS 3 - Poor | CS 4 - Severe |
|---|---|---|---|
| Not applicable. | The element has impact damage. The specific damage caused by the impact has been captured in condition state 2 under the appropriate material defect entry. | The element has impact damage. The specific damage caused by the impact has been captured in condition state 3 under the appropriate material defect entry. | The element has impact damage. The specific damage caused by the impact has been captured in condition state 4 under the appropriate material defect entry. |

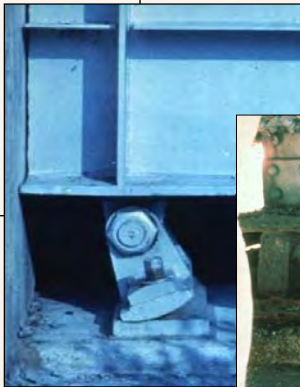
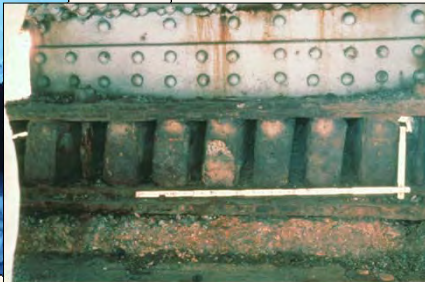
| CS 1 - Good | CS 2 - Fair | CS 3 - Poor | CS 4 - Severe |
|---|---|---|---|
| Free to Move. | Minor Restriction. | Restricted but not warranting structural review. | The condition warrants a structural review to determine the effect on strength or serviceability of the element or bridge; OR a structural review has been completed and the defects impact strength or serviceability of the element or bridge. |

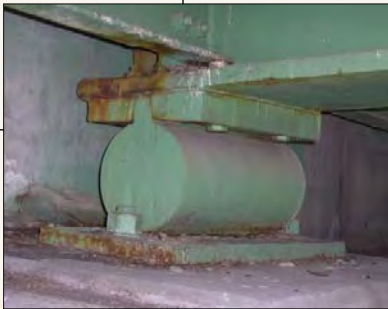
| CS 1 - Good | CS 2 - Fair | CS 3 - Poor | CS 4 - Severe |
|---|---|---|---|
| Lateral and vertical alignment is as expected for the temperature conditions. | Tolerable lateral or vertical alignment that is inconsistent with the temperature conditions. | Approaching the limits of lateral or vertical alignment for the bearing but does not warrant a structural review. | The condition warrants a structural review to determine the effect on strength or serviceability of the element or bridge; OR a structural review has been completed and the defects impact strength or serviceability of the element or bridge. |

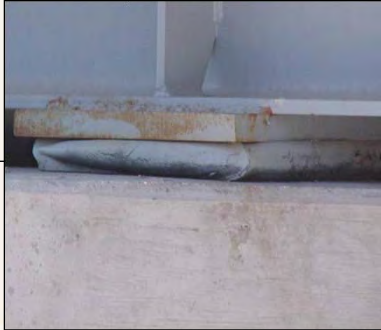
| CS 1 - Good | CS 2 - Fair | CS 3 - Poor | CS 4 - Severe |
|---|---|---|---|
| None | Bulging less than 15% of the thickness. | Bulging 15% or more of the thickness. Splitting or tearing. Bearing's surfaces are not parallel. Does not warrant structural review. | The condition warrants a structural review to determine the effect on strength or serviceability of the element or bridge; OR a structural review has been completed and the defects impact strength or serviceability of the element or bridge. |

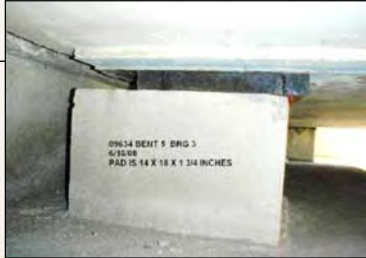
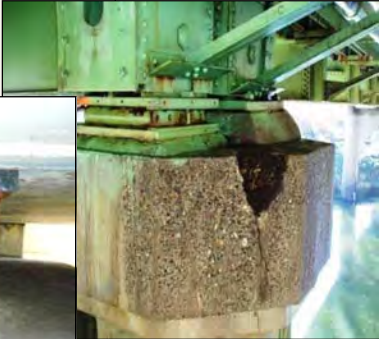
| CS 1 - Good | CS 2 - Fair | CS 3 - Poor | CS 4 - Severe |
|---|---|---|---|
| None. | Less than 10%. | 10% or more but does not warrant structural review. | The condition warrants a structural review to determine the effect on strength or serviceability of the element or bridge; OR a structural review has been completed and the defects impact strength or serviceability of the element or bridge. |

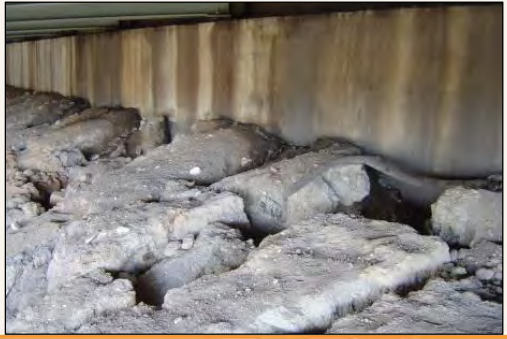
| CS 1 - Good | CS 2 - Fair | CS 3 - Poor | CS 4 - Severe |
|---|---|---|---|
| None | Minimal. Minor dripping through the joint. | Moderate. More than a drip and less than free flow of water. | Free flow of water through the joint. |

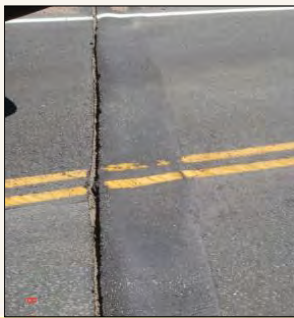
| CS 1 - Good | CS 2 - Fair | CS 3 - Poor | CS 4 - Severe |
|---|---|---|---|
| Fully adhered. | Adhered for more than 50% of the joint height. | Adhered 50% or less of joint height but still some adhesion. | Complete loss of adhesion. |

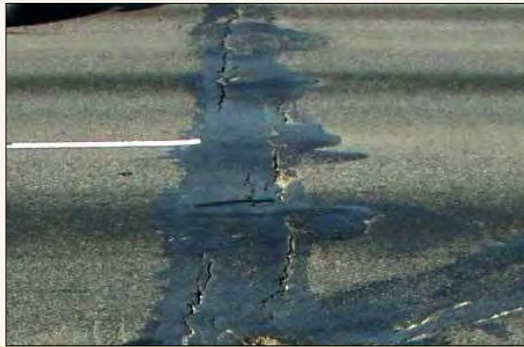
| CS 1 - Good | CS 2 - Fair | CS 3 - Poor | CS 4 - Severe |
|---|---|---|---|
| None. | Surface crack. | Crack that partially penetrates the seal. | Crack that fully penetrates the seal. |

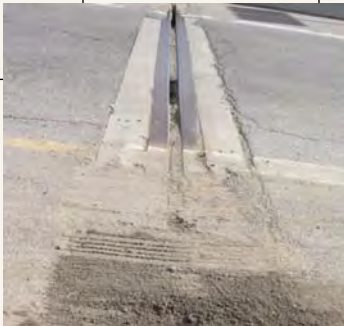
| CS 1 - Good | CS 2 - Fair | CS 3 - Poor | CS 4 - Severe |
|---|---|---|---|
| No debris to a shallow cover of loose debris may be evident but does not affect the performance of the joint. | Partially filled with hard-packed material, but still allowing free movement. | Completely filled and impacts joint movement. | Completely filled and prevents joint movement. |

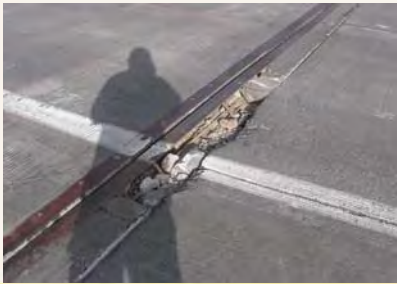
| CS 1 - Good | CS 2 - Fair | CS 3 - Poor | CS 4 - Severe |
| Sound. No spall, delamination or unsound patch. | Edge delamination or spall 1 in. or less deep or 6 in. or less in diameter. No exposed rebar. Patched area that is sound. | Spall greater than 1 in. deep or greater than 6 in. diameter. Exposed rebar. Delamination or unsound patched area that makes the joint loose. | Spall, delamination, unsound patched area or loose joint anchor that prevents the joint from functioning as intended. |

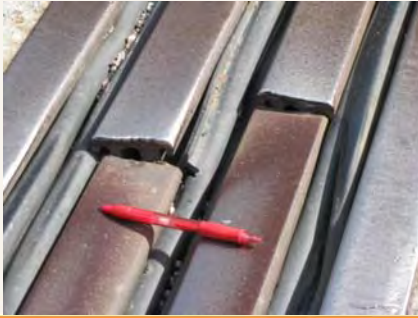
## Joints - Metal Deterioration or Damage (2370)

| CS 1 - Good | CS 2 - Fair | CS 3 - Poor | CS 4 - Severe |
|---|---|---|---|
| None | Freckled rust, metal has no cracks, or impact damage. Connection may be loose but functioning as intended. | Section loss, missing or broken fasteners, cracking of the metal or impact damage but joint still functioning. | Metal cracking, section loss, damage or connection failure that prevents the joint from functioning as intended. |

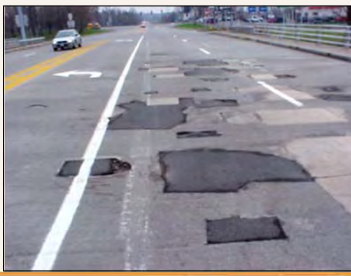
## WS - Delamination/Spall/Patched Area/Pothole (3210)

| CS 1 - Good | CS 2 - Fair | CS 3 - Poor | CS 4 - Severe |
|---|---|---|---|
| None. | Delaminated. Spall less than 1 in. deep or less than 6 in. diameter. Patched area that is sound. Partial depth pothole. | Spall 1 in. deep or greater or 6 in. diameter or greater. Patched area that is unsound or showing distress. Full depth pothole. | The wearing surface is no longer effective. |

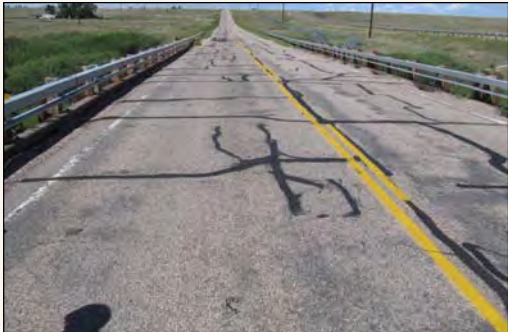
## WS - Crack (3220)

| CS 1 – Good | CS 2 - Fair | CS 3 - Poor | CS 4 - Severe |
|---|---|---|---|
| Width less than 0.012 in. or spacing greater than 3.0 ft. | Width 0.012–0.05 in. or spacing of 1.0–3.0 ft. | Width of more than 0.05 in. or spacing of less than 1.0 ft. | The wearing surface is no longer effective. |

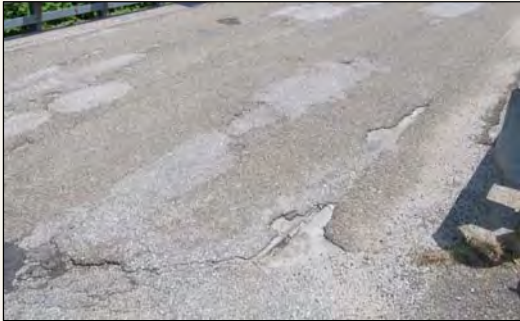
| CS 1 – Good | CS 2 - Fair | CS 3 - Poor | CS 4 - Severe |
|---|---|---|---|
| Fully effective. No evidence of leakage or further deterioration of the protected element. | Substantially effective. Deterioration of the protected element has slowed. | Limited effectiveness. Deterioration of the protected element has progressed. | The wearing surface is no longer effective. |

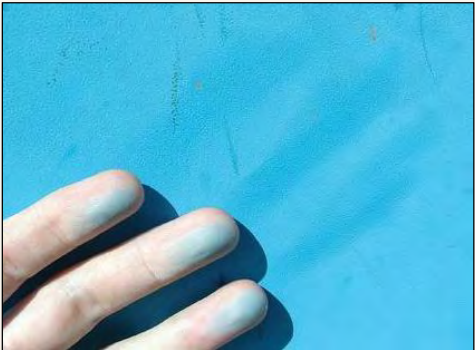
| CS 1 - Good | CS 2 - Fair | CS 3 - Poor | CS 4 - Severe |
|---|---|---|---|
| None. | Surface Dulling. | Loss of Pigment. | Not Applicable. |

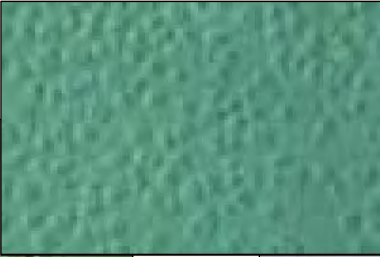
## SPC - Peeling / Bubbling / Cracking (3420)

| CS 1 - Good | CS 2 - Fair | CS 3 - Poor | CS 4 - Severe |
|---|---|---|---|
| None. | Finish coats only. | Finish and primer coats. | Exposure of bare metal. |

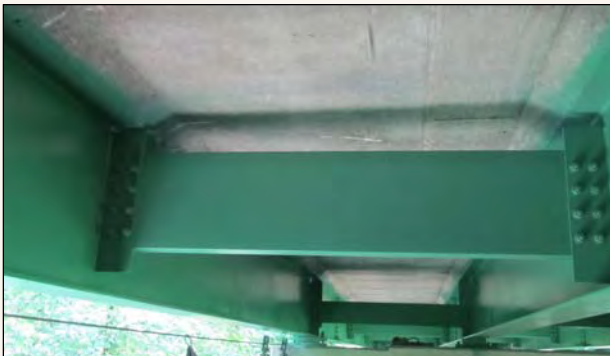
| CS 1 - Good | CS 2 - Fair | CS 3 - Poor | CS 4 - Severe |
|---|---|---|---|
| Fully effective. | Substantially effective. | Limited effectiveness. | Failed, no protection of the underlying metal |

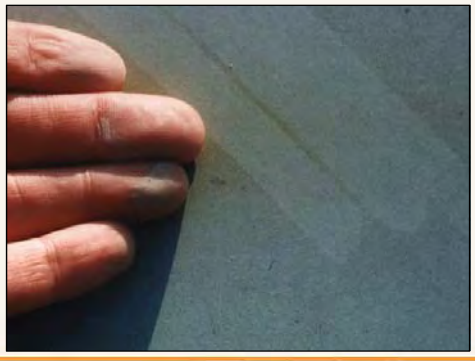
| CS 1 - Good | CS 2 - Fair | CS 3 - Poor | CS 4 - Severe |
|---|---|---|---|
| None. | Surface Dulling. | Loss of Pigment. | Not Applicable. |

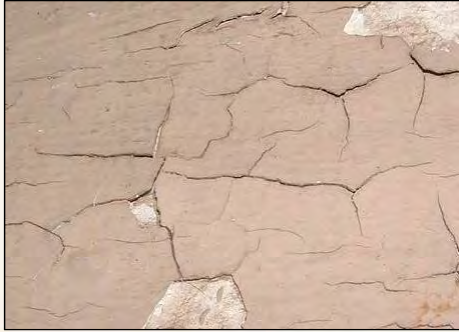
## CPC - Peeling / Bubbling / Cracking (3530)

| CS 1 - Good | CS 2 - Fair | CS 3 - Poor | CS 4 - Severe |
|---|---|---|---|
| None. | Finish coats only. | Finish and primer coats. | Exposure of bare concrete. |

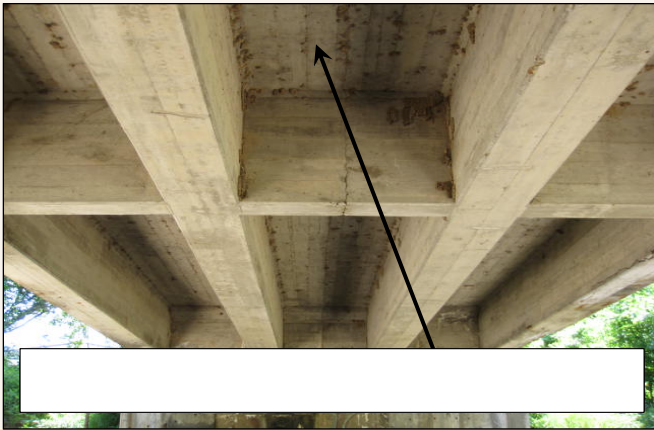
## Decks / Slabs – RC Top Flange

- Element 16 – RC Top Flange
  - Quantity is for top flange riding surface only
    - Girder web and bottom flange evaluated by appropriate girder element
  - Assess similarly as decks/slabs
  - Additional wearing surface or protective systems addressed separately
  - Reinforced concrete condition state definition

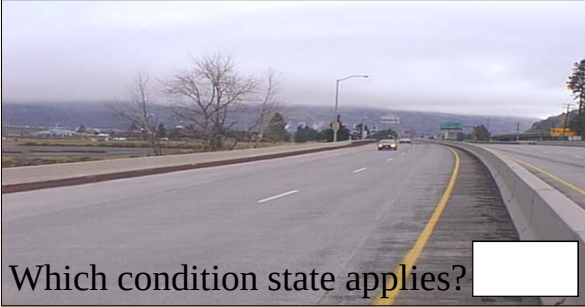
No spalls, delaminations or patches. 0.03 in. wide cracks at 2 ft. spacing throughout.

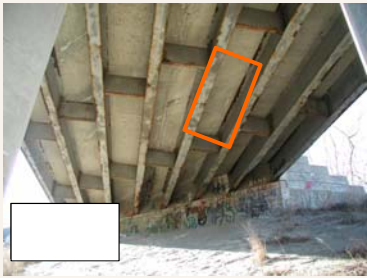
No spalls and/or delaminations. 50 sq. ft. of 0.010 in. wide cracks with efflorescence and spaced more than 3 ft. apart.

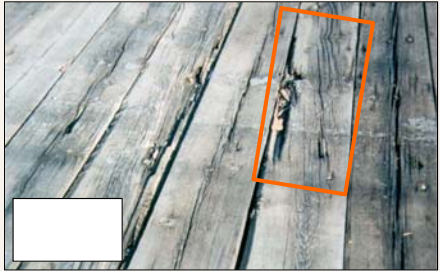
2 sq. ft. of decay greater than 10% of section and split length greater than member depth.

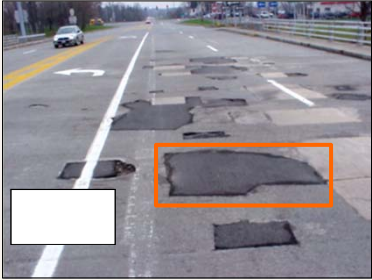
5 sq. ft. patched area that appears to be sound.

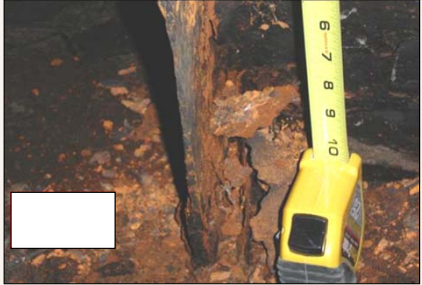
2 ft. of deep pitting.  
More than 10% section loss.  
Flaking steel.

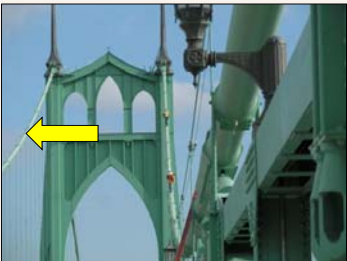
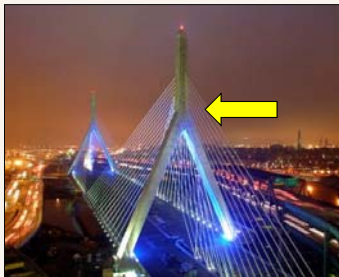
## Superstructure – Steel Cables

147 – Steel Main Cables  
Main suspension or cable stay cables  
not embedded in concrete.

Units – Length (ft.)  
Sum of the lengths measured  
longitudinally along the travel way.

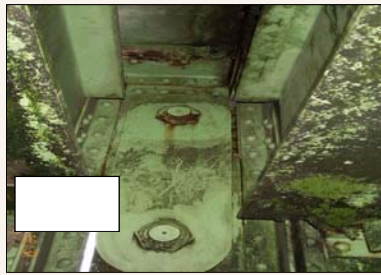
Freckled rust. No cracks.  
Connection sound.

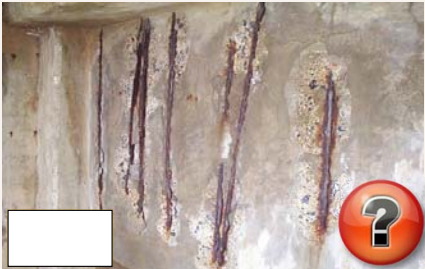
15 ft. of spalls greater than 1 in. deep with exposed reinforcing steel near girder end. Exposed rebar has no measureable section loss.

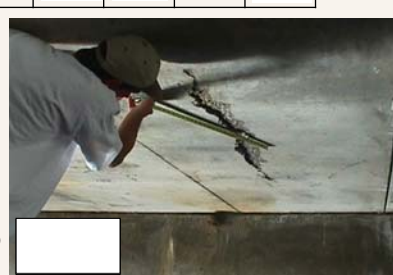
4 ft. of delaminations with spall greater than 1 in. deep.  
No exposed steel.

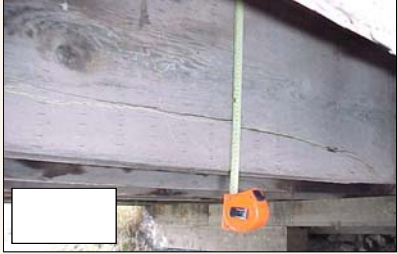
10 ft. long split that is greater than the member depth. No prior structural review with this defect.

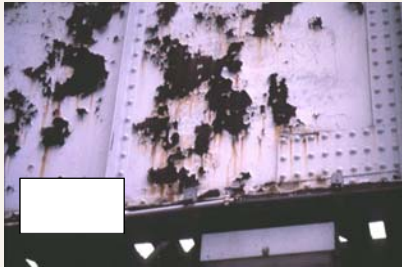
25 sq. ft. of peeling with exposed bare metal.

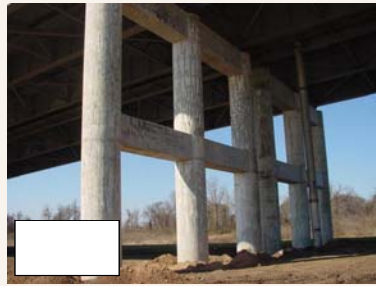
1/32 in. (0.031 in.) wide cracks throughout at 1 ft. spacing.

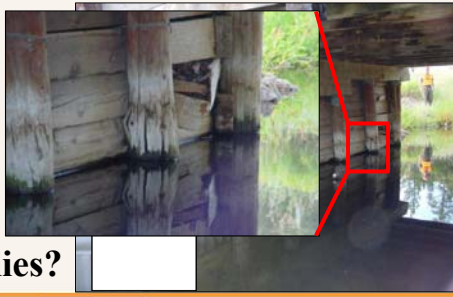
1 pile with decay greater than 10% and crushing.

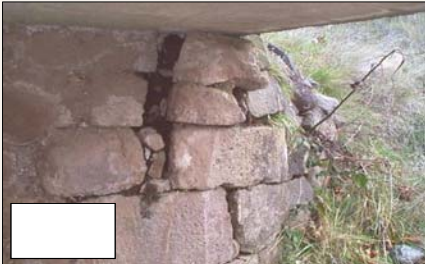
5 ft. of complete mortar loss, separation of stones and loss of bearing support.

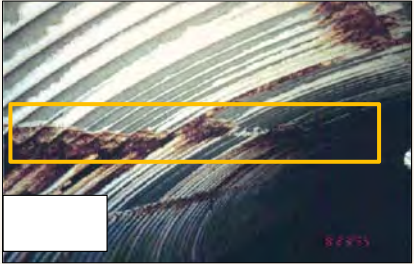
30 feet of corrosion with section loss, no impact on load capacity. No distortion, cracking, or separation of seams.

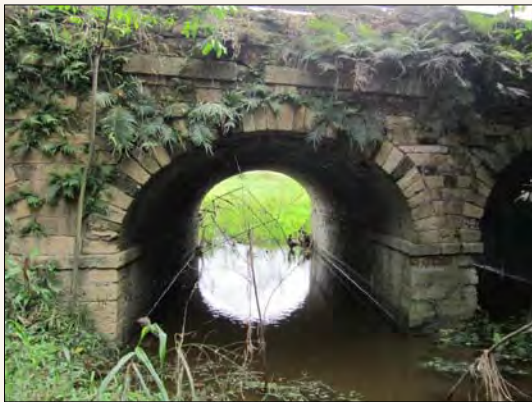
Element 244

Masonry block or stone culverts.

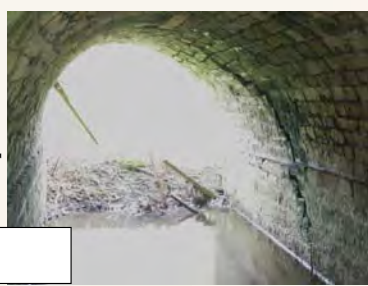
2 ft. of block has significant shifting at a masonry joint that does not impact strength or serviceability. Surface white efflorescence. Mortar and blocks intact.

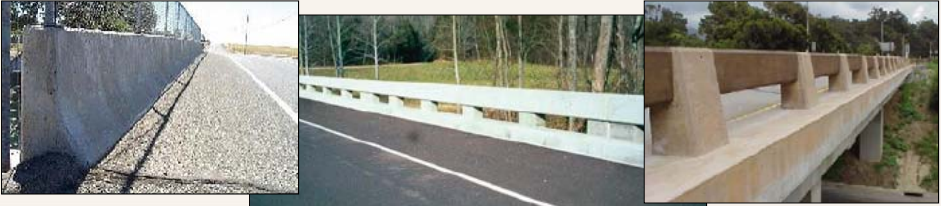
- All types and shapes of RC bridge railing
- All elements of the railing must be concrete
- Quantity is the number of rows of bridge rail on the bridge times the length of the bridge

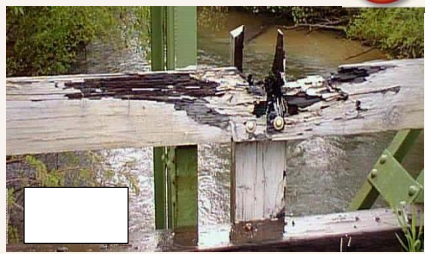
8 ft. of decay affects more than 10% of the member and impacts strength of the element. Missing fasteners.

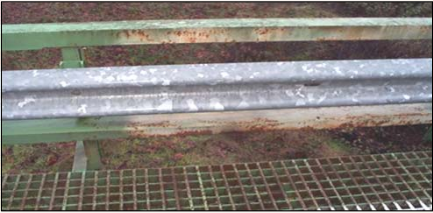
- Element 515
  - Paint
  - Galvanizing
  - Metalizing
  - Weathering steel patina
  - Other top coat steel corrosion inhibitor

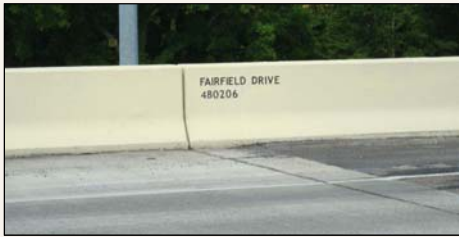
- Element 521
  - Water proofing and crack sealers
    - Silane/siloxane
    - High Molecular Weight Methacrylate (HMWM)
  - Any top coat barrier that protects concrete from deterioration and reinforcing steel from corrosion

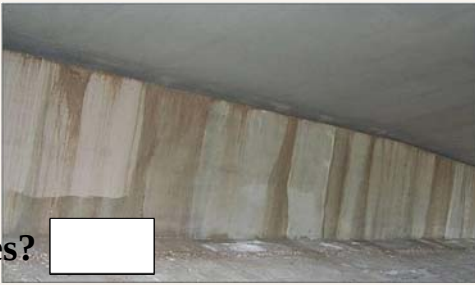
Free flow of water through the entire length of joint.

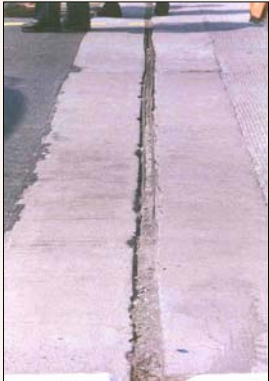
- Joints filled with a preformed compression type seal
- May or may not have an anchor system to confine the seal
- Element 302

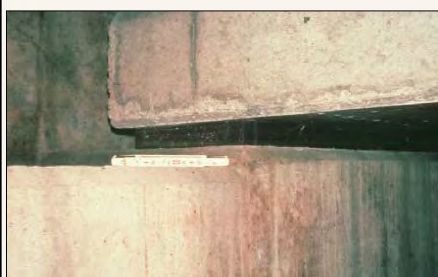
Element 310 - Bearings constructed primarily from elastomeric material (ex. rubber, neoprene) that may contain fabric or metal reinforcement

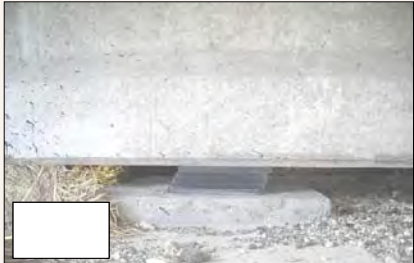
Alignment at 10 bearings is inconsistent with current temperature, but tolerable.

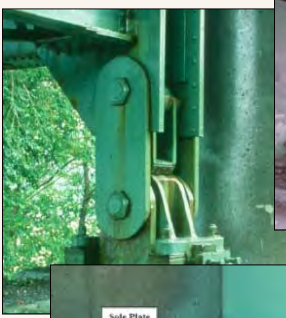
Element 311 - Bearings primarily constructed of steel that provide for both rotation and longitudinal movement by means of roller, rocker, or sliding mechanisms

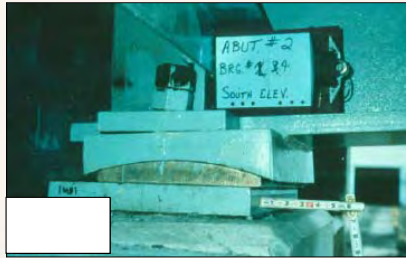
5 bearings with alignment beyond tolerable limits and bent anchor bolts. No defects for remainder of bearings.

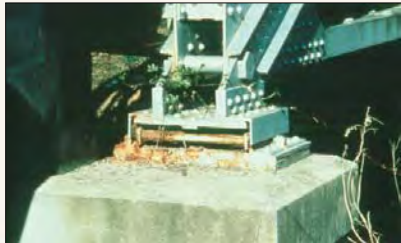
- Element 312 - Not open/visible for detailed inspection
- Assess the condition based on
  - Alignment
  - Grade across the joint
  - Persistence of debris
  - Other indirect indicators

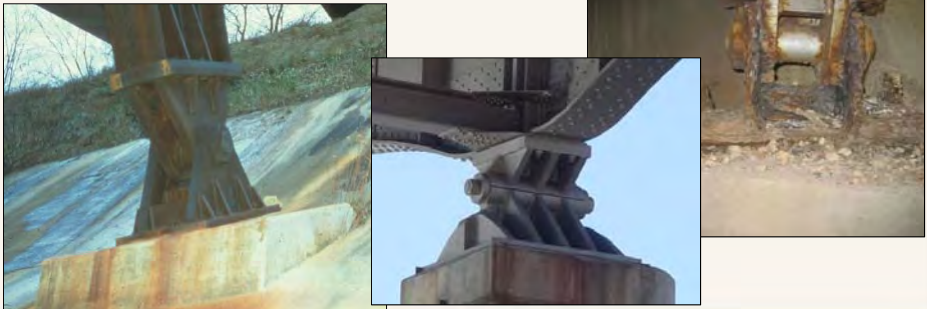
Element 313 - Bearings that provide for rotation only (no longitudinal movement)

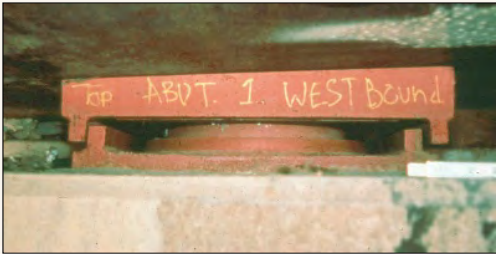
Element 314 - Capable of high loads, contain a confined elastomer, allow movement in multiple directions

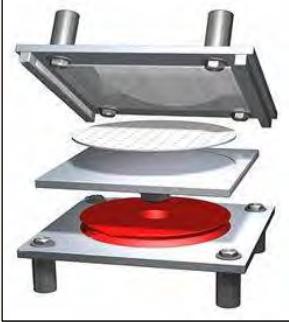
Element 315 - Capable of high loads, contains a hard plastic disk, allow movement in multiple directions

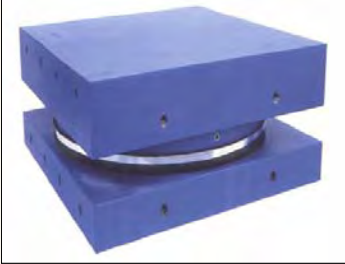
Element 316 – Bearings constructed of materials that cannot be classified using other defined elements, regardless of translation or rotation constraints.

**Friction  
Pendulum**  
Use 316 or 311  
or ADE-NBE

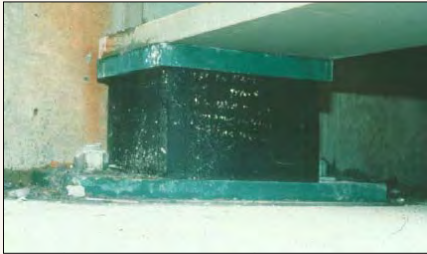
Use 310 or 316 or  
ADE-NBE

Lead Core Seismic  
Isolation Bearing

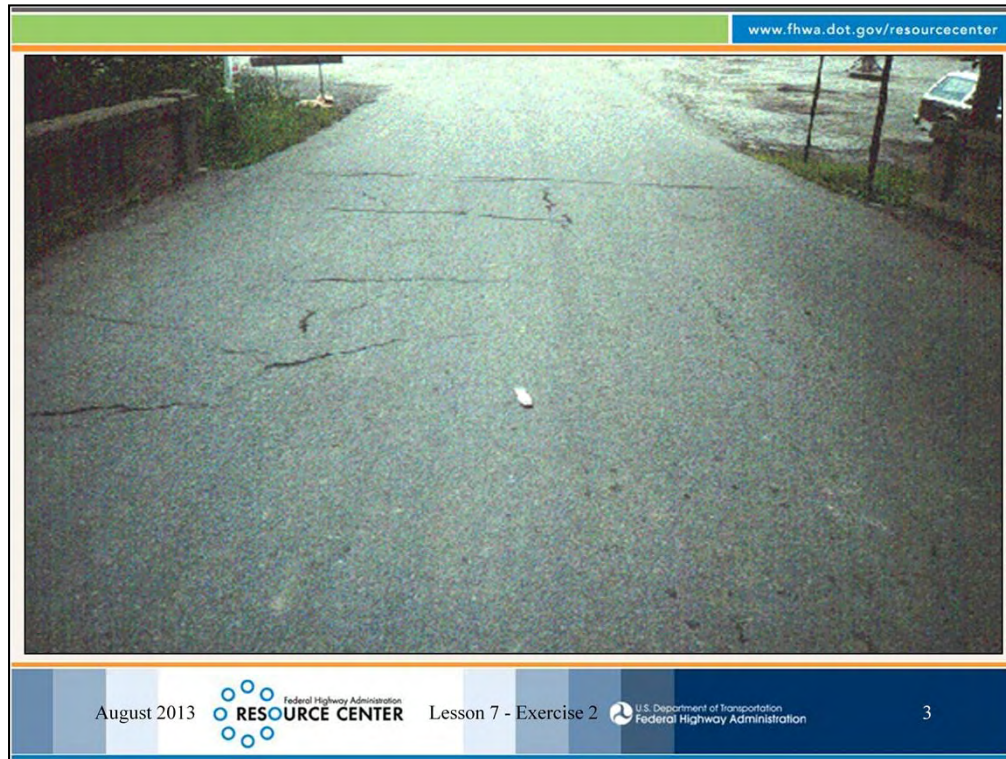
Wearing Surface: Asphalt wearing surface 20 ft. wide by 30 ft. long with random transverse and longitudinal cracks that vary from 1/4 in. to 3/4 in. wide over a 180 sq. ft. area. Remaining area has no noteworthy deficiencies.

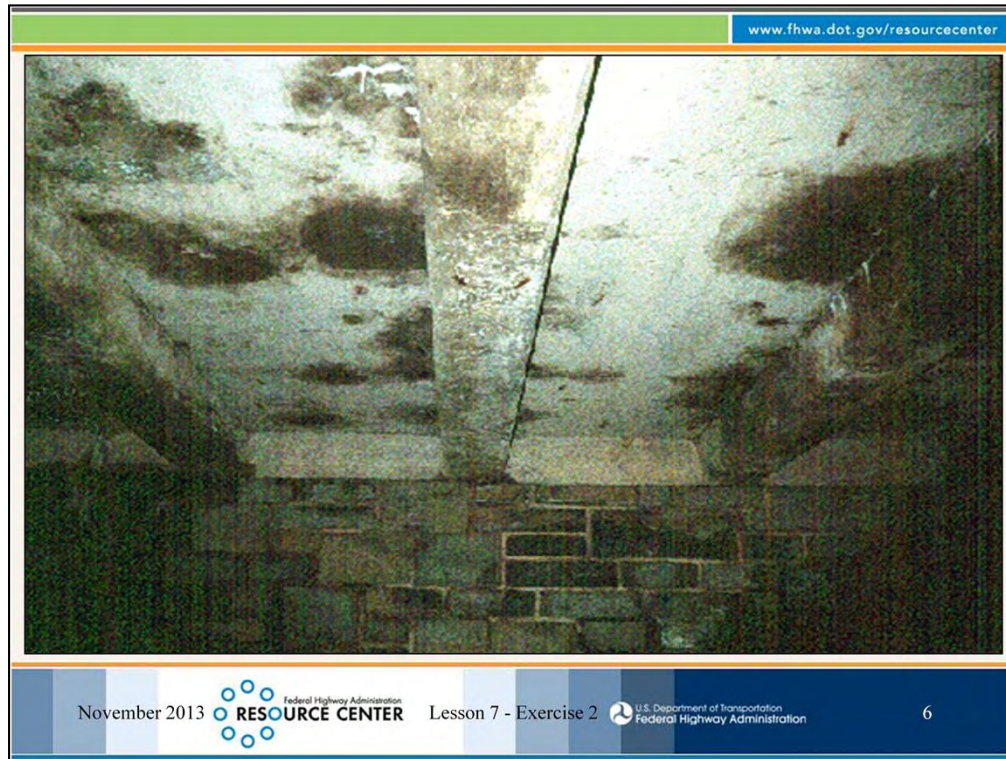
Superstructure, Beam 2: Longitudinal cracks up to 0.05 in. wide throughout with efflorescence and no rust staining. Dark stained areas are delaminations that exist for the full length. No exposed reinforcing steel.

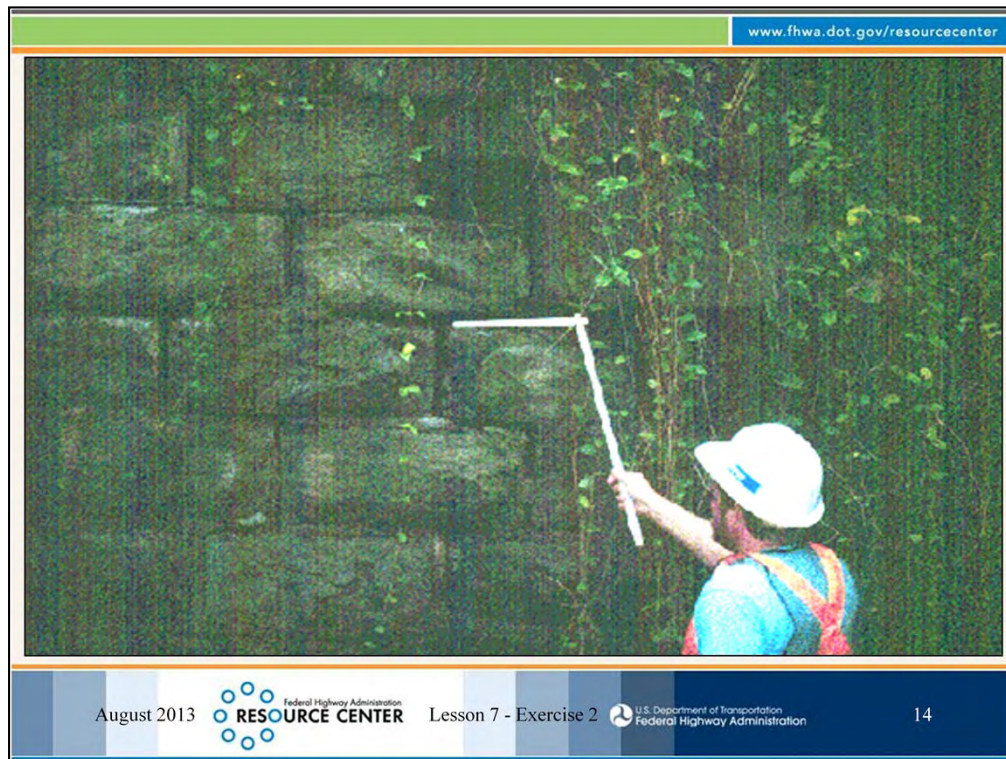
Substructure, Abutment 2: Far downstream wingwall. Wingwall is 10 ft. long and integral with abutment. Failure of stone with portions missing at streambed level for a 2 ft. length.

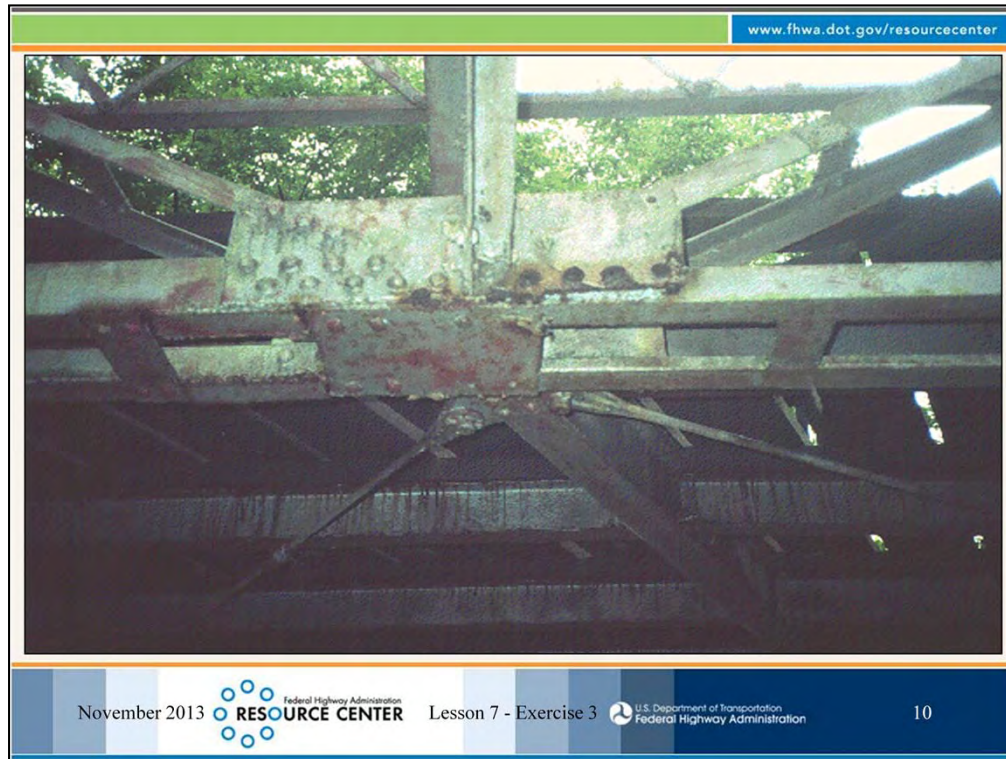
Superstructure, Truss: There is corrosion and section loss of the top chords and end posts with rust packing between channel member and top plate. Typical for entire length of trusses.

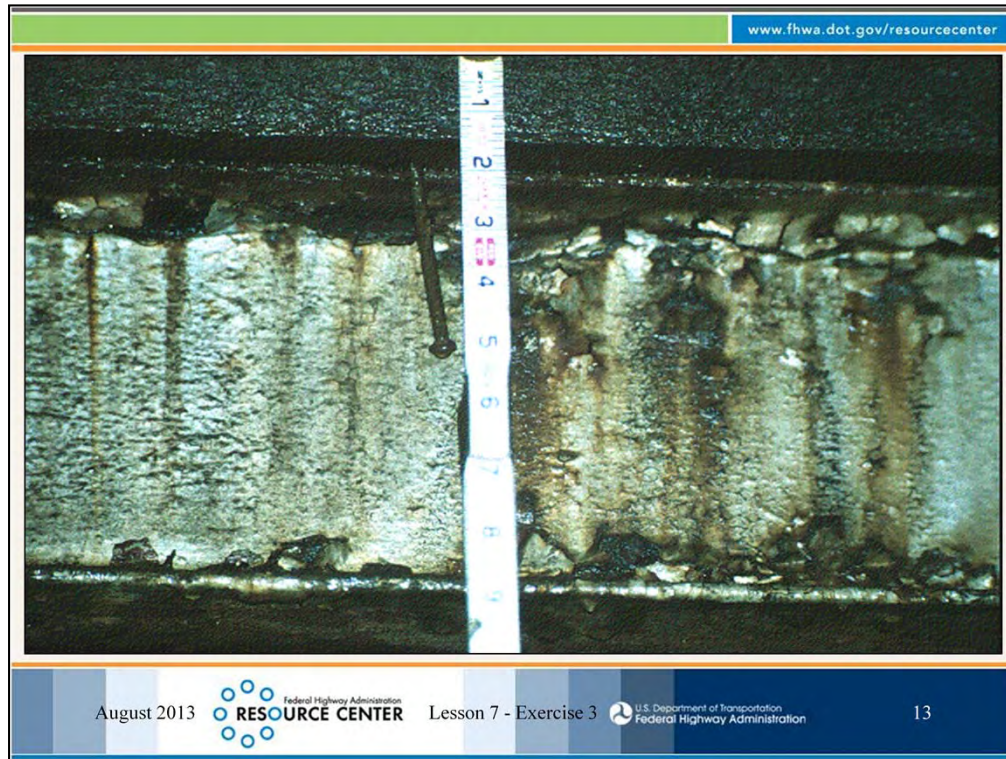
Superstructure , Stringers: Typical stringer to floorbeam connection. All connections are sound.

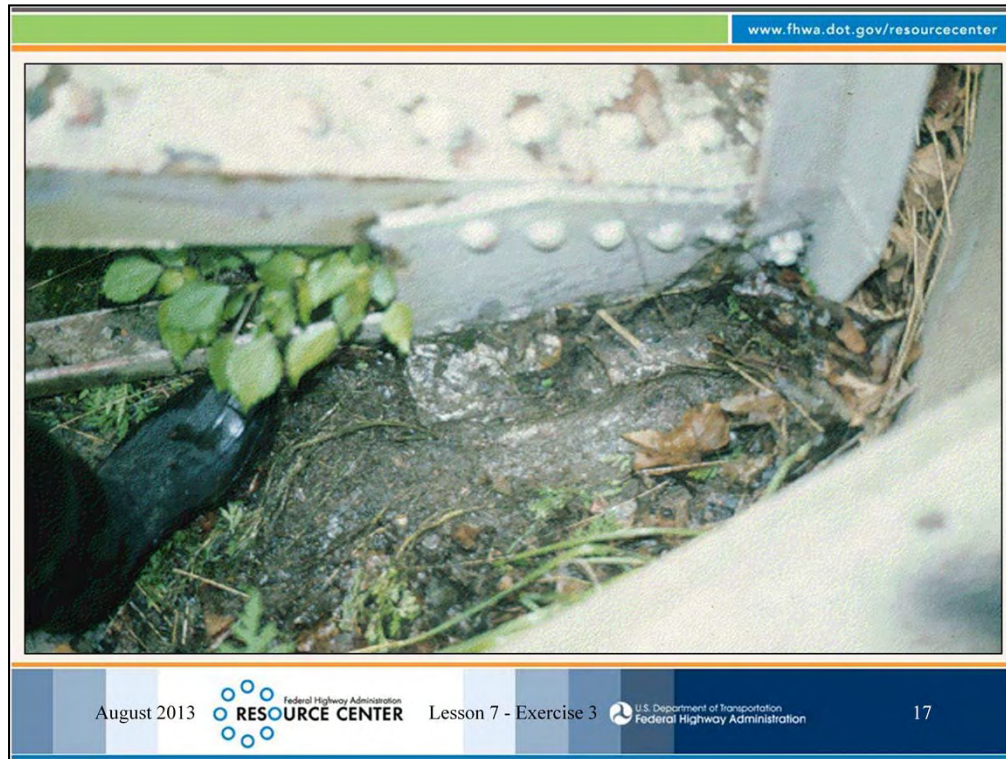
Movable Bearings: Near abutment upstream sliding plate expansion bearing has corrosion with section loss and coating is no longer effective. Typical condition both bearings. Coating system area for bearings is 2 sq. ft. per bearing.

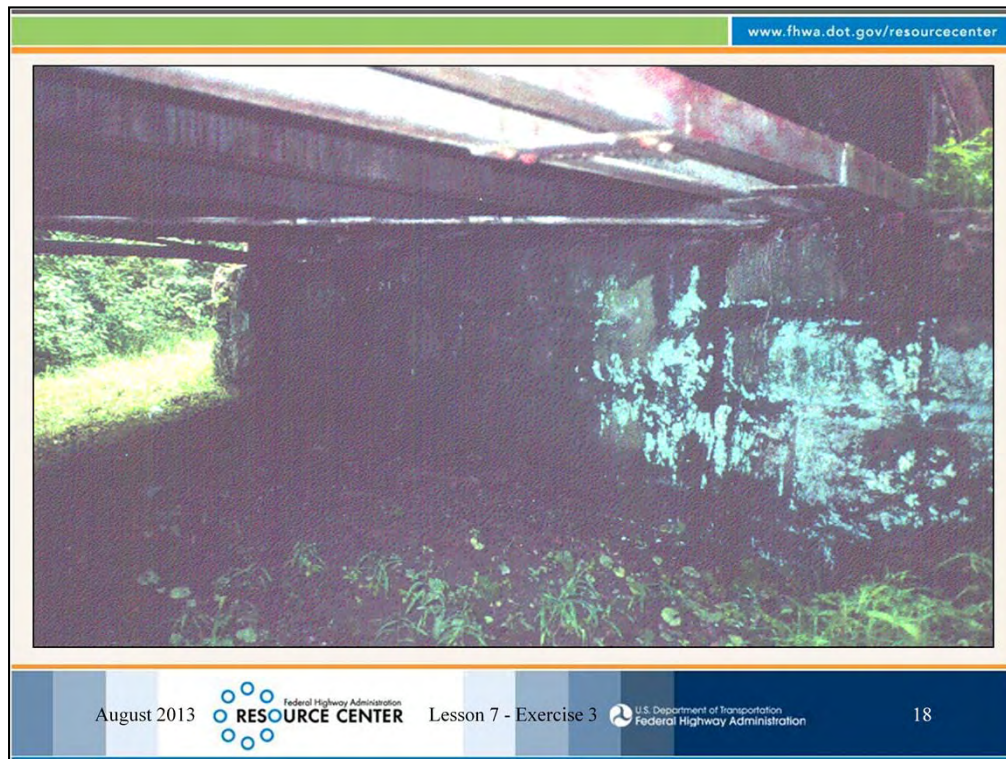
Fixed Bearings: Far abutment upstream fixed steel plate bearing. No noteworthy deficiencies. Coating system area for bearings is 2 sq. ft. per bearing. Coating system is substantially effective.

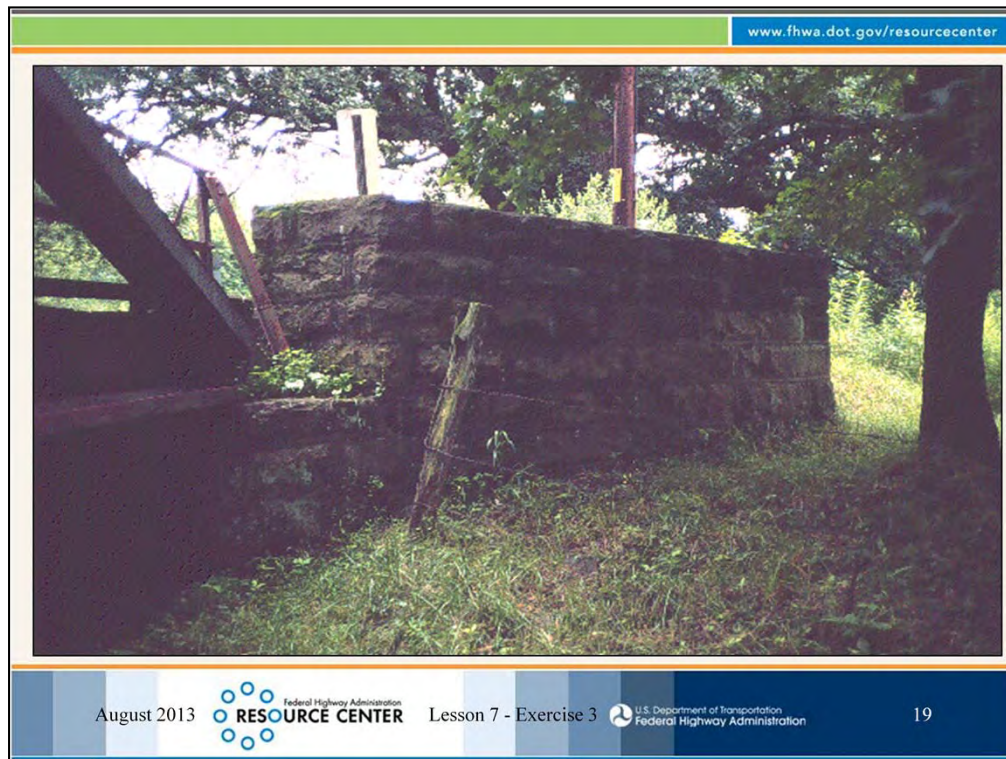
Substructure, Abutment 1: General view of near abutment. Stone masonry construction. Abutment face measures 19 ft. long. All stones and mortar joints are sound.
