# Introduction to Element-Level Bridge Inspection

## Participant Workbook (1-Day Version)

U.S. Department of Transportation  
Federal Highway Administration

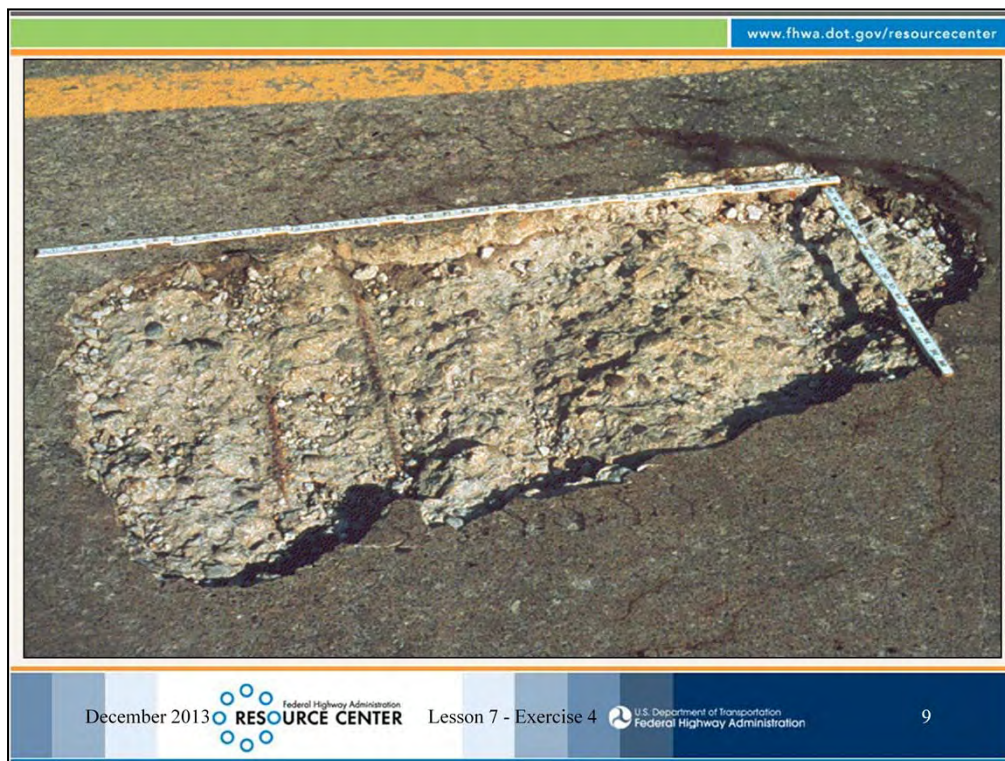
Deck: Span 4 at mid-span of the right lane. Spall greater than 6 in. diameter with exposed reinforcing steel (10 sq. ft.). There is no section loss of the exposed reinforcing steel.

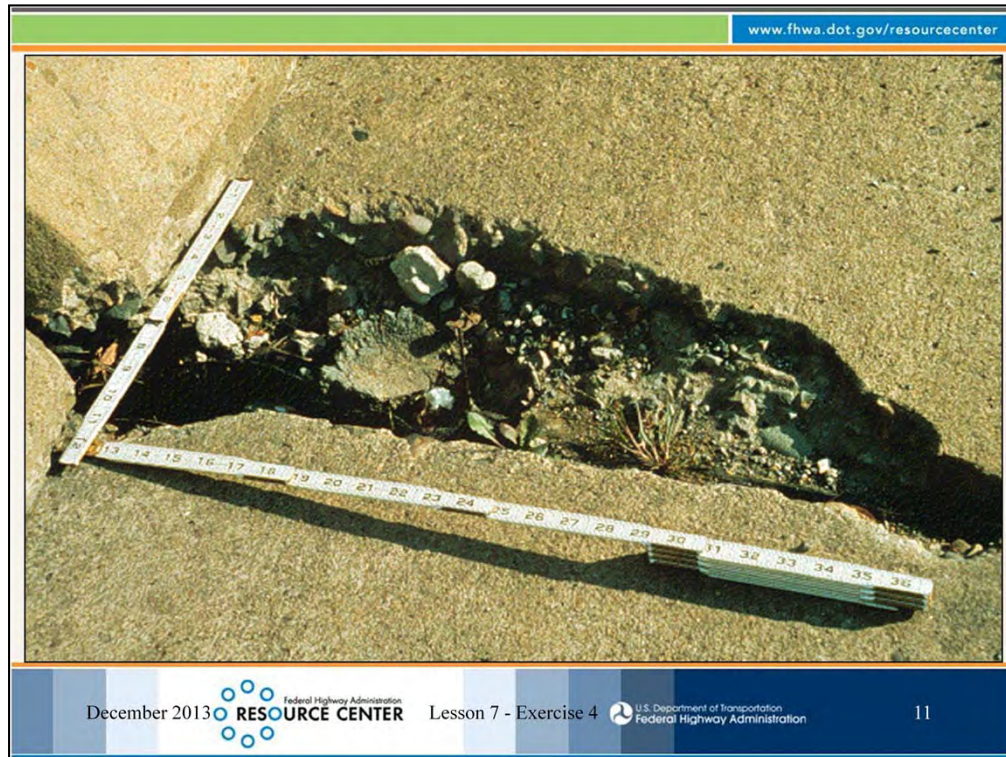
Deck: Spall greater than 6 in. diameter (2 sq. ft.) located at left side of deck at Bent 1 expansion joint.

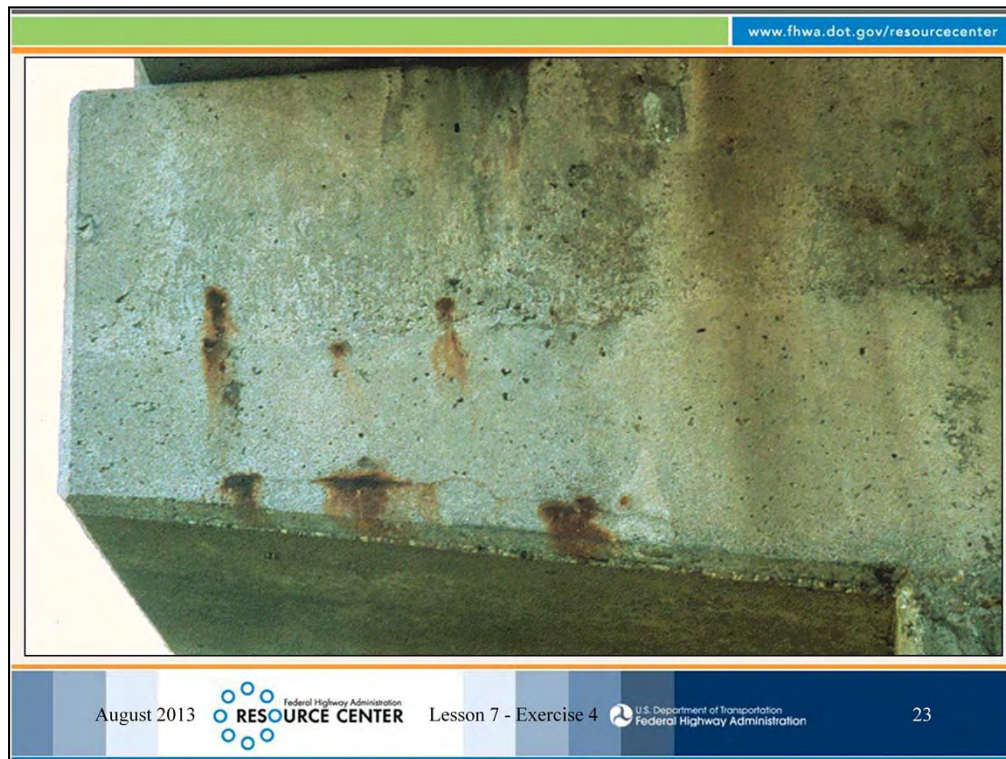
Substructure, Bent 3: Bent cap has 2 ft. long 0.04 in. wide crack and rust staining at Bent 3 on the left side of the near (west) face.
