# **FATIGUE LIFE OF DOUBLE NOTCH ALLOY STEEL BREAKAWAY COUPLINGS**

**Illinois Department of Transportation  
Bureau of Materials  
126 East Ash St.  
Springfield IL 62704**

**July 2022**

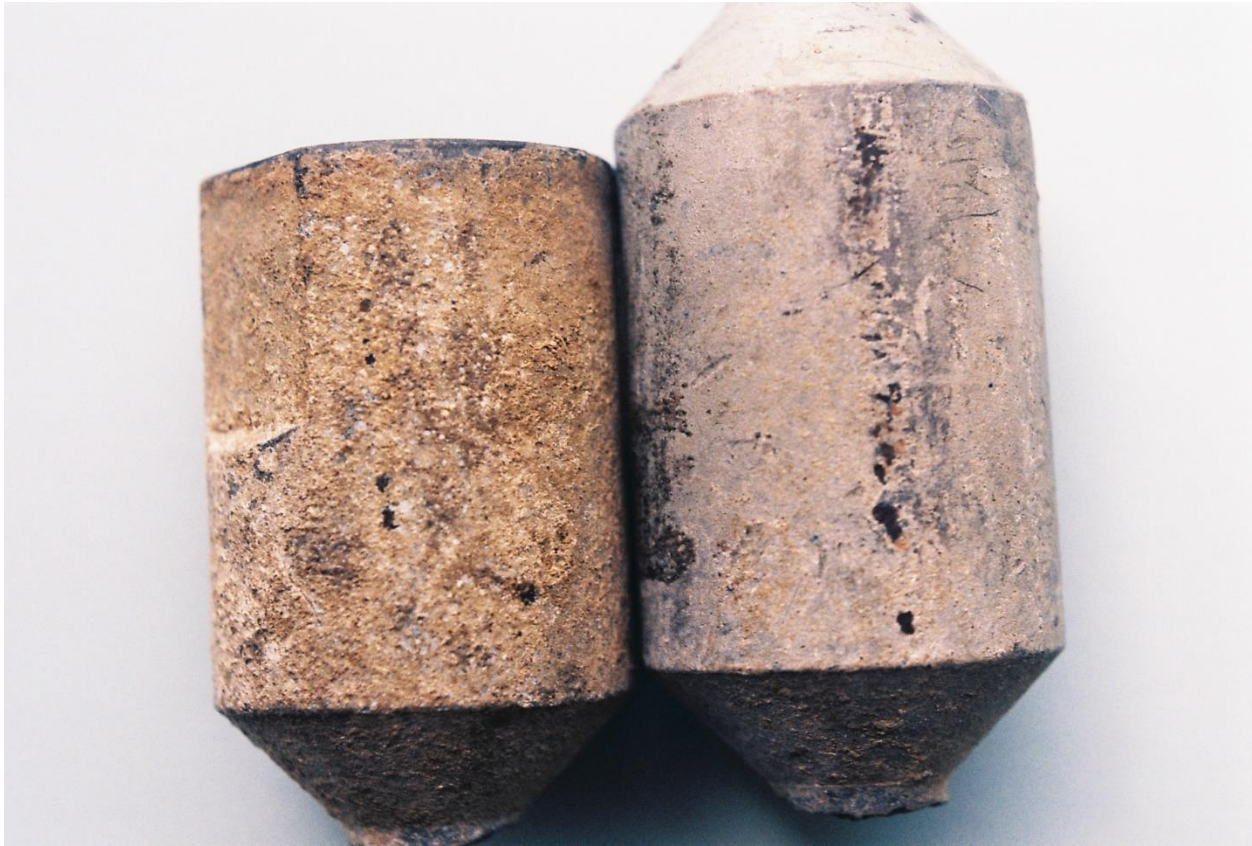
*Figure 7.* The zinc coatings on the couplings had degraded by forming zinc oxides and chlorides (oxides are white and yellow; chlorides are white) as a function of long-term exposure to moisture, salt spray and the accumulation of dirt and debris. Note the formation of pits in the sides of the couplings when the zinc coating was depleted. Pits also formed at notches, leading eventually to deeper cracks.

6. *Loss of zinc coating.* There are several areas on the galvanized coatings where loss of zinc resulted in penetration into the steel substrate (see *Figures 7 and 12-15* for photos). Two couplings had sustained a considerable loss of zinc, as shown by surface roughening and the formation of zinc oxide which covers more than 80% of its surface. According to the Model 4100 information sheet, the couplings were galvanized in accordance with ASTM A653. Specifying this standard makes no sense because A653 is for sheet products. The correct standard for bar products is ASTM A123. If A123 was specified, based on the size of the coupling, typical zinc thickness would range from 3.0 to 3.9 mils. The average zinc thickness on the recovered couplings was 2.99 mils on virtually uncorroded areas, which indicates that the couplings probably would have met the requirements of A123.

Veterans Parkway of Illinois 4 has a suburban atmosphere. However, the couplings are at ground level where they are subject to salt-spray during the winter and moisture condensation during the spring, fall and summer, along with pickup of debris. The long-term corrosion rate for zinc for hardware and structural shapes in atmospheric environments where the zinc is well-drained and dried is 0.097 to 0.104 mils/year, but if subject to salt spray or salt fall the corrosion rate increases to [Ref. 17, p. 106]. If the zinc coating (Zinc its Corr resistance, p106. When zinc is coupled to an alloy steel, its corrosion rate is elevated considerably [Ref. 17, p. 151]. More recent studies of pure zinc in mild saline solutions showed that within 14 days, zinc sustains a corrosion rate of 2.5 mpy [Ref. 18] Y. Meng, et al, Initial Formation of Corrosion Products on Pure Zinc in Saline Solution, *Bioactive Materials*, Vol 4., Dec 2019, pp 87-96. Since the zinc is constantly picking up moisture by condensation and near ground level where dust collects, the corrosion rate is 2.5 mils/year (mpy) upon initial exposure. To adjust to temperature effects in Illinois from 20°C to 10°C, this rate is reduced by a factor of 0.532, making the initial corrosion rate 1.33 mpy. For a coating thickness of 0.003" (3 mils), assuming complete uniformity of penetration and coating thickness, the galvanized zinc coating would be penetrated in 3.6 years turning to zinc oxides and chlorides. After receiving salt spray, a 3-mil zinc coating would be depleted in about 3 years in some sections of the coupling. The bottom sections sustained the largest losses of zinc coating. Due to formation of protective corrosion products, corrosion rates are substantially reduced to 0.2-0.3 mpy, whereby the zinc coating will be intact after 15 years. This of course assumes that the corrosion penetration rate is completely uniform. However, pits developed (they are black in color), which indicates penetration into the steel substrate. Typical surface conditions after exposures to conditions after 28 years are shown in *Figure 7*.

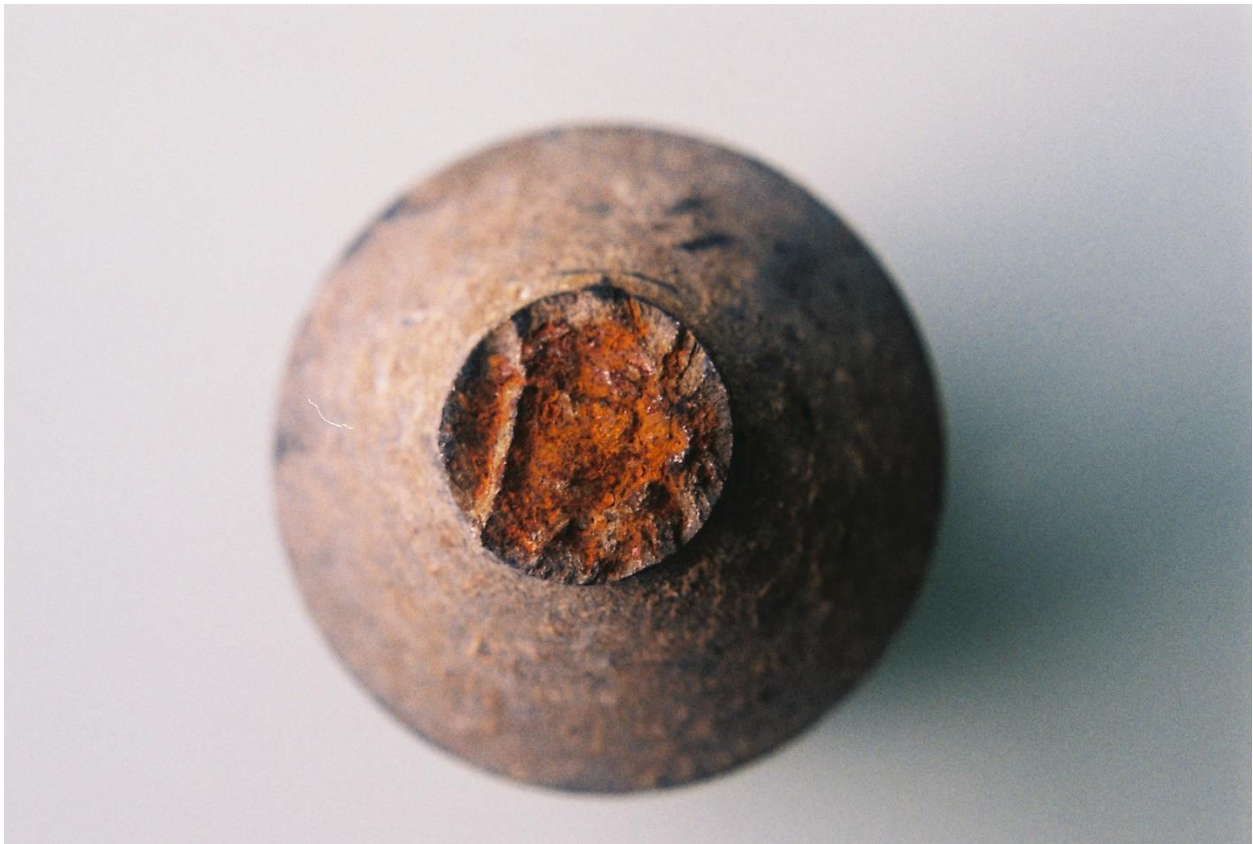
*Figure 13.* The initial crack surface shown here as the darker thumbnail-shaped area between the 2:00 to 4:30 position of the notched section. The coupling notch crack has a measured depth of 0.191”.

However, there are only a few insulated small areas where the zinc coating is still bright and virtually unoxidized on some couplings. About 95% of the remaining surface areas of the couplings are covered with zinc oxide and other corrosion products of zinc, primarily on the sides of the couplings, where complete penetration of the zinc to the steel substrate in the form of pitting was observed. Rusting of the cracked notch surfaces was evident, indicating inward propagation of surface cracks. The cracked surfaces showed minimal-to-substantial oxidation of the alloy steel, presence of crack initiation sites, fatigue propagation, and final markings of fast fracture rupture. See *Figures 13, 14, 15 and 16* for photographs of the cracked coupling surfaces.

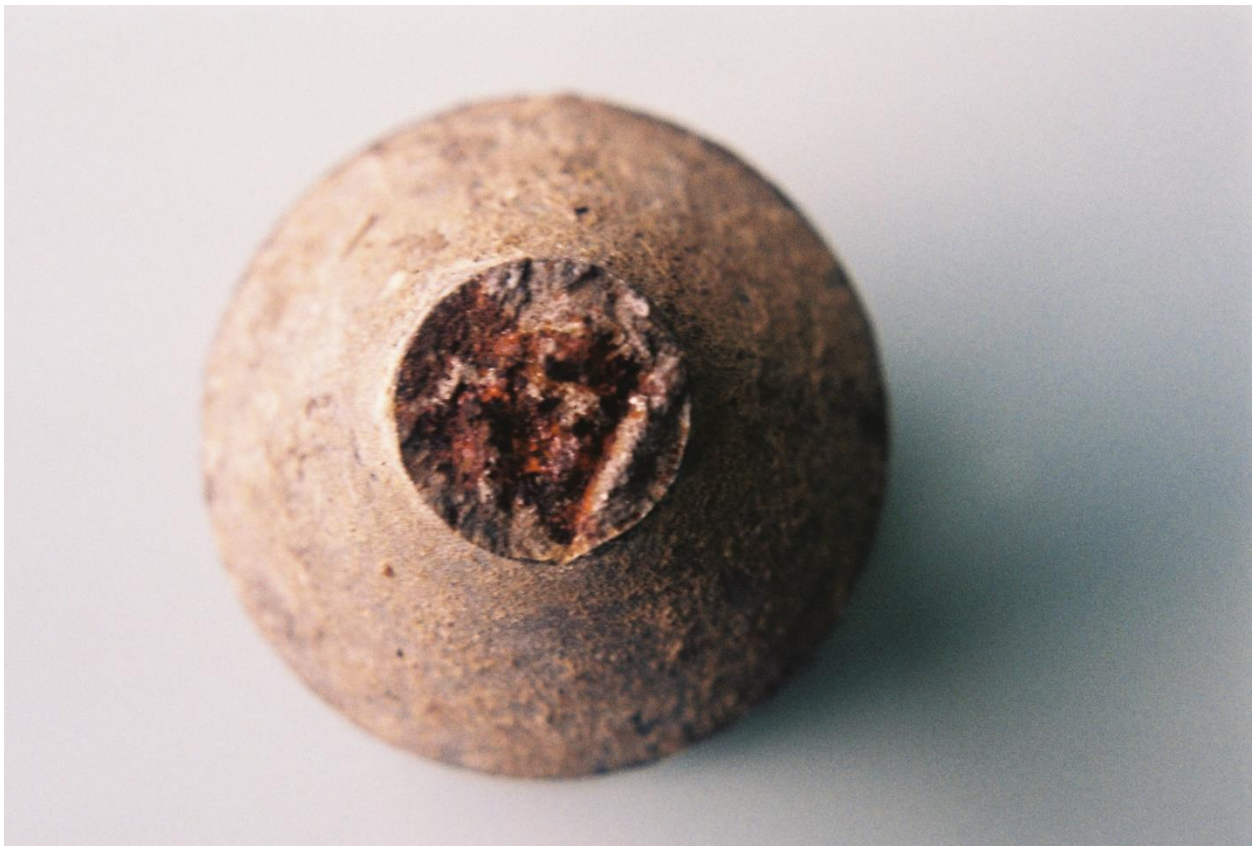
*Figure 14.* The other coupling with a prominent fatigue crack at the 6:00 to 11:00 position, with a shear lip at the 2:30 to 6:00 position. The initiation crack has a somewhat irregular shape, with the deepest penetration of 0.190” at the 10:30 position.

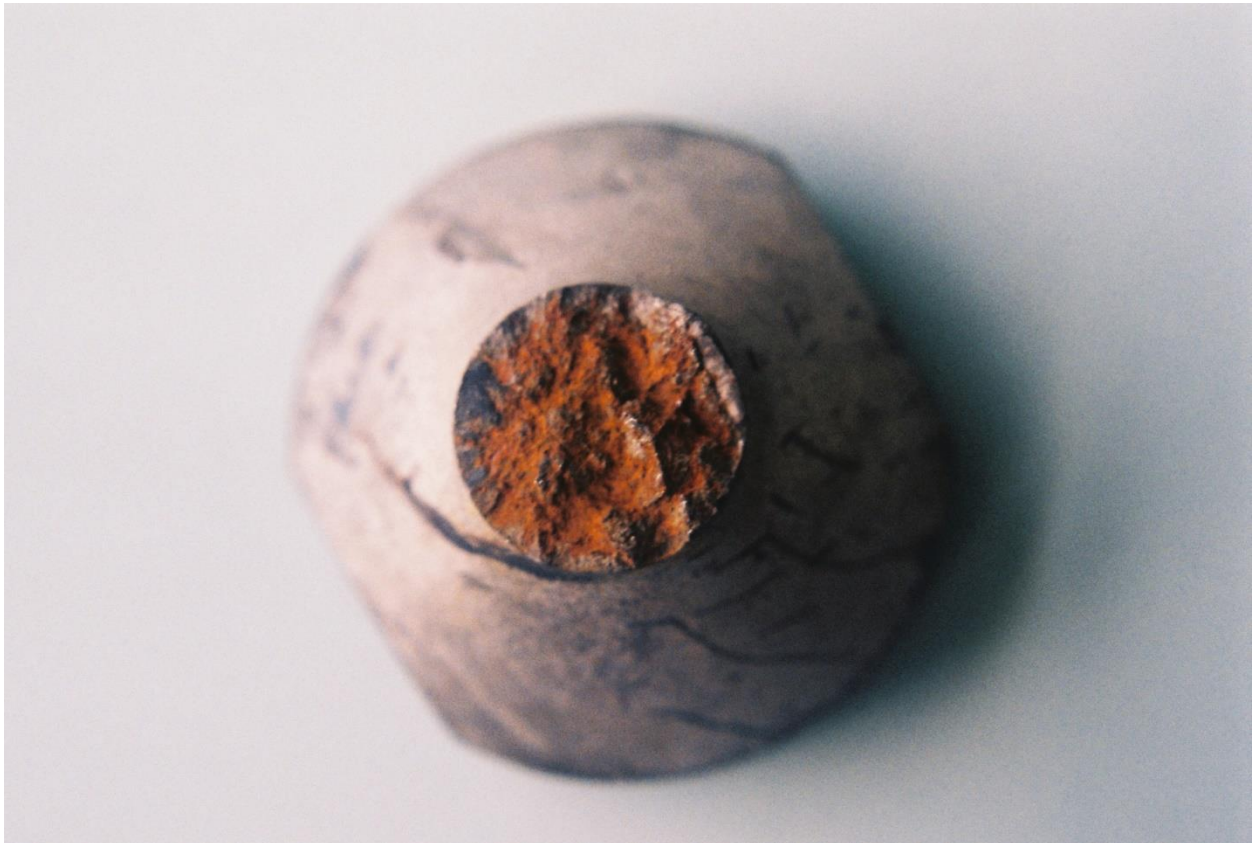
*Figure 15.* The third coupling has incipient initial fatigue cracks at the 8:00 to 10:30 clock position but exhibits relatively faster crack propagation fracture surfaces as loads were

transferred from the other two couplings that had sustained deeper cracking. Crack depth varies from 0.051" to 0.104".

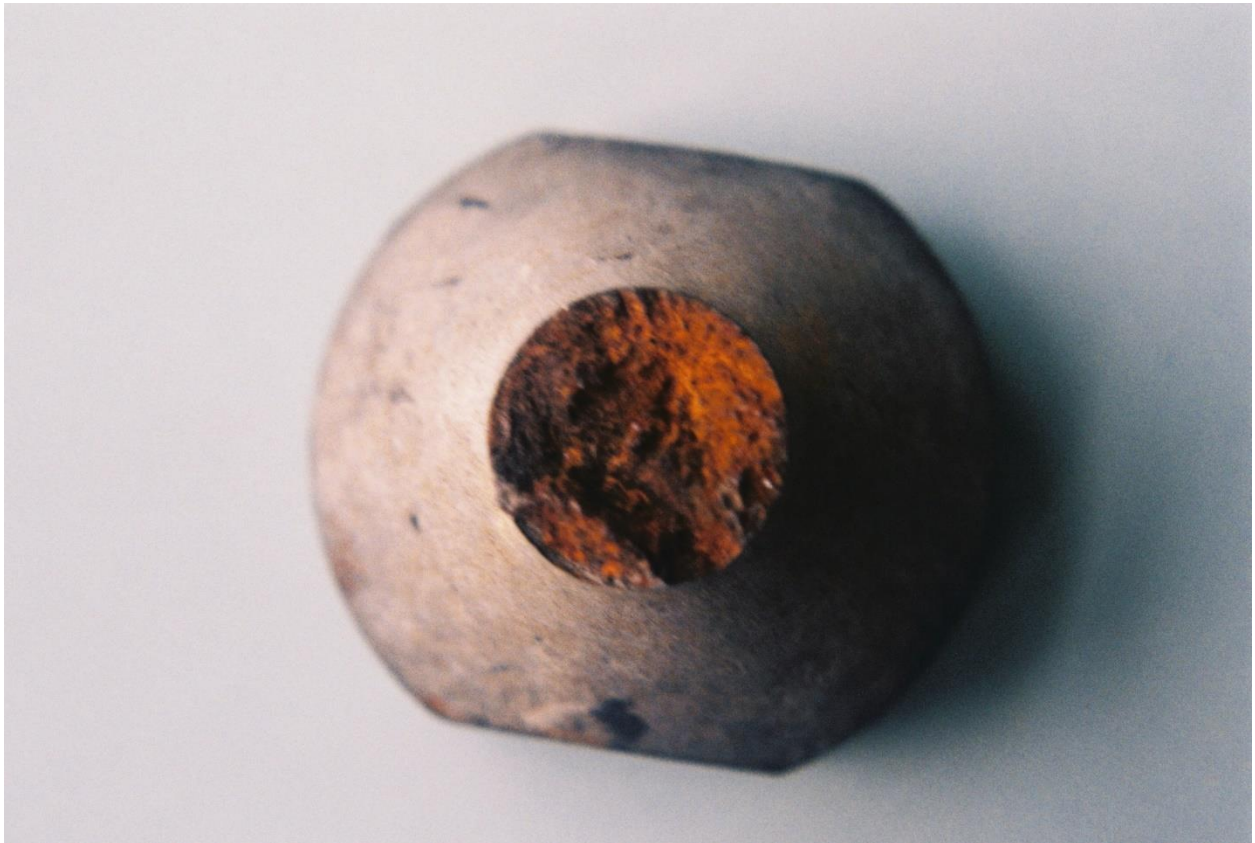
*Figure 16.* The fourth coupling, showing initial fatigue cracking at the 8:30 to 11:30 position at a depth of 0.171", leading to a fast-fracture river gorge-like pattern beginning at 12:00, shows divergence into a shear failure deep valley and peak of almost 70% of its ruptured section.
