# AGGREGATE SUBGRADE THICKNESS DETERMINATION

**PHYSICAL RESEARCH REPORT NO. 154**  
**August 2009**

**Illinois Department of Transportation**

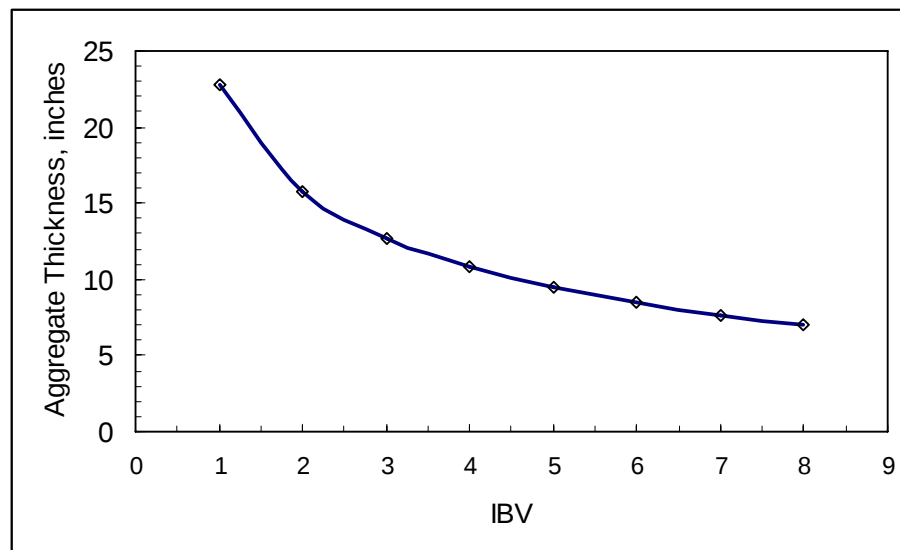
When using Equation 1 to determine aggregate thickness for a range of IBV, Thompson et al. considered an equivalent single wheel load of 12,000 lb and 5000 passes. Based on the combination of the finite element analysis results and repeated load studies, the results were multiplied by 60 percent to achieve the recommended thickness. Figure 1 graphically shows the results for a range of subgrade IBV assuming an 80 psi tire contact pressure.

**Figure 1. Aggregate Thickness Recommendations Based on Thompson et al.**

Figure 1 has been used by IDOT since 1982 to determine appropriate improved subgrade thickness, and the most recent edition of the Subgrade Stability Manual (IDOT, 2005)

reaffirms this chart's use. The minimum 12-inch improved subgrade thickness requirement is based on the assumption that most Illinois soils have an in-situ moisture content wet of optimum resulting in an in-situ IBV around 3 (IDOT, 2002). Figure 1 indicates an IBV of 3 requires a thickness of 12 inches. Although aggregate properties are not directly input, both Thompson et al. and the Subgrade Stability Manual (IDOT, 1982/2005) discuss the importance of aggregate properties to performance. They recommended a minimum Illinois Bearing Ratio (IBR) of 15 to 20 and an aggregate with low moisture sensitivity. Low moisture sensitivity was characterized by having crushed materials with a lower fines content having a low Plasticity Index (PI).

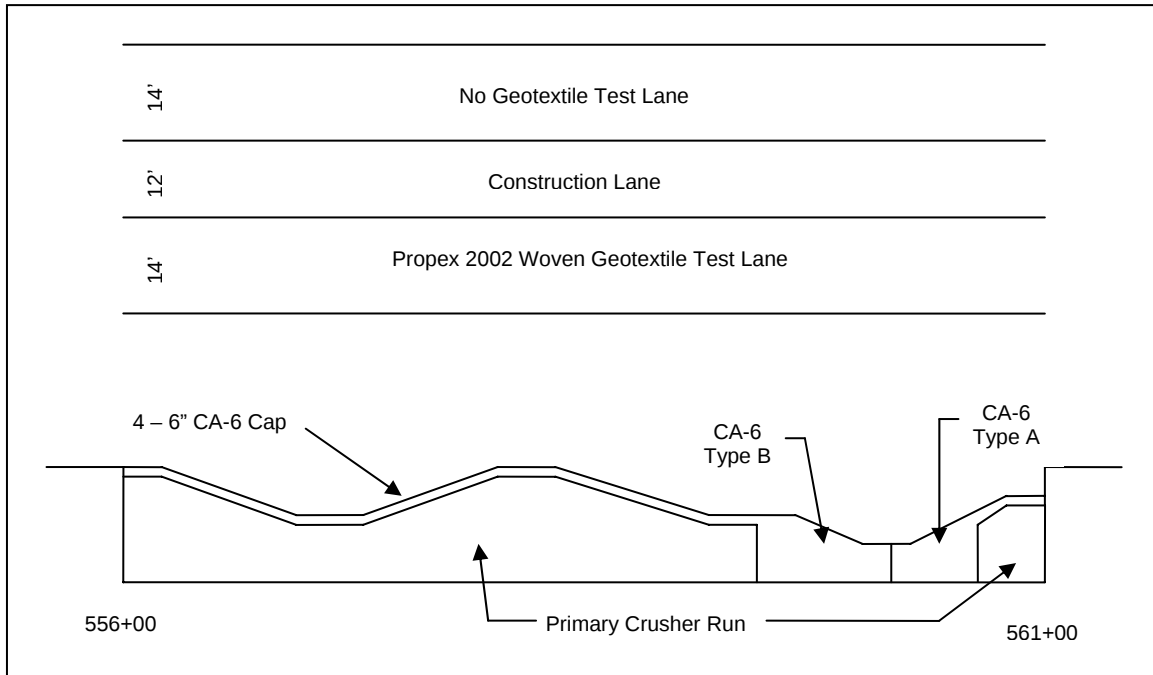
**Figure 2. Example Plan and Profile View from Northbound Lane**

Because of the difficulty involved with grading aggregate to a variable depth, actual test locations were determined based on comparing a detailed survey before and after placing aggregate. Because of the construction variability inherent with fine grading, some locations with a particular desired aggregate thickness could not be identified. Test locations were grouped according to the specific aggregate types being compared and similarity of soil conditions.

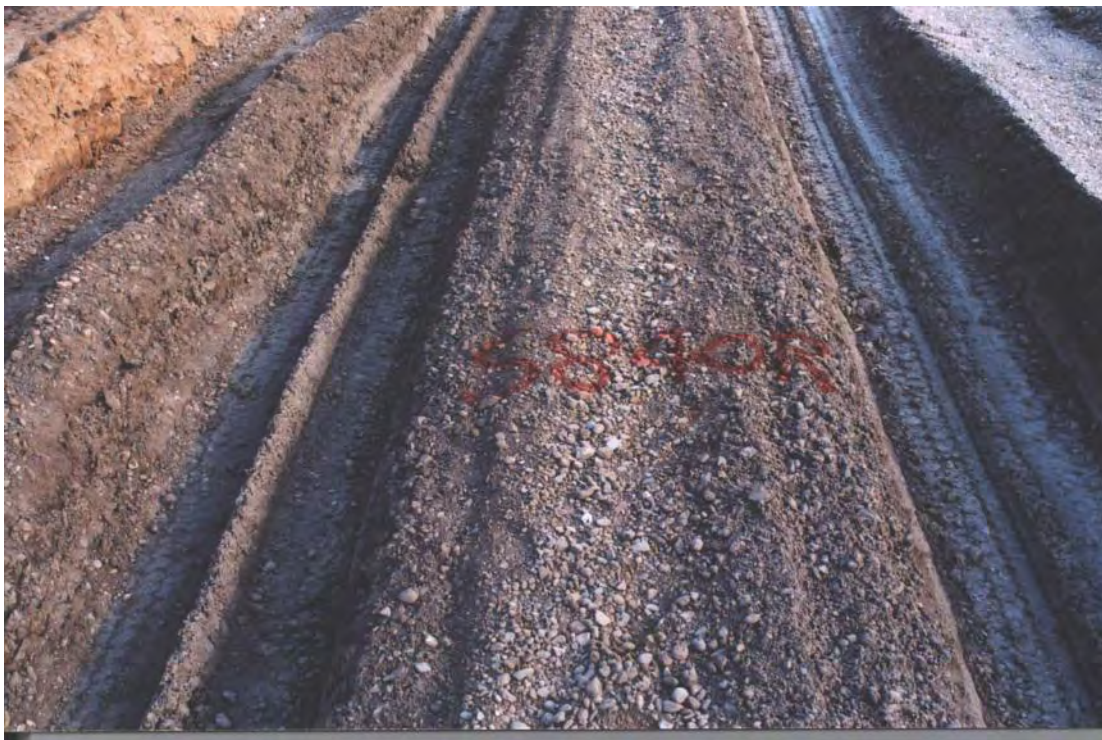
Figure 3 visually shows the magnitude of rutting representative of these locations. Accurately measuring rut depth was difficult in these situations because there was a combination of rutting and shoving. As a result, no meaningful data was obtained following the 10 load pass measurements. Trucks were diverted to the construction lane after about 20 passes because of difficulty driving through the ruts.

**Figure 3. Test Location S840R: 12" Gravel without Geotextile after 20 Load Passes**

The poor performance of this section may have been a direct result of inadequate compaction. The subgrade IBV was sufficient to support the aggregate thickness used, and the clay soil within the gravel test area was not prone to pumping. Therefore, most of the rutting occurred within the aggregate layer itself. If an area is compacted only to the "satisfaction of the Engineer," the quality of compaction can vary depending on the Engineer's bias and also material type. Both the gravel and CLS sections were compacted using the same compactive effort. The CLS was able to achieve a higher percent compaction perhaps due to a larger amount of fines.

The rounded particle shape of the uncrushed gravel is likely to have contributed to the higher rut depth when compared to the CLS. Also, the laboratory CBR data shown in Table 2 does not accurately represent the field performance of either aggregate. The laboratory CBR test was performed at close to the same percent compaction and moisture content of that observed in the field. The lab data indicated relatively high CBRs, which should have indicated the ability to support the 10 load passes. This shows CBR to be an unreliable test on gravel, most likely because of the confining effects of the mold.

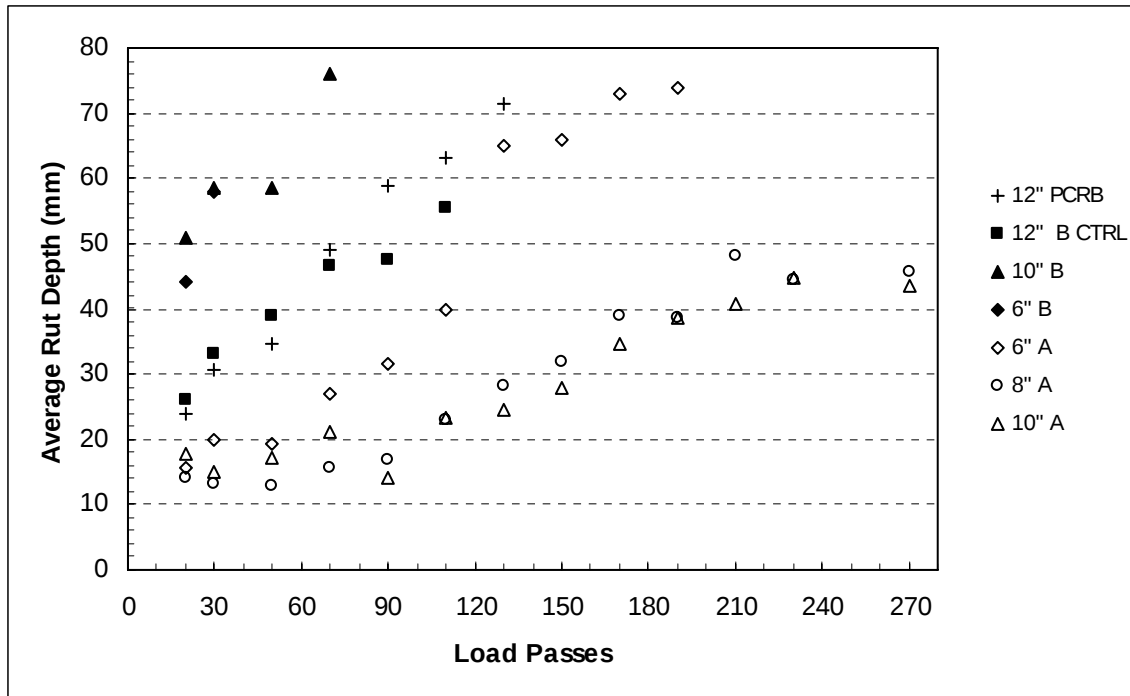
**Figure 5. Crushed Limestone CA-6 Rut Depth versus Load Passes with no Geotextile**

The data shown in Figure 5 indicates Type A materials outperform Type B materials. The rutting observed within the 12-inch Type B CLS control section was similar to that observed within the uncrushed gravel and RAP CLS control locations. However, the Type A material outperformed the control material at every thickness down to 6 inches. The oversize material capped with Type B material performed only slightly better than the control. With the exception of the 8-inch Type A CLS, all of the materials exceeded the maximum 0.5-inch (12.5 mm) rut depth allowed by IDOT policy (IDOT, 2005). Complete rutting data is shown in Appendix C.

The data shown in Figure 7 show a significant improvement in Type B CLS performance as load passes increase when compared with the no-geotextile data shown in Figure 5. When a geotextile is used, the Subgrade Stability Manual allows a one-third reduction in aggregate thickness (IDOT, 1982/2005). As a result, the control location consisted of 8 inches of Type B materials rather than the 12 inches used in the no-geotextile sections. The data indicates the sections with geotextile limited rutting to the required 0.5-inch (12.5 mm) maximum for less than 30 load passes.

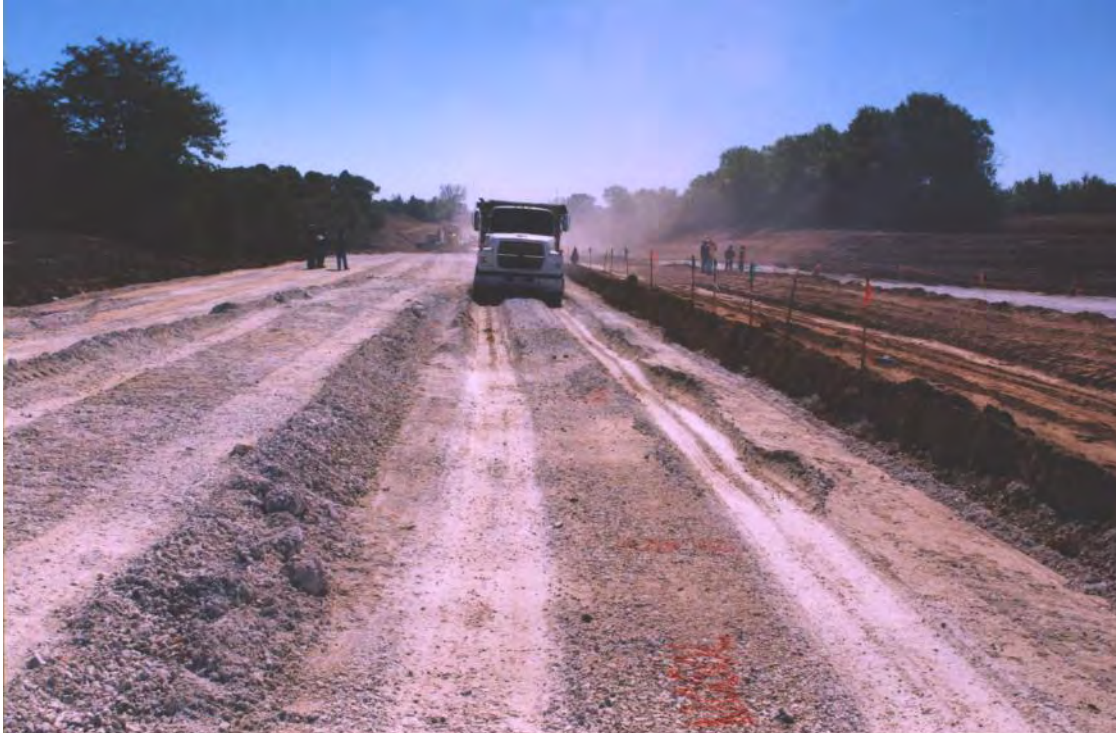
After approximately 20 load passes, the left most wheel path over the length of the Type B material showed approximately two times the rutting depth as the right wheel path as shown in Figure 6. The likely reason for these edge effects is inadequate compaction along the left edge. To compensate for this, the Type B data rutting data described in this section represents the average of the 2 rut depth measurements opposite the edge, with the largest two measurements along the edge discarded. The test location representing the 8-inch Type B material (N950L) has also been discarded because, even after compensating for edge effects, the rut measurement after 20 passes was 112 mm. This value is unrealistically high, especially given the measurements obtained at the 6-inch test location. A review of subgrade data indicates the high rut depth may have been due to a localized area with IBV less than 3.

**Figure 6. Loading Transition area between Type A (foreground) and Type B (background) CLS CA-6. Note edge effects the right side of the photo corresponding to the left wheel path**

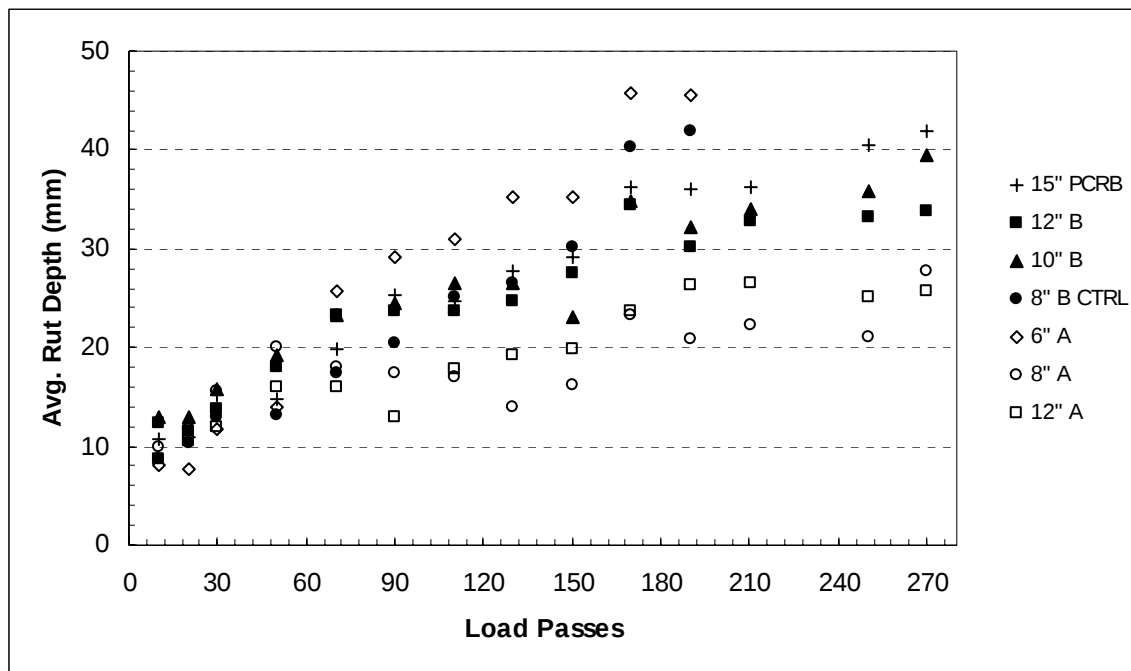
Figure 7. Average Rut Depth Versus Load Passes for CLS CA-6 over Geotextile

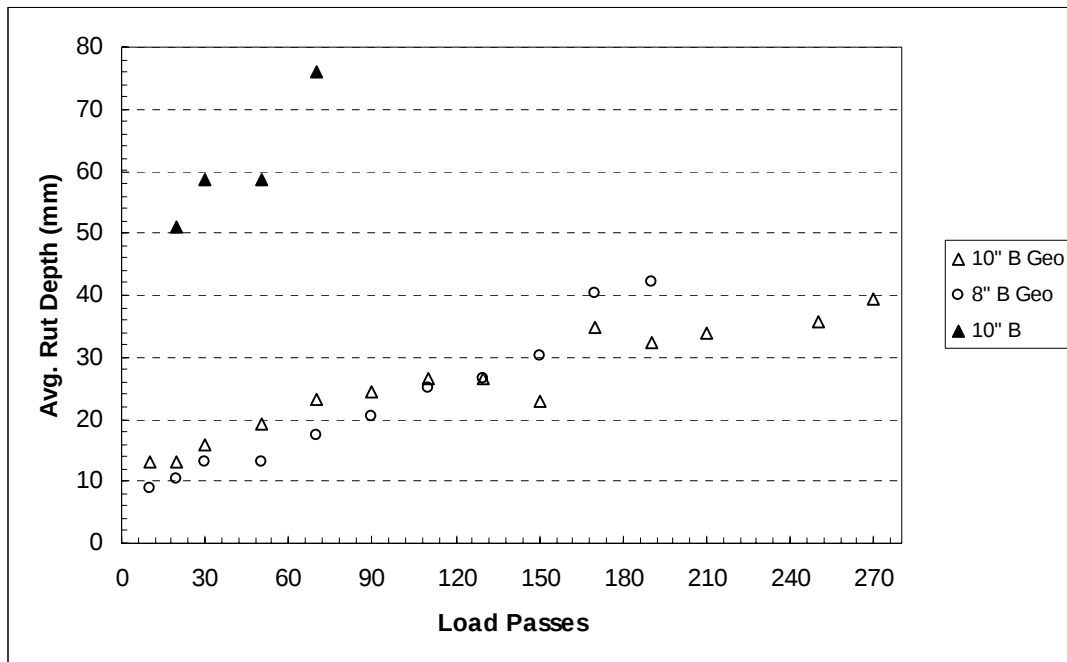
**Figure 8. Type B CLS With and Without Geotextile Rut Depth vs. Load Passes**

The data in Figure 8 shows the geotextile significantly improved the performance of Type B CLS. However, the data may be misleading. One reason the rutting data with geotextile is significantly lower than without geotextile is the lack of any observed edge effects within the geotextile test section. The lack of edge effects may be a result of better edge compaction within the geotextile section. However, it cannot be determined whether this is a result of construction variability or a benefit of using geotextile. The data for Type A materials in Figure 9 may provide a more accurate representation of the effect of geotextile.

Figures 8 and 9 below provide a clearer comparison between performance with and without geotextile. Figure 8 shows Type B materials and Figure 9 shows Type A materials.

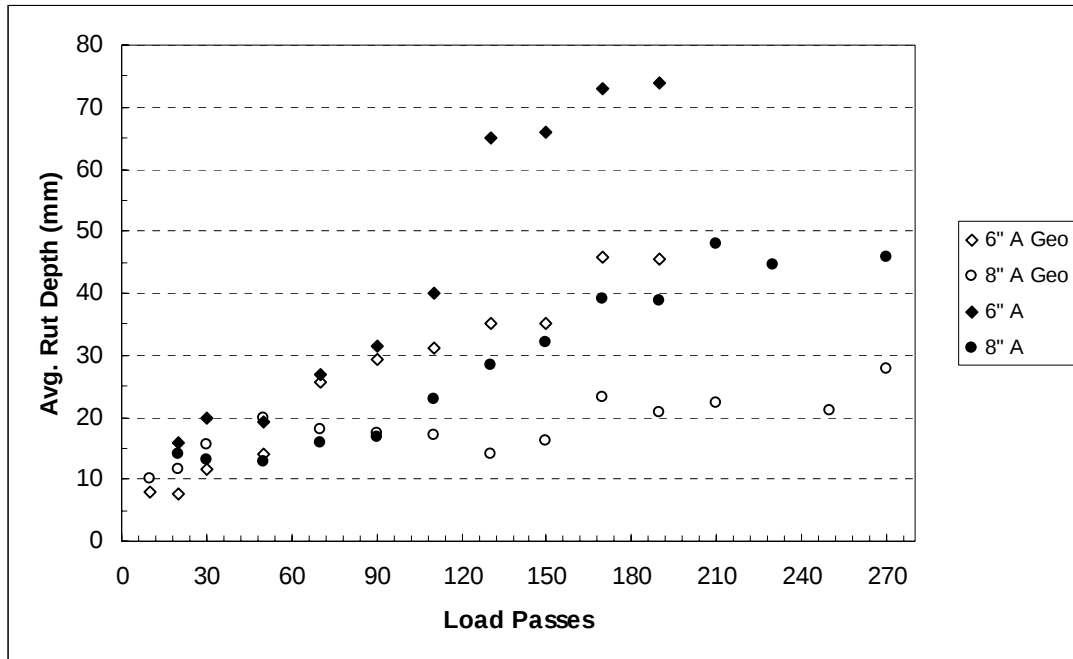
**Figure 9. Type A CLS With and Without Geotextile Rut Depth vs. Load Passes**

Figure 9 indicates there was no real benefit to using geotextile when the number of load passes was less than 90. Because there was no significant difference in rut depth at fewer than 90 passes, reinforcement was likely not the mechanism by which the geotextile was functioning. Given the relatively high IBV of 4.9, it is unlikely there was sufficient deflection to mobilize significant strength of the woven fabric material. After 90 passes, the fabric may have helped to prevent intrusion of the aggregate into the underlying subgrade.

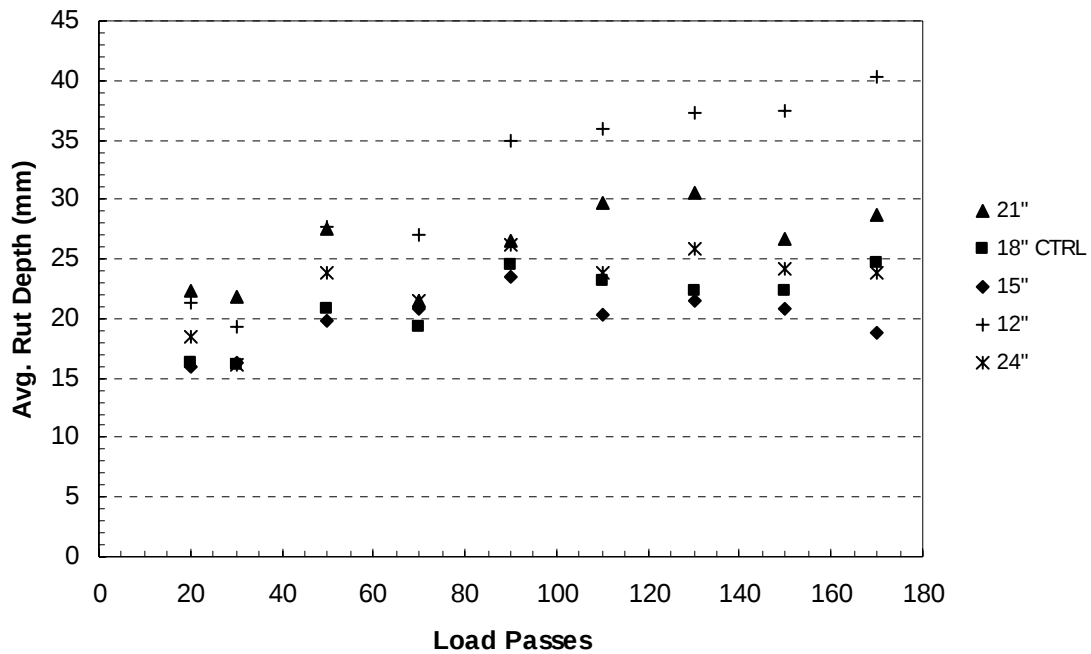
**Figure 10. Rut Depth vs. Load Passes for CLS Oversize Materials Capped with CA-6**

The number of load passes shown in Figure 10 was limited to 170. At loadings greater than 170, the rut width began to increase because of truck tracking variability. This increase in rut width began to interfere with measurements because it exceeded the straightedge width. This resulted in an apparent reduction in rut depth with increasing loading, which is not possible. Complete rutting data is shown in Appendix C.

The data in Figure 10 shows the rutting after 20 passes already exceeded the minimum 12.5 mm requirement. This result was similar to all the previously discussed test segments. Because of the relatively high IBV in relation to aggregate thickness, a majority of the rutting deformation is likely to have occurred within the aggregate layers themselves. The data shows some unexpected trends. One would expect rutting to increase with decreasing aggregate thickness. This was obvious with the 12-inch thick test location, but with the thicker test locations, there seemed to be no correlation between aggregate thickness and rutting. For example, the 21-inch thick test location consistently performed worse than the 15-inch, 18-inch and 24-inch locations, and the 15-inch test location outperformed the 24-inch location. This reinforced the hypothesis that the rutting was more a function of aggregate properties and uniformity of construction.

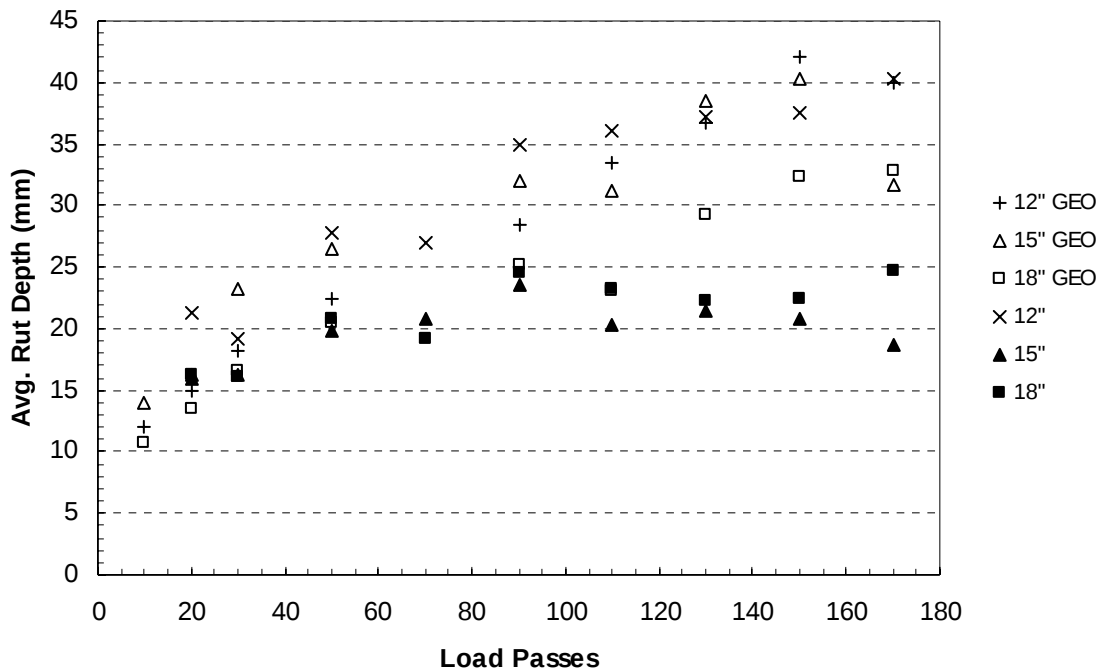
**Figure 11. Oversize CLS Capped with CLS CA-6 With and Without Geotextile Rut Depth vs. Load Passes**

The data in Figure 11 shows there was no benefit to using a geotextile in this case. The IBV was not low enough to allow the geotextile to act as reinforcement. The variation in rut depth between the geotextile and no geotextile locations was probably due to variations in construction.

Figure 11 compares rutting with and without geotextile.

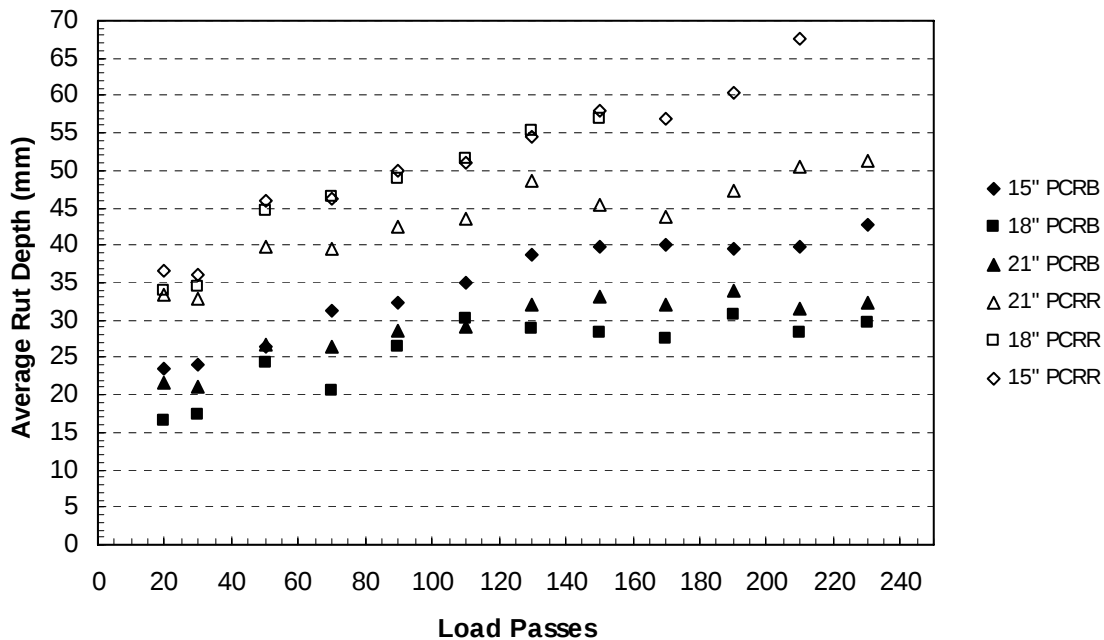
**Figure 12. Rut Depth versus Load Passes for RAP and CLS CA-6 Capping Materials**

The data in Figure 12 shows the CLS CA-6 outperformed RAP as a capping material. Unfortunately, no field measurements of cap density or moisture content were obtained. Compaction was to the satisfaction of the Engineer. Again the CA-6 gradation may perform better because of the additional fines content as discussed in Section 2.4.2.

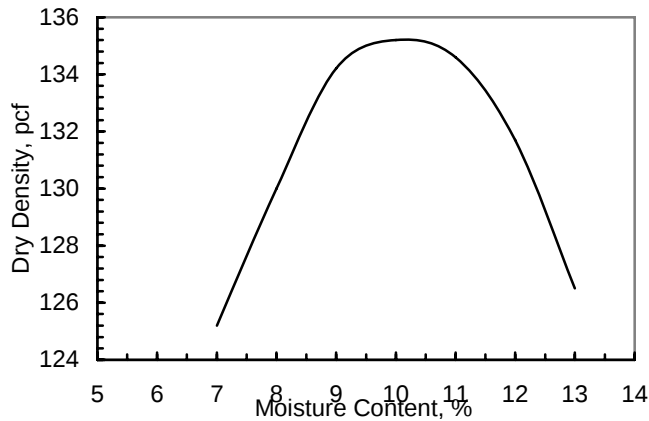
**Moisture-Density Relationship**  
**Subbase Granular Material, Type A**  
**SDD = 135.2 pcf @ 9.6% OMC**

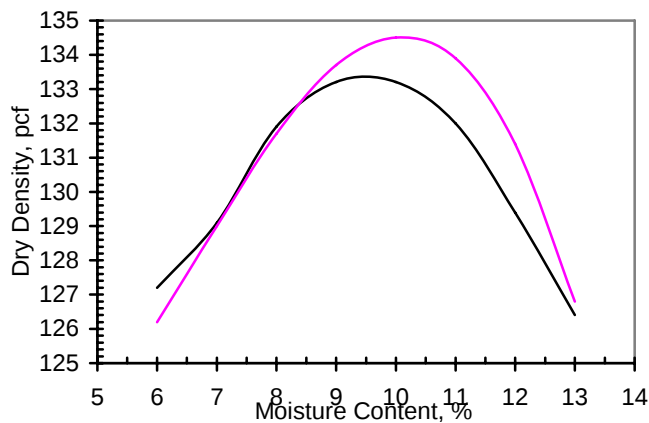
### Moisture-Density Relationship

Subbase Granular Material, Type B (CLS)

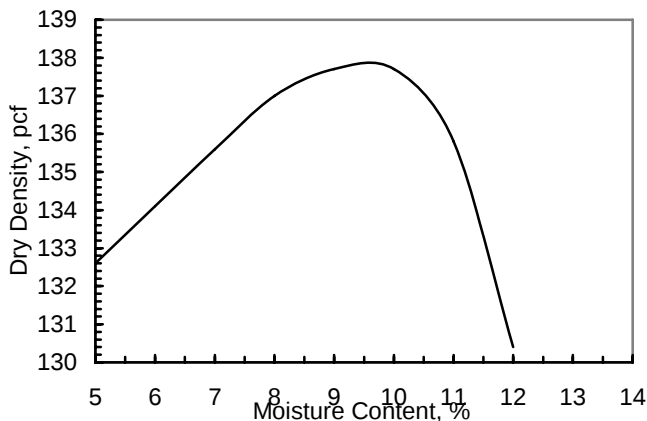
### Moisture-Density Relationship

Subbase Granular Material, Type B (Gravel)

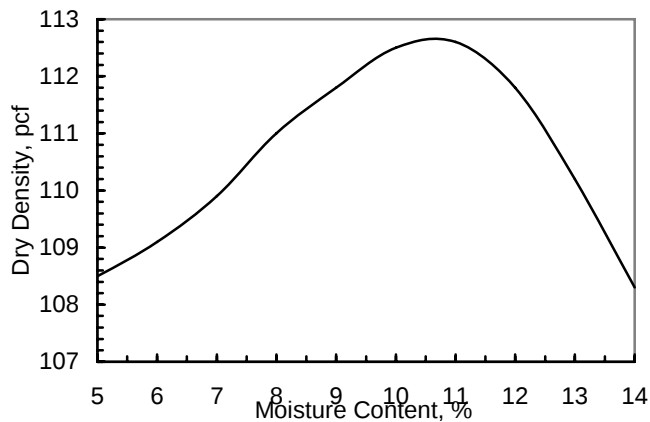
Moisture-Density Relationship  
Subbase Granular Material, Type B (CLS)  
#1 SDD = 112.7 pcf @ 10.5% OMC

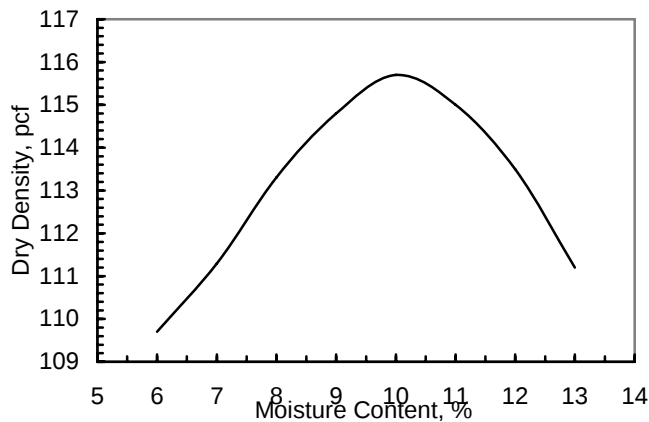
Moisture-Density Relationship  
Subbase Granular Material, Type B (CLS)  
#1 SDD = 115.8 pcf @ 10.1% OMC
