Performance Evaluation of Jointed Concrete Pavement Rehabilitation Without Resurfacing

Final Report

Physical Research Report No. 102 / August 1986

Illinois Department of Transportation
Bureau of Materials and Physical Research

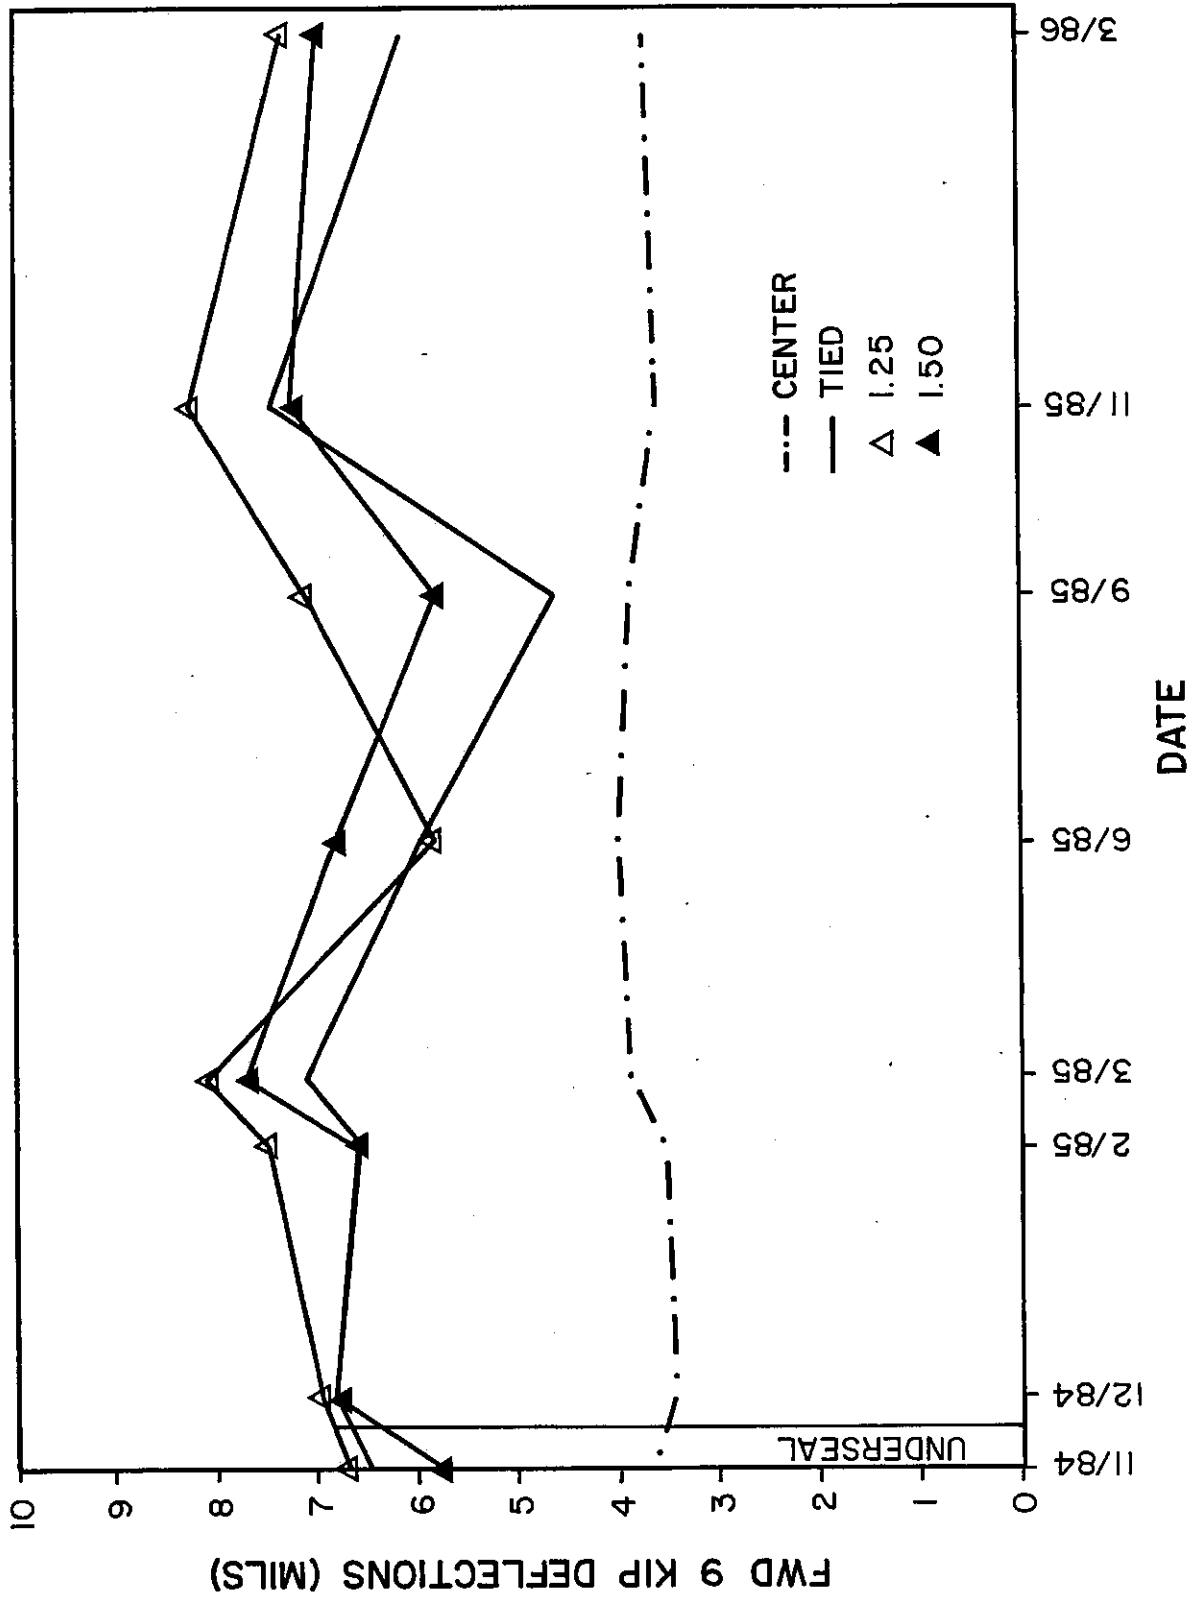
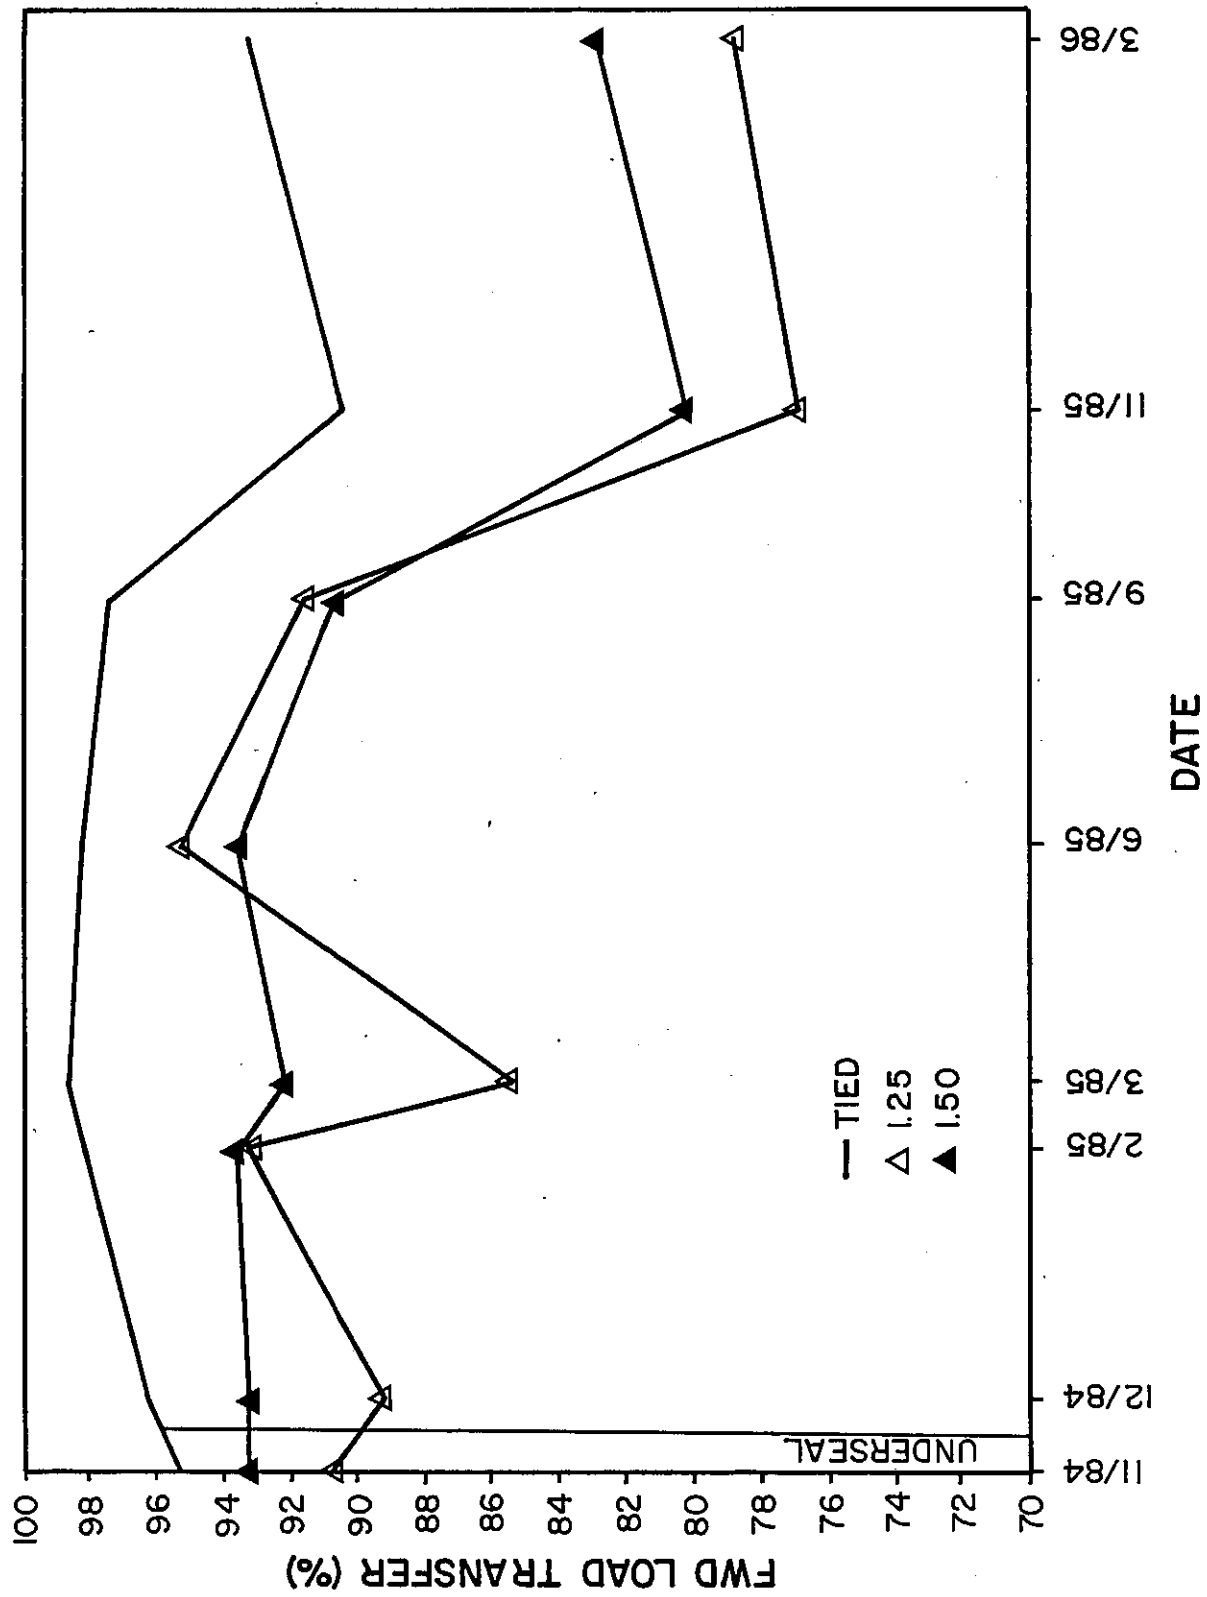
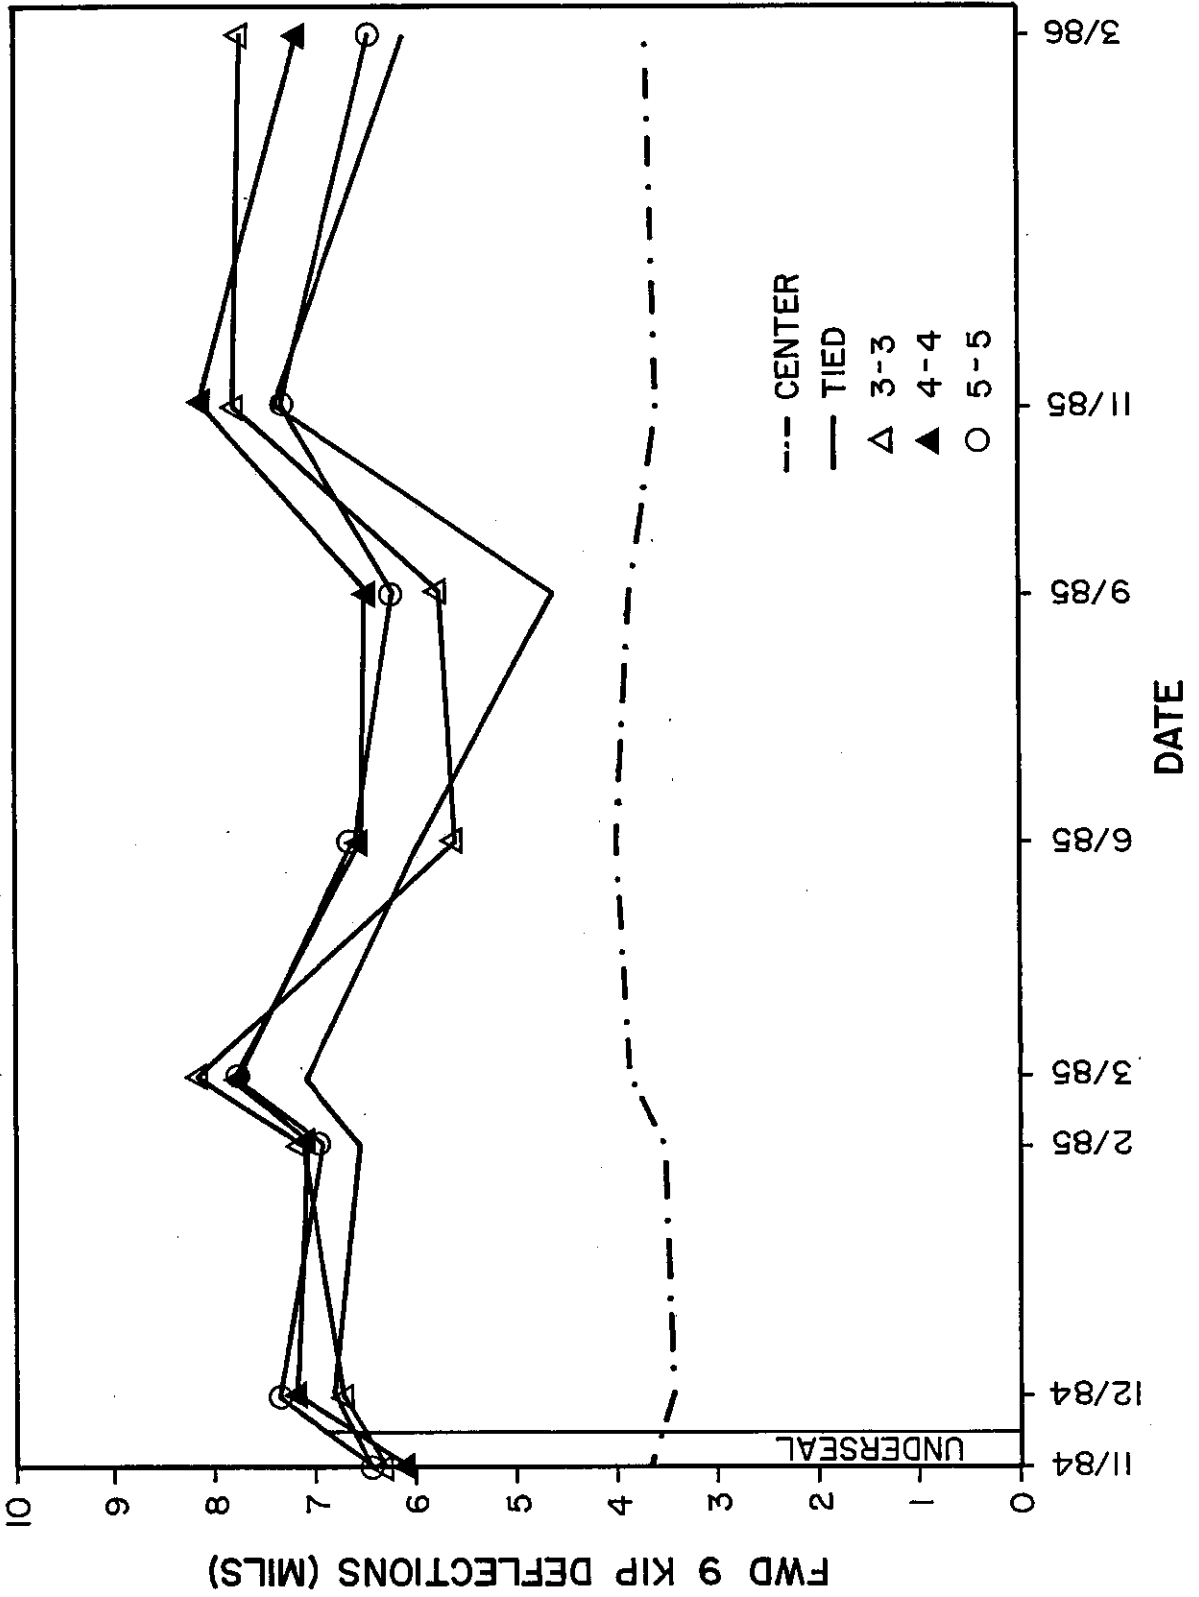
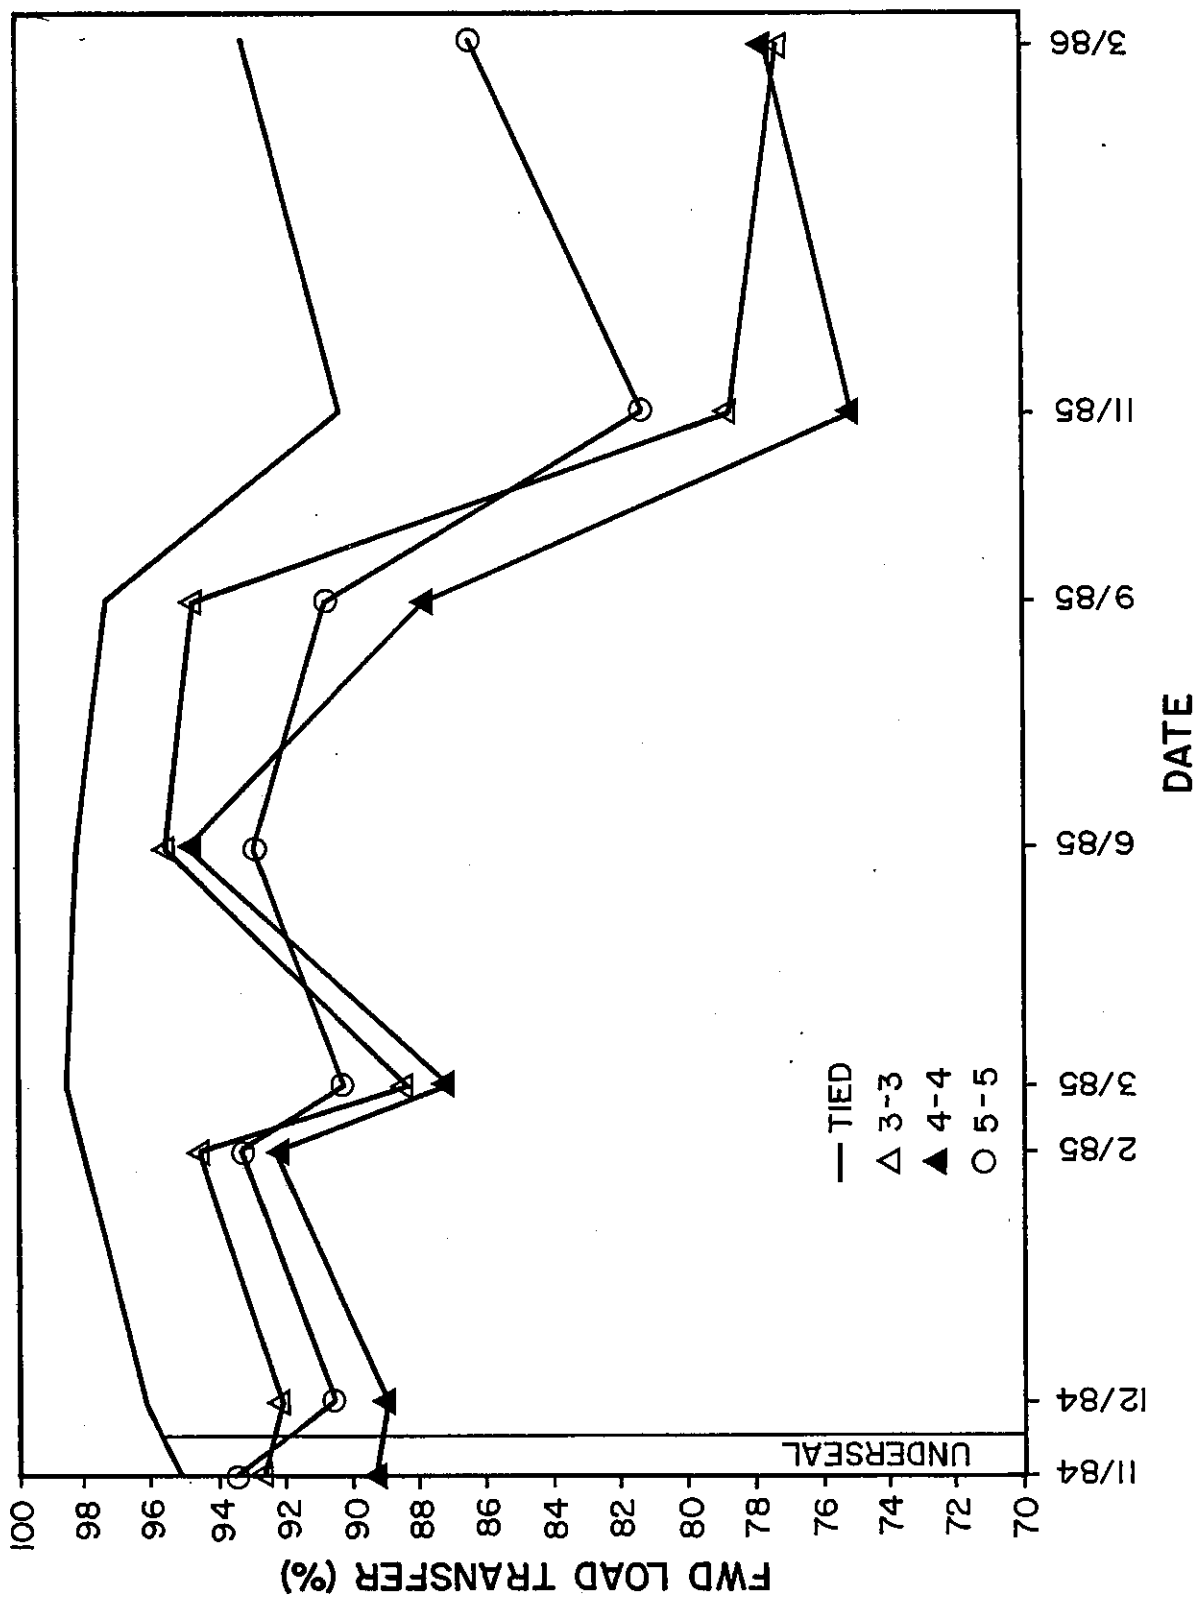
Evaluation of the patches was by visual inspection and deflection testing using an FWD. From the visual inspection, all of the experimental patches were in excellent condition with no indication of spalling or any other distresses. Deflection testing results are present in terms of a deflection due to a 9 kip load and load transfer across the patch joints in the outer wheel path. Load transfer is measured by dividing the deflection on the unloaded side of a joint by the deflection on the loaded side and is reported on a percentage basis. Testing was conducted before the experimental patches were undersealed then after undersealing before the roadway was opened to traffic. After the roadway was opened to traffic, the patches were tested periodically. Deflection and load transfer results for dowel bar size are presented in Figures 8 and 9, while results for dowel bar arrangement are presented in Figures 10 and 11. Also shown on the deflection plots are center of slab tests, which are taken at least 6 feet away from any joints or cracks and give an indication of subgrade support. At the end of the evaluation, all deflections and load transfers indicated that the patches were performing outstandingly.

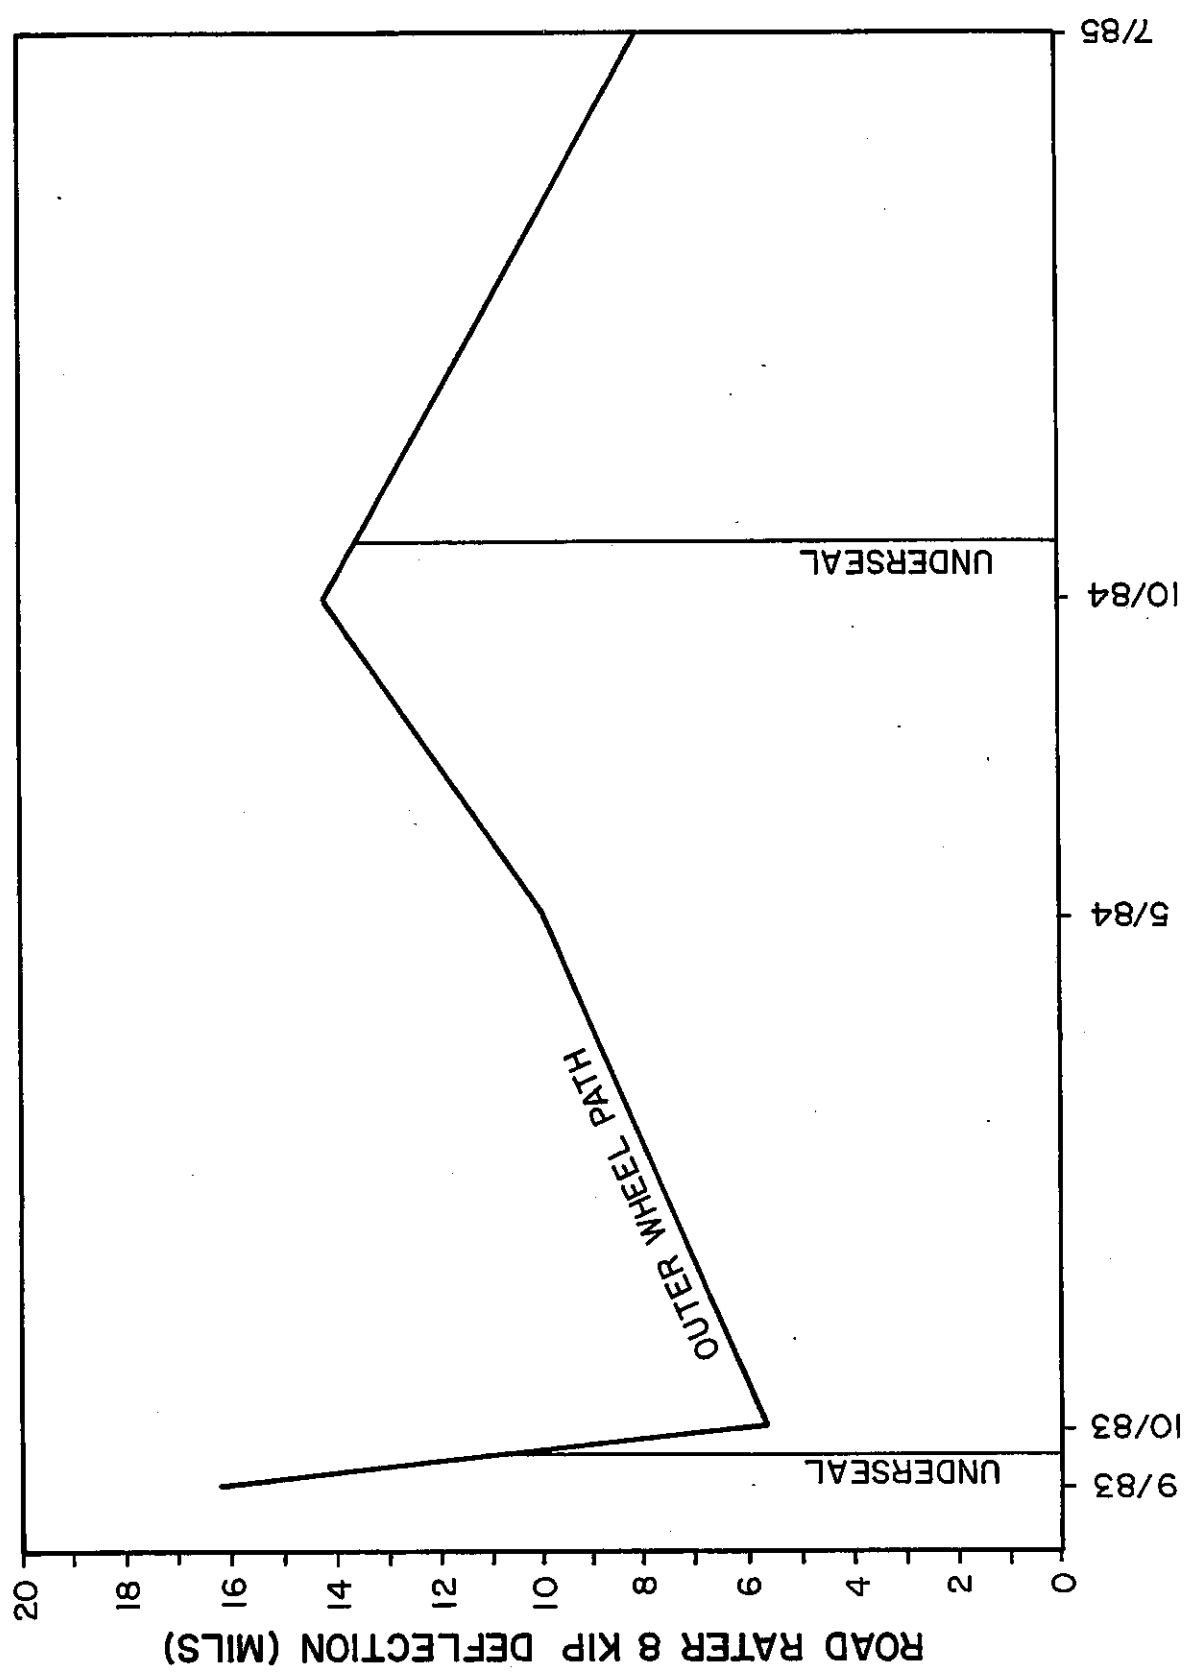
Figure 14. Deflection History of Patch Undersealing on Project Number 1

In Project 1, nine patches, which were pumping and rocking under traffic, were selected for undersealing in conjunction with rehabilitation on Project 2 in 1983. Deflection testing, using the Road Rater, was conducted before and after undersealing. Deflections were greatly reduced, but continued testing showed that within one year deflections had nearly reached pre-undersealing levels. These patches, along with all other patches in Project 1, were undersealed again in the Fall of 1984. The Road Rater deflection history is shown in Figure 14.

- Spalled, rocking and pumping patches should be replaced rather than undersealed.
- Future use of Double Vee or similar load transfer devices should be on a limited experimental basis to determine performance.
- More research is needed to determine the effectiveness of underdrains.
- Joint sealant reservoirs should be designed to provide the proper shape factors for the sealant and movement needs.
