# An Evaluation of IDOT's Current Underdrain Systems

Physical Research Report No. 120  
December 1995

**Illinois Department of Transportation**  
Bureau of Materials and Physical Research

AN EVALUATION  
OF  
IDOT'S CURRENT UNDERDRAIN SYSTEMS

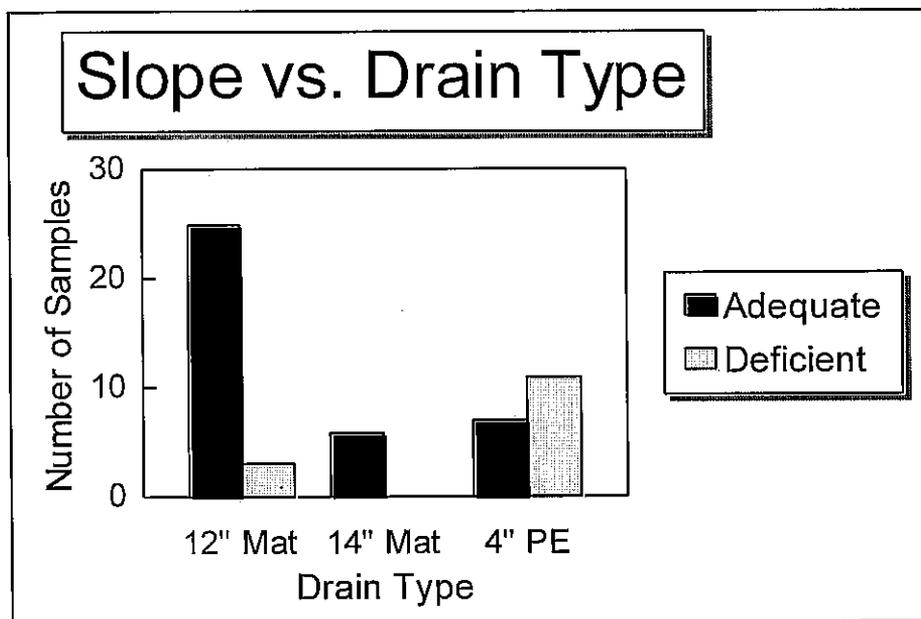
**Figure 6. Qualitative assessment of underdrain longitudinal slope.**

order to provide a proper outlet slope without burying the headwalls in the ditchline. Sags were found to be common, with 11 of 18 pipe underdrain excavations showing some water ponding. Although this is not an ideal condition, the majority of the water should still drain away, while the remainder should pose little threat due to its distance below the pavement structure. A qualitative assessment of the adequacy of longitudinal slope of the various underdrain types is illustrated in Figure 6.

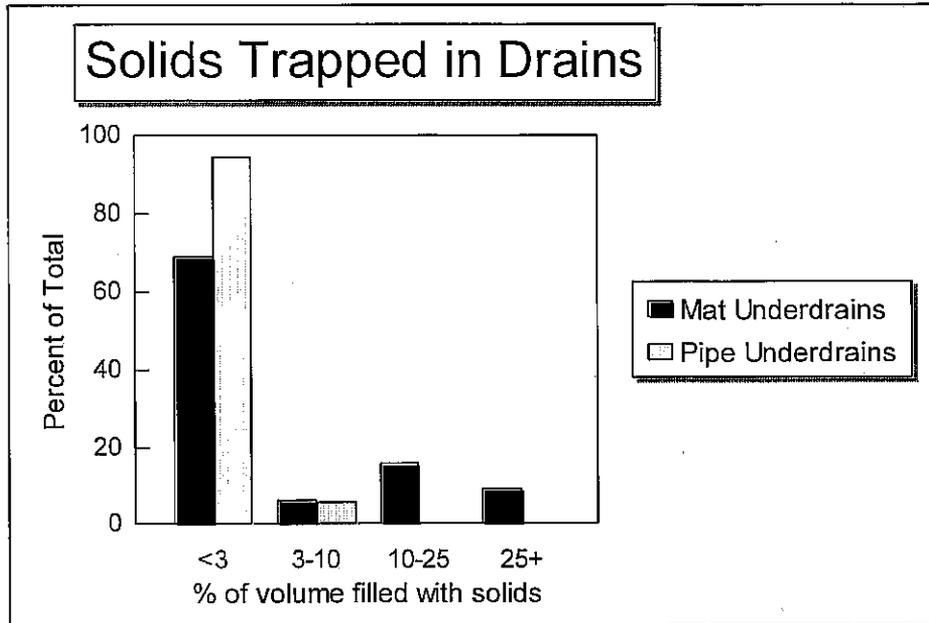
**Figure 12. Distribution of percent solids vs. drain type.**

the mat underdrains (see Figure 12). This appears to be a result of the beneficial

filtering properties of the granular backfill used for pipe underdrains and not for mat underdrains, which were all backfilled with in situ material. Table 3 summarizes the type and amount of solids found in the underdrain field samples.

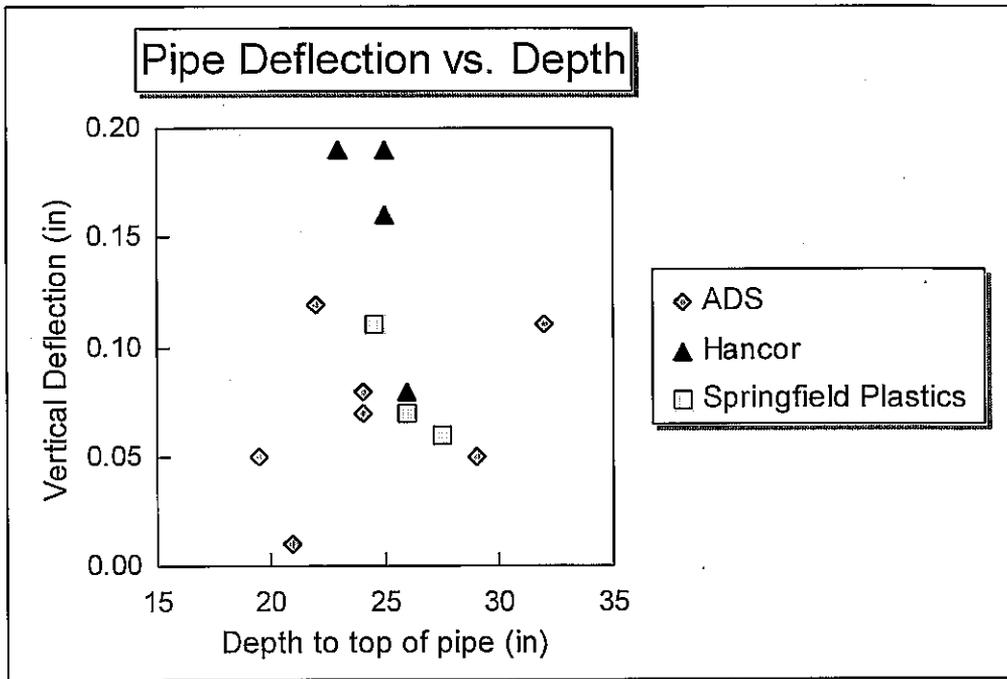
**Figure 13. Plot of pipe deflection vs. depth.**

Most of the pipe depths were measured in the field. Using these depth values along with the estimated vertical deflections, a comparison can be made between the two variables. The purpose of the comparison is to determine if decreasing the underdrain trench depth will have an adverse effect on pipe deflection. If not, a feasible solution to the problem of outlets located too close to the ditchline would be to raise the underdrain elevation. A plot of pipe deflection vs. depth (Figure 13) reveals there is no correlation between trench depth and deflection. It appears that deflection is determined by some other factor such as installation procedure. Therefore, decreasing the trench depth from 30 inches to 24 inches should be a viable option.

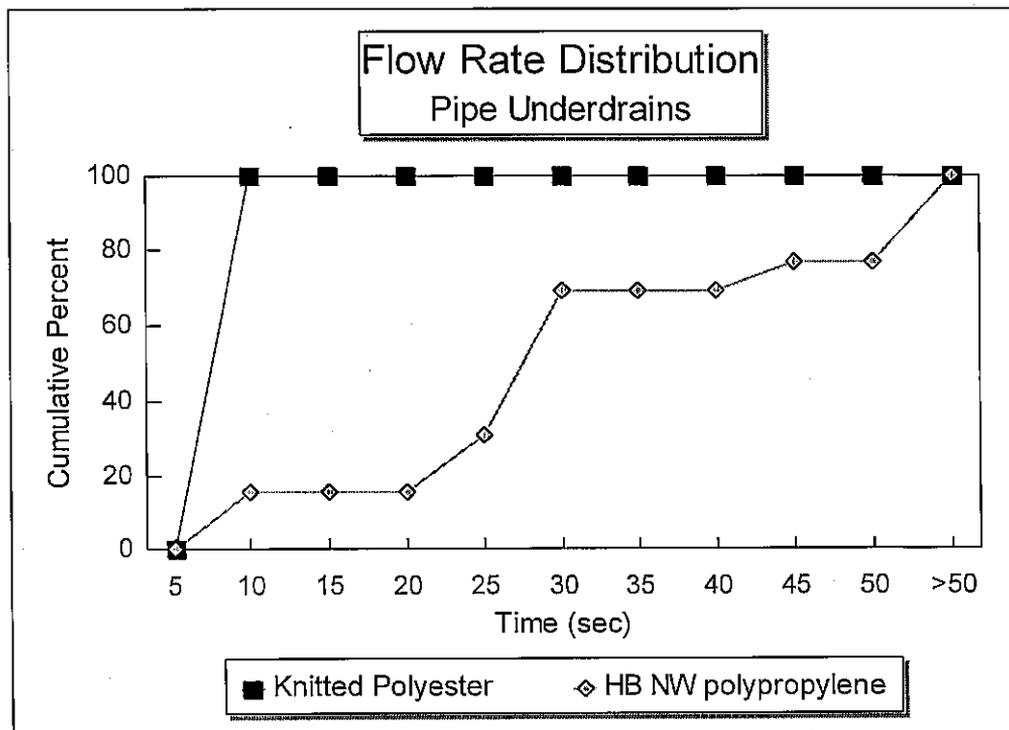
Figure 22. Flow rate distribution for pipe underdrain samples.

diameter acetate tube suspended over a 1000 ml beaker. The geotextile was oriented so that the water would flow in the same direction as in the field. The entire test was videotaped and the time for the water to pass through the fabric was recorded. In addition, the color of the filtered water was noted. The geotextile samples were taken from the bottom half of the underdrains. Although this probably represents the worst case, it was felt that, with time, the rest of the geotextile would approach the same condition. Table 6 summarizes the results of the permeability testing. From the data in Table 6, plots were prepared comparing the flow rate distribution for the various geotextiles. Since the pipe underdrains contained granular backfill and the mat underdrains did not, they were considered separately. Figure 22 contains a plot of the results of the permeability tests pertaining to the pipe underdrain samples.

When new, most geotextiles tested let water through as fast as it could be poured (<10 seconds). However, it took approximately three times as long for the water to pass through the heat-bonded, non-woven, polypropylene when new and this material showed a greater tendency to retain fines and lose permeability. It can be seen in Figure 22 that the knitted polyester did not lose any permeability with time, whereas less than 70 percent of the heat-bonded, non-woven, polypropylene maintained its original, slower, flow rate. All of the knitted polyester samples let the water pass through in under 10 seconds whereas less than 20 percent of the heat-bonded, non-woven, polypropylene samples could make the same claim.

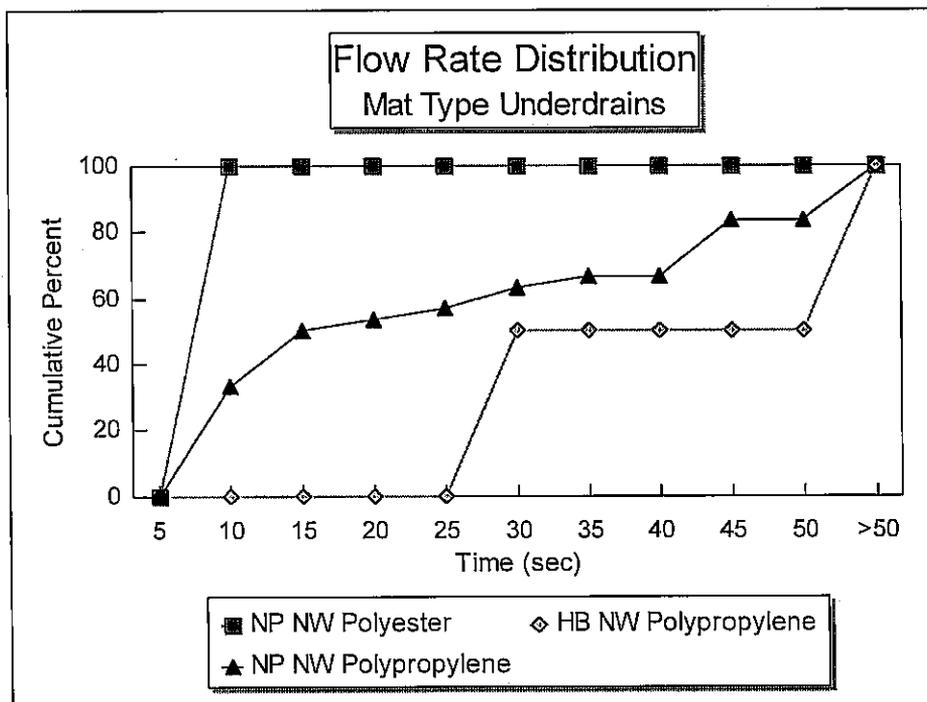
Figure 23. Flow rate distribution for mat underdrain samples.

Figure 23 contains a plot of the permeability test results pertaining to the drainage mat samples. The needle-punched, non-woven, polyester performed the

best of the mat underdrain geotextiles. It should be noted that both samples of this material were taken from areas with a granular subgrade. Therefore, the difference may be more attributable to the cleaner subgrade than to a material superiority. The heat-bonded, non-woven, polypropylene again performed the worst of the fabrics tested. Without the aid of a granular backfill, the performance was even worse than it was for the pipe underdrains. Intermediate results were obtained from the needle-punched, non-woven, polypropylene. A wide range of values were obtained with this material ranging from under 10 seconds to over one hour. The samples with the slowest flow rates were found to contain a coating of silty clay on their interior.
