RESULTS OF BRIDGE DECK CONDITION SURVEYS AND  
CORROSION RATE DETERMINATION

Interim Report

Bridge Deck Condition Survey

June 1979

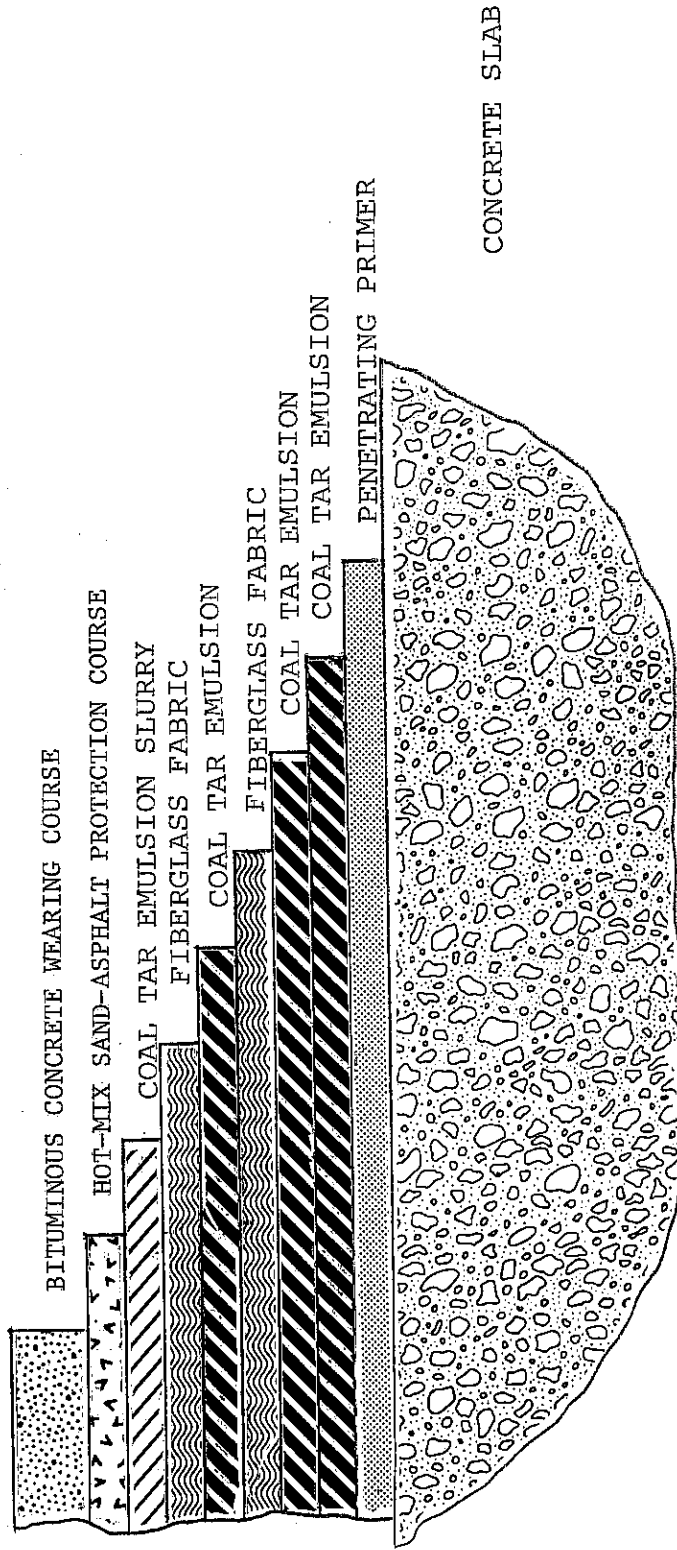
Figure 2. Waterproofing System.

The waterproofing membrane system used on each deck is as shown in Figure 2 and consists of a penetrating primer, a built-up coal tar pitch emulsion membrane with two plies of coated glass fabric, and a 1/2-inch hot-mix sand-asphalt protection layer. Prior to placement, spalled and delaminated areas were repaired
