From February 24, 2017, Closure of I-276 Delaware River Bridge Event Report

Event Report

Subject: Closure of I-276 Delaware River Bridge (PA Turnpike and NJ Turnpike)

Date of Event: January 20, 2017

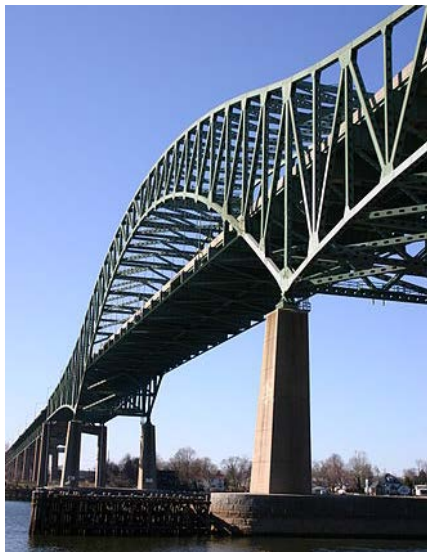
Figure 1 Main river span

The bridge has 31 spans, with a total structure length of 6,751' and a main river span of 682'. The overall deck width is 80'. As shown in Figure 1, the main river span is a distinctive arch-shaped through truss, with suspended deck and vertical clearance of 135'.

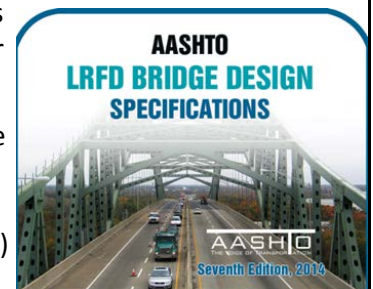
leading up to the arch. The center two spans of the 4-span continuous unit are shown in Figure 2 on

the following page, which was the location of the critical finding. (Interesting aside—PennDOT pointed out that the bridge is also featured on the cover of the 2014 LRFD spec.)

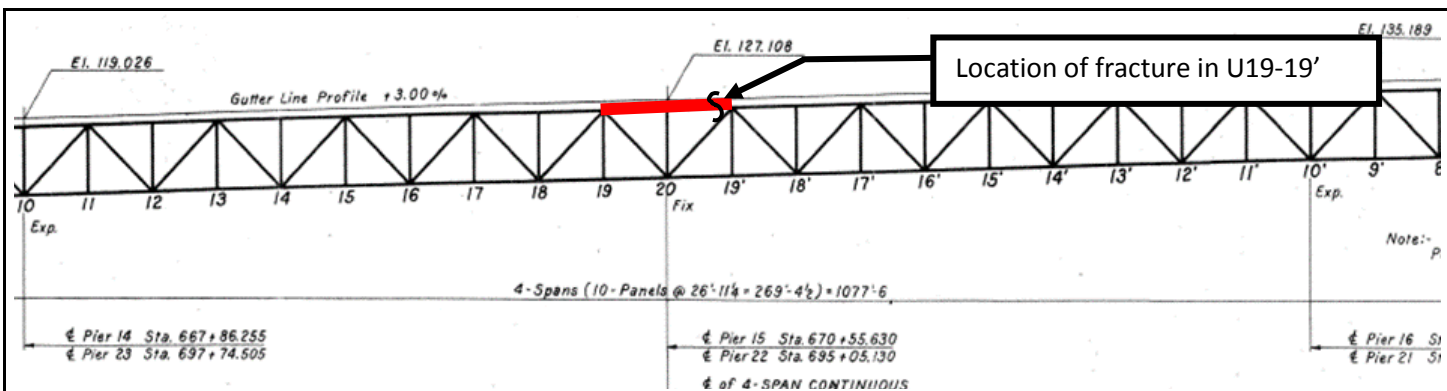
Figure 2 Deck Truss elevation view, Spans 15 and 16 (as-builts). East to the right, north into the page.

The fracture occurred on the north truss face, on the 16th span, just prior to panel point 19'. The member is designated U19-19' and is a rolled 14WF314 that is weak axis oriented. Figure 3 shows the fracture in the field.
