Open Graded Drainage Layer Performance in Illinois

**FINAL REPORT
PHYSICAL RESEARCH REPORT NO. 147
AUGUST 2004**

Illinois Department of Transportation

Final Report

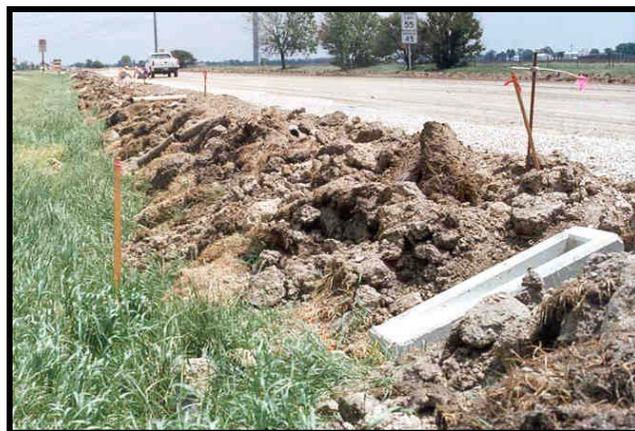
The median through this section of Interstate 80 is very shallow and very flat. To help compensate for this, the underdrain system was raised from the standard 30-inch depth to 22 inches below the pavement surface. However, several of the median underdrain outlet pipes and headwalls were still placed at the bottom of the median ditch with a zero percent slope on the outlet pipe. Figure 6 illustrates the shallow median ditch and placement of the headwall at the bottom of the ditch.

Shallow Median Ditch with Underdrain Headwall

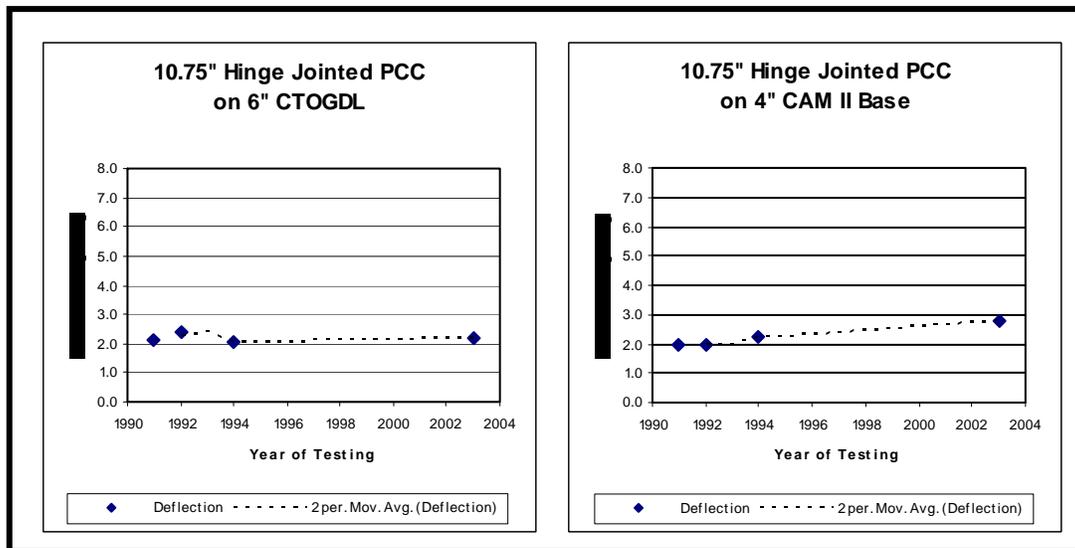
Figure 10
Average FWD Deflections for I-39 at Bloomington

The FWD data for this project indicates that the pavement deflections at the center of each panel have remained constant between 2.0 and 3.0 mils for both the test and control sections. Figure 10 illustrates the FWD test results and a two point moving average trend line for those results. In addition, the load transfer efficiencies for the pavement joints have remained constant between 85.0 and 90.0 percent since construction for both sections.

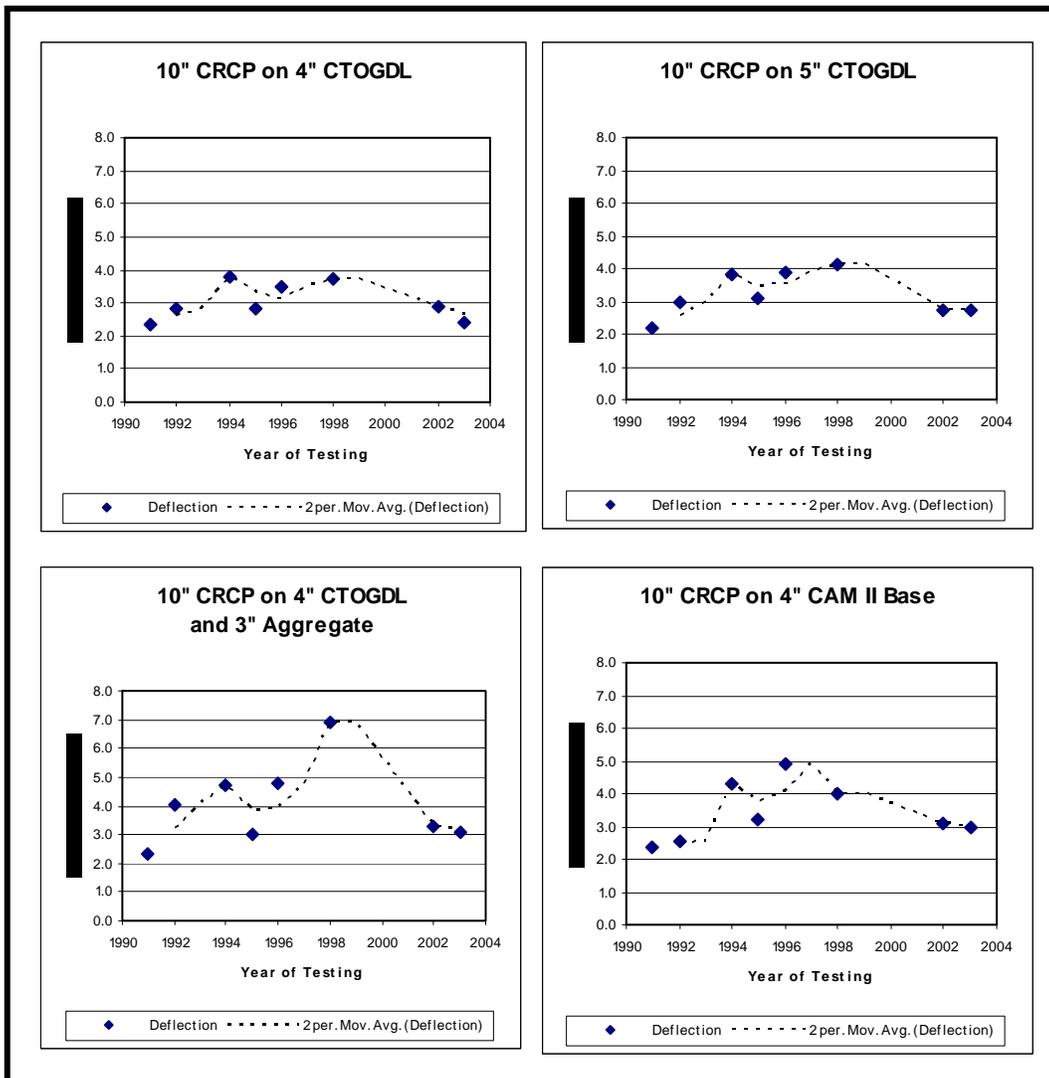
Figure 12
Average FWD Deflections of CTOGDL for I-39 at Lostant

The FWD data for these sections indicates that both the test and control sections have remained constant between 2.0 and 5.0 mils since the time of construction. The only exception to this is the 4-inch CTOGDL that is on 3 inches of aggregate material. The 1998 deflection for this section is approximately 7.0 mils. The FWD results and a two point moving average of the results for all the sections may be found in Figures 12 and 13.

The FWD results for these sections indicate that there is no significant difference between the CTOGDL, the ATOGDL, and the control section. The results also indicate that there is no significant difference based on the thickness of the OGD, or the addition of an aggregate separation layer below the OGD. The load transfer efficiency of the transverse cracks has also remained consistently above 90 percent for all of the test sections at Lostant. The FWD results for this project may be biased, however, due to the short length (500 feet) of the test sections.

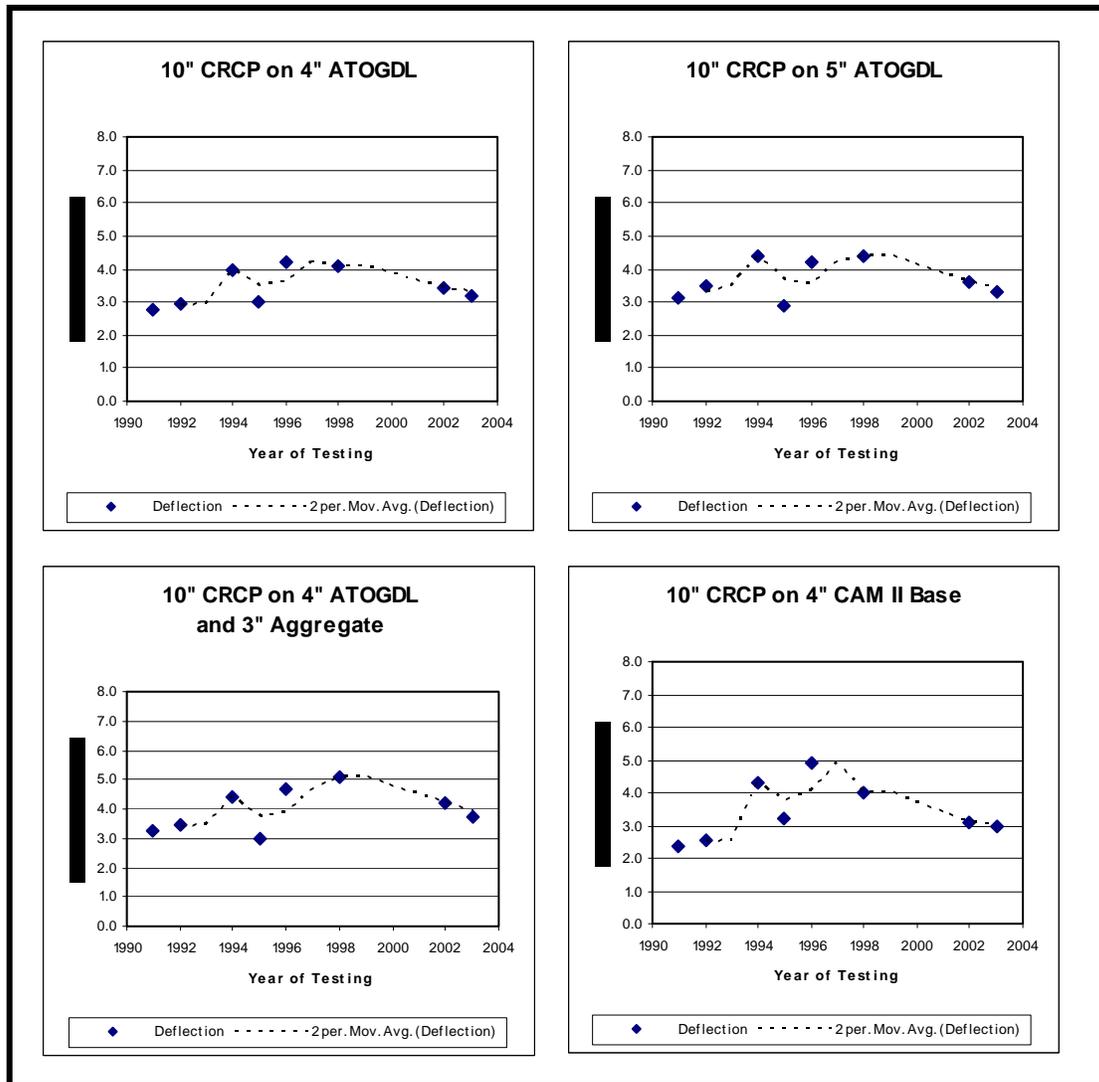
Figure 13

Average FWD Deflections of ATOGDL for I-39 at Lostant

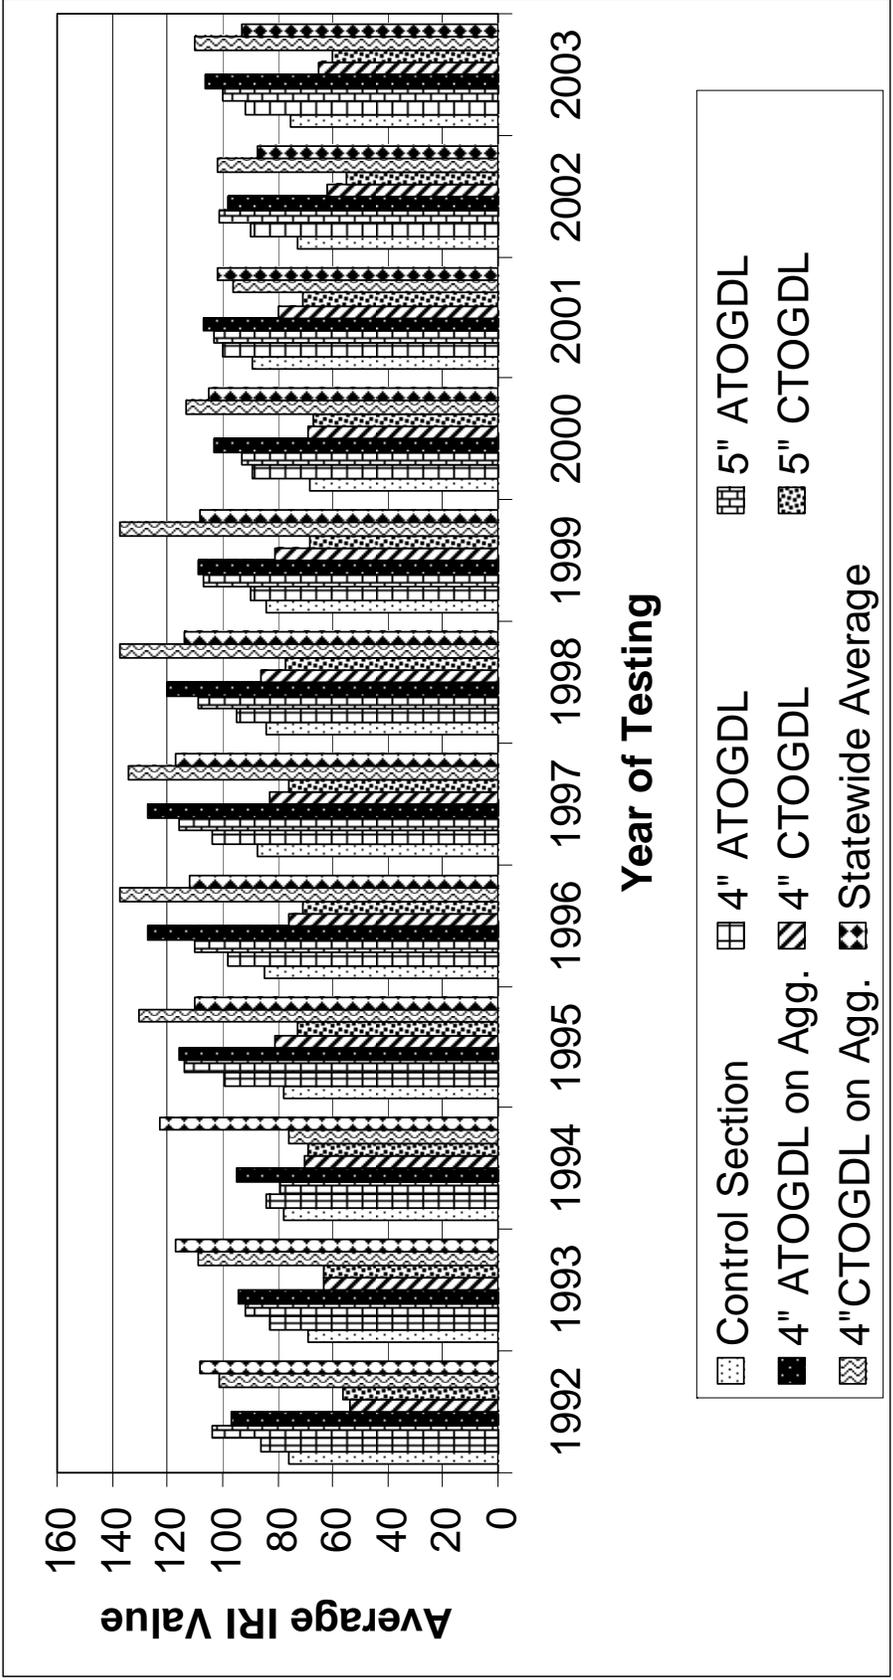
Figure 14
Average IRI Values for I-39 at Lostant

The IRI data for these test and control sections indicates a wide variety of trends. The best performing (smoothest) sections are the 4- and 5-inch CTOGDL sections. The worst performing (roughest) sections are the 4-inch ATOGDL and 4-inch CTOGDL on aggregate material. Also, it is clearly shown that the 4- and 5-inch CTOGDL sections are smoother than the 4- and 5-inch ATOGDL sections. Finally, the ATOGDL sections tend to follow the statewide average IRI values, while the CTOGDL sections are well below the statewide average. The exception to this is the 4-inch CTOGDL on aggregate material section. Figure 14 on page 21 illustrates the IRI values for the various test and control sections.

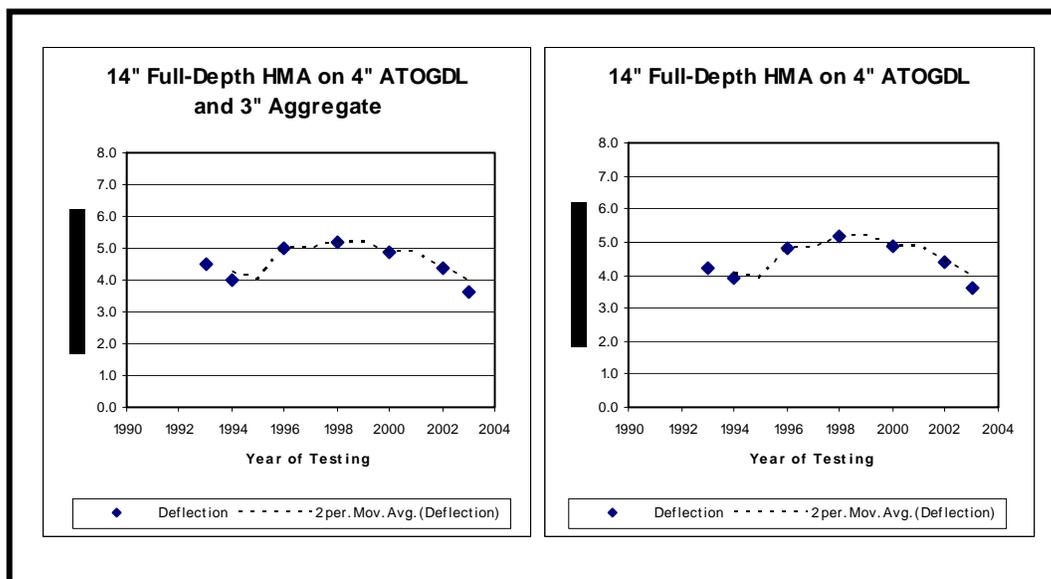
The FWD deflections for this project are very consistent between the two test sections. There is no control section for this project, so no comparison can be made to standard construction practice. Figure 17 illustrates the average deflections and a two point moving average of the results for the two test sections.

Average FWD Deflections for Illinois Route 161

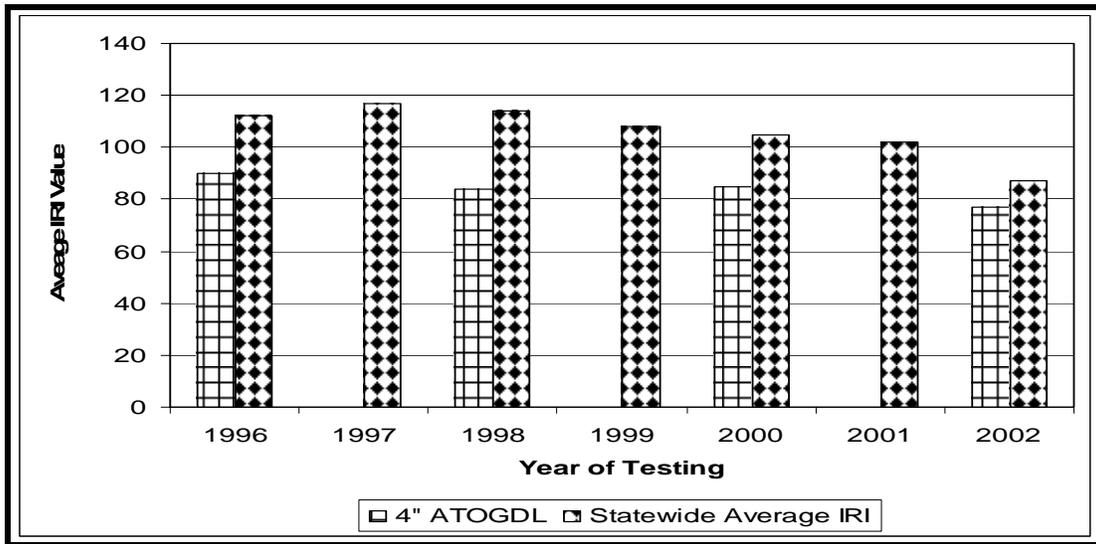
Figure 18
Average IRI Values for Illinois Route 161

The IRI data for this project was only collected during the even numbered years, as is standard for the state primary routes. Also, the IRI data was not separated for the two different pavement cross sections. The IRI data that is available indicates this project was constructed smooth and has remained smooth compared to the statewide average IRI values. This trend is displayed in the following figure, Figure 18.

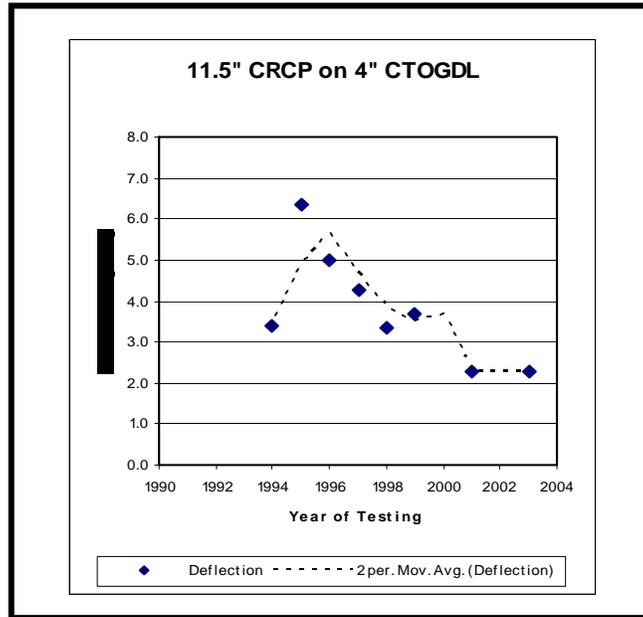
Figure 19
Average FWD Deflections for I-80

The average FWD deflections for this project jumped from 3.4 to 6.4 mils within the first year after construction. Due to the sudden increase in pavement deflection, the eastbound and westbound lanes were undersealed to arrest the deflection problems. The

average FWD deflections showed an immediate response by dropping down to 5.0 mils within the next year. The general trend of the average deflections has continued to decrease since 1996. Figure 19 illustrates the sudden rise and decline of the average FWD deflections for this project. The load transfer efficiency of the cracks has remained between 90 and 95 percent for the entire project even with the high deflections.

A side effect of the pavement undersealing has been the increase in transverse and longitudinal cracking of the pavement surface. The severity level for some of the transverse cracks has also increased since the undersealing was performed. The development of longitudinal cracks at a regularly spaced interval is alarming due to the potential formation of punchouts at the pavement edge. In addition, the combination of longitudinal and transverse cracks creates a grid pattern of small rectangular blocks across the pavement surface. These small blocks may begin to move independently and fail as the load transfer efficiency of the surrounding cracks is reduced.
