**EVALUATION OF HIGH PERFORMANCE  
CONCRETE BRIDGE DECKS  
AND  
OTHER EXPERIMENTAL BRIDGE  
DECKS THROUGHOUT ILLINOIS**

**PHYSICAL RESEARCH REPORT NO. 166  
December 2017**

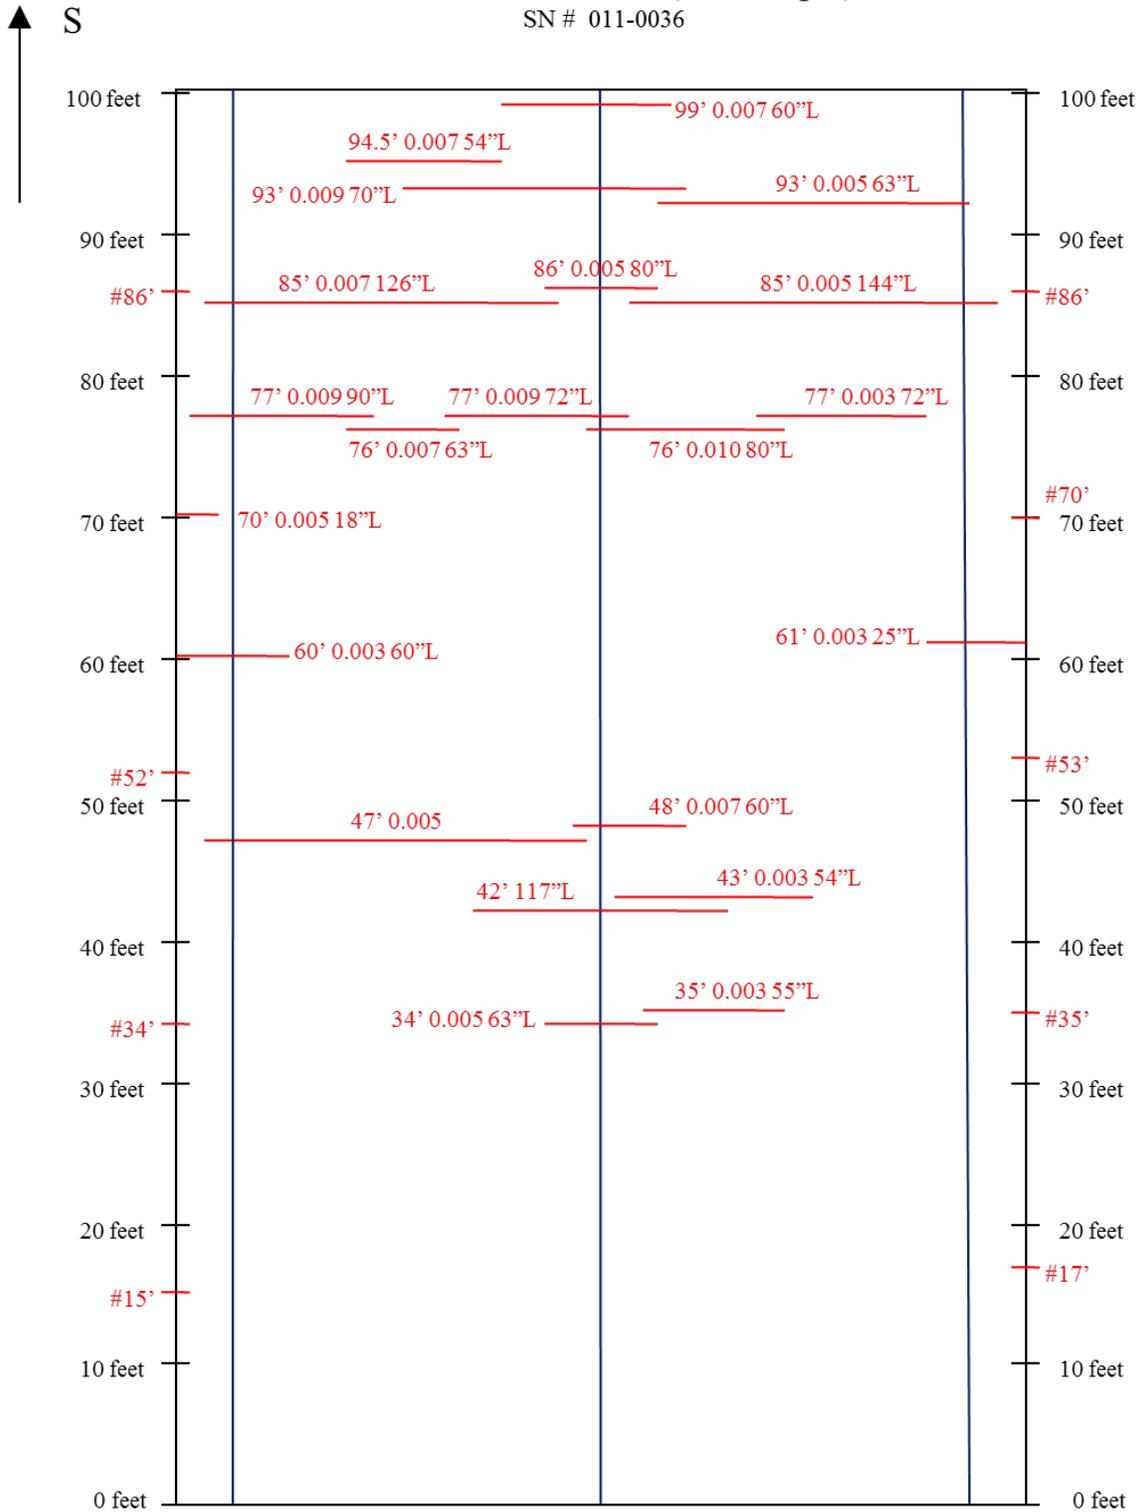
Figure 2.1-2

Christian County – SN#011-0036 – Surveyed 9/16/2003

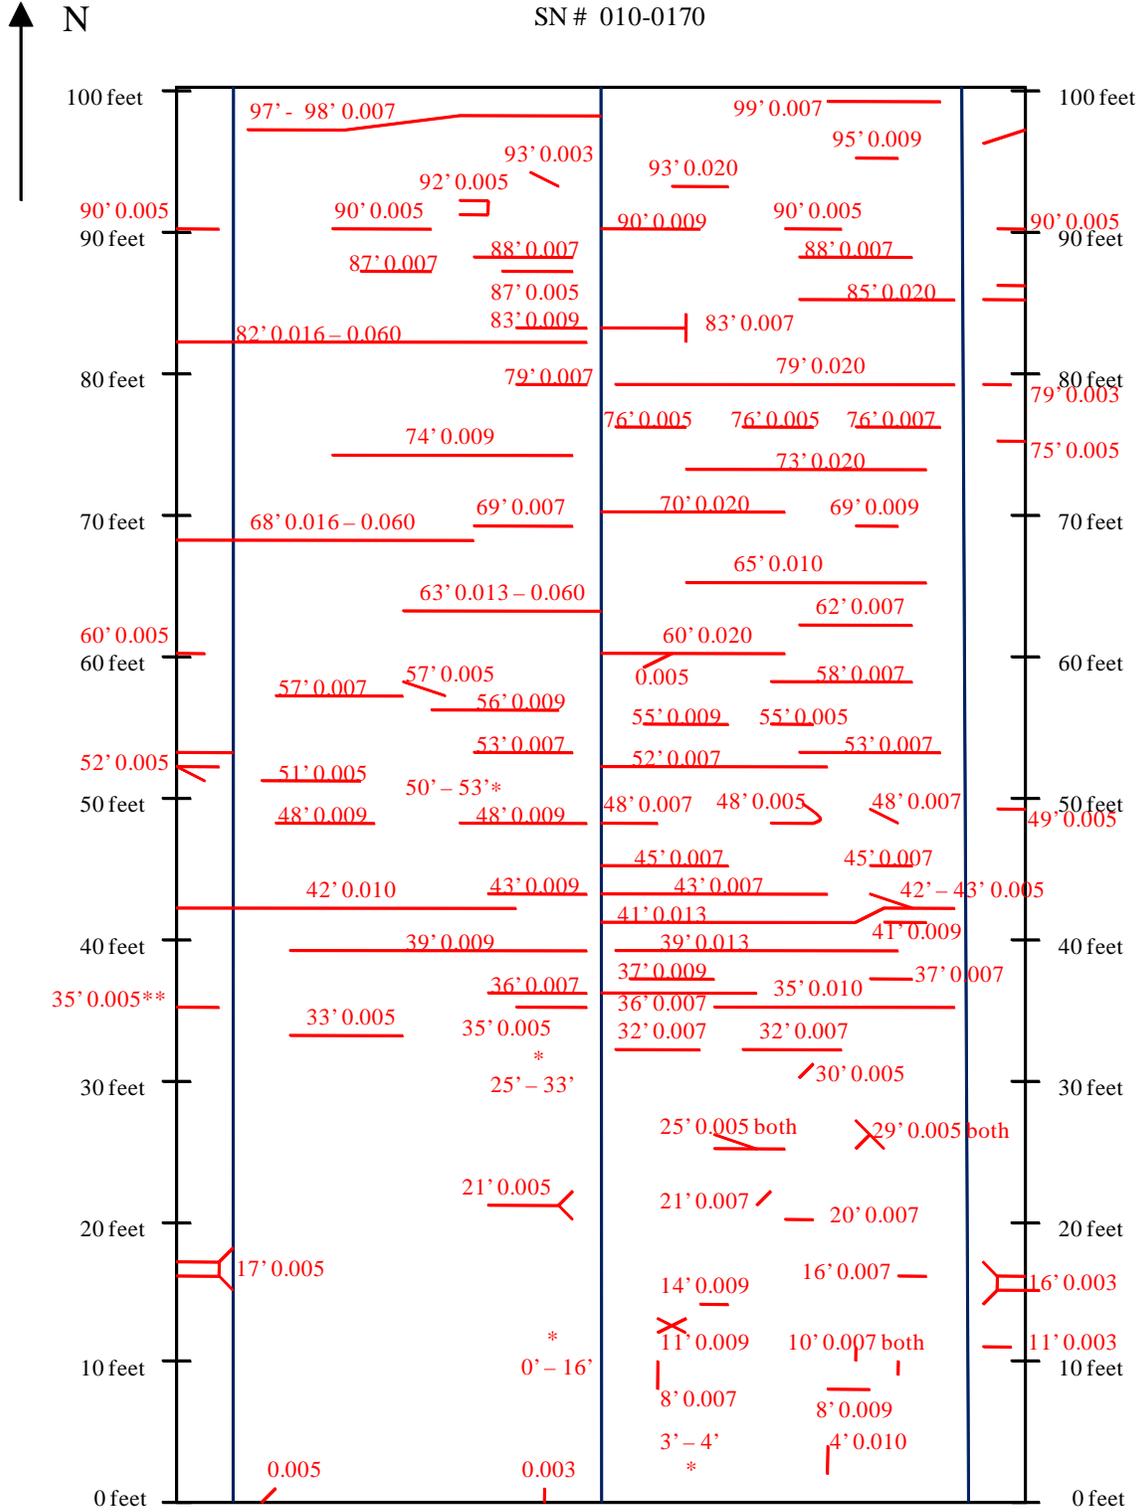
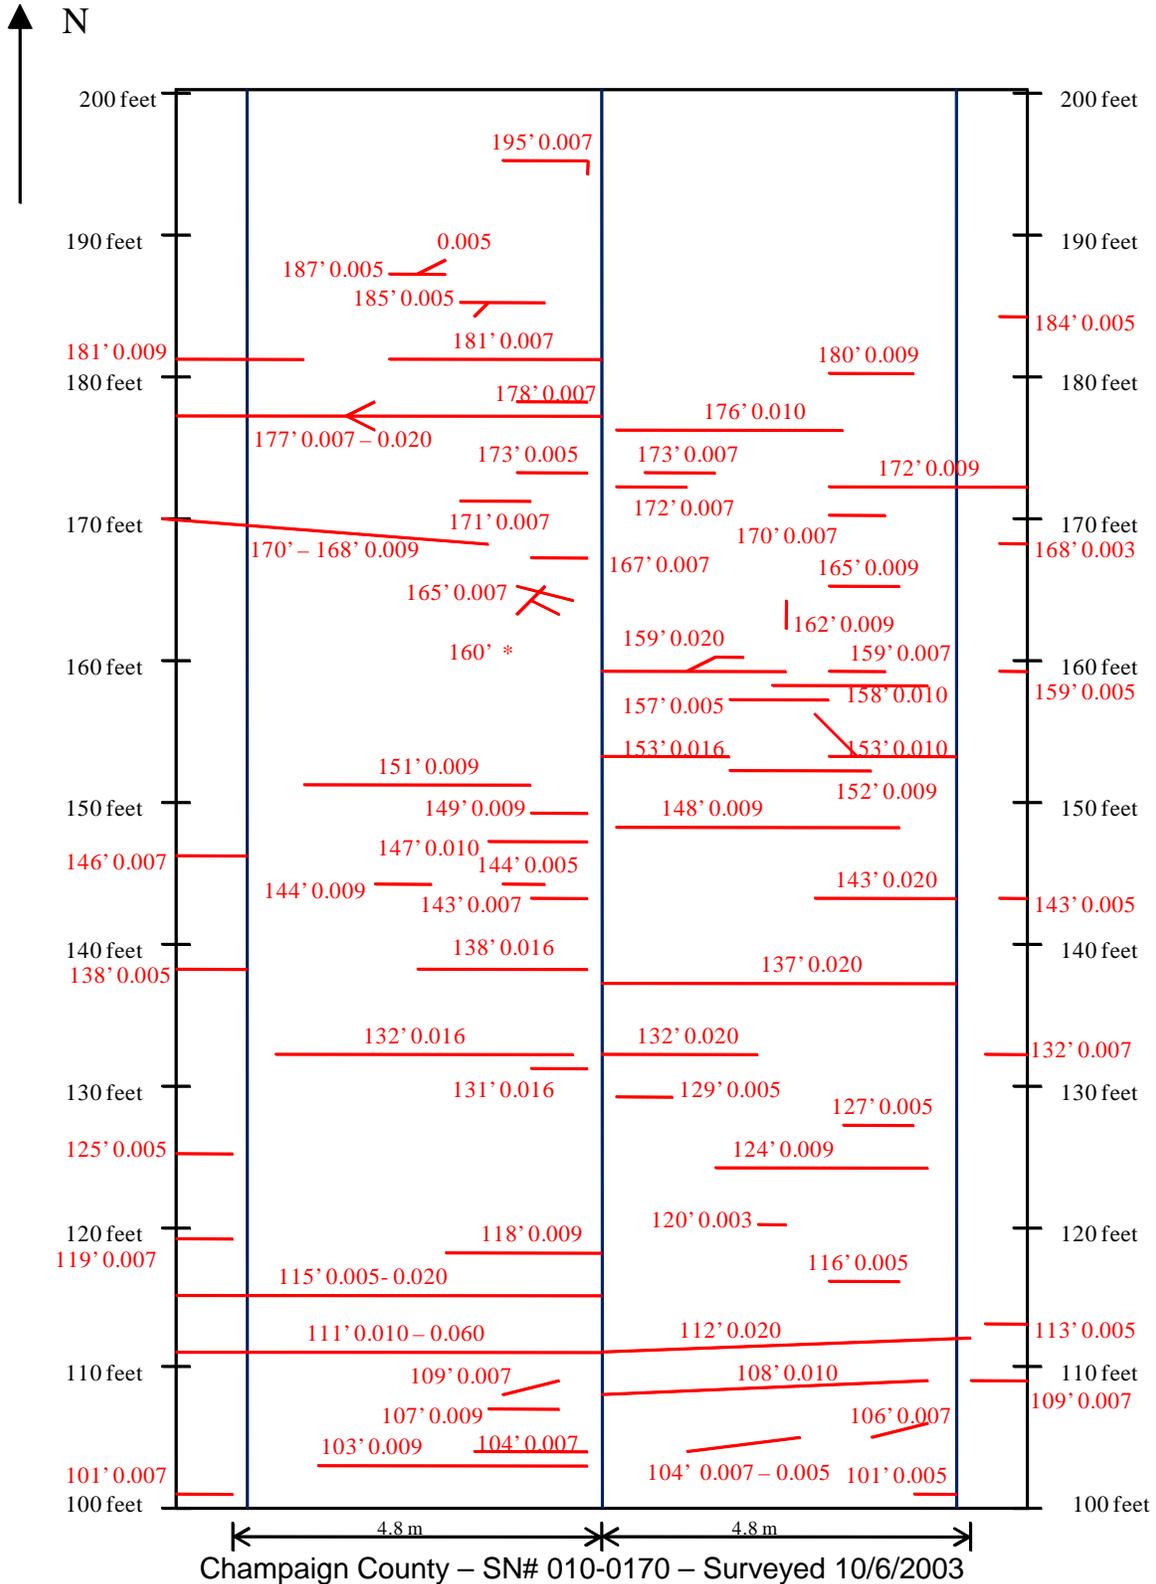
# Duncan Road over I-72

Champaign County – SN# 010-0170 – Surveyed 10/6/2003

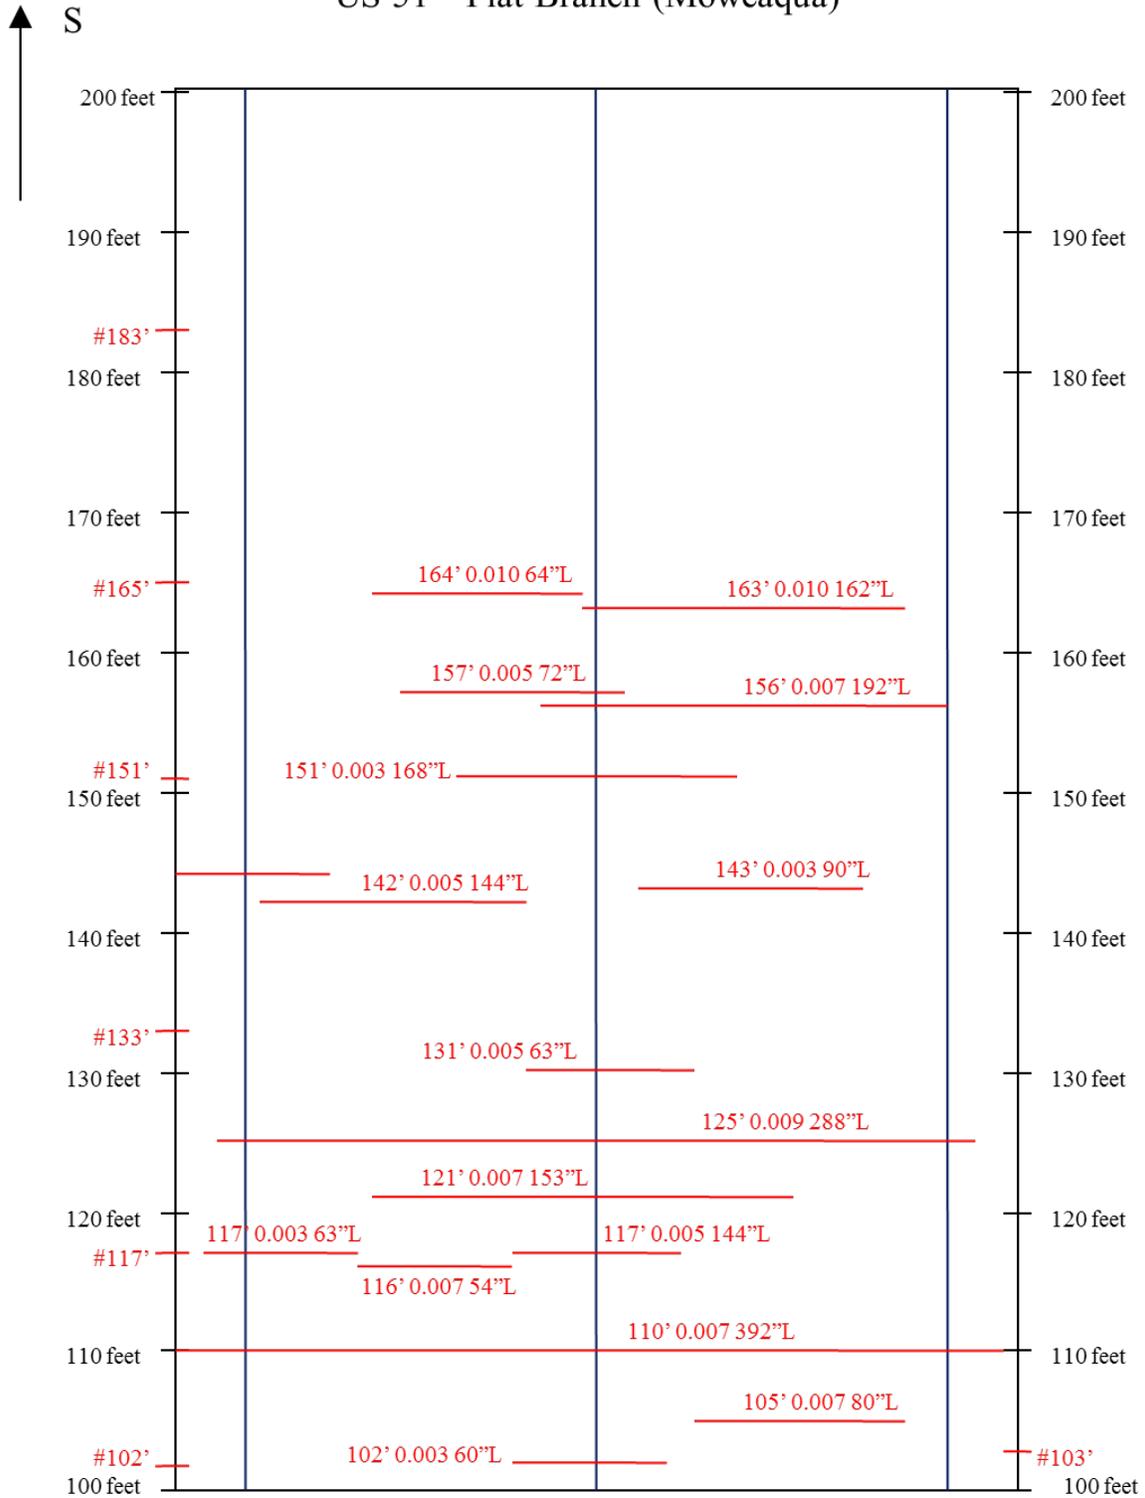
# US 51 – Flat Branch (Moweaqua)

Christian County – SN#011-0036 – 9/19/2003  
 The “#” symbol represents cracks in the parapet only.

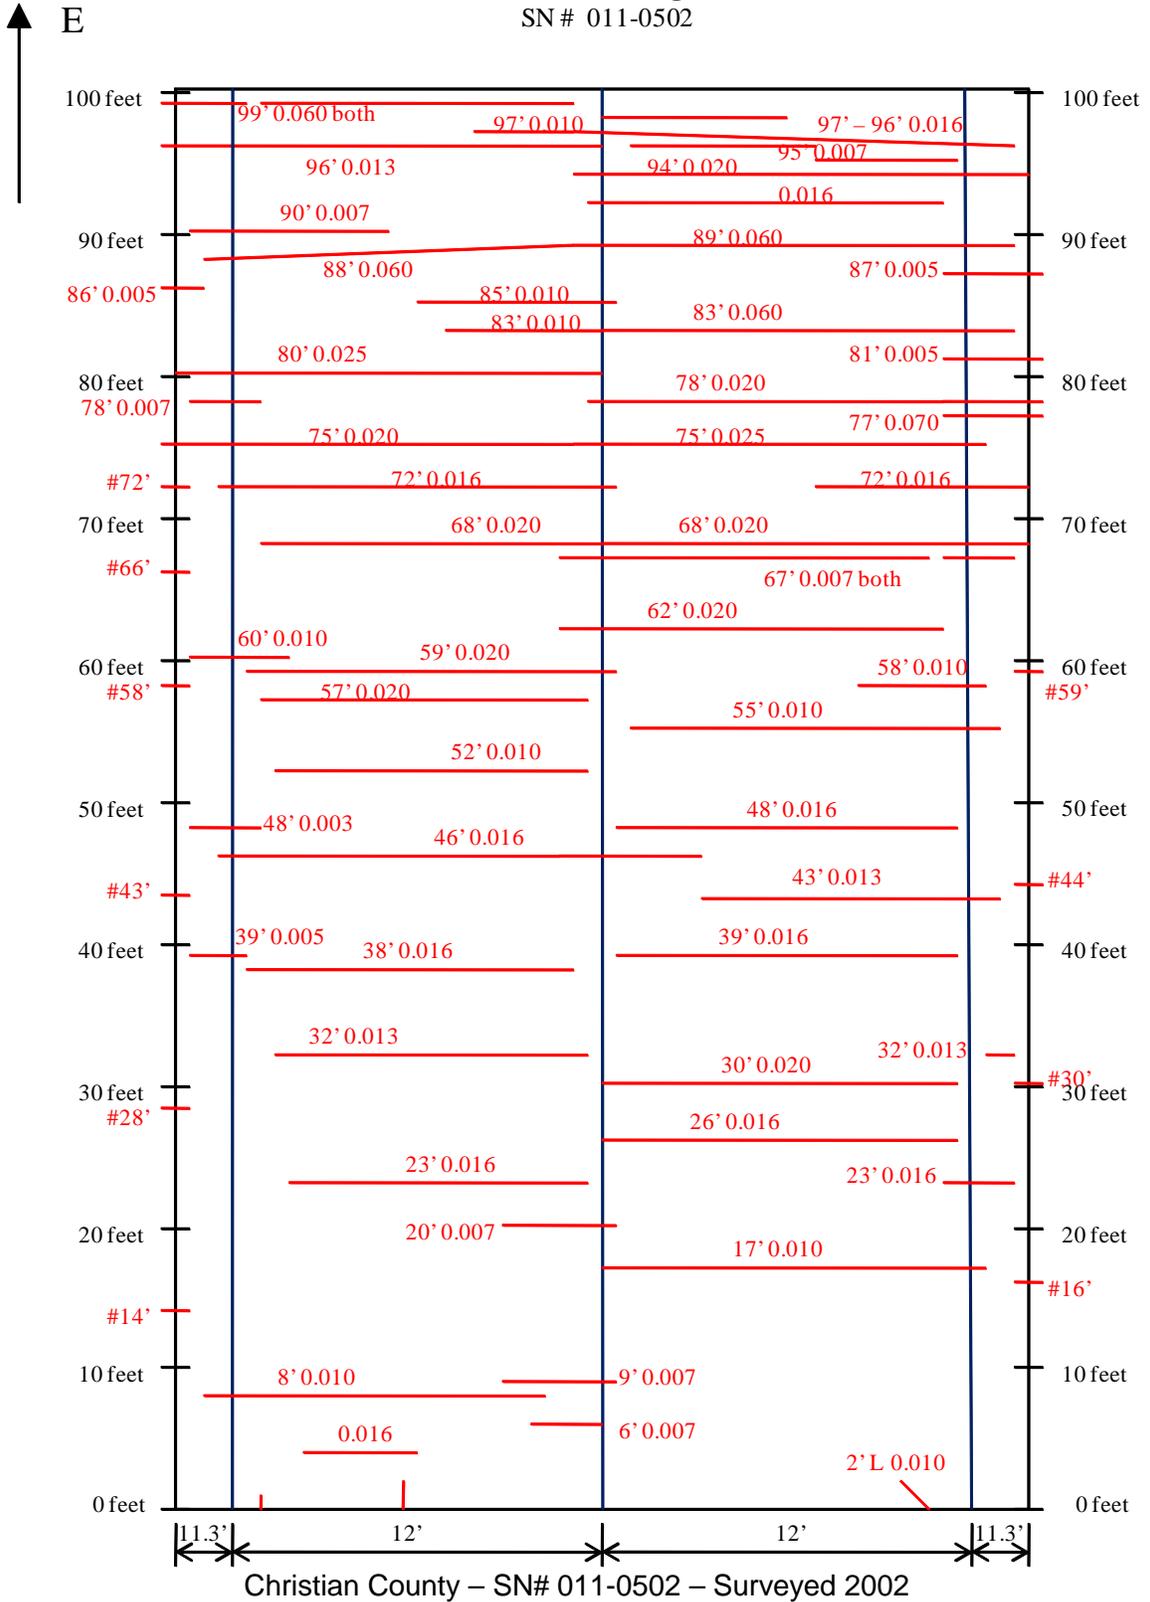
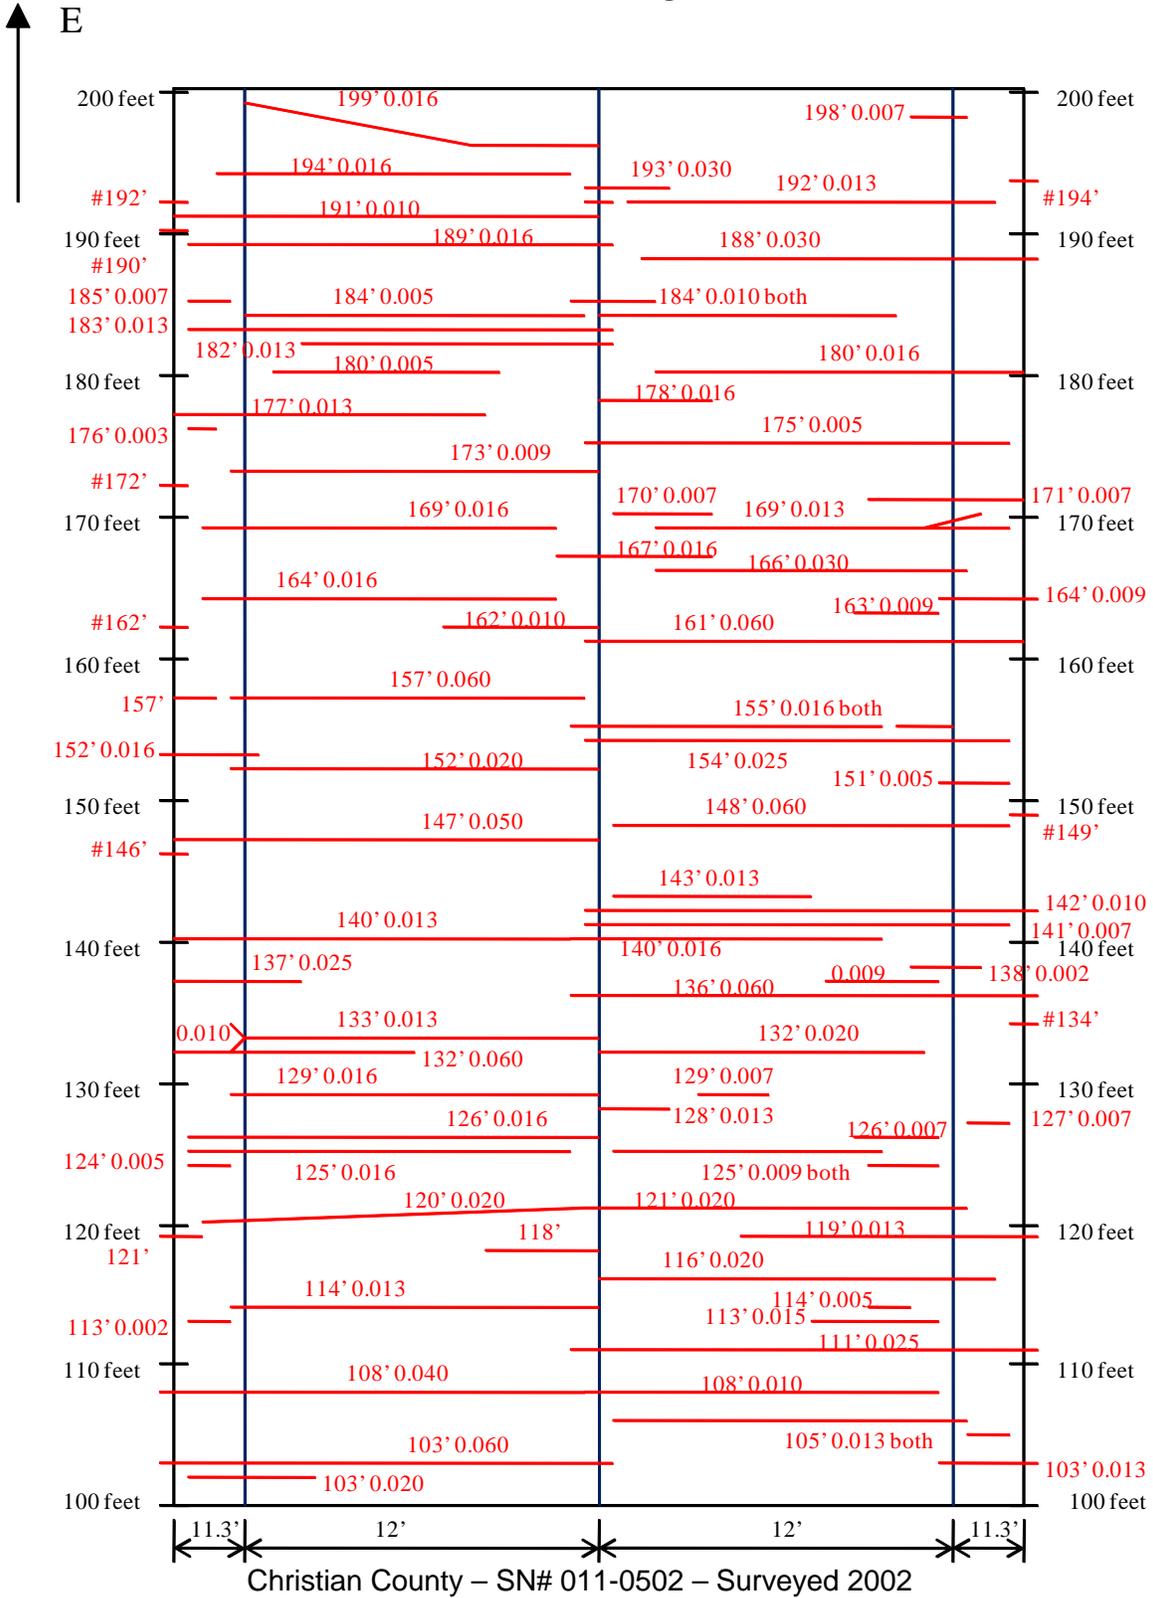
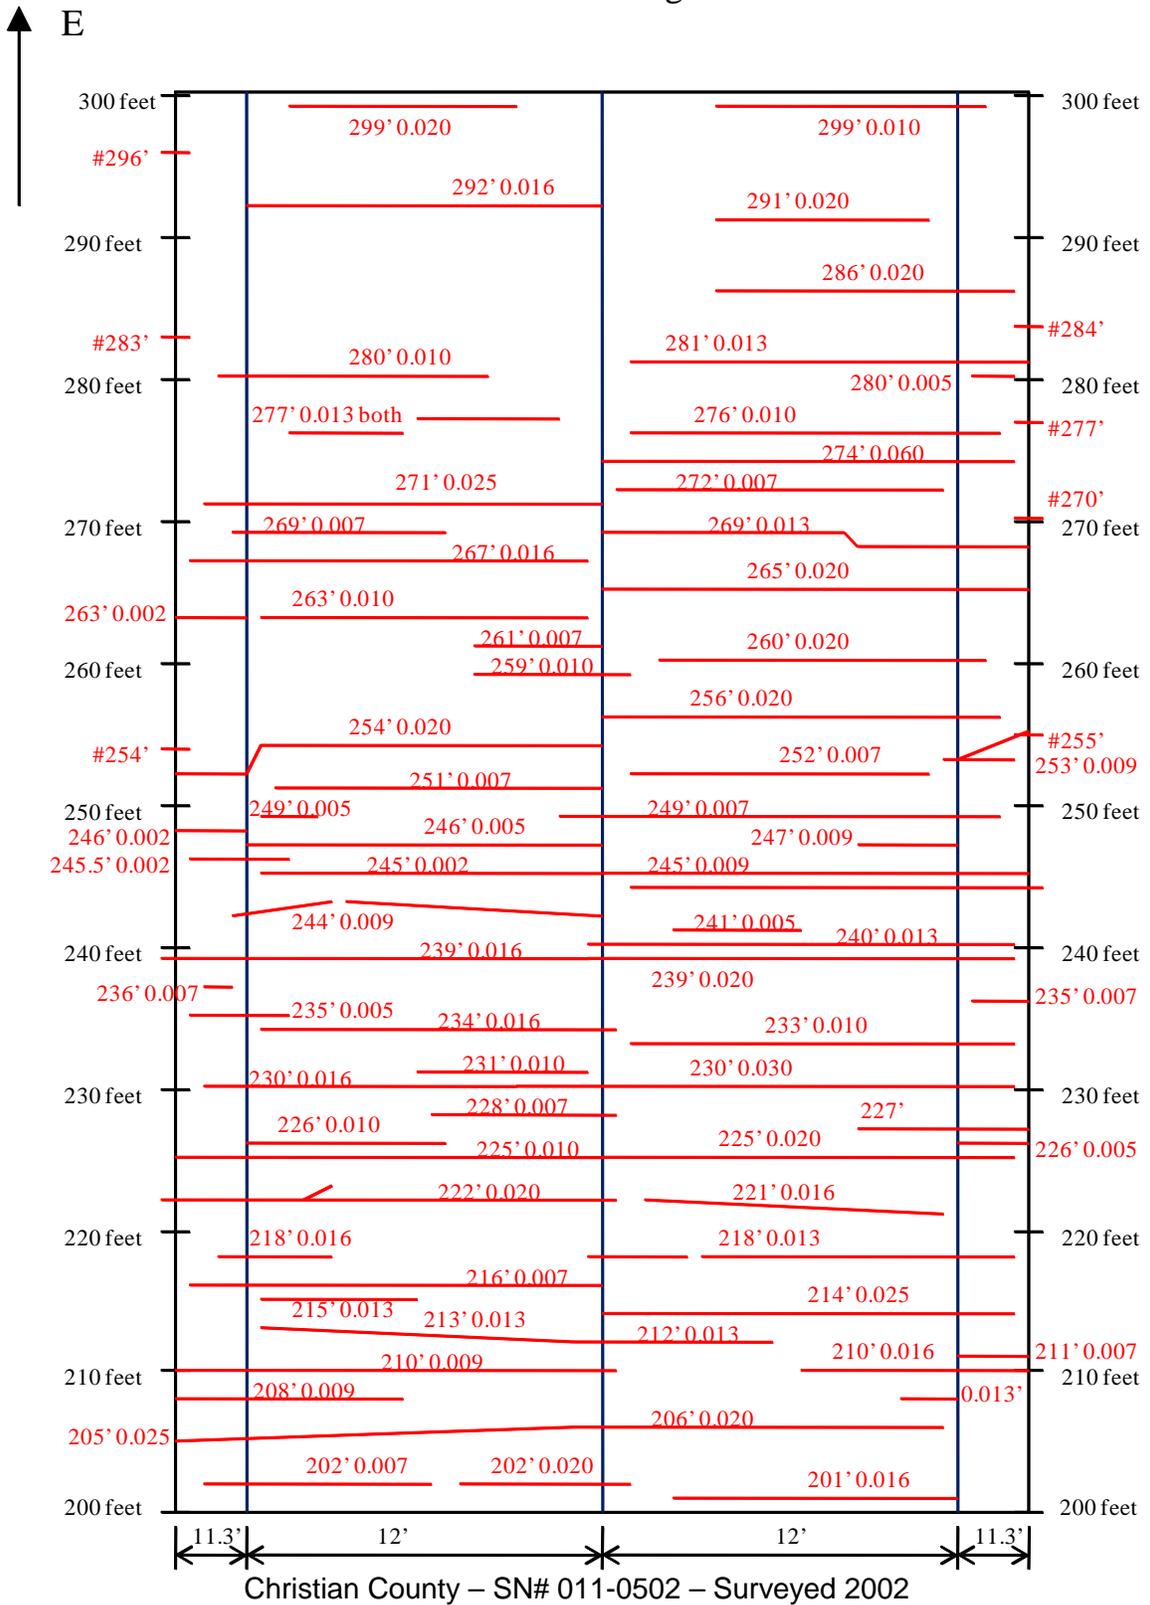
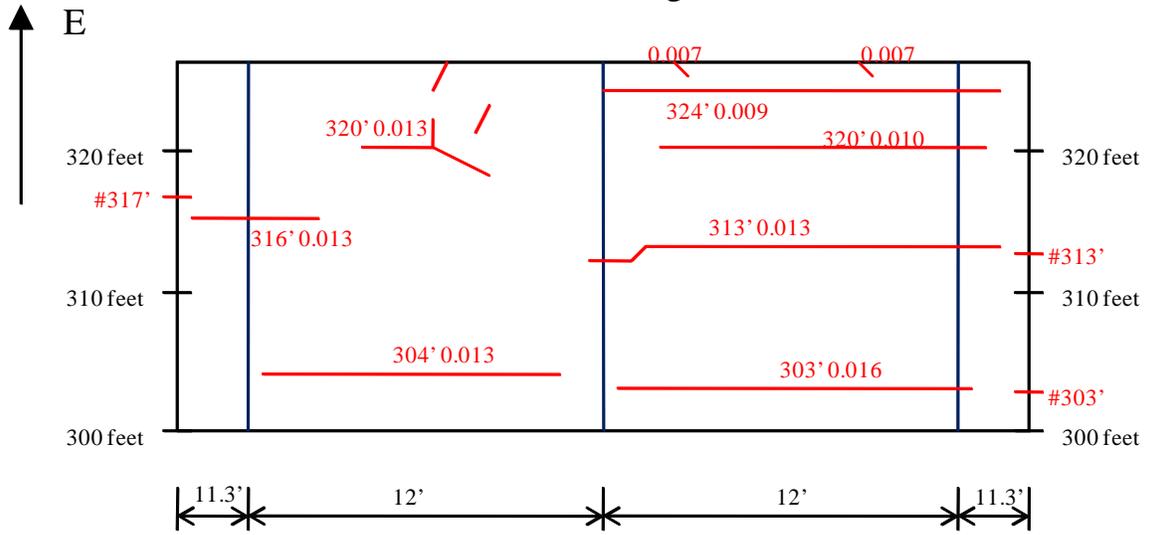
# 104 over S. Fork Sangamon River

Christian County – SN# 011-0502 – Surveyed 2002  
 The “#” symbol represents cracks in the parapet only.

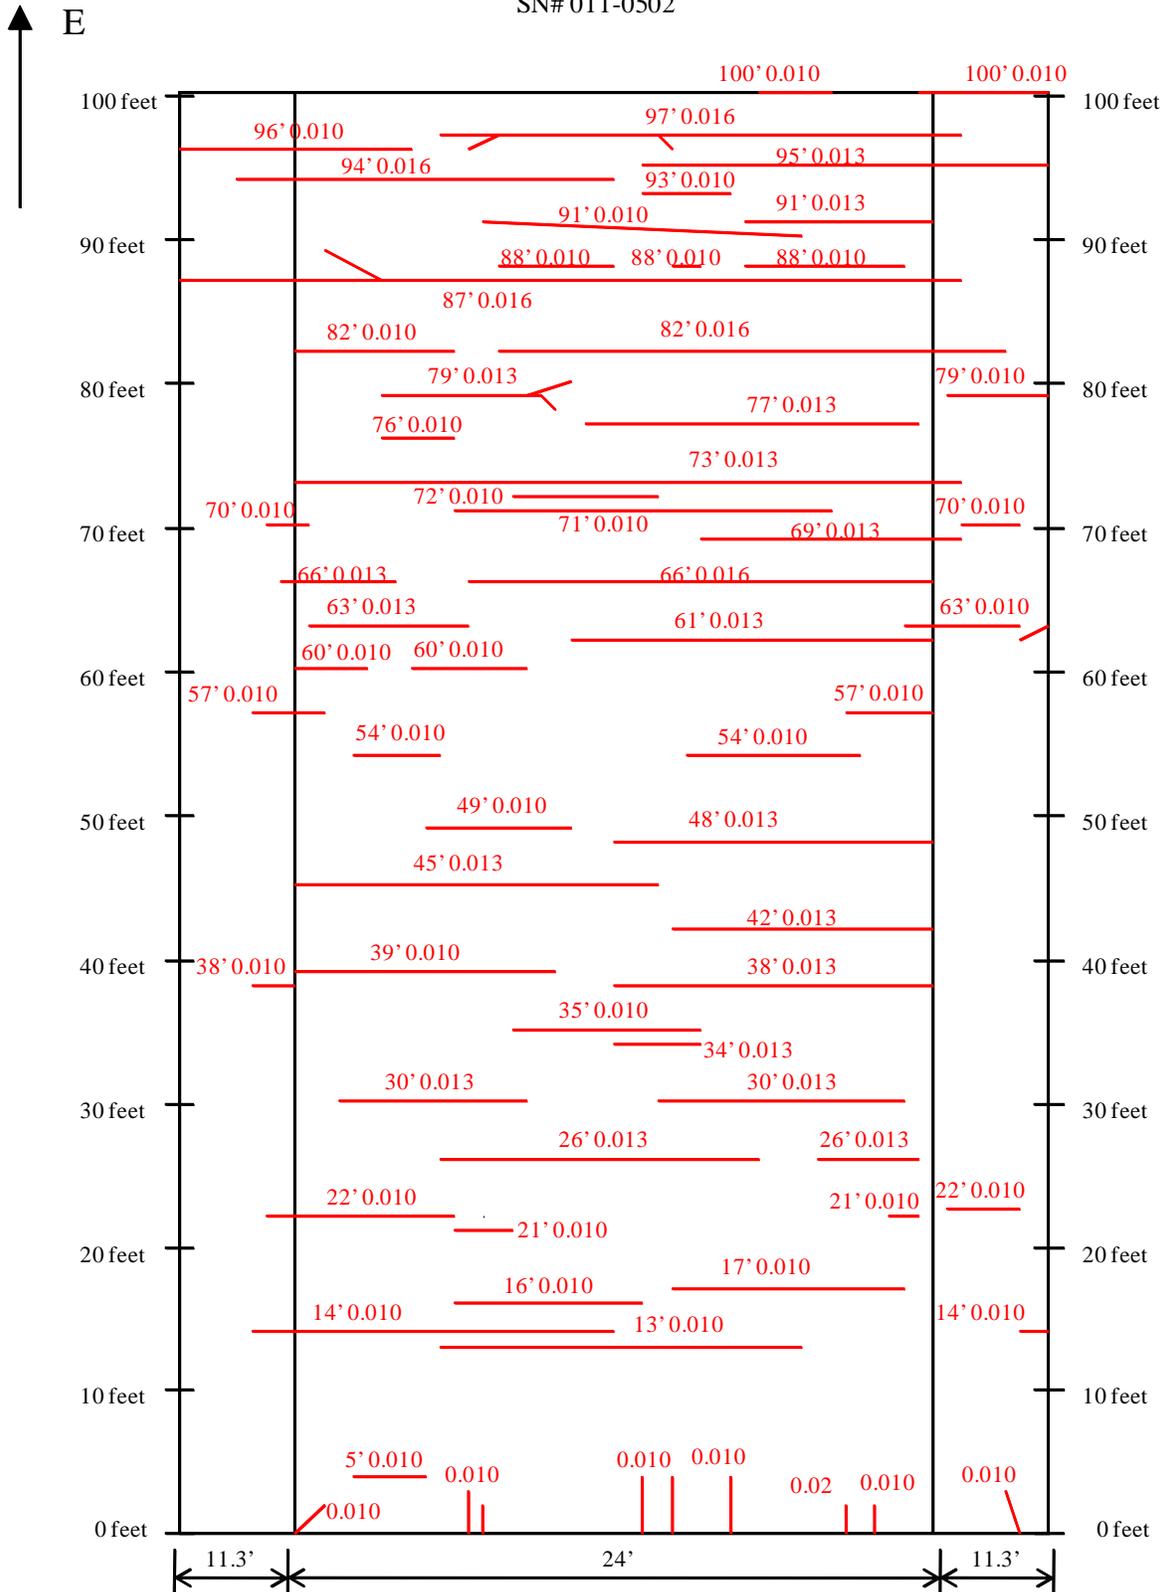
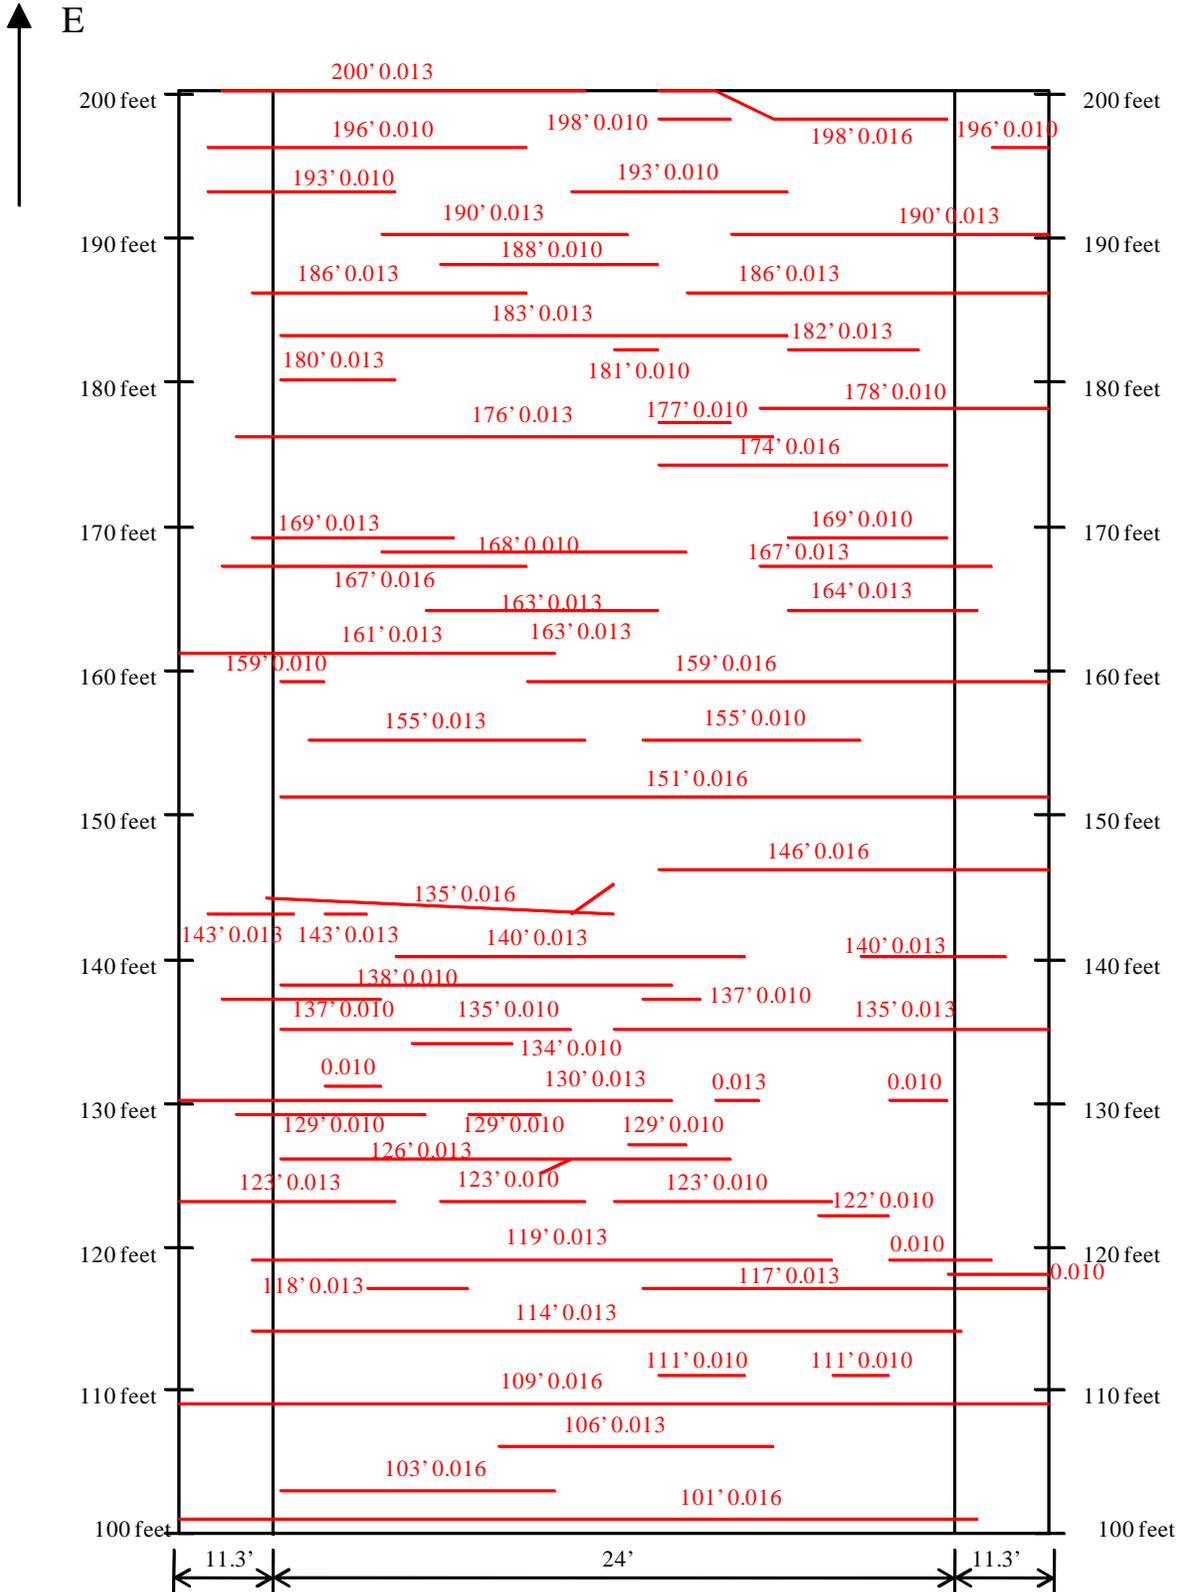
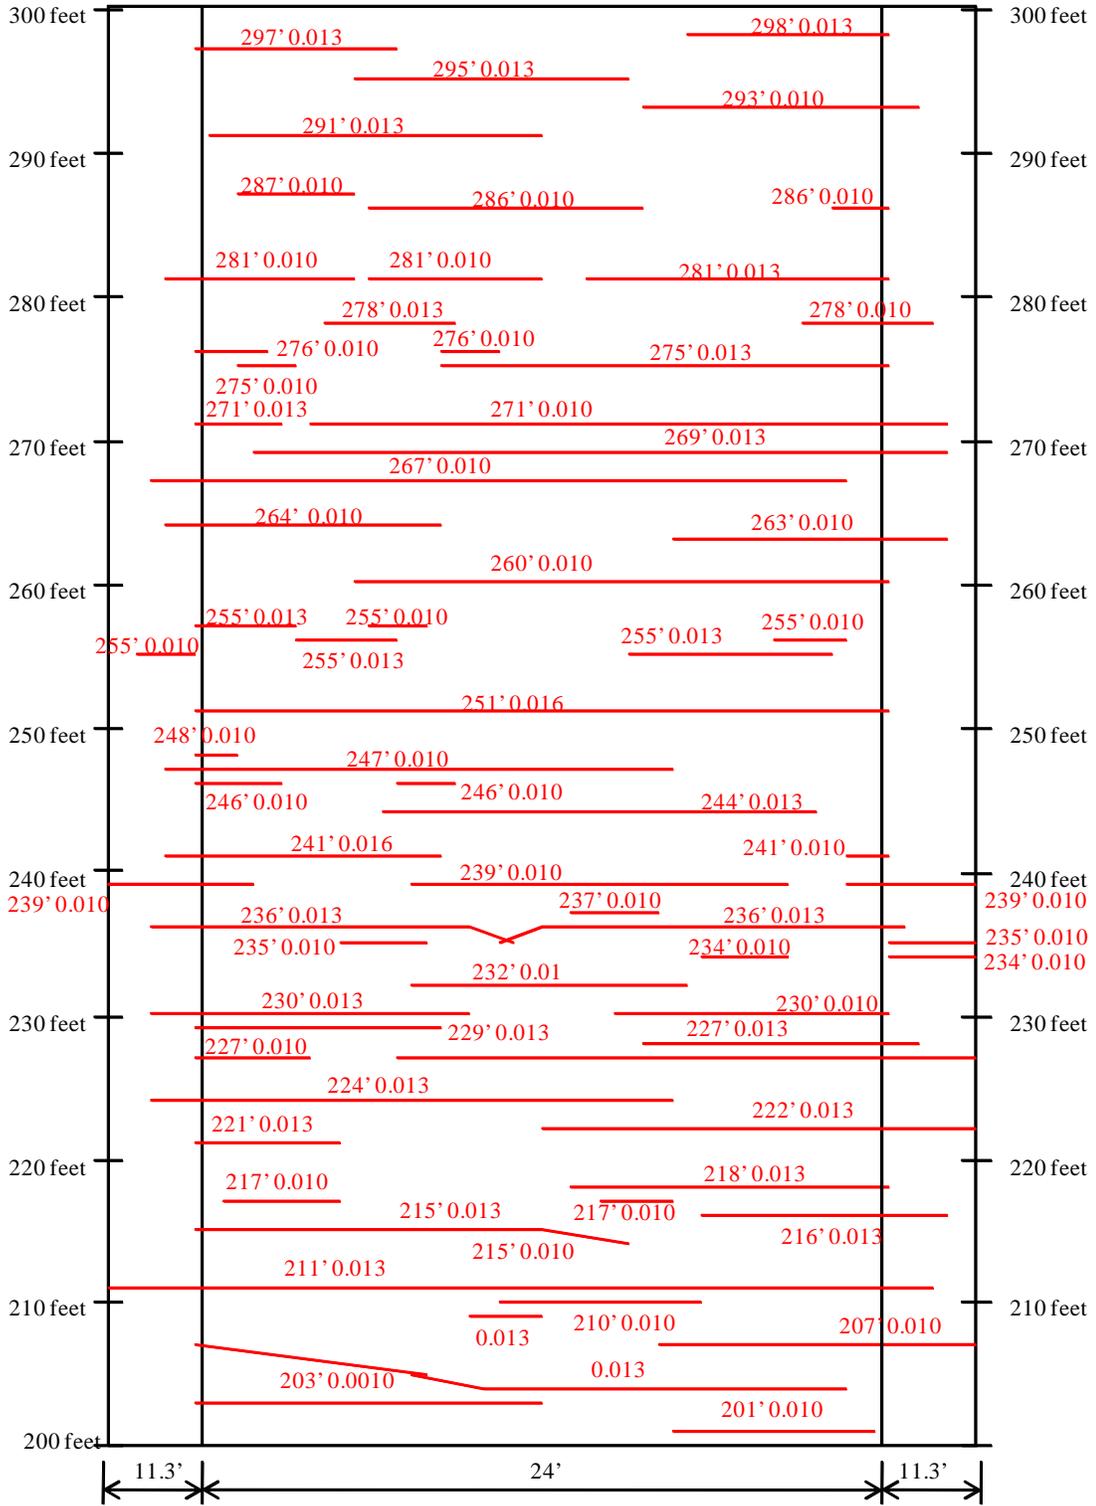
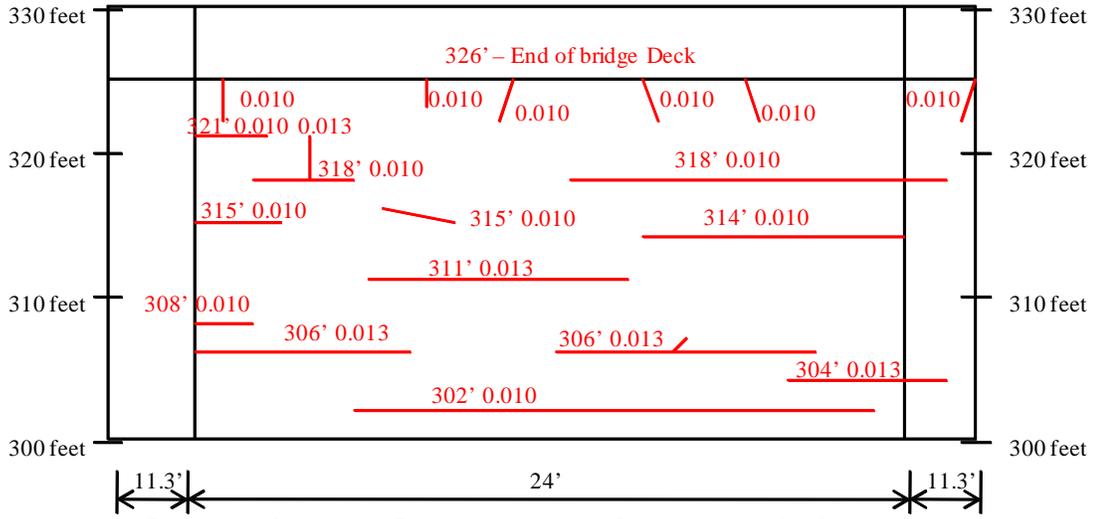
# IL 104 over South Fork Sangamon River

Christian County – SN# 011-0502 – Surveyed 12/30/2003
