**EVALUATION OF HIGH PERFORMANCE  
CONCRETE BRIDGE DECKS  
AND  
OTHER EXPERIMENTAL BRIDGE  
DECKS THROUGHOUT ILLINOIS**

**PHYSICAL RESEARCH REPORT NO. 166  
December 2017**

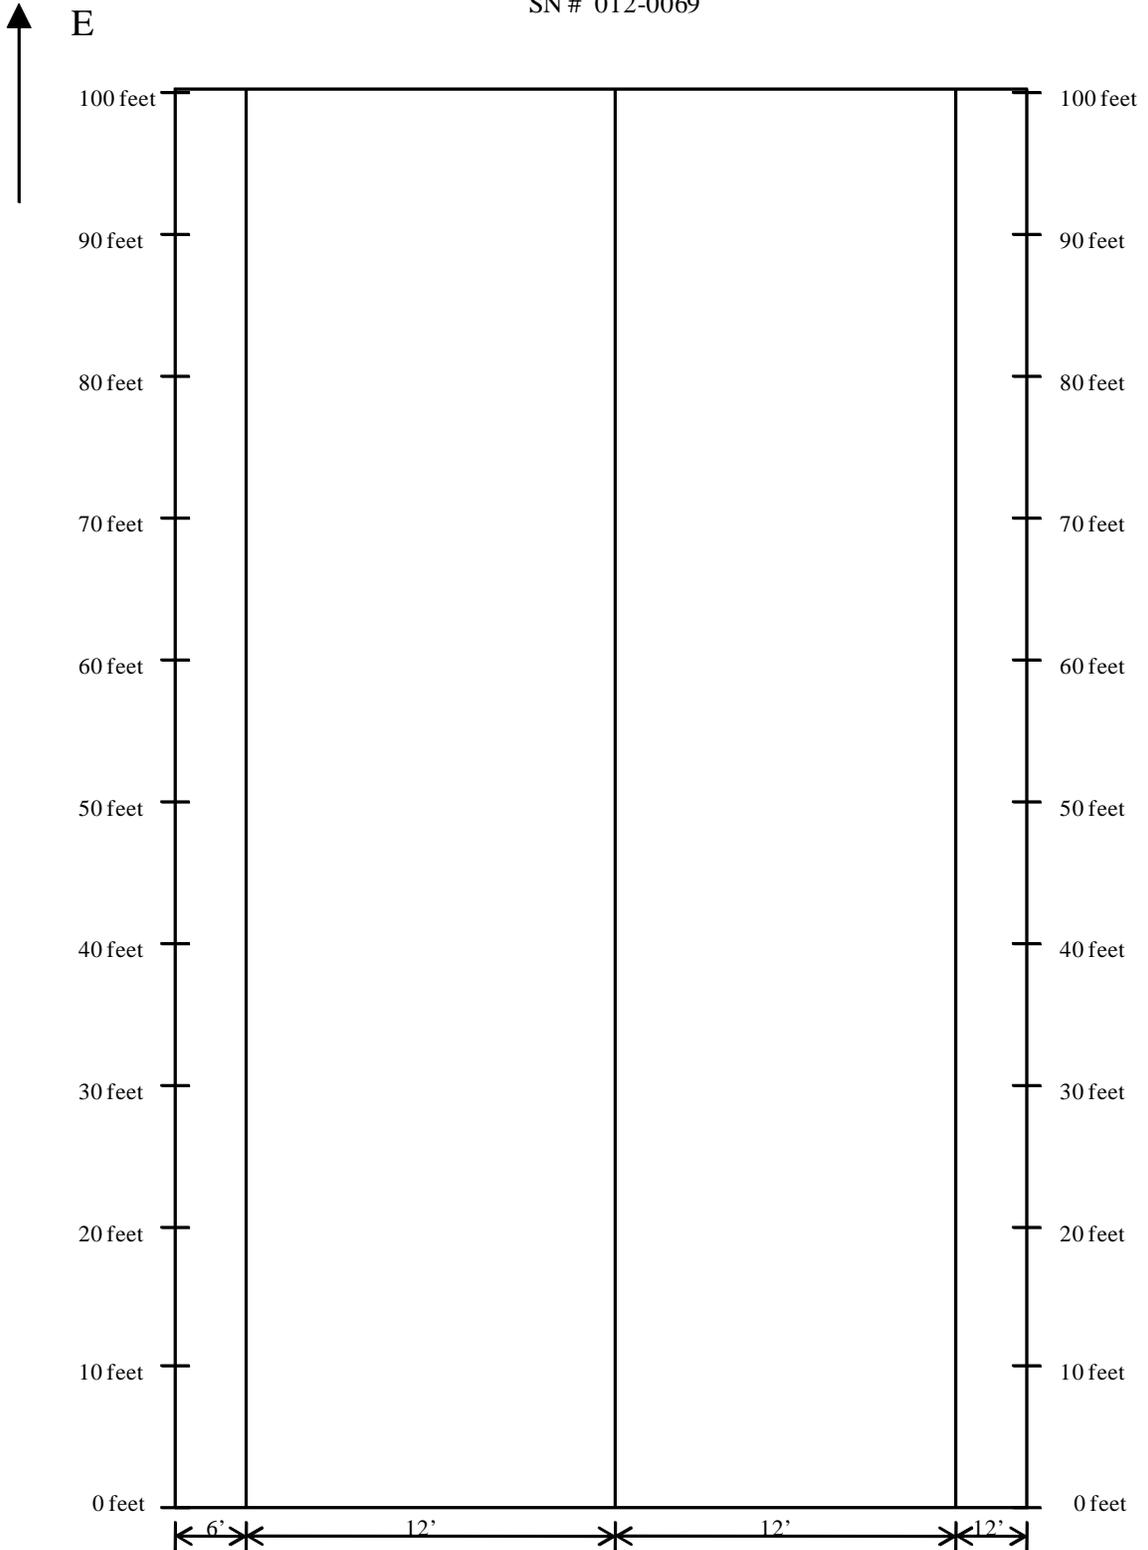
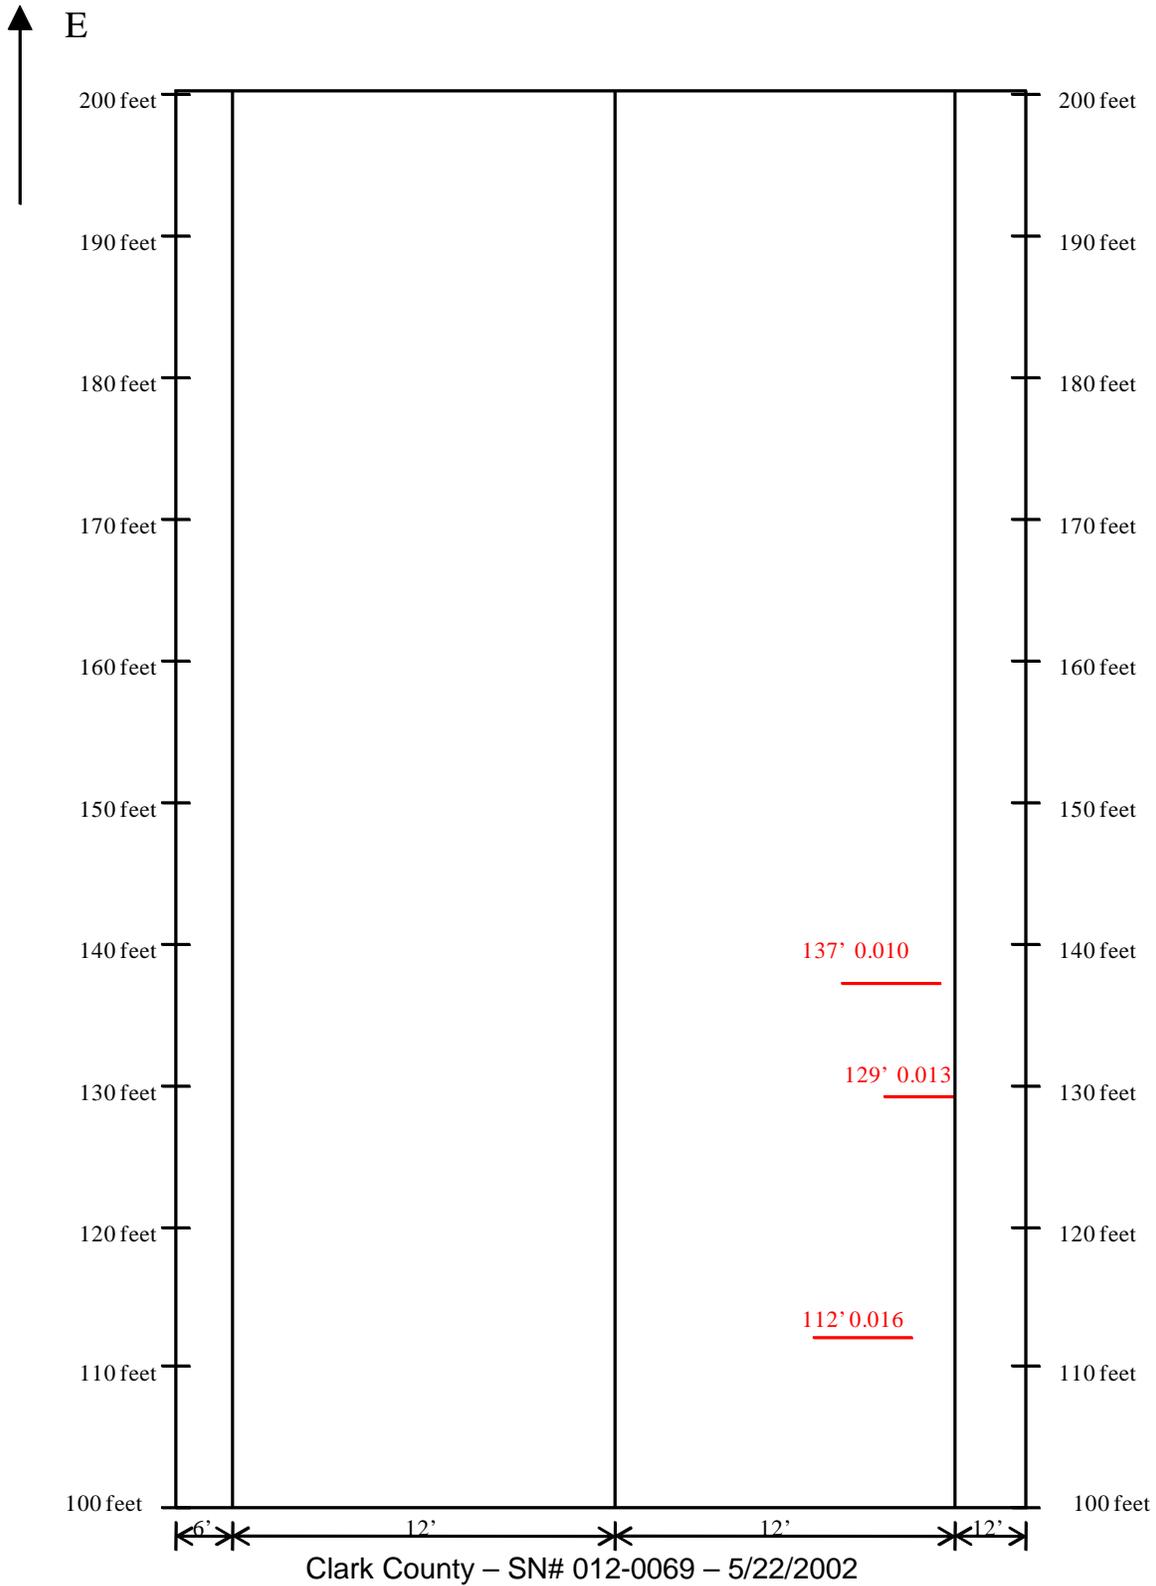
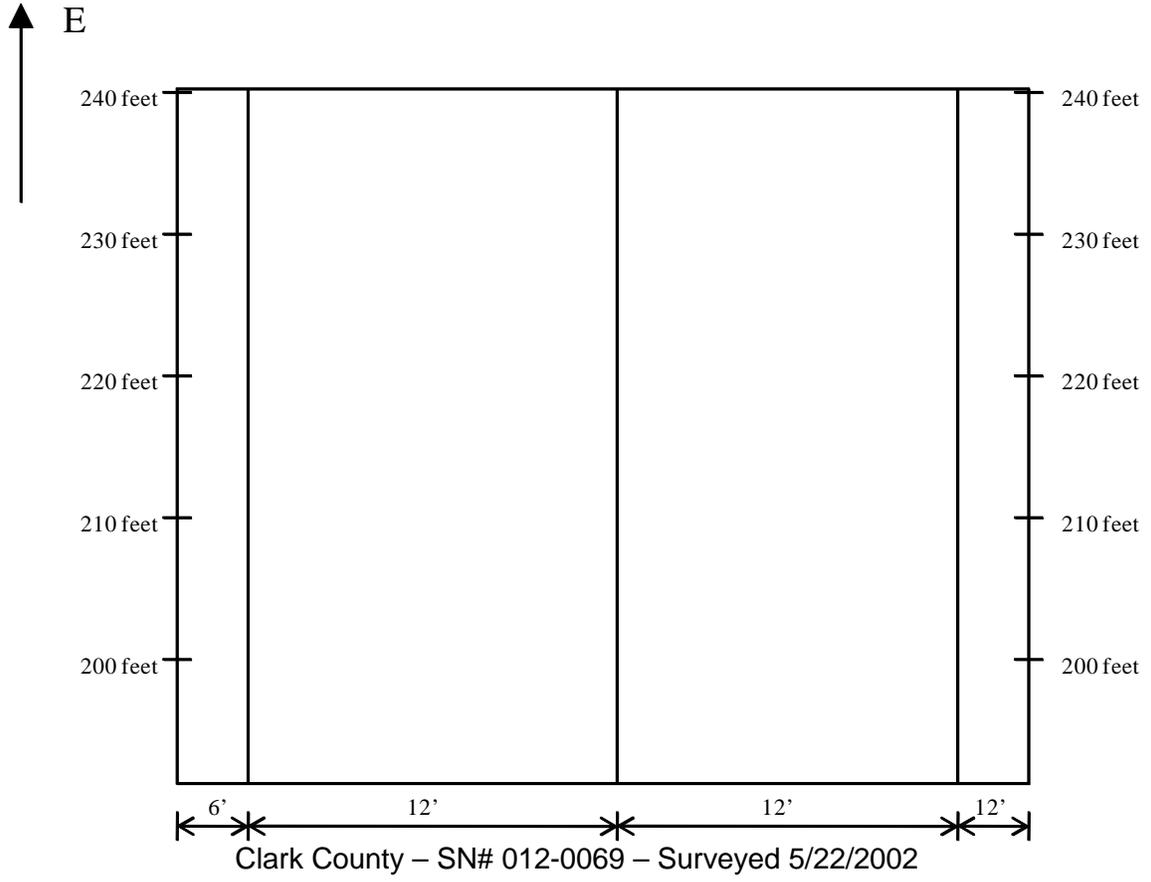
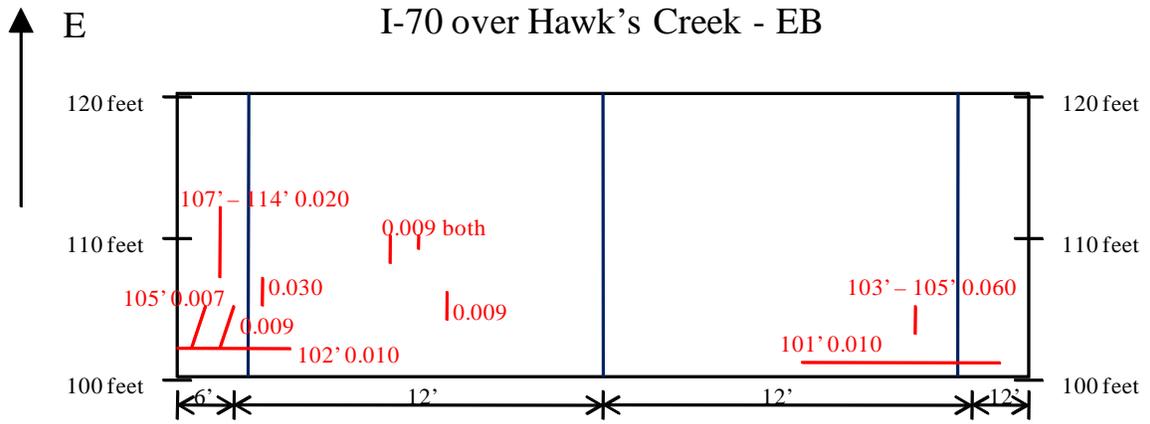
# I-70 Over Hawks Creek (EB)

Clark County – SN# 012-0069 – Surveyed 5/22/2002

Clark County – SN# 012-0069 – Surveyed 10/1/2003

This is a partial deck survey due to time constraints and traffic safety concerns.

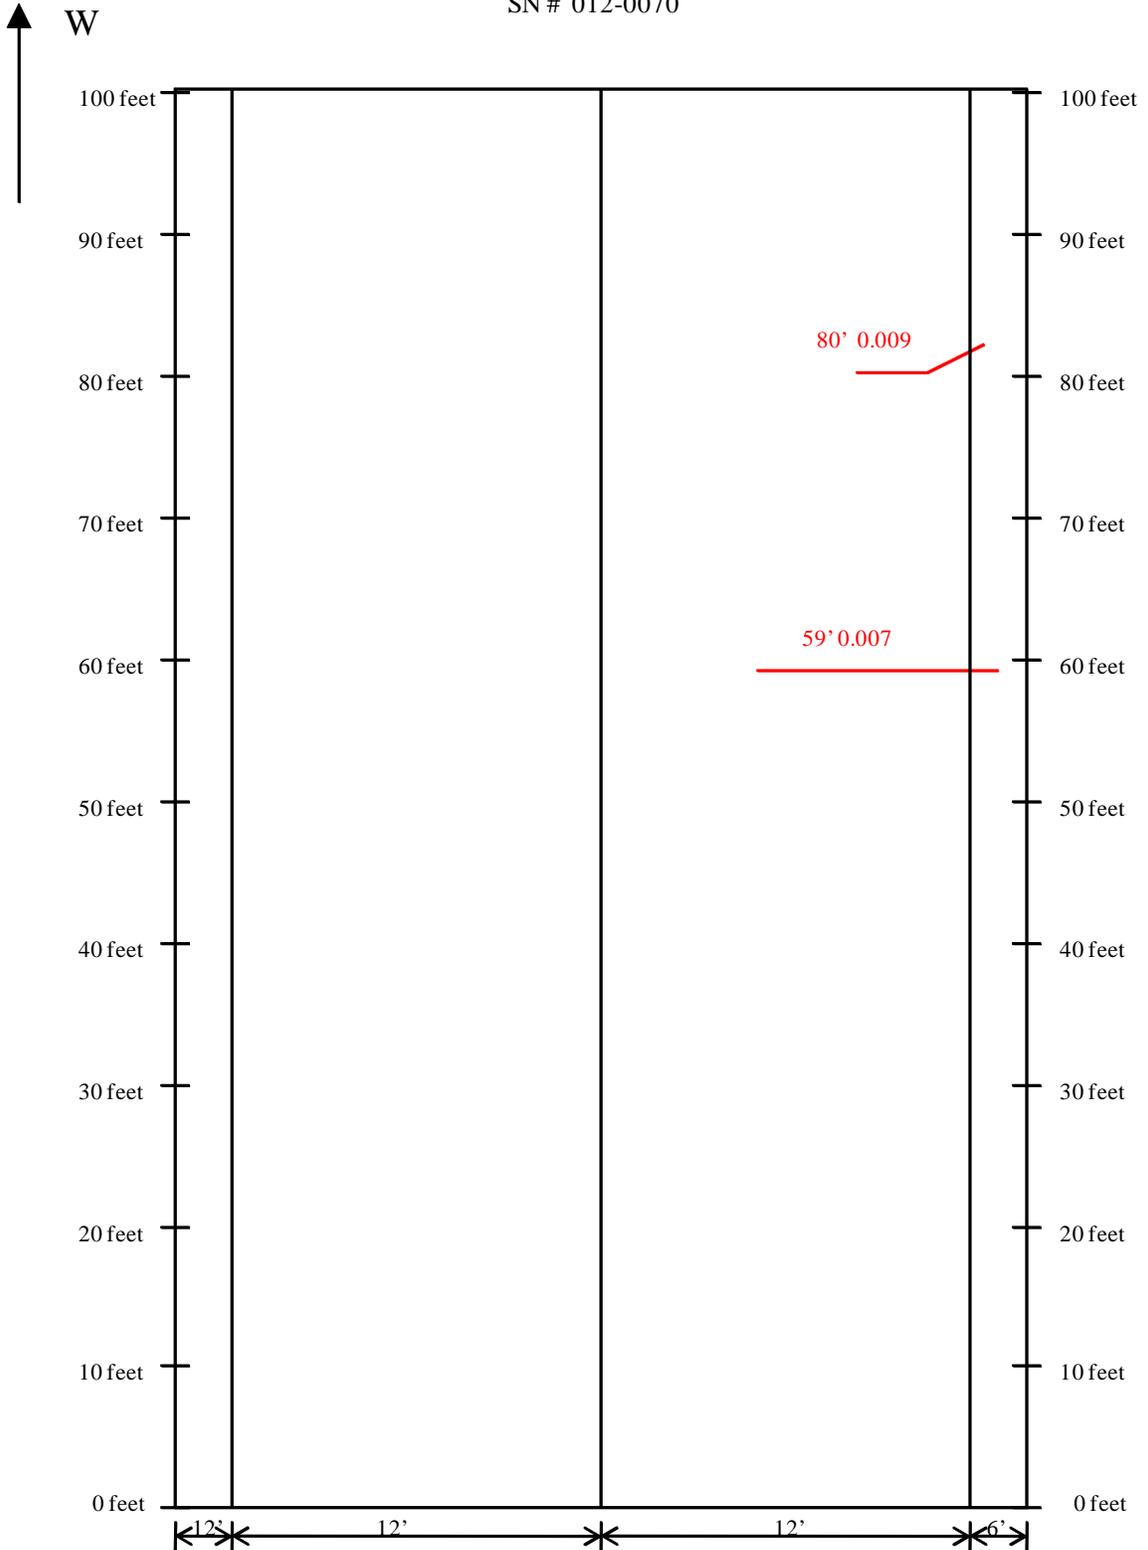
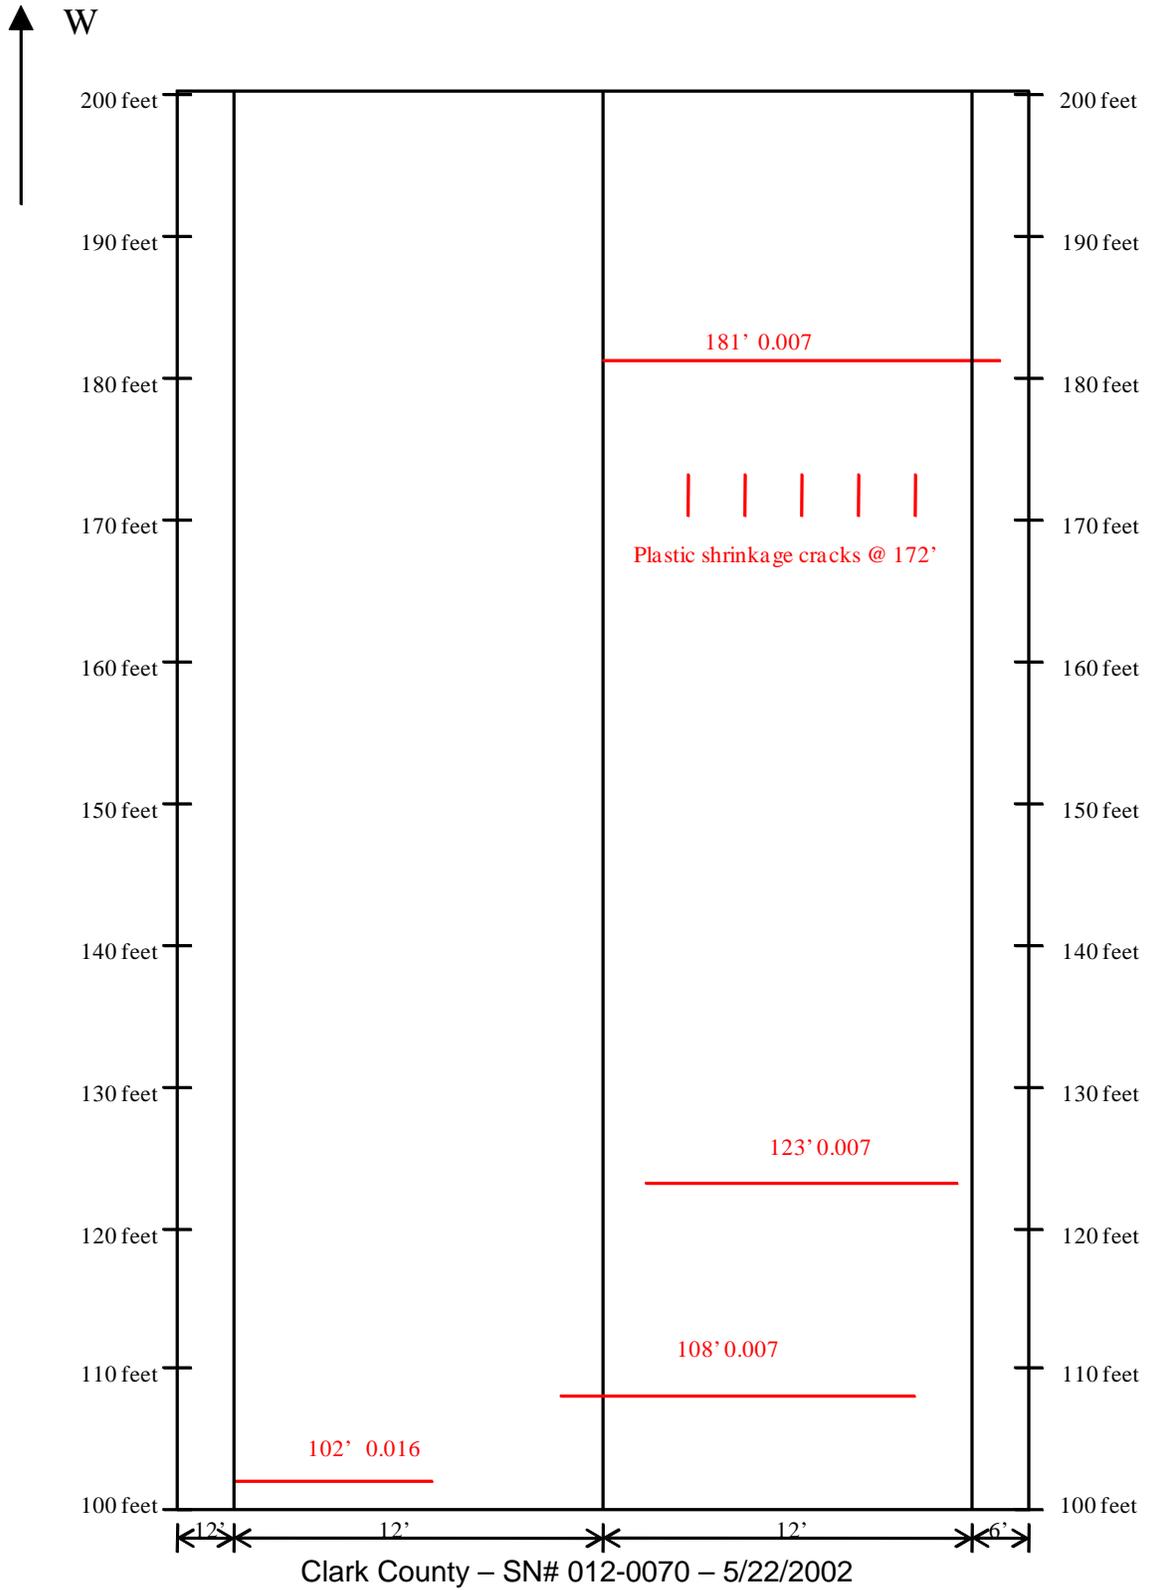
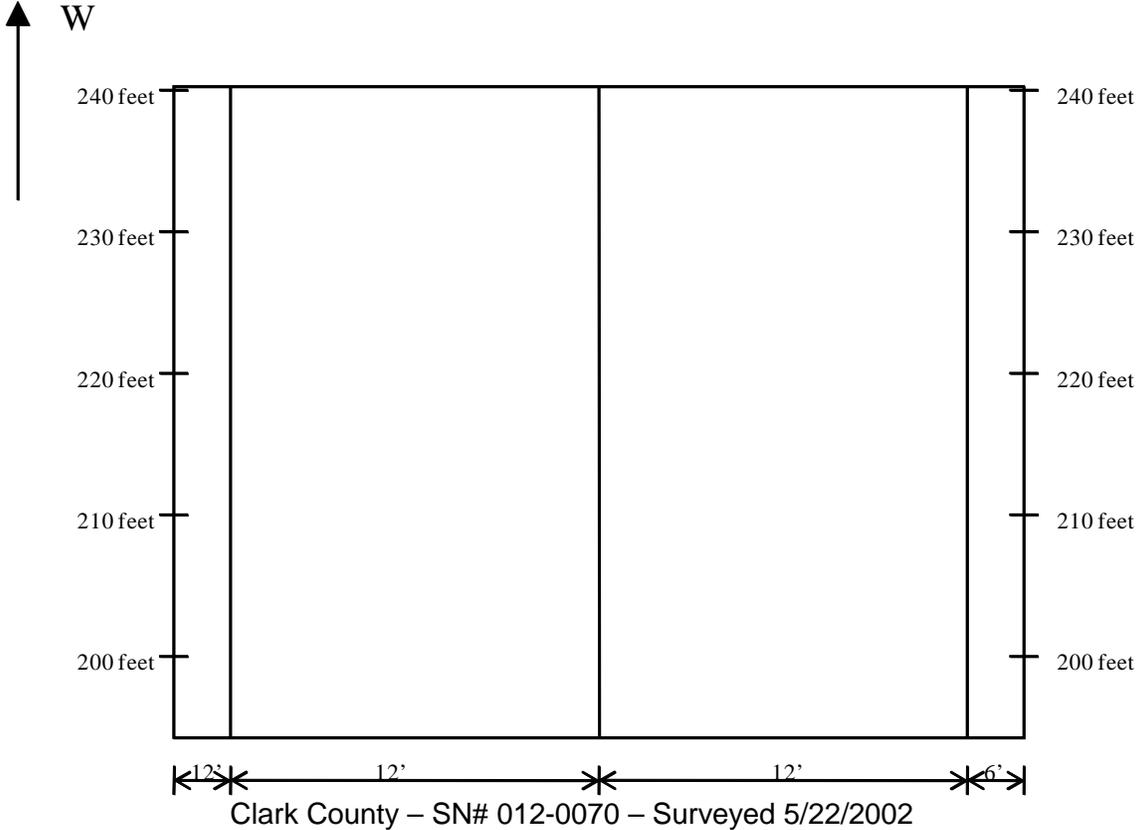
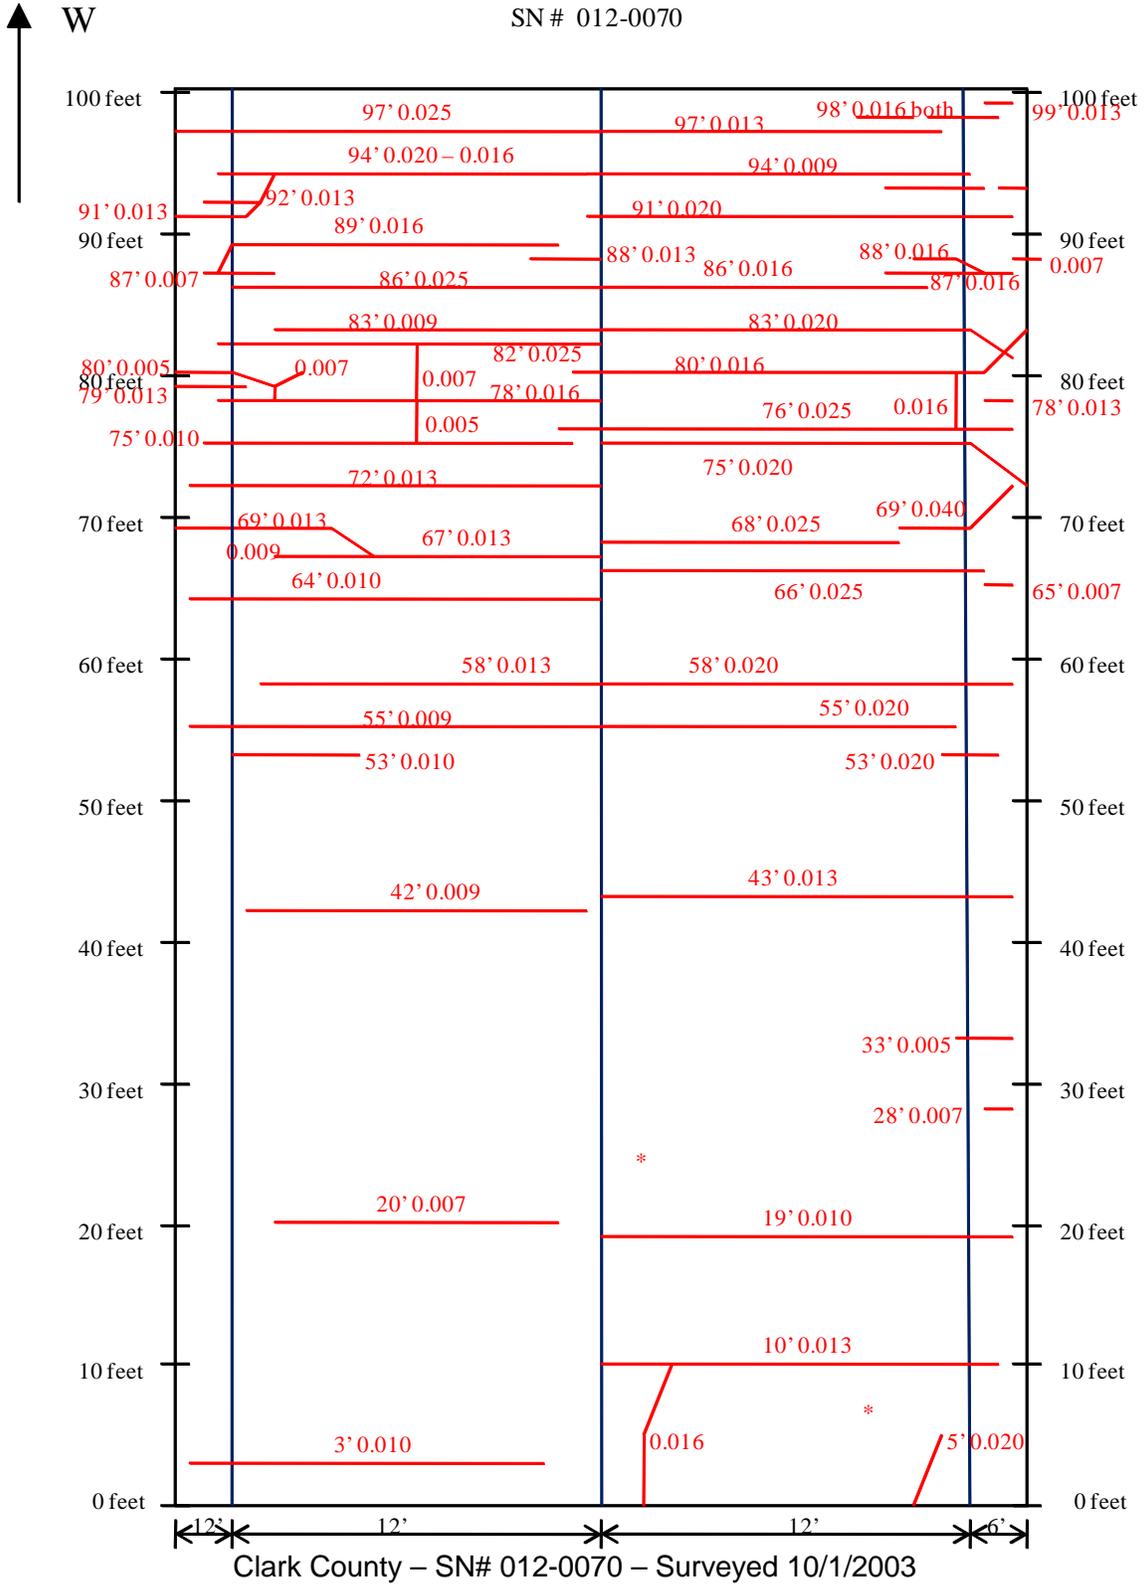
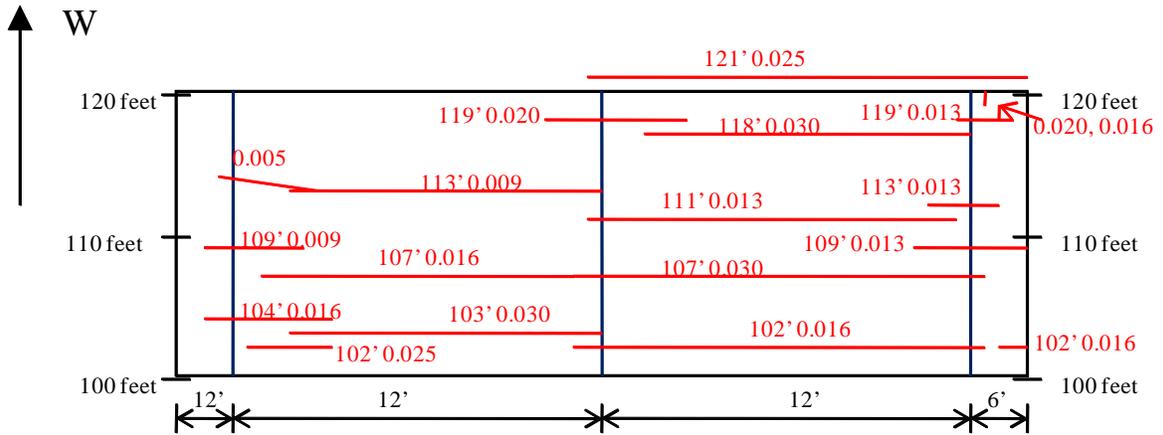
# I-70 Over Hawks Creek (WB)

Clark County – SN# 012-0070 – Surveyed 5/55/2002

Clark County – SN# 012-0070 – 10/1/2003

This is a partial deck survey due to time constraints and traffic concerns.

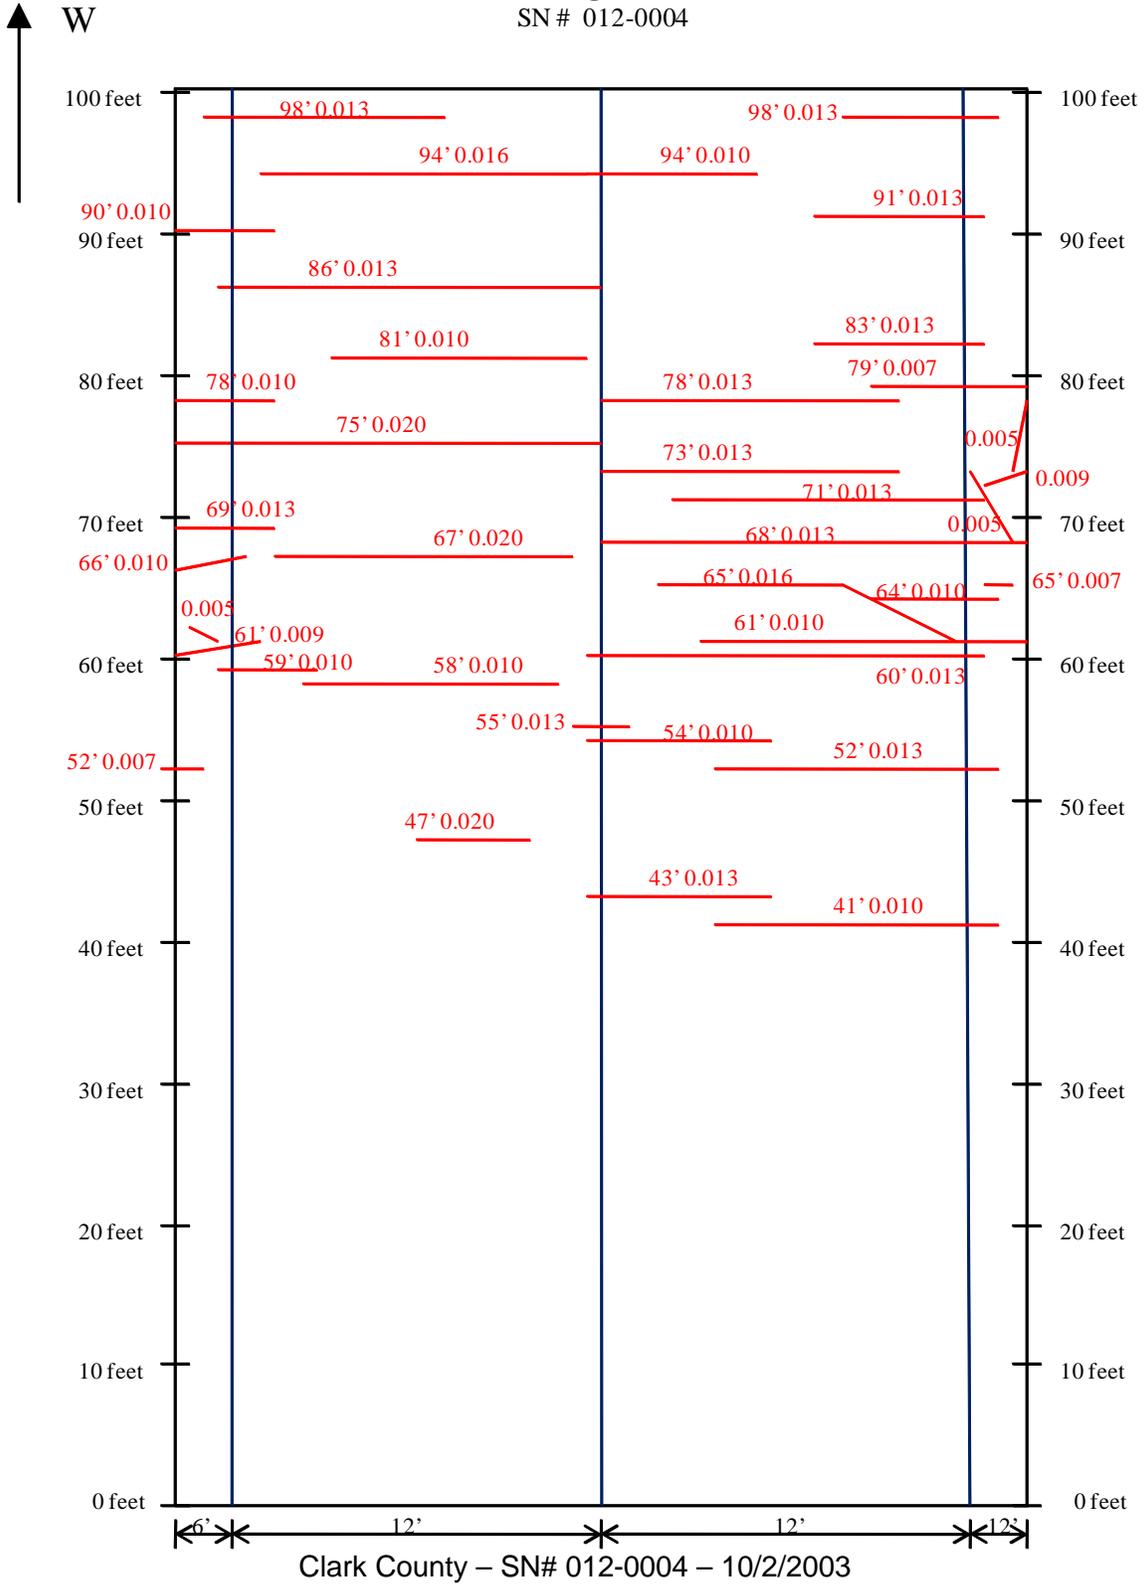
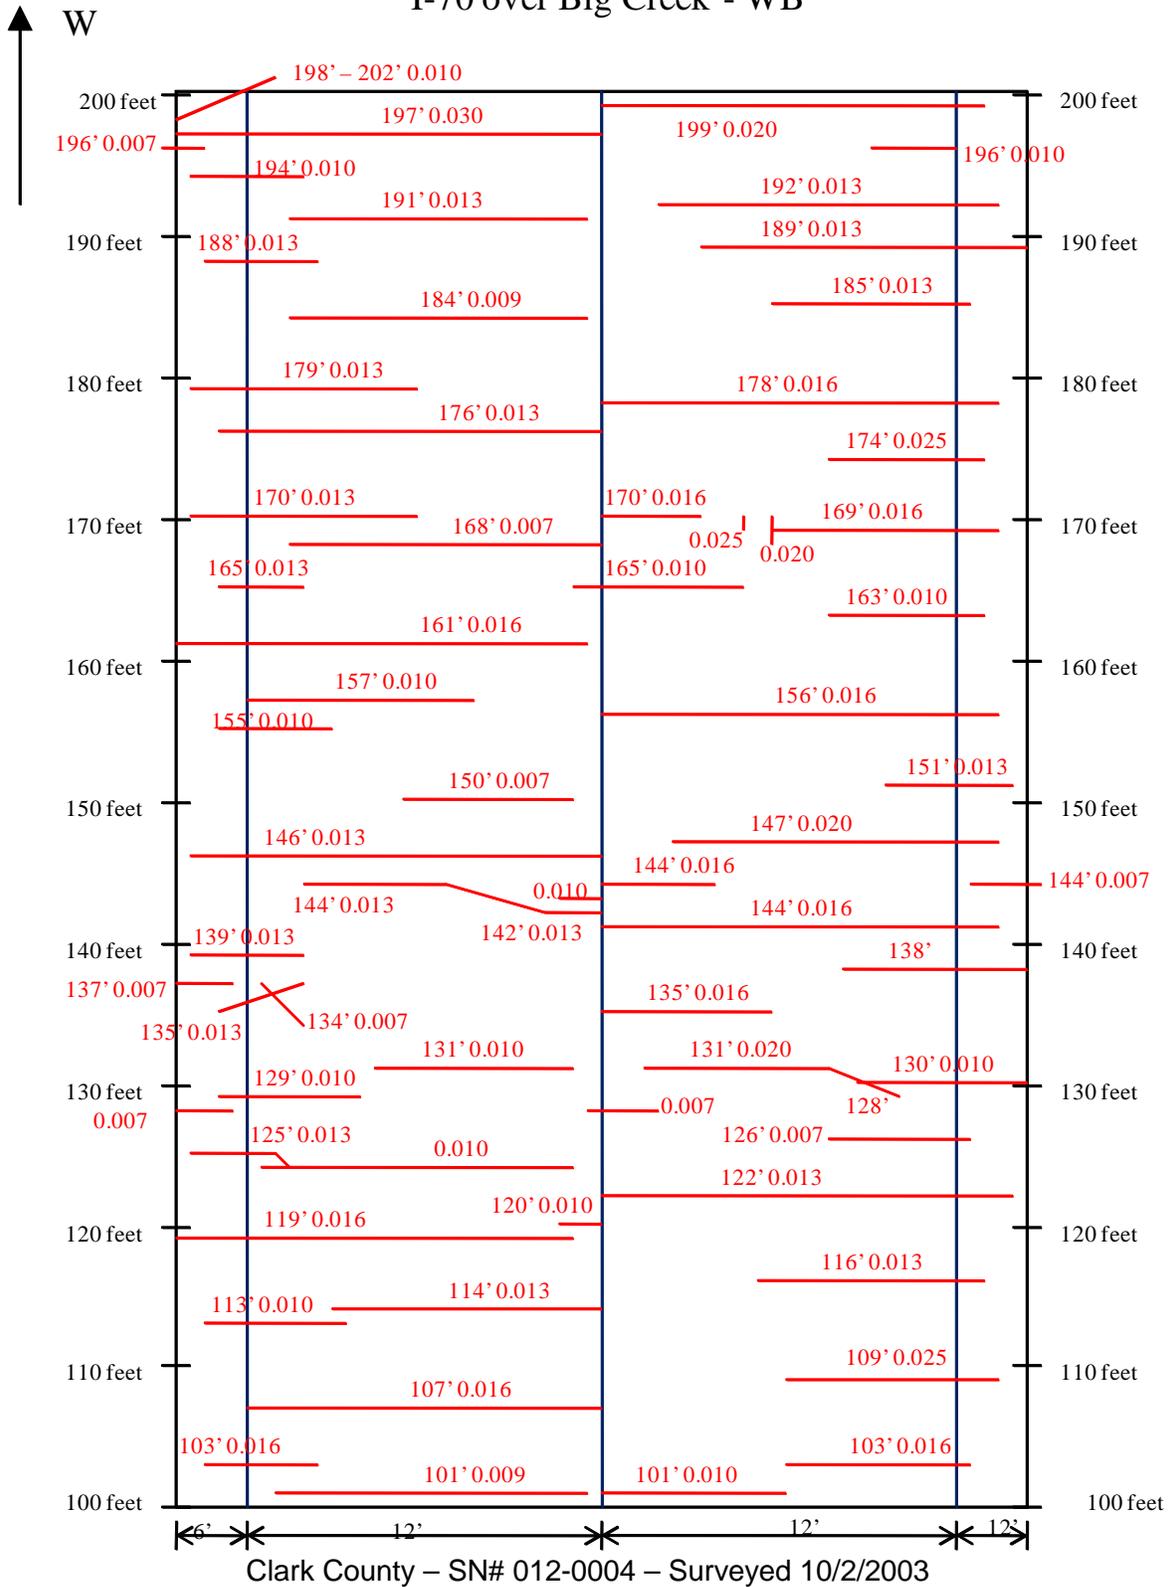
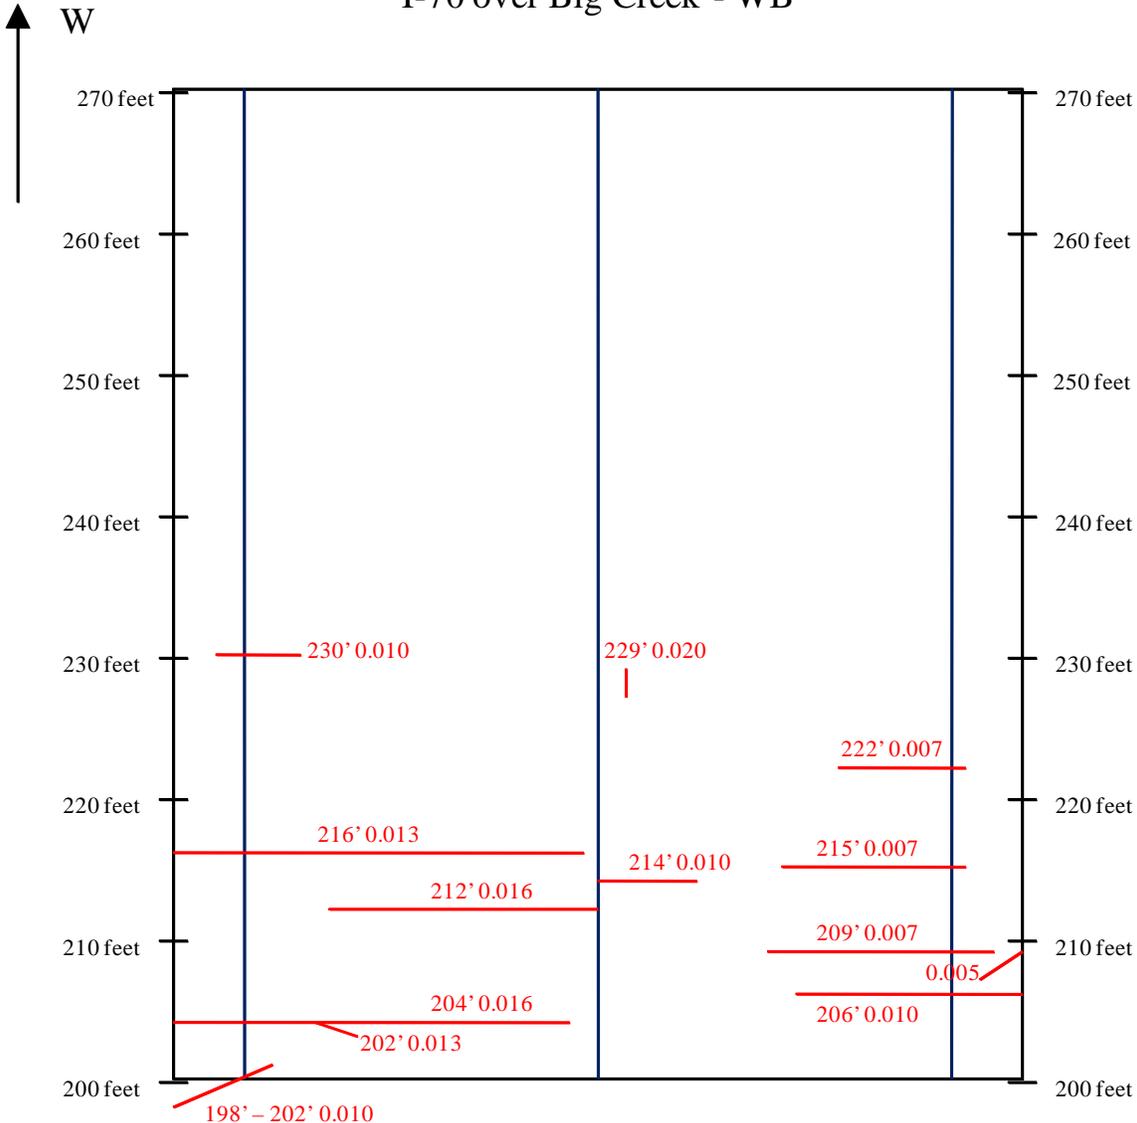
I-70 over Big Creek – WB  
 SN # 012-0004

Clark County – SN# 012-0004 – 10/2/2003

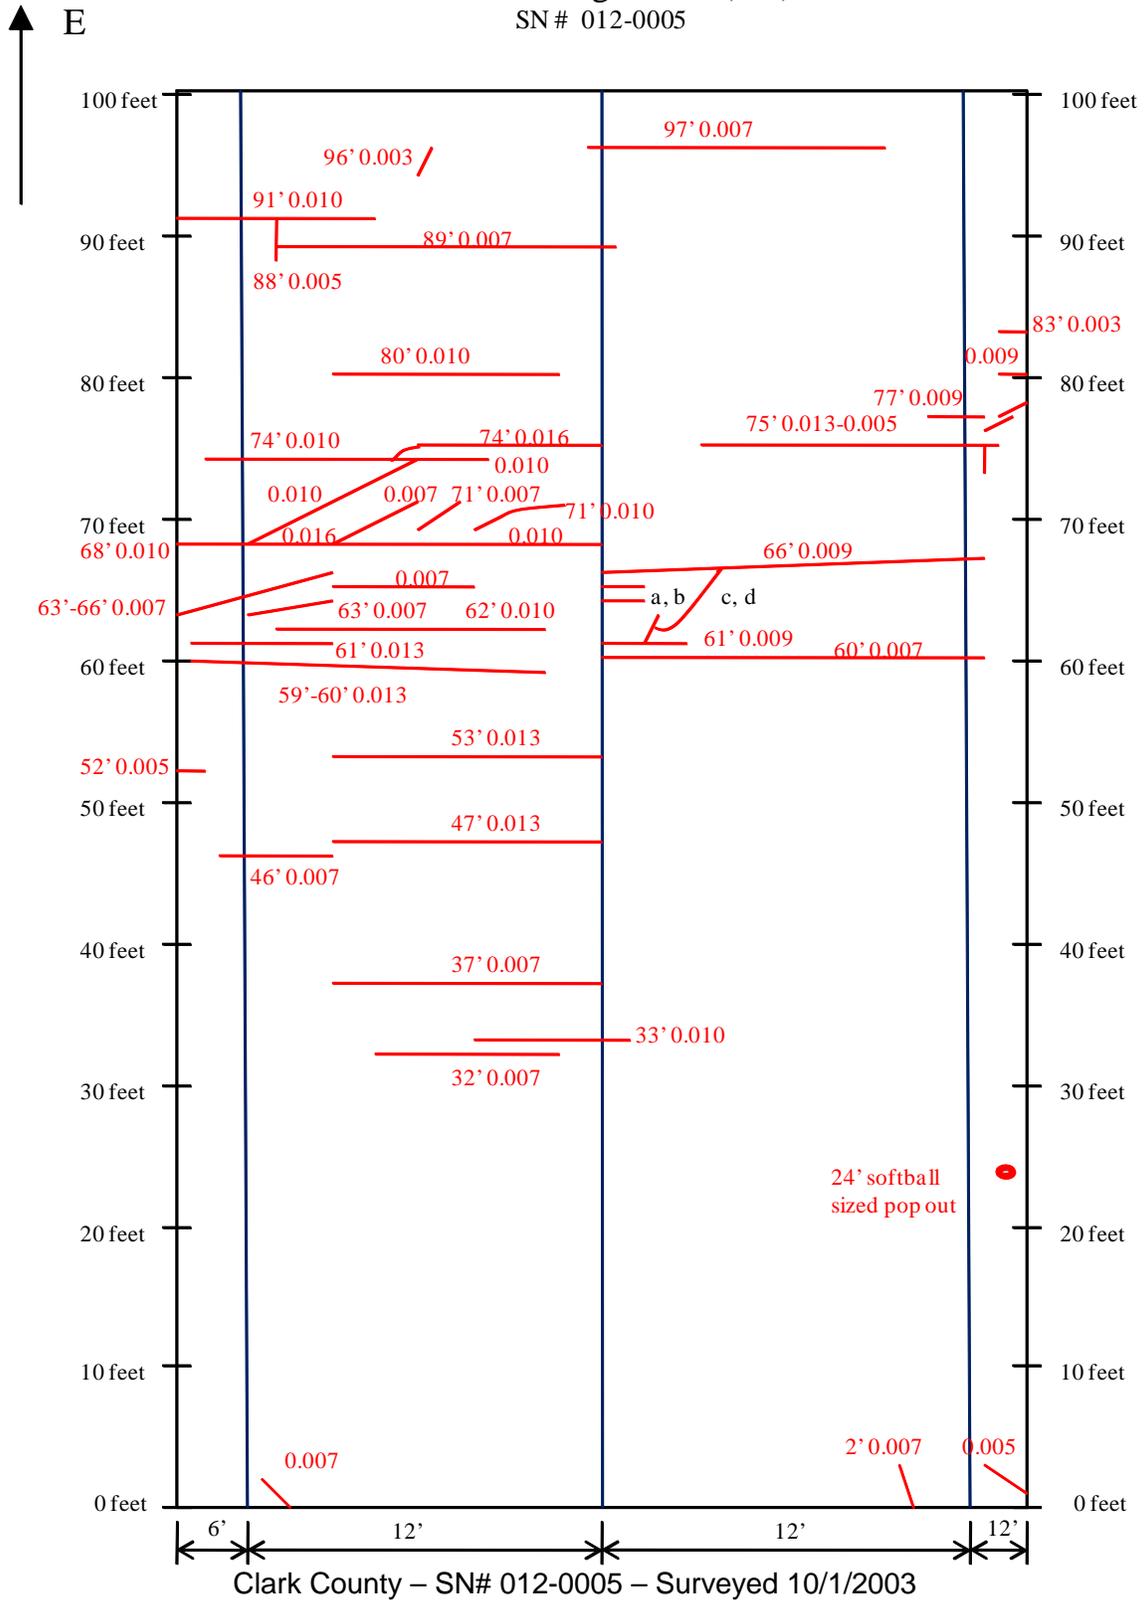
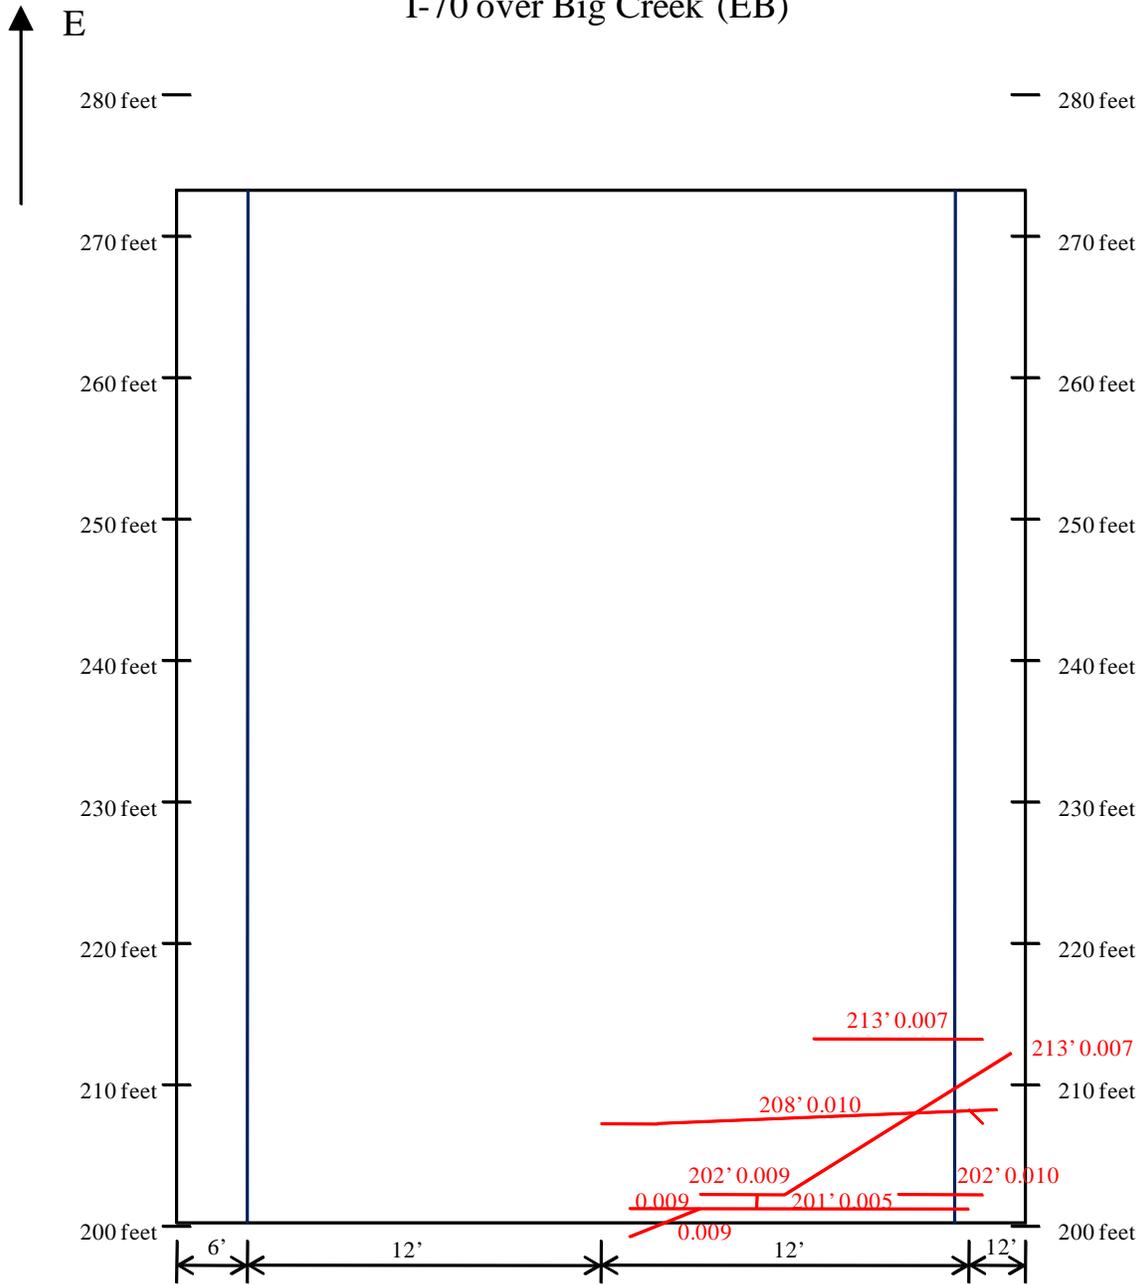
I-70 over Big Creek (EB)  
SN # 012-0005

Clark County – SN# 012-0005 – Surveyed 10/1/2003  
 This survey was a partial survey due to time limitations and traffic safety.  
 a = 0.007 @ 64'; b = 0.009 @ 65'; c = 0.009; d = 0.009
