**EVALUATION OF HIGH PERFORMANCE  
CONCRETE BRIDGE DECKS  
AND  
OTHER EXPERIMENTAL BRIDGE  
DECKS THROUGHOUT ILLINOIS**

**PHYSICAL RESEARCH REPORT NO. 166  
December 2017**

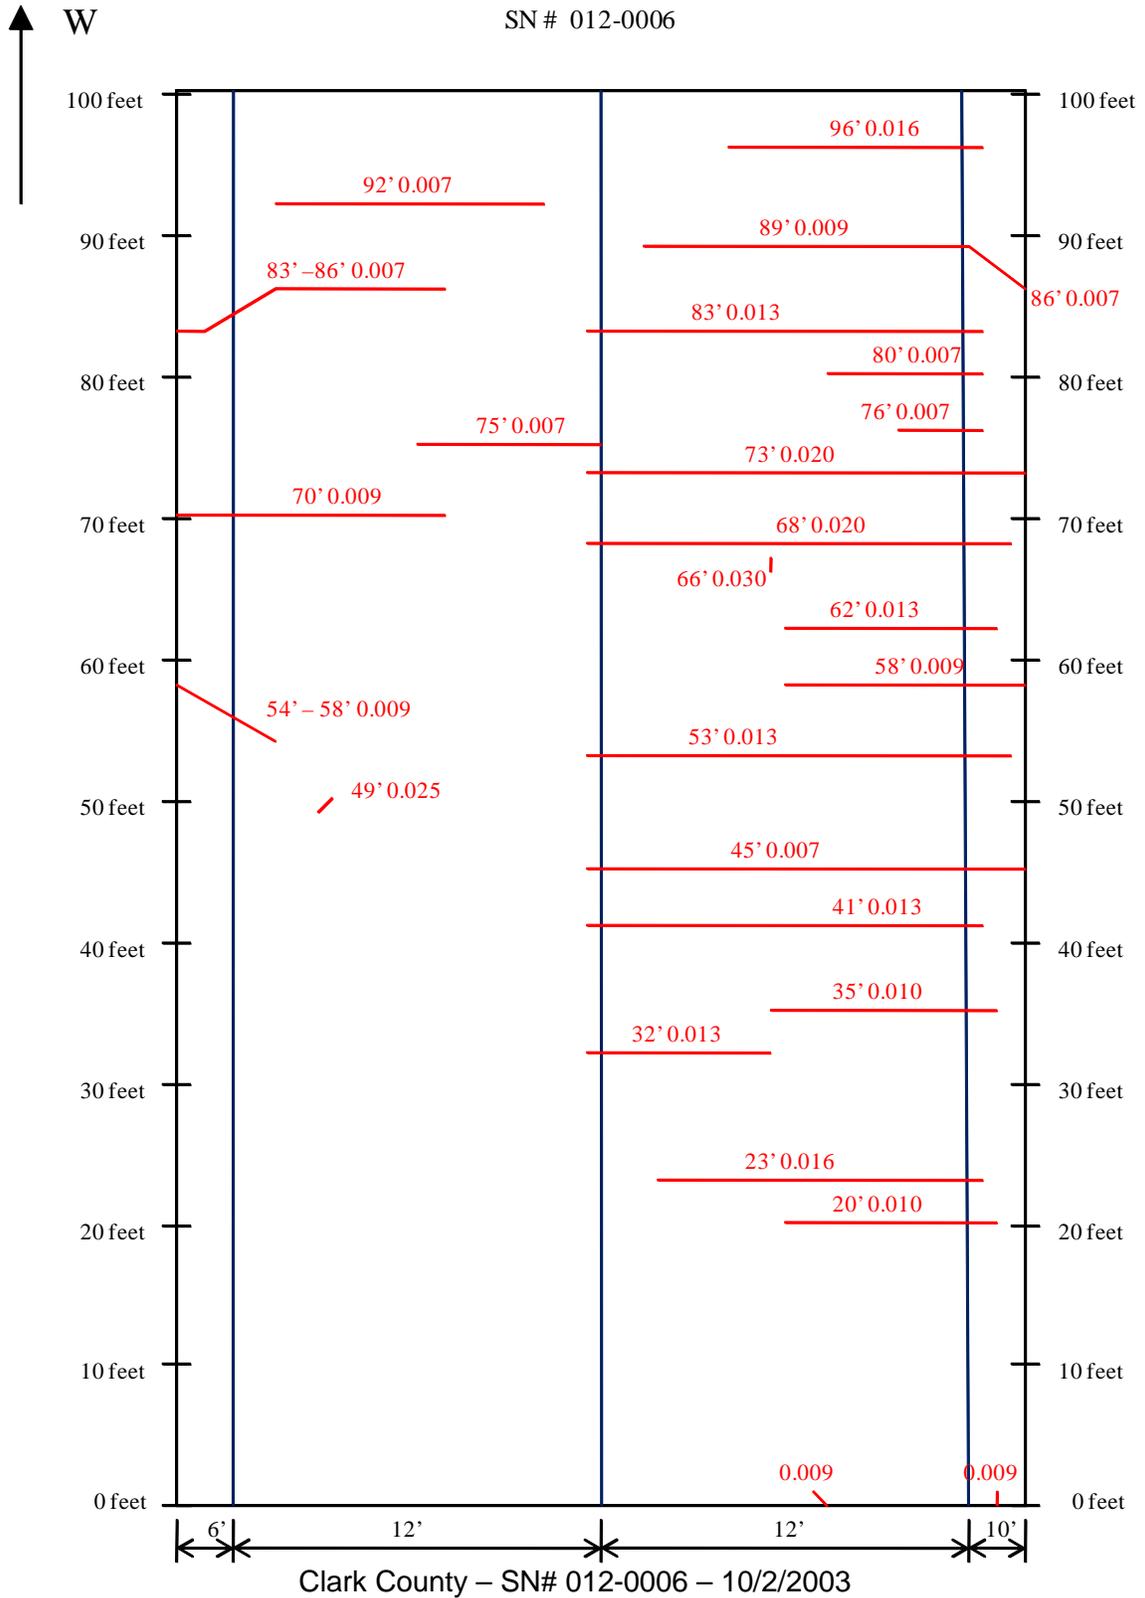
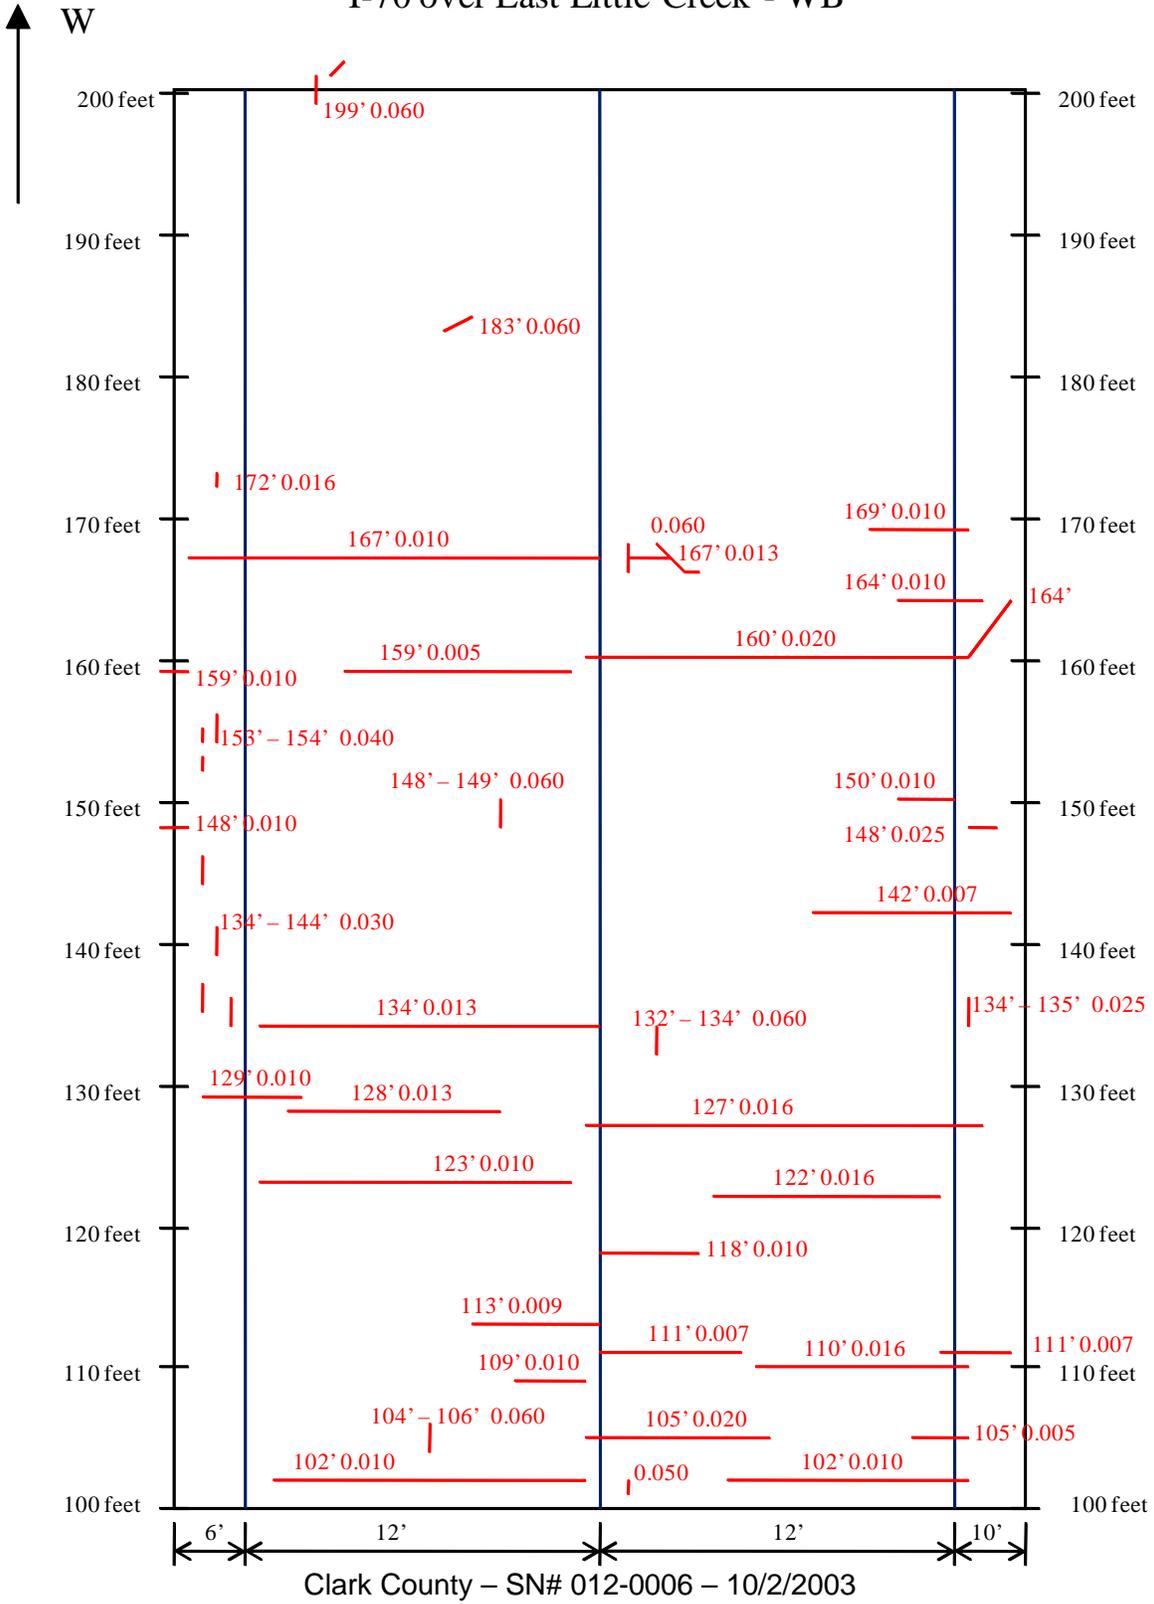
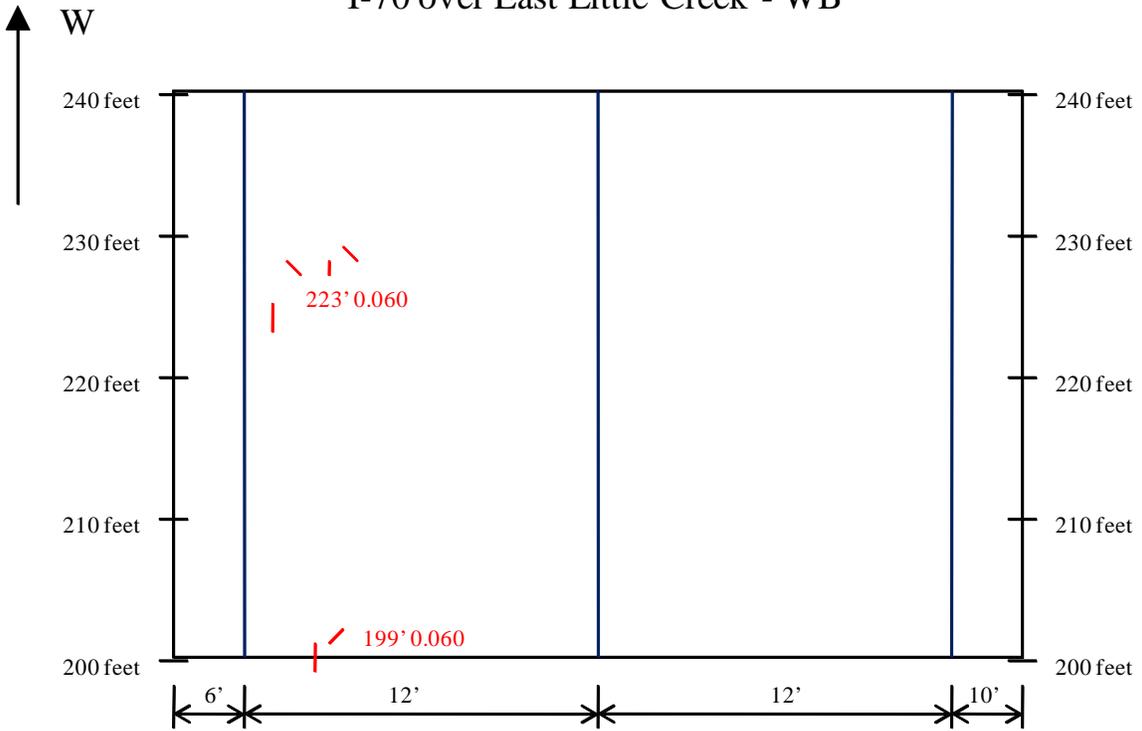
I-70 over East Little Creek – WB  
 SN # 012-0006

Clark County – SN# 012-0006 – Surveyed 10/2/2003

This is a partial deck survey due to time constraints and traffic safety concerns.

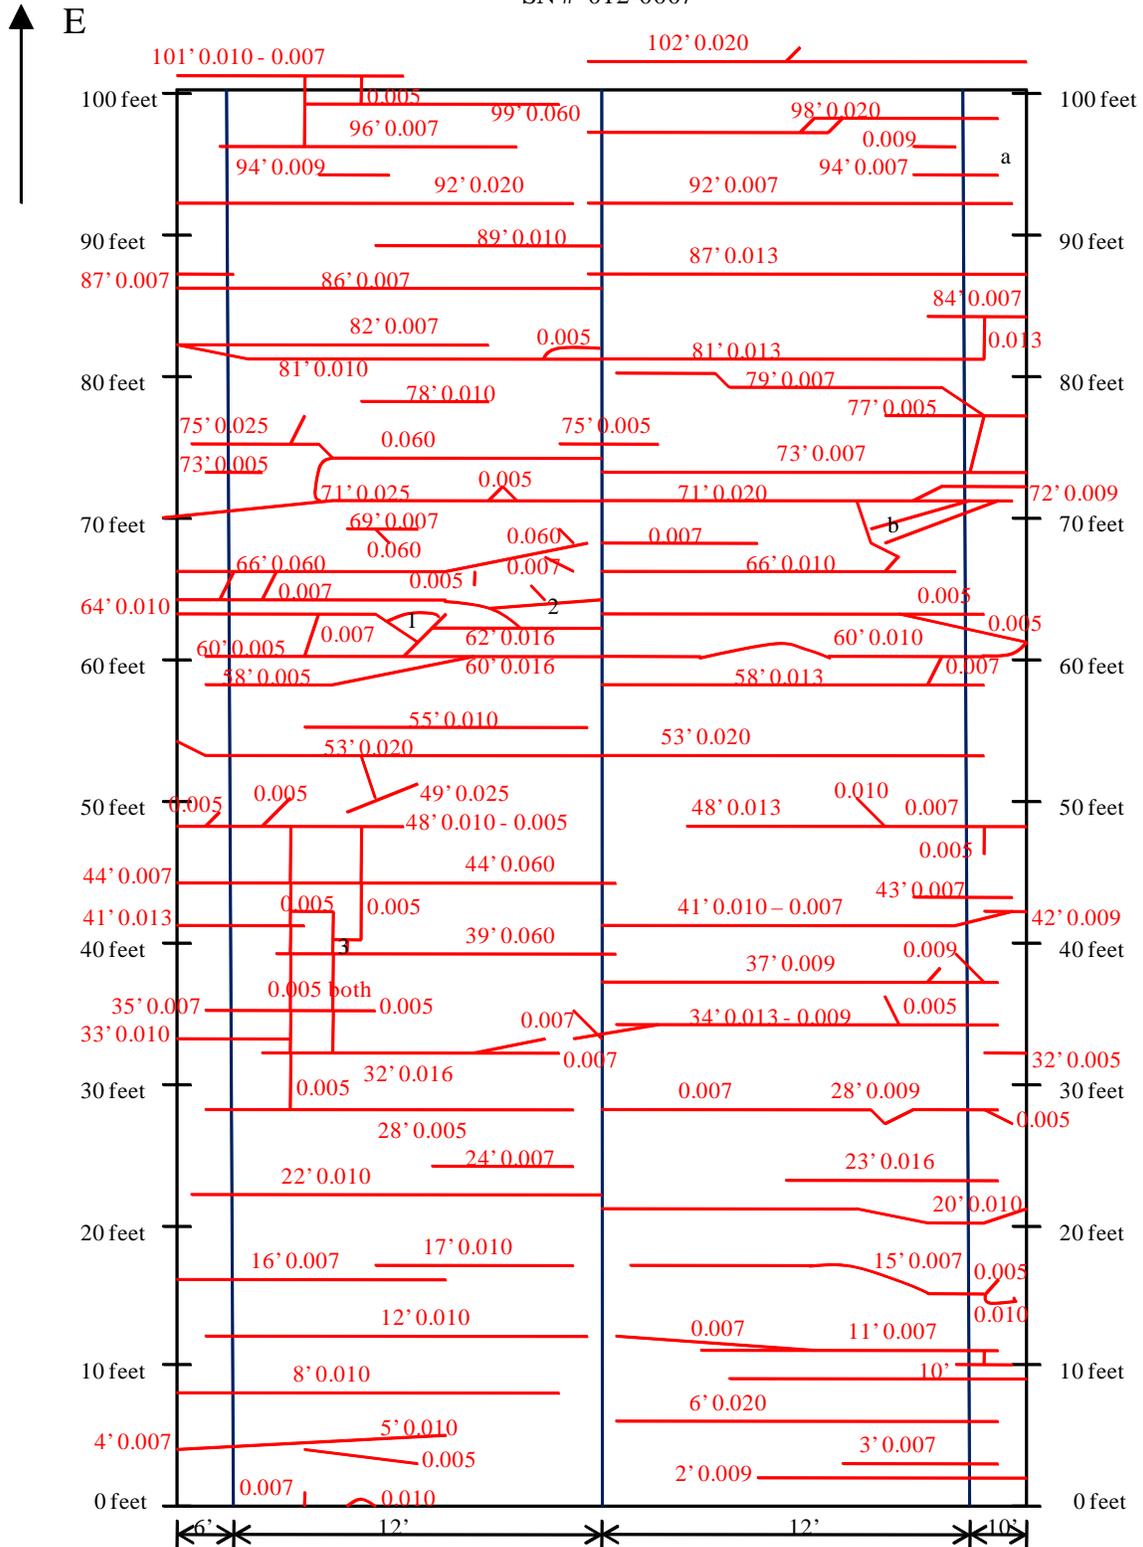
I-70 over E. Little Creek – EB  
SN # 012-0007

Clark County – SN# 012-0007 – Surveyed 10/1/2003

This is a partial deck survey due to time constraints.

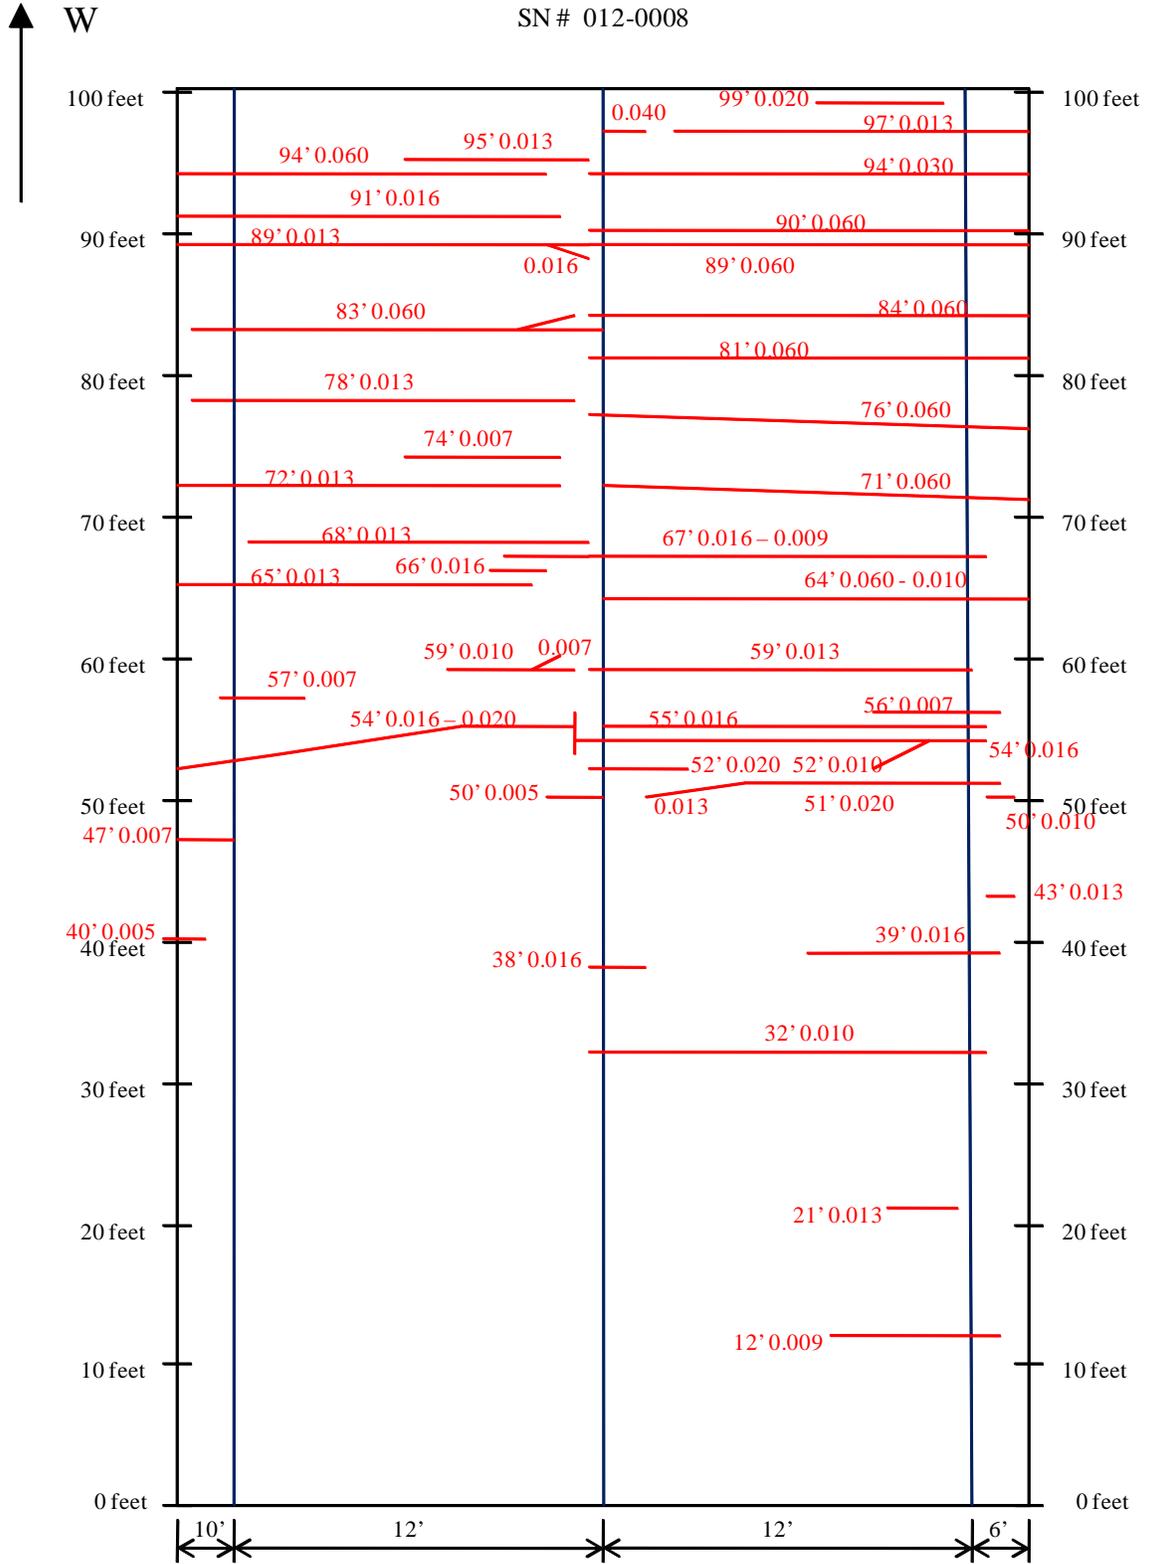
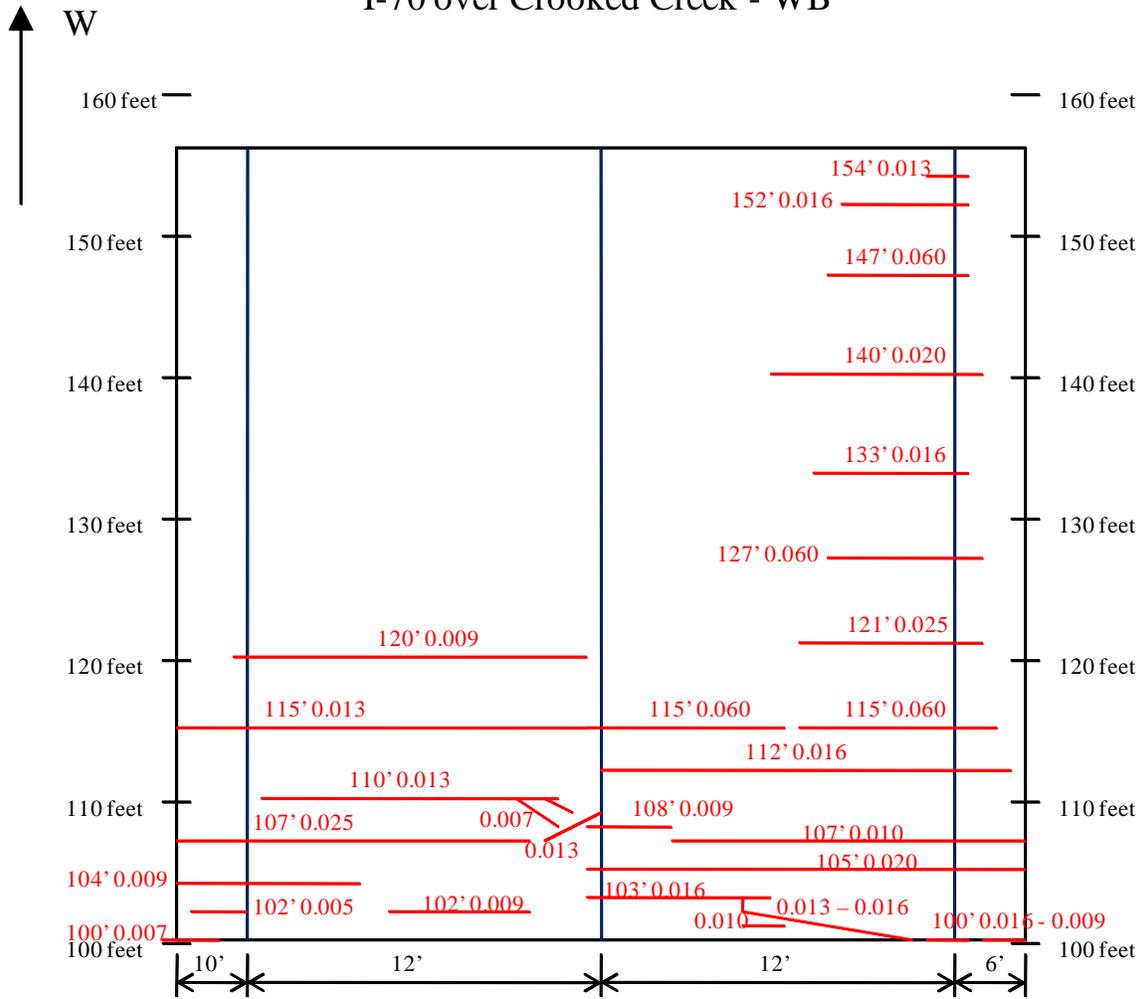
I-70 over Crooked Creek – WB  
SN # 012-0008

Clark County – SN# 012-0008 – 10/1/2003

Clark County – SN# 012-0008 – Surveyed 10/1/2003

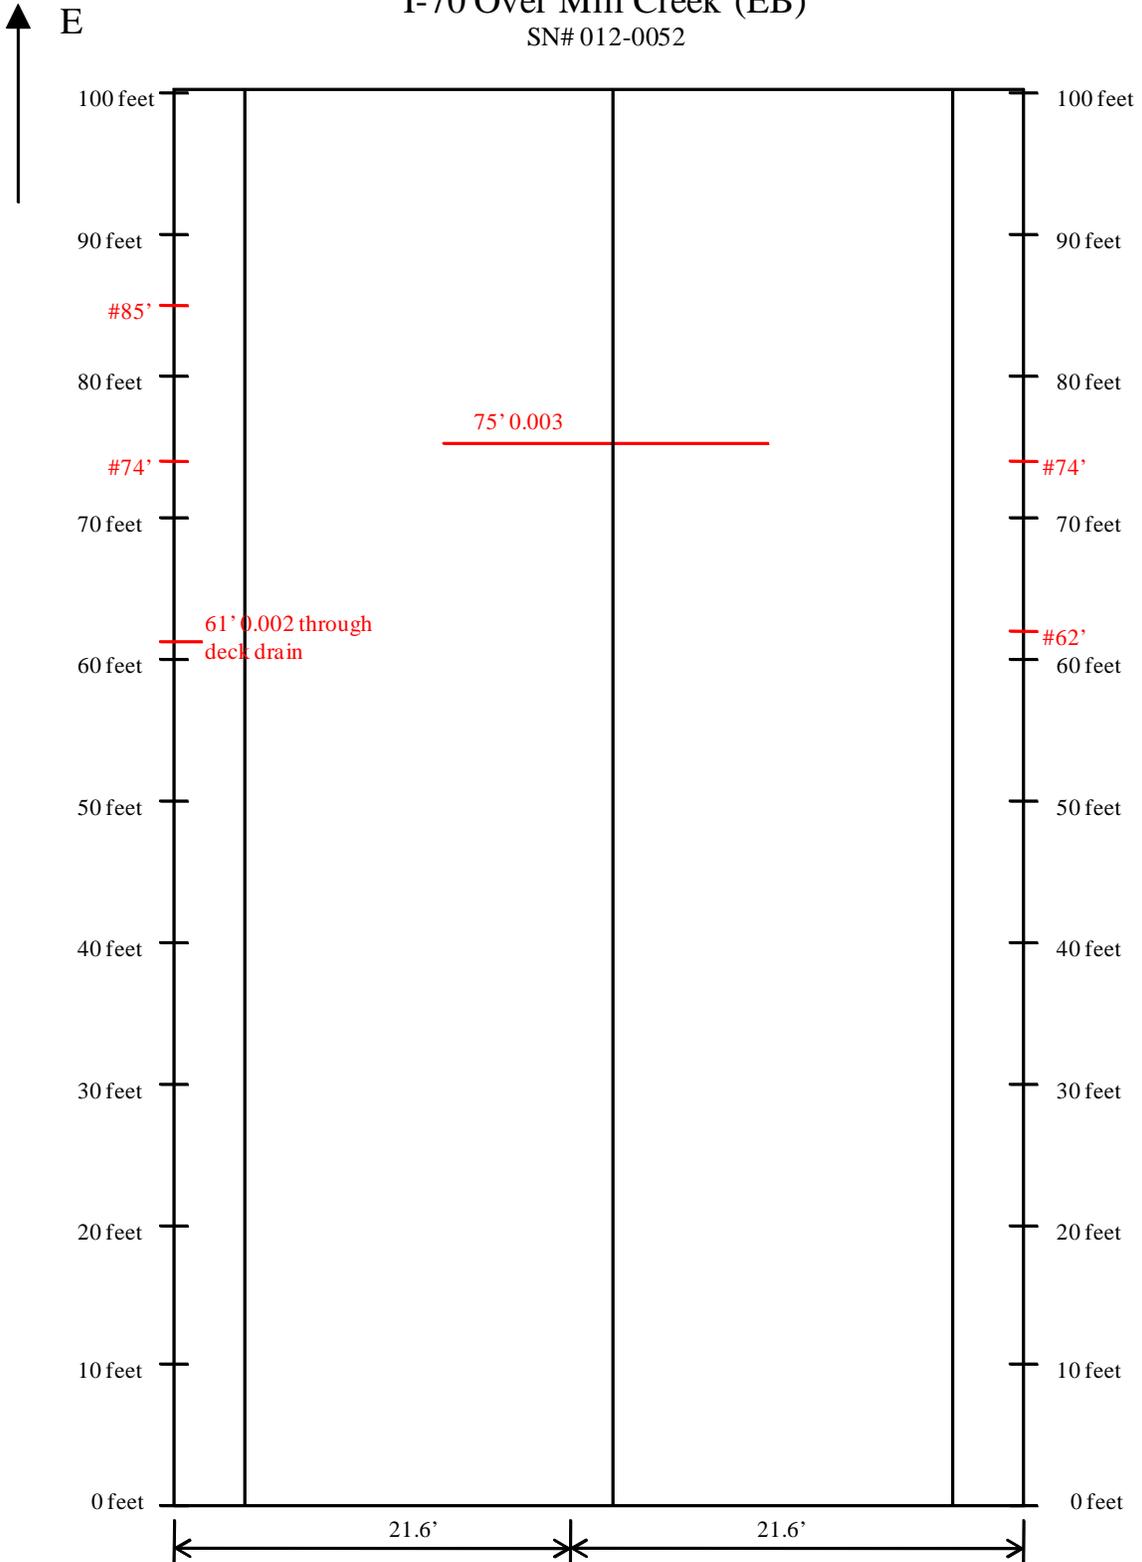
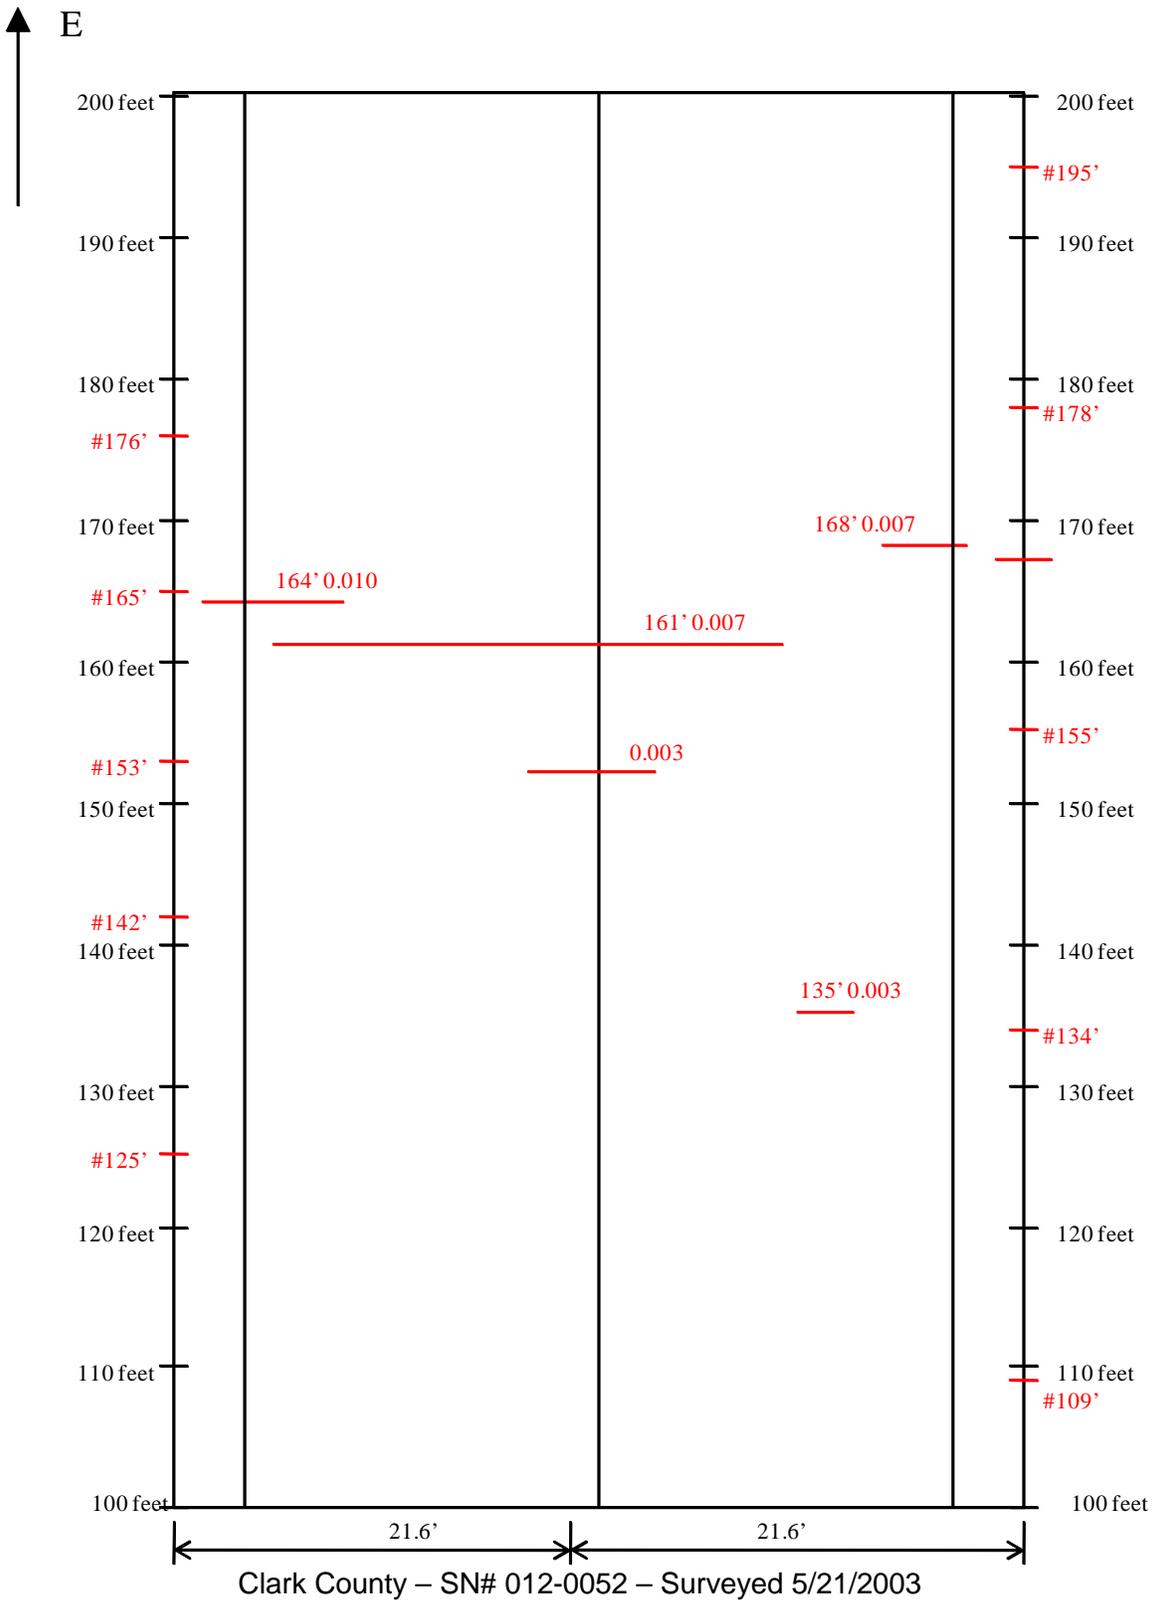
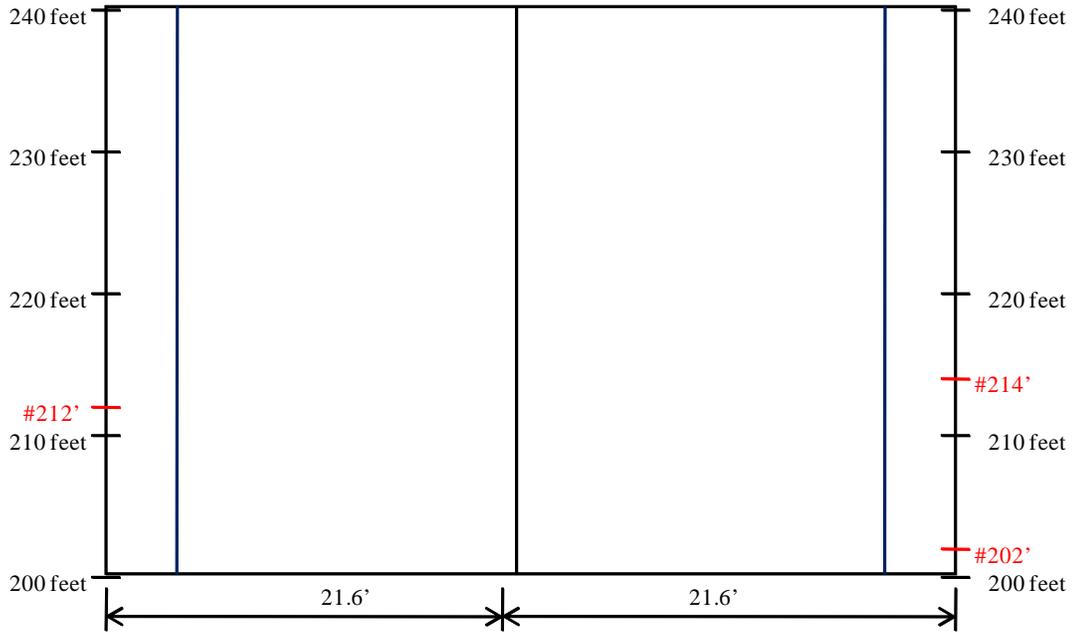
I-70 Over Mill Creek (EB)  
SN# 012-0052

Clark County – SN# 012-0052 – Surveyed 5/21/2003

Clark County – SN# 012-0052 – Surveyed 5/21/2003  
The “#” symbol represents cracks in the parapet only.

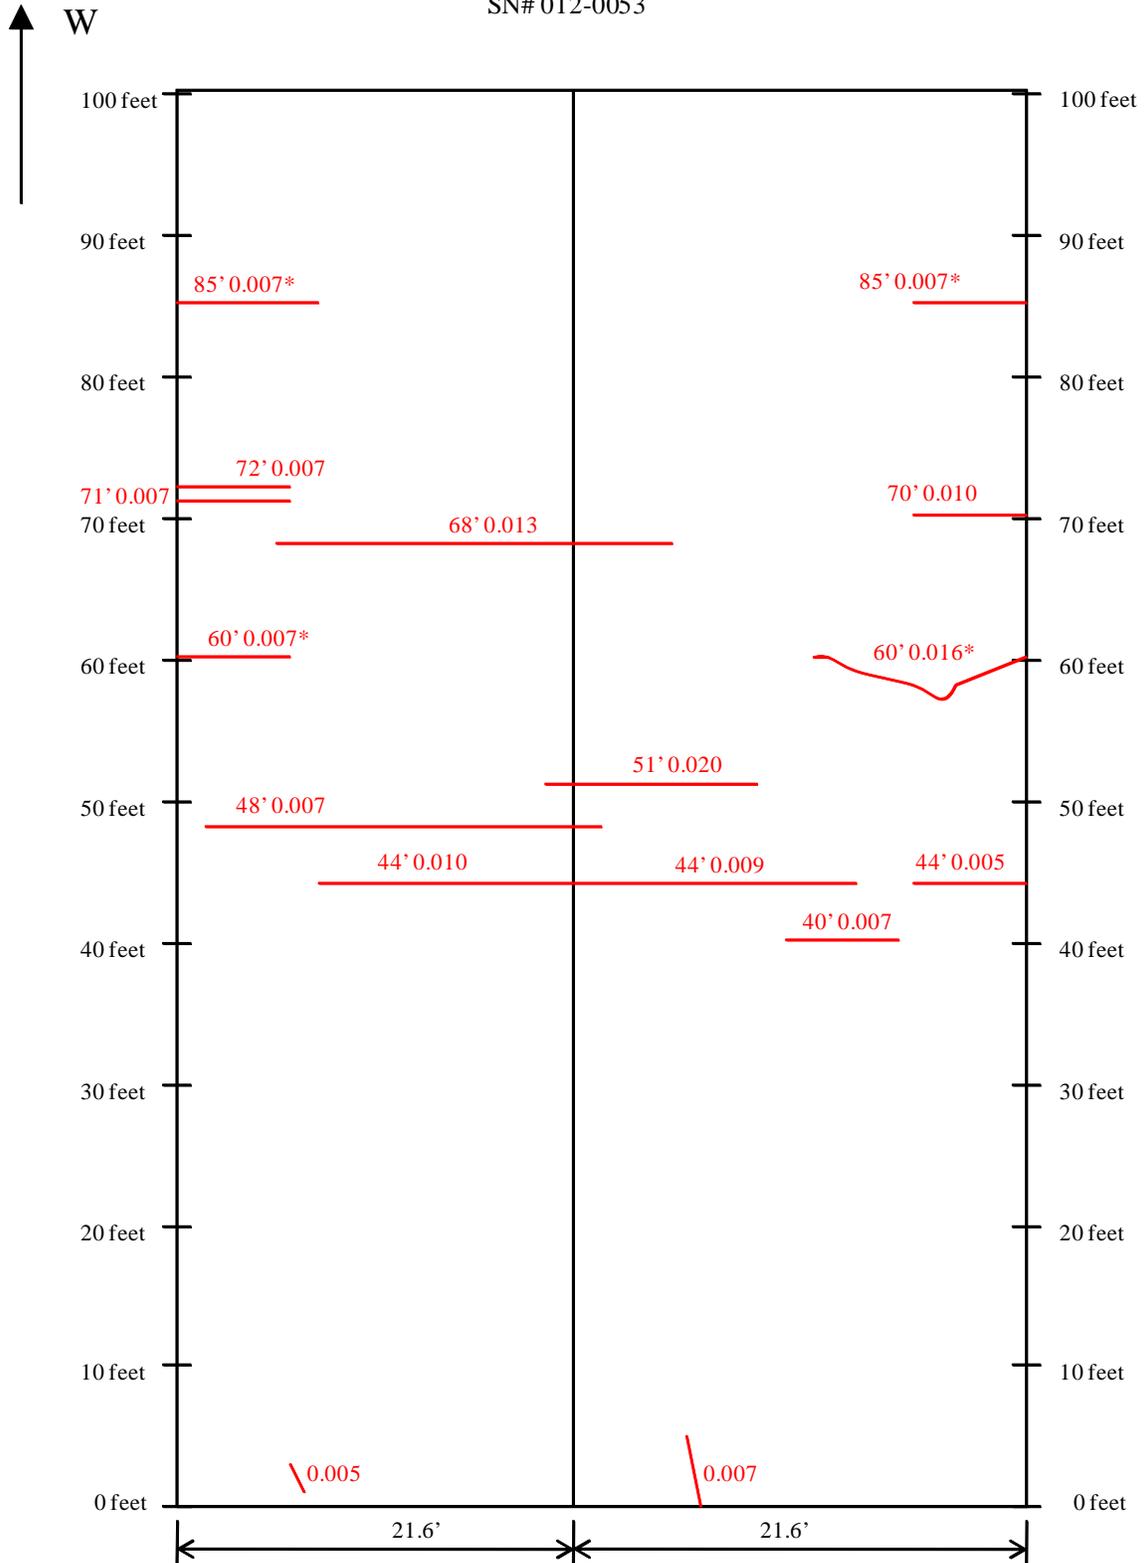
I-70 Over Mill Creek (WB)  
SN# 012-0053

Clark County – SN# 012-0053 – Surveyed 10/1/2003

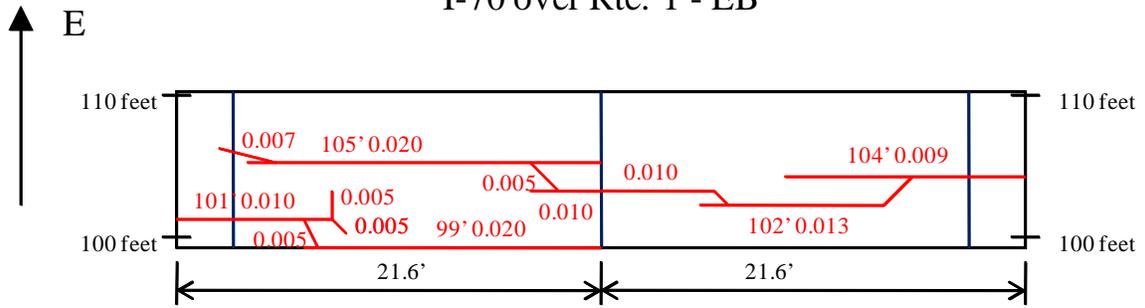
# I-70 over Rte. 1 - EB

Clark County – SN# 012-0054 – Surveyed 10/1/2003

The southwest corner was chipped off.

This was a partial deck survey due to time constraints and traffic conditions.

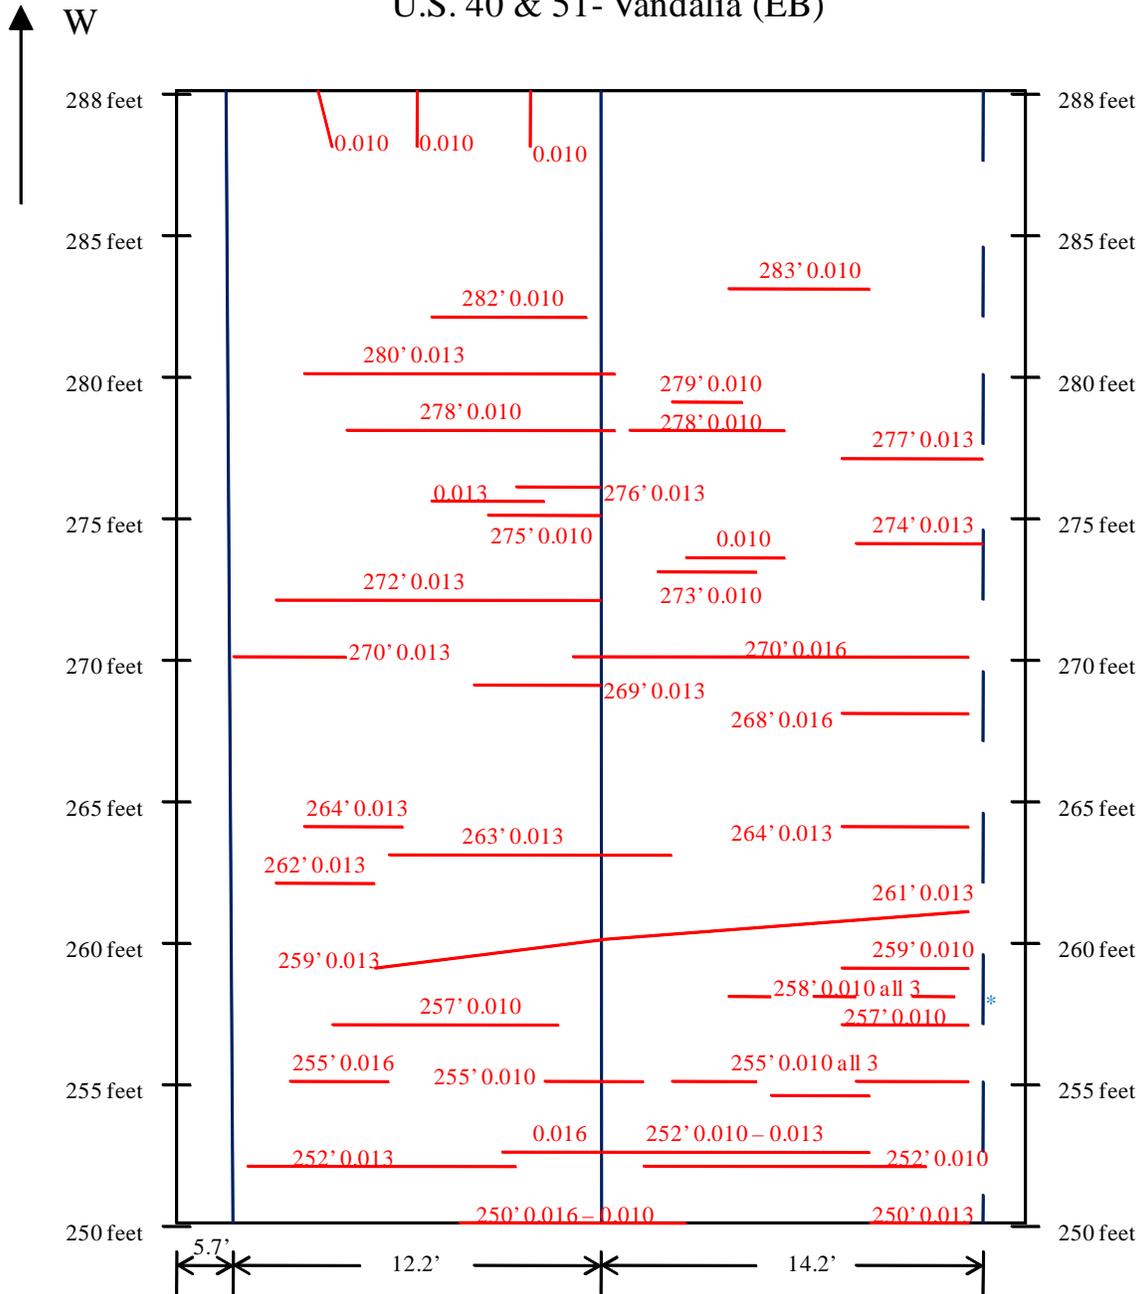
## U.S. 40 & 51- Vandalia (EB)

Fayette County – SN# 026-0034 – Surveyed 10/17/2008

The survey did not cover the entire deck because of time constraints.

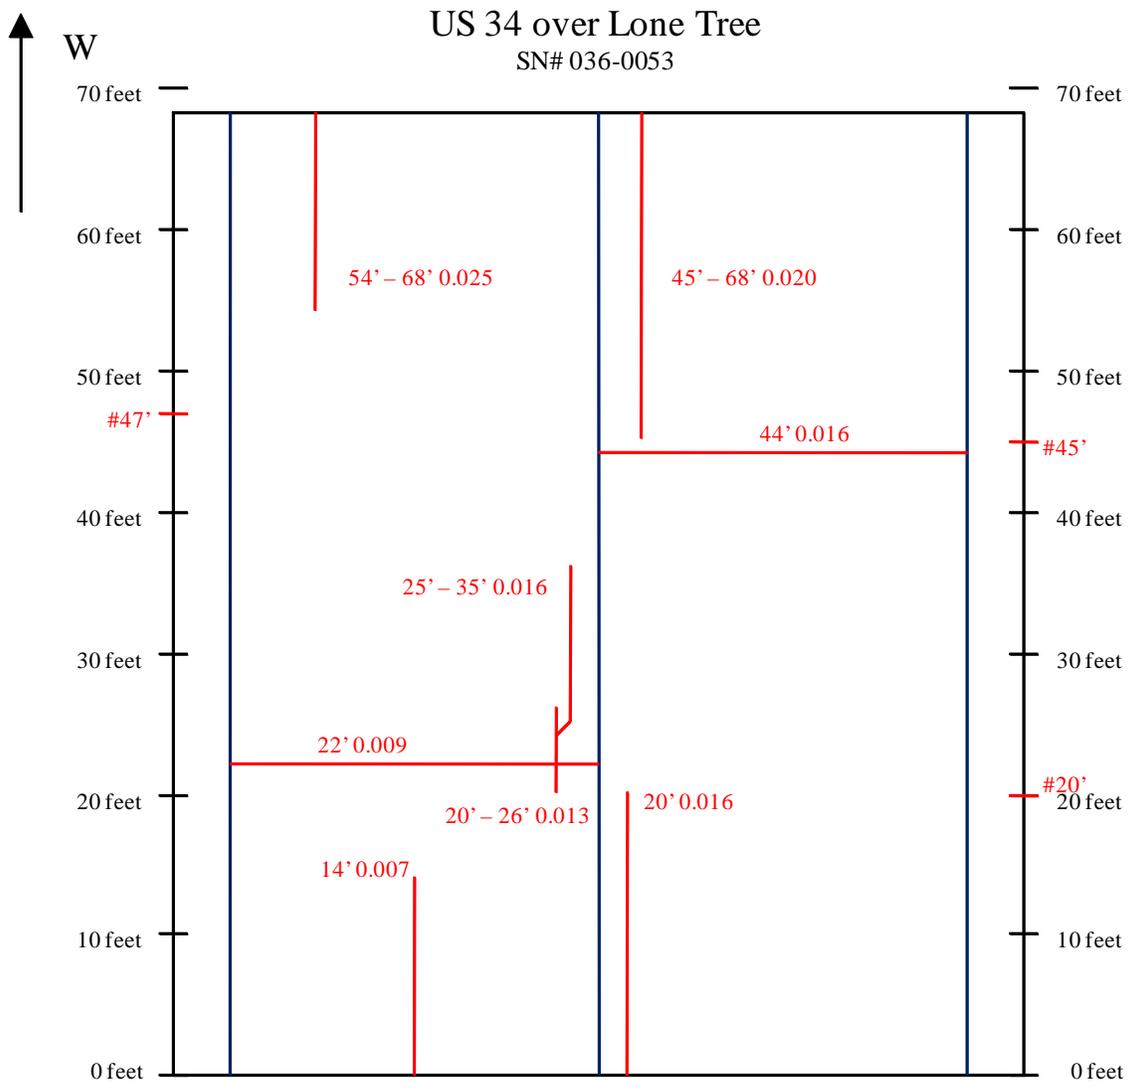
Henderson County – SN# 036-0053 – Surveyed 10/20/2003  
 The “#” symbol represents cracks in the parapet only.

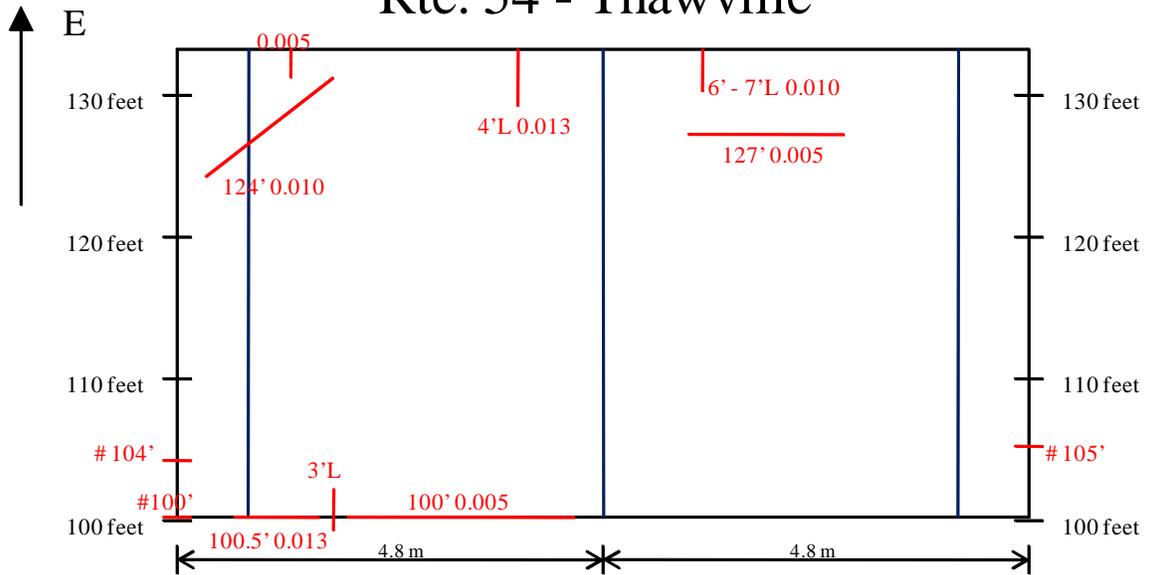
# Rte. 54 - Thawville

Iroquois County – SN# 038-0207 – Surveyed 11/22/2002

The “#” symbol represents cracks in the parapet only unless otherwise specified.

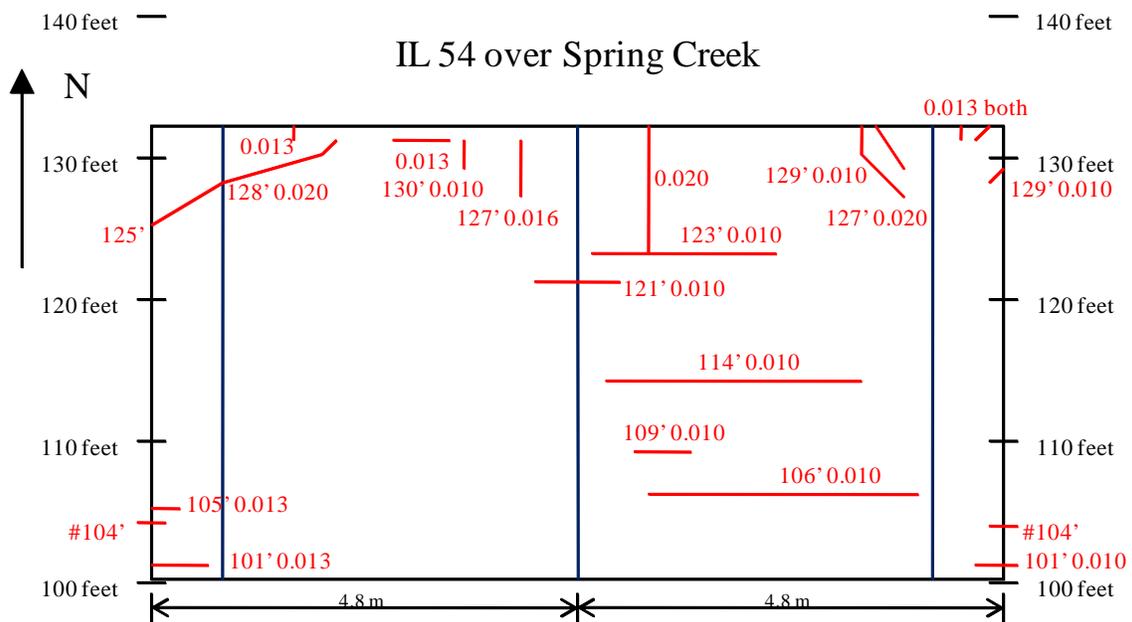
Iroquois County – SN# 038-0207 – Surveyed 10/28/2005  
 The “#” symbol represents cracks in the parapet only.

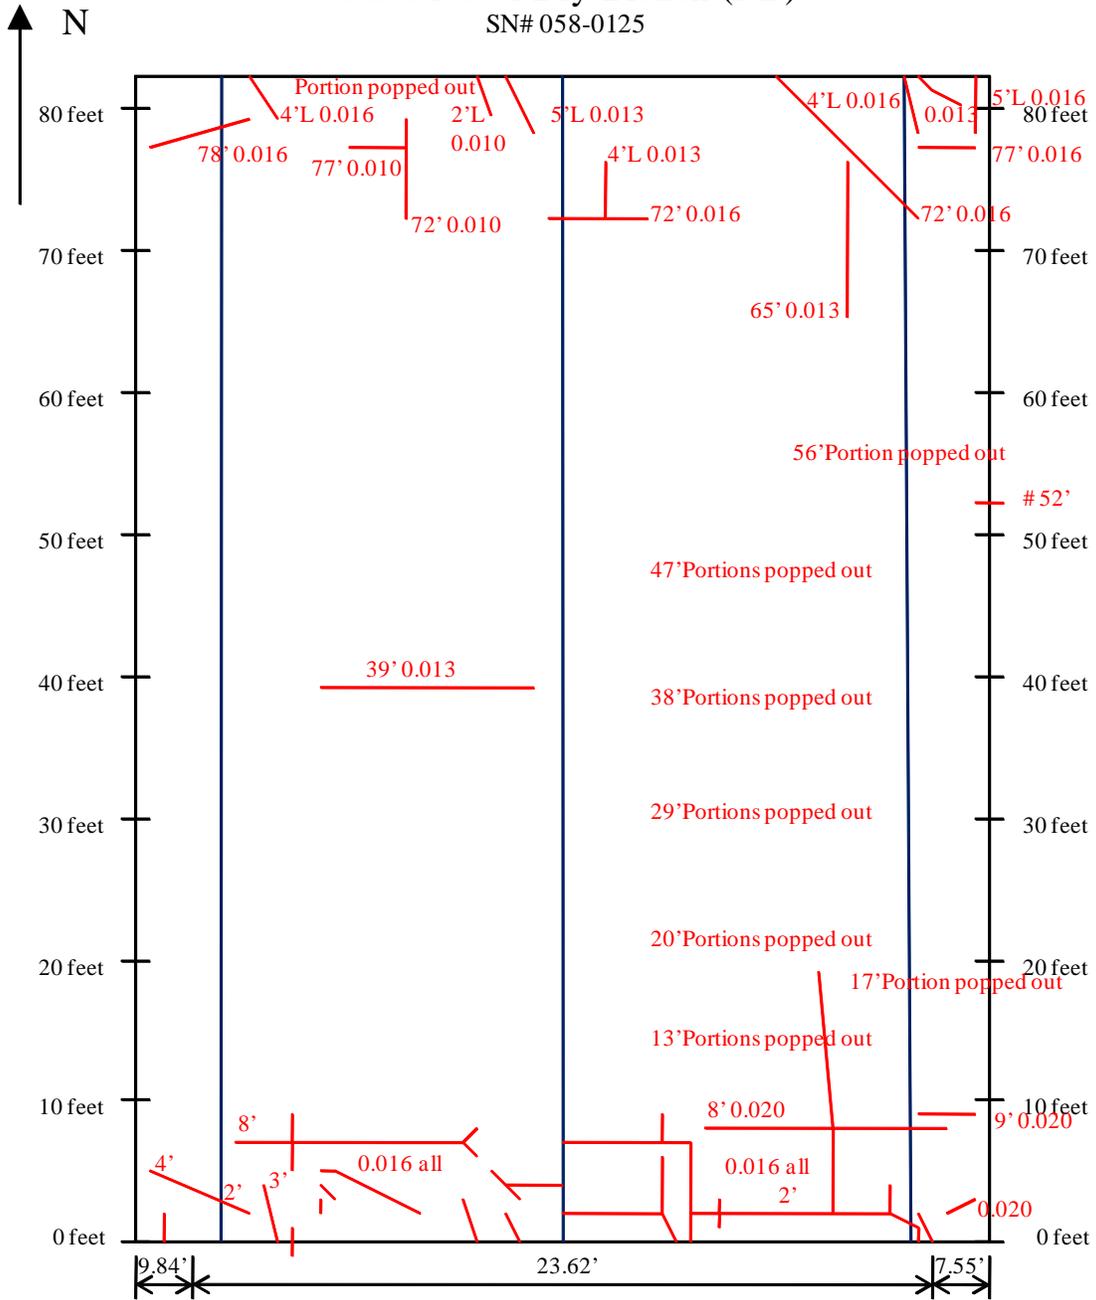
# U.S. 51 over Dry Branch (NB)

Macon County – SN# 058-0125 – Surveyed 10/25/2005  
 Some portions of the bridge deck in the driving lane were popped out.  
 The “#” means parapet only.

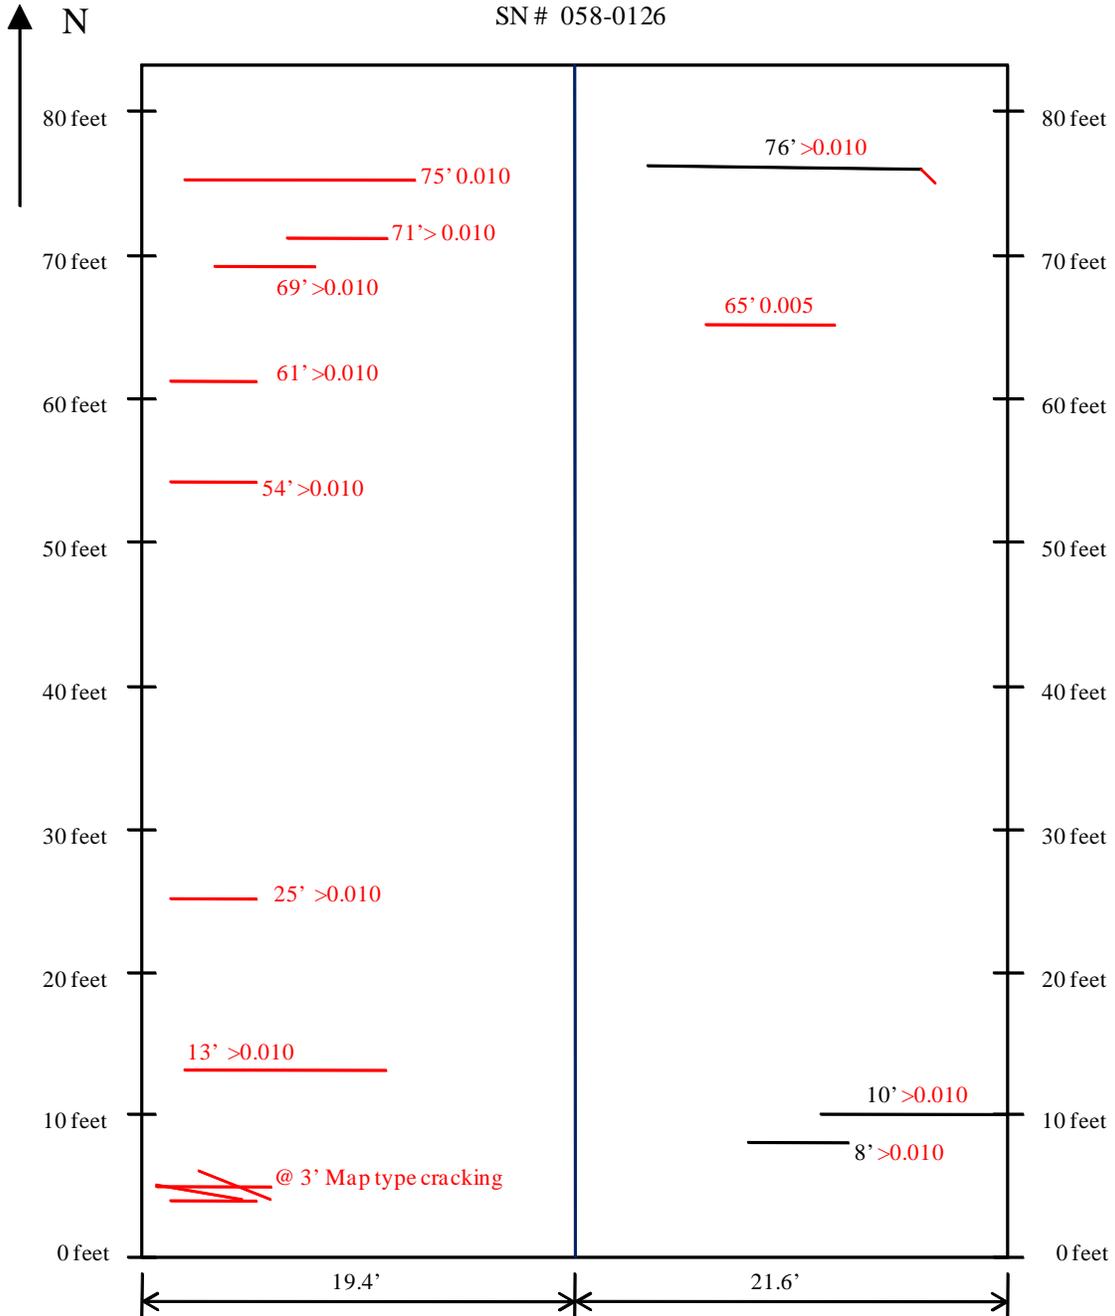
Macon U. S. 51 – SB  
SN# 058-0126

Macon County – SN# 058-0126 – Surveyed 5/7/2001, 10/19/2001  
Deck poured on October 03, 2000. No initial survey was conducted due the dirty surface.
