**EVALUATION OF HIGH PERFORMANCE  
CONCRETE BRIDGE DECKS  
AND  
OTHER EXPERIMENTAL BRIDGE  
DECKS THROUGHOUT ILLINOIS**

**PHYSICAL RESEARCH REPORT NO. 166  
December 2017**

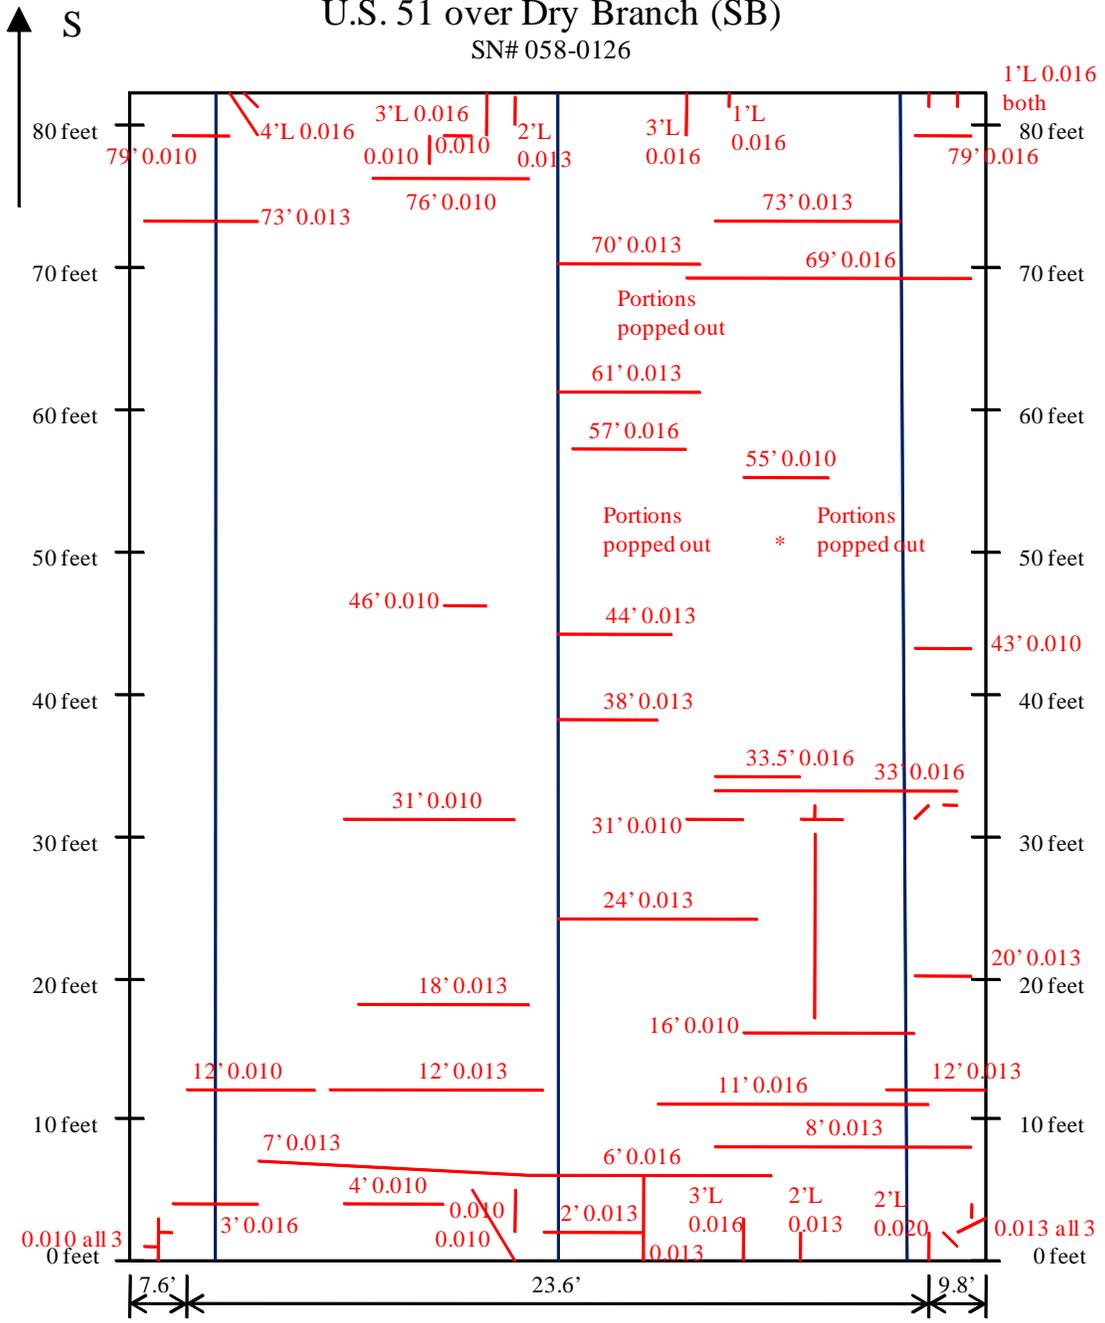
**U.S. 51 over Dry Branch (SB)**  
SN# 058-0126

Macon County – SN# 058-0126 – Surveyed 10/25/2005  
Some portions of the bridge deck in the driving lane were popped out.  
The “\*” symbol denotes a footprint.

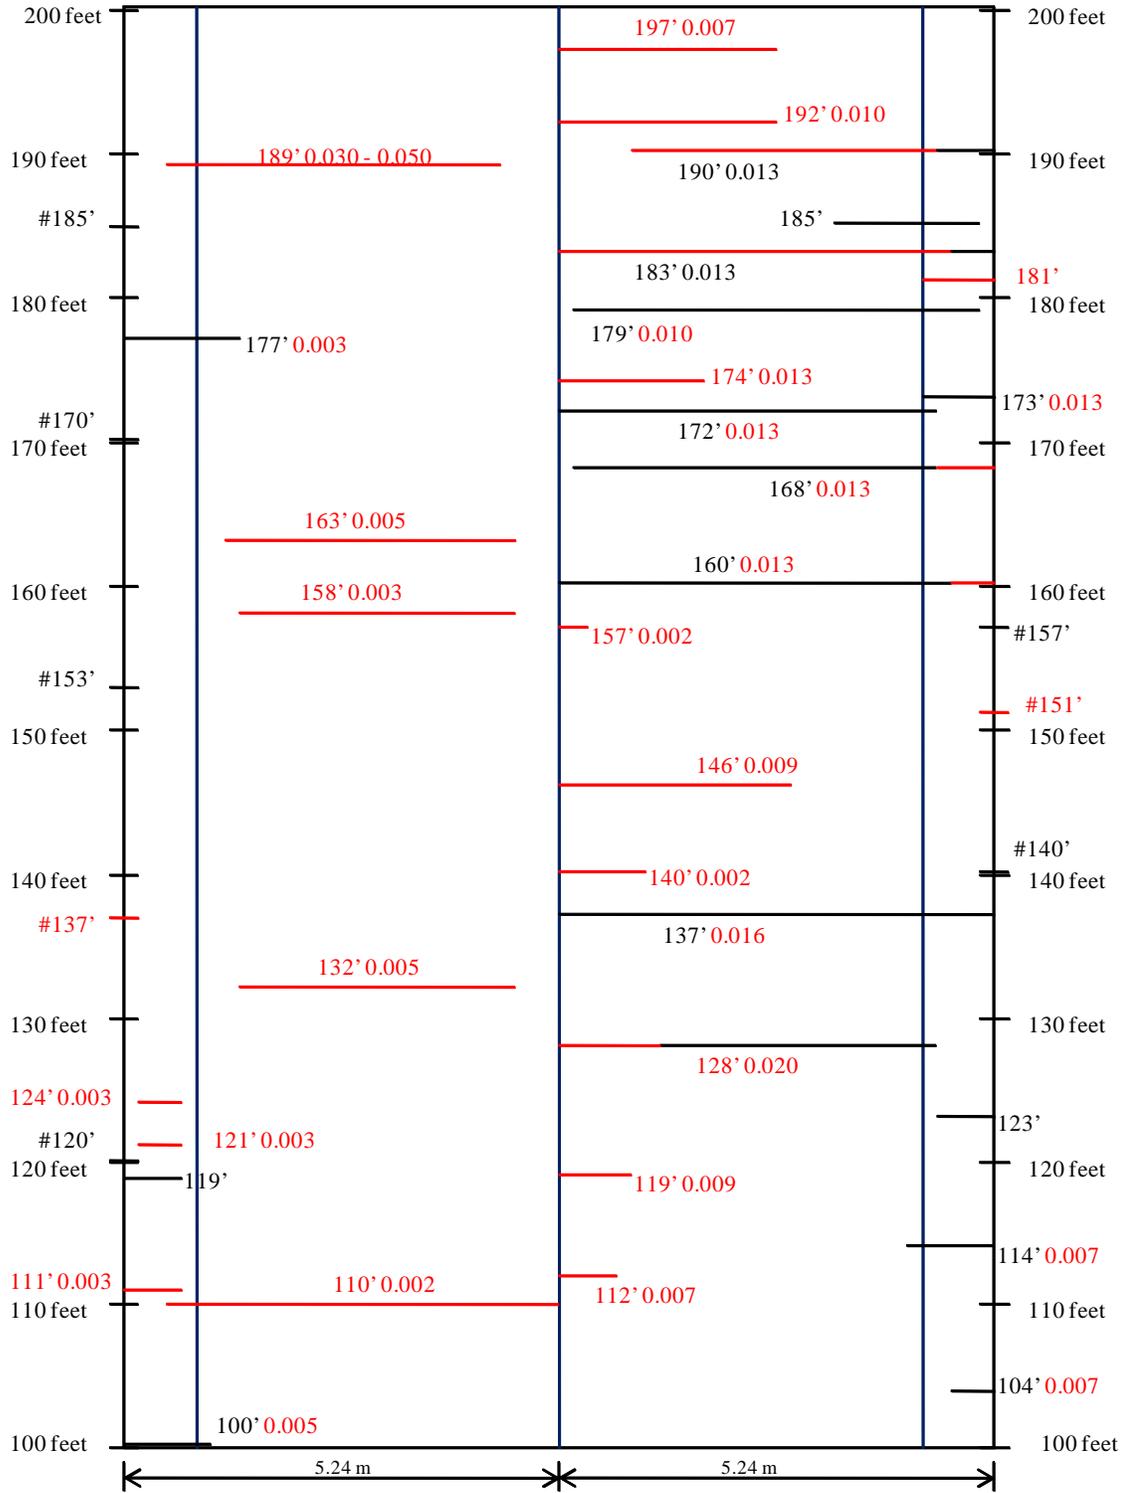
Madison County – SN# 060-0108 – Surveyed 5/8/2001, 8/2/2001

The initial survey of the southbound lane showed only one transverse crack.  
The initial survey of the northbound lane showed five hairline transverse cracks.

The “#” symbol represents cracks in the parapet only.

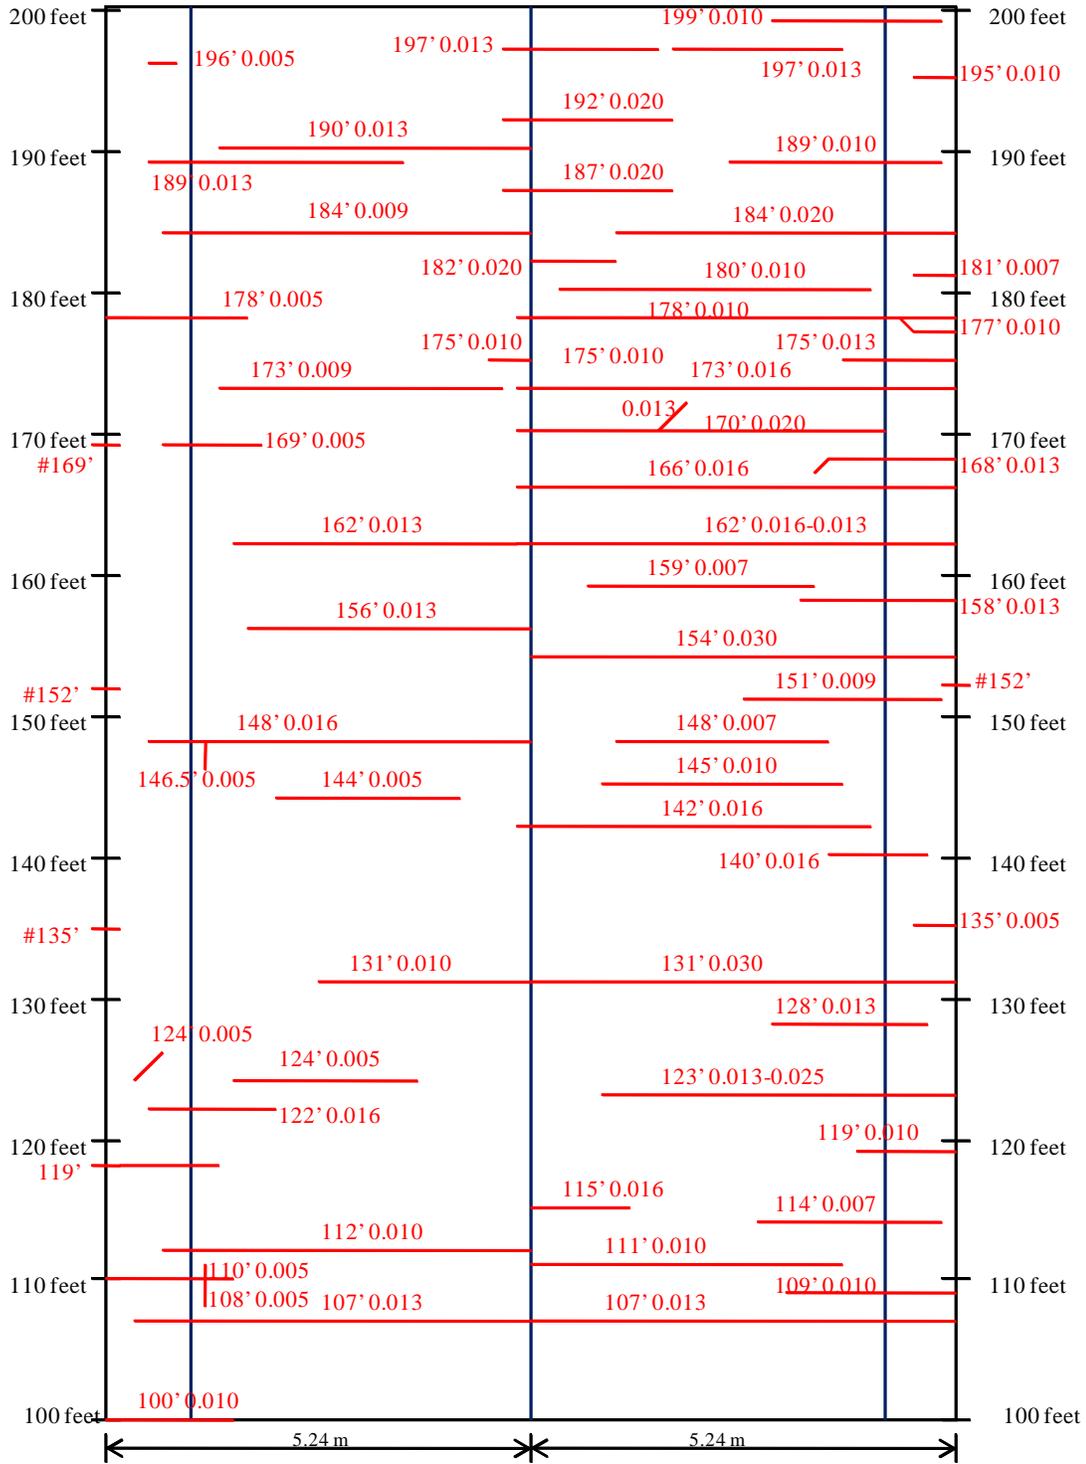
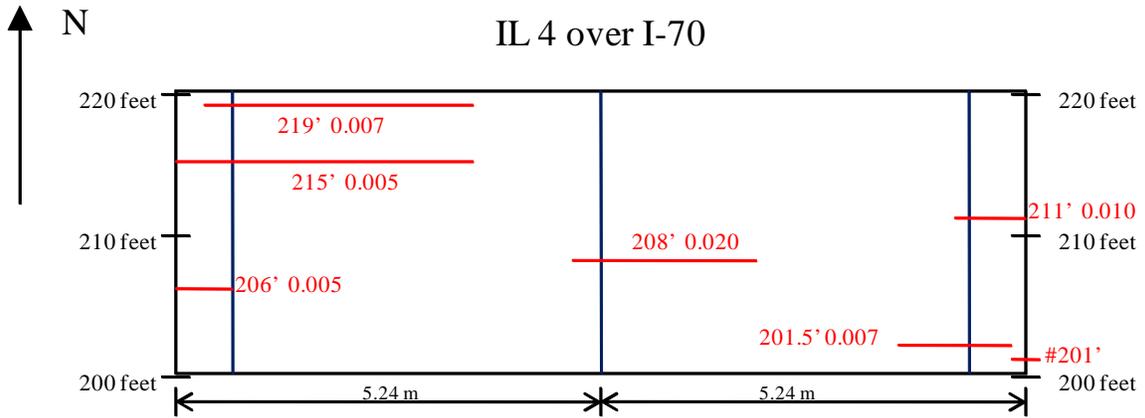
Madison County – SN# 060-0108 – Surveyed 9/29/2003

This was a partial deck survey due to time constraints and traffic conditions.

The “#” symbol represents cracks in the parapet only.

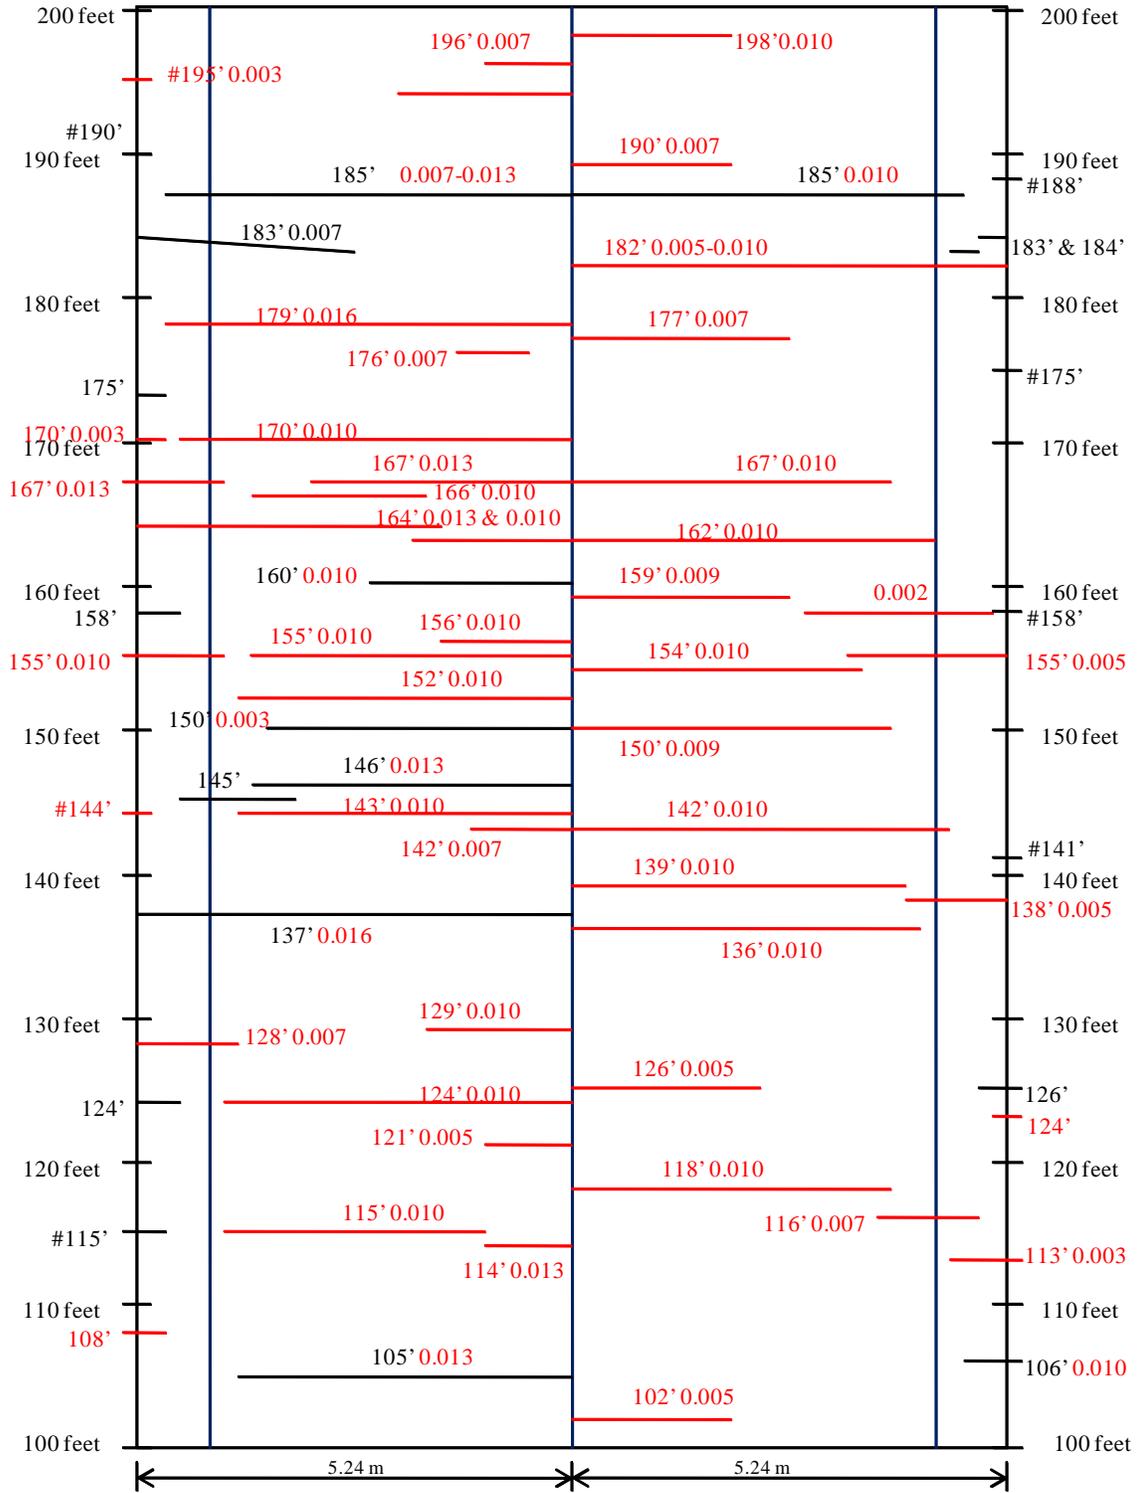
Madison County – SN# 060-0151 – Surveyed 5/8/2001, 8/2/2001  
 The initial bridge deck survey showed five hairline transverse cracks.  
 The “#” symbol represents cracks in the parapet only.

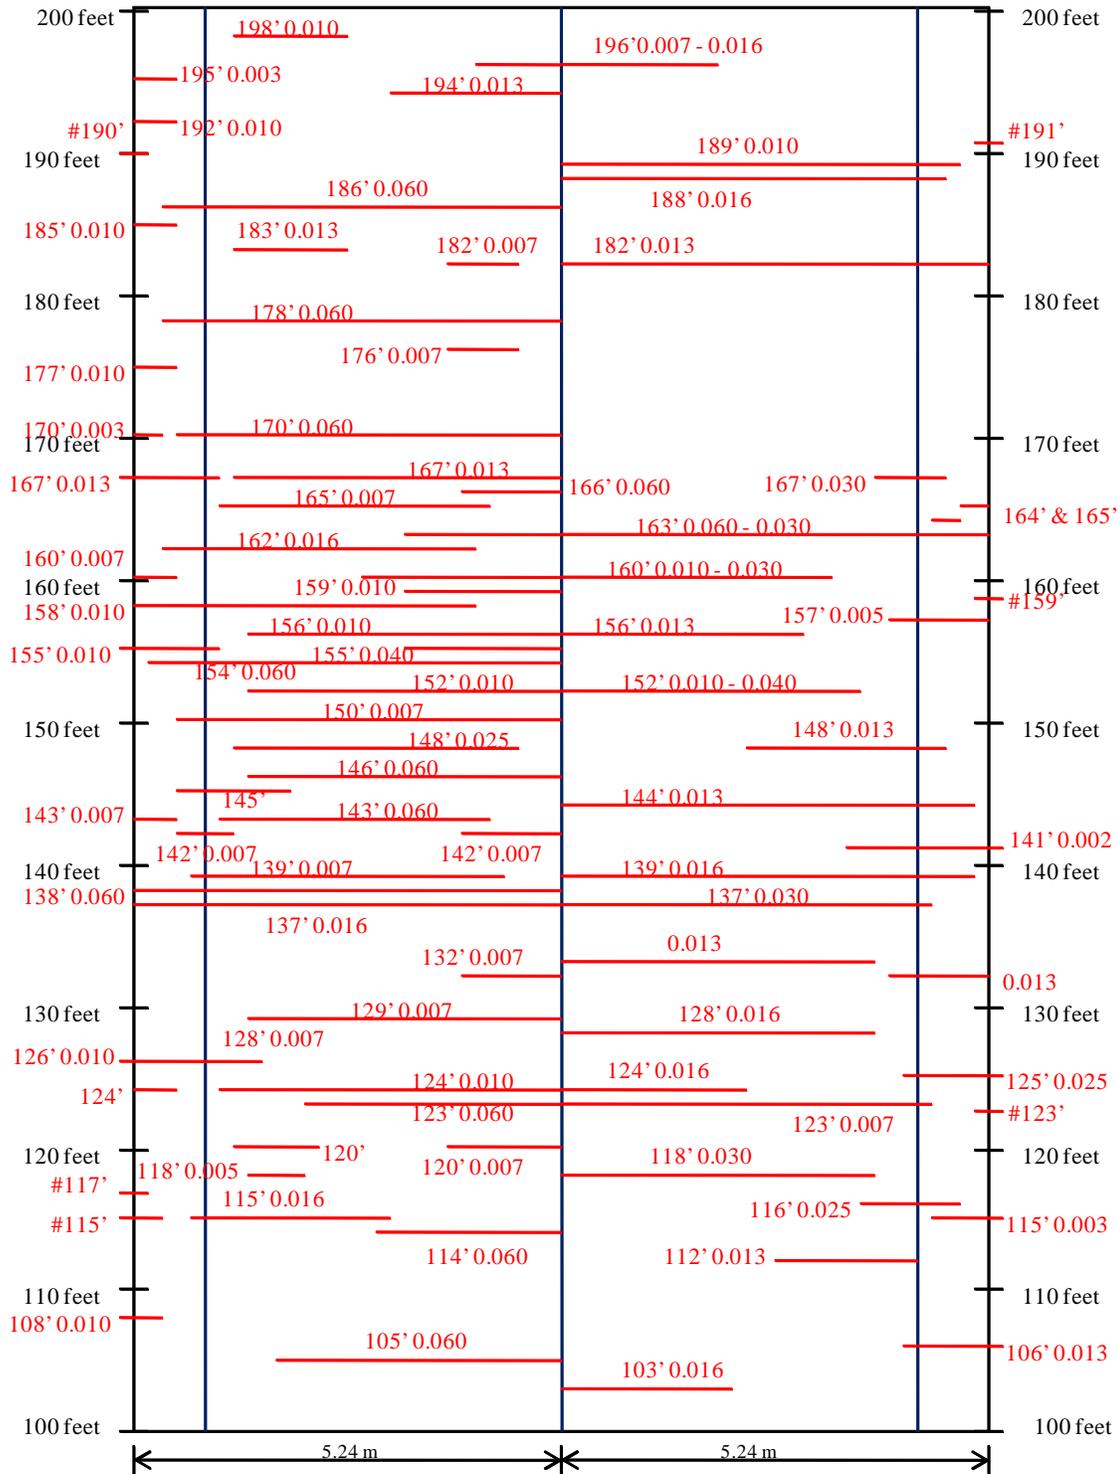
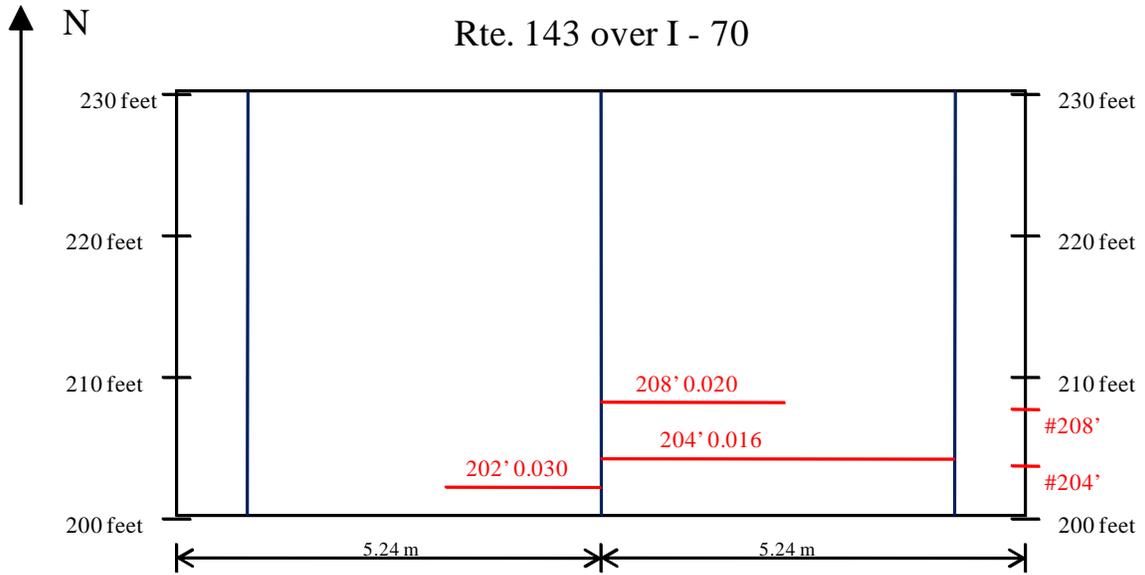
Madison County – SN# 060-0151 – Surveyed 8/12/2002  
 The “#” symbol represents cracks in the parapet only.

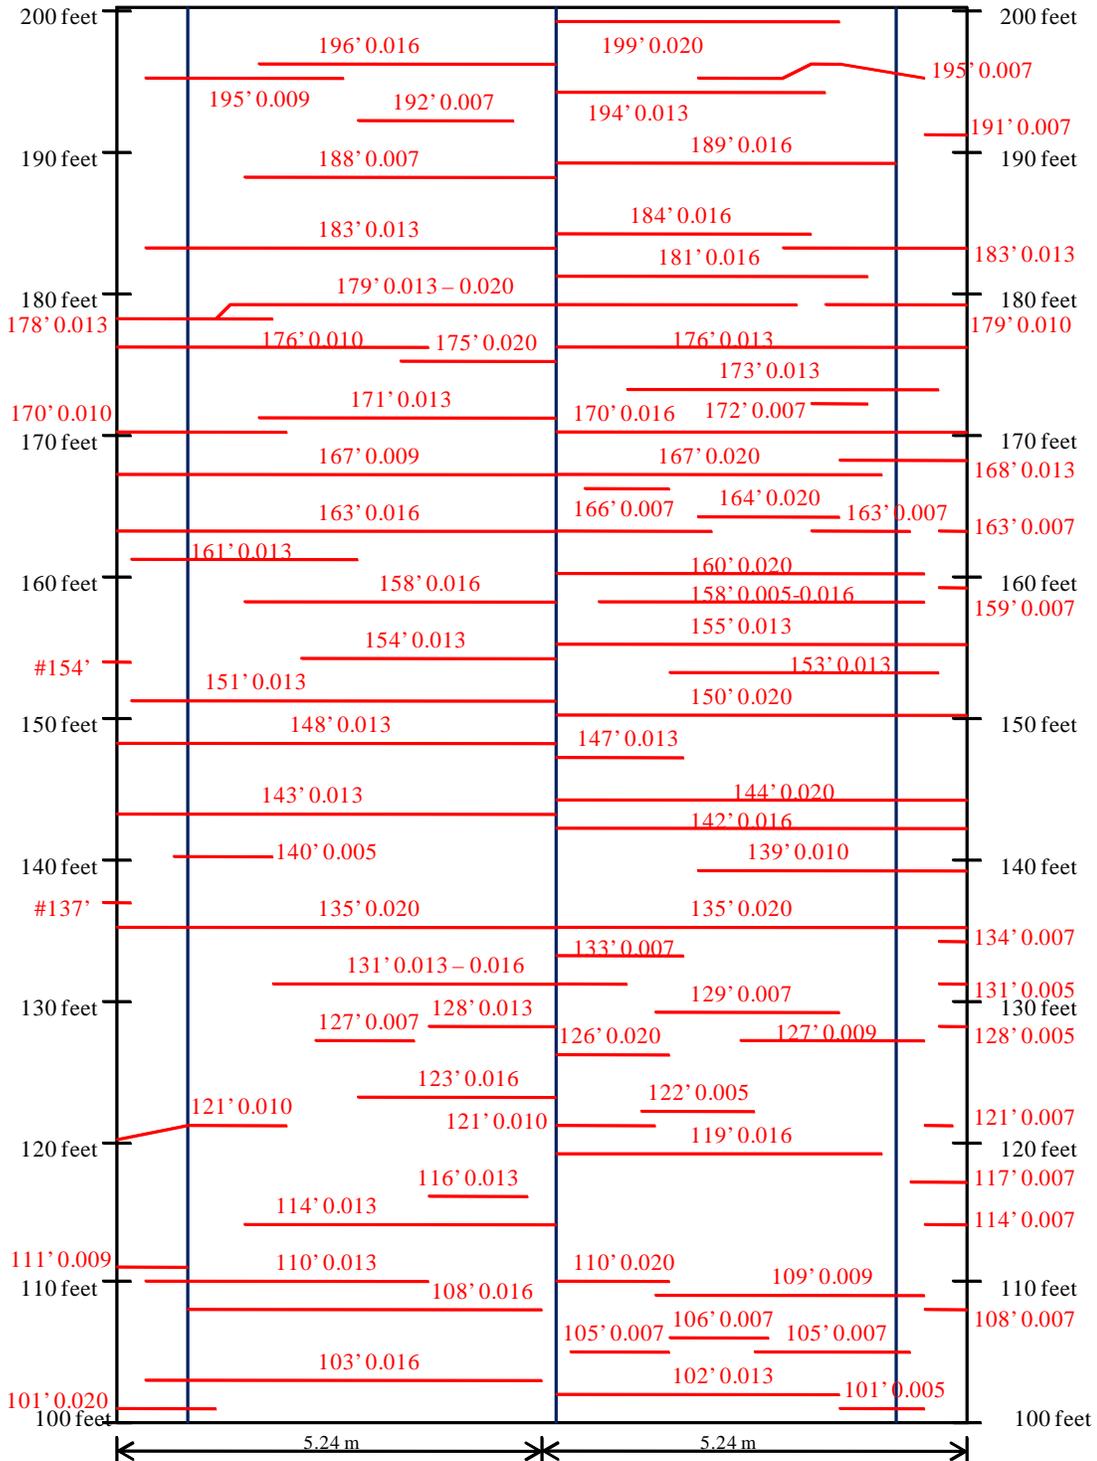
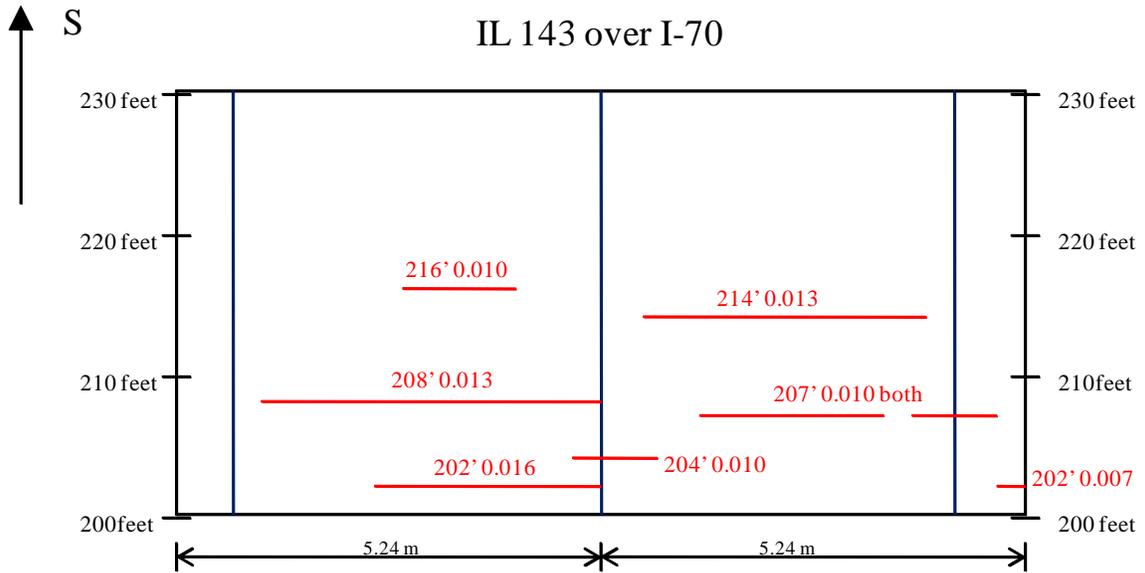
Madison County – SN# 060-0151 – Surveyed 9/29/2003  
 The “#” symbol represents cracks in the parapet only.

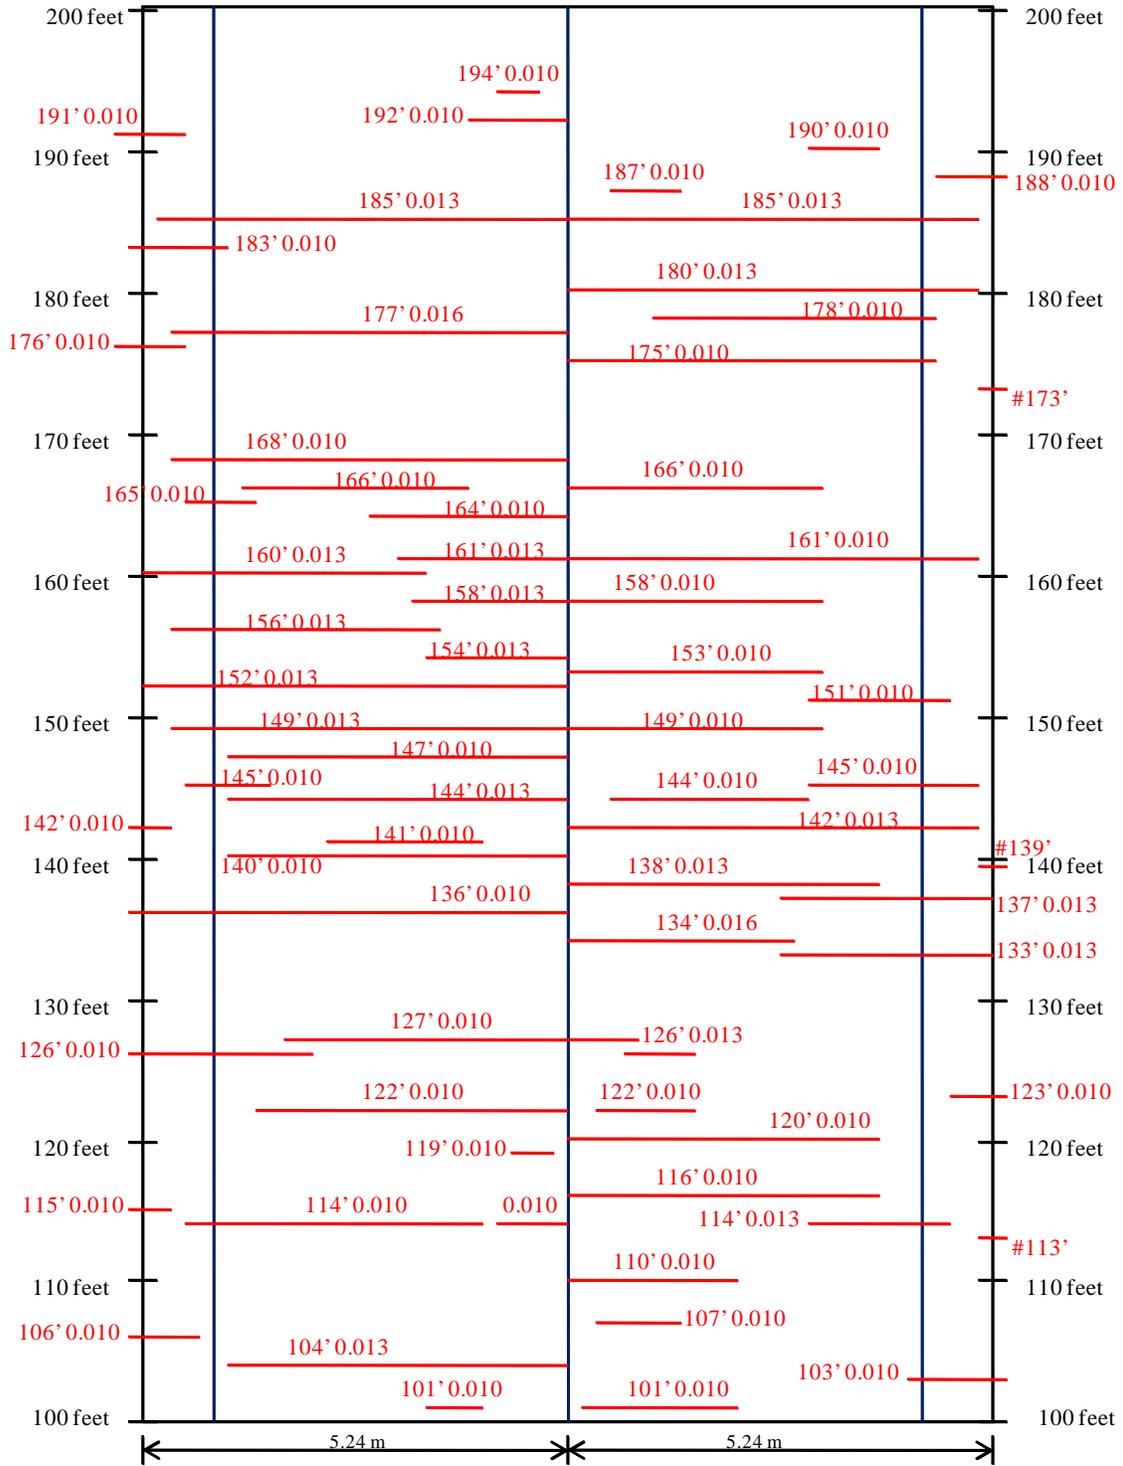
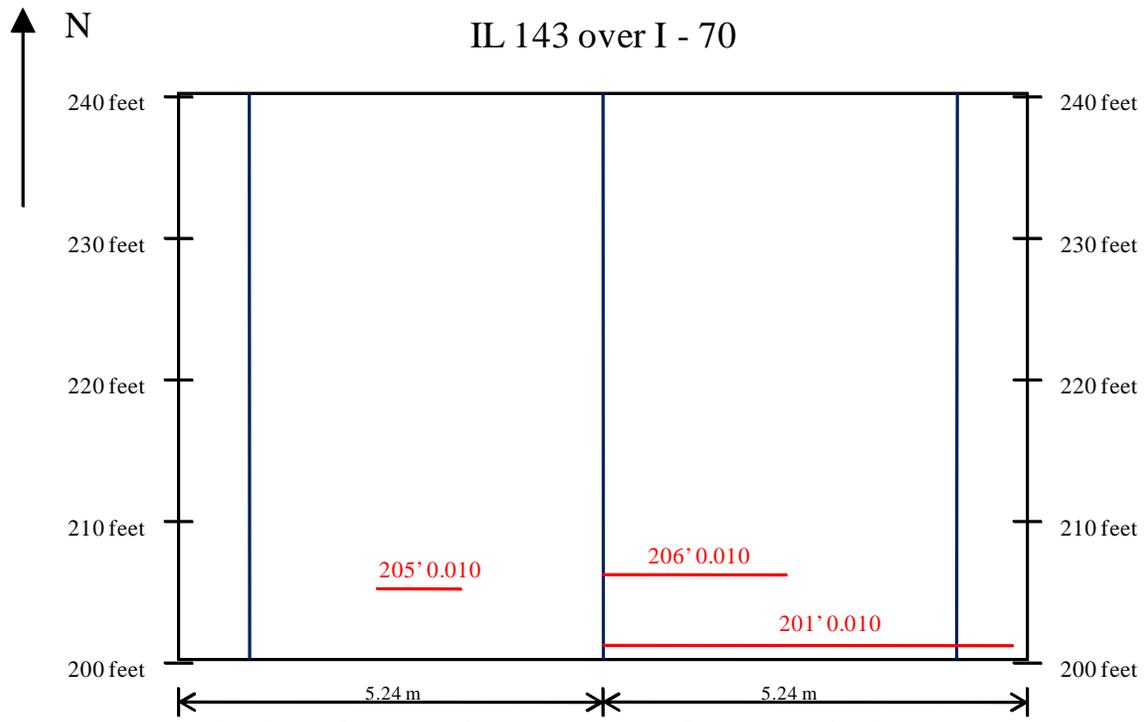
Madison County – SN# 060-0151 – Surveyed 9/28/2005  
 The “#” symbol represents cracks in the parapet only.

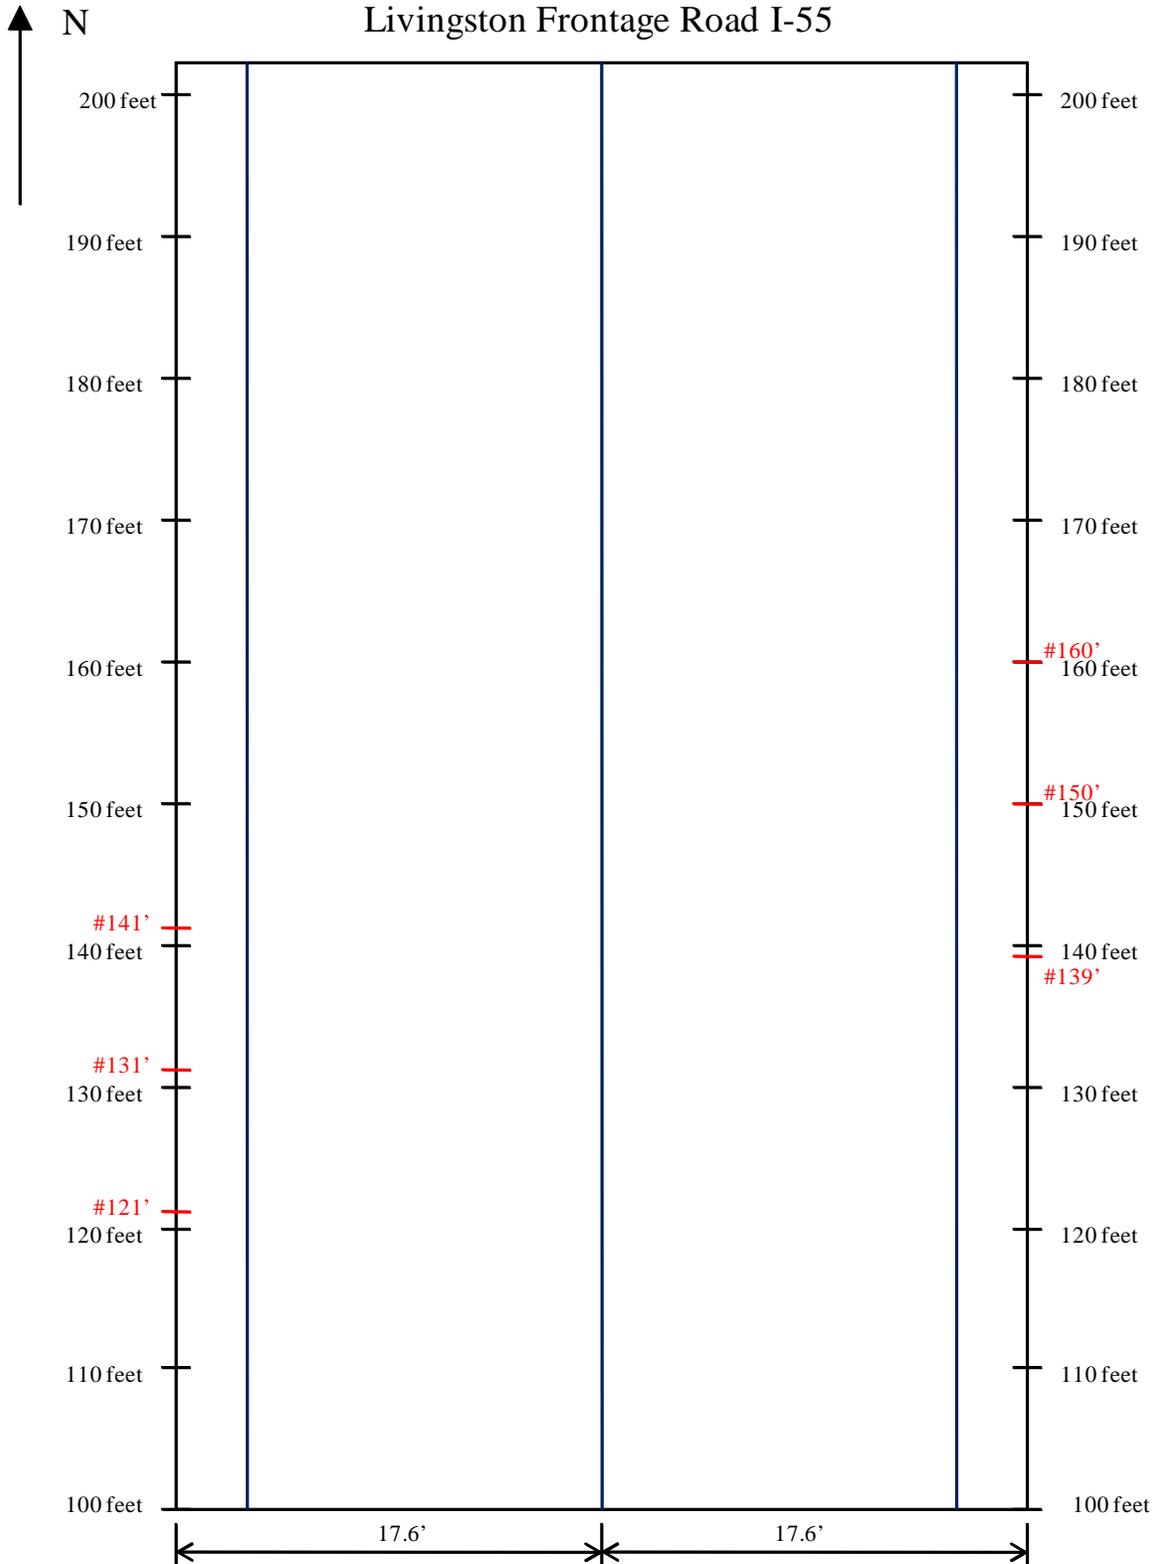
Madison County – SN# 060-0004 – Surveyed 8/12/2002  
 The “#” symbol represents cracks in the parapet only.

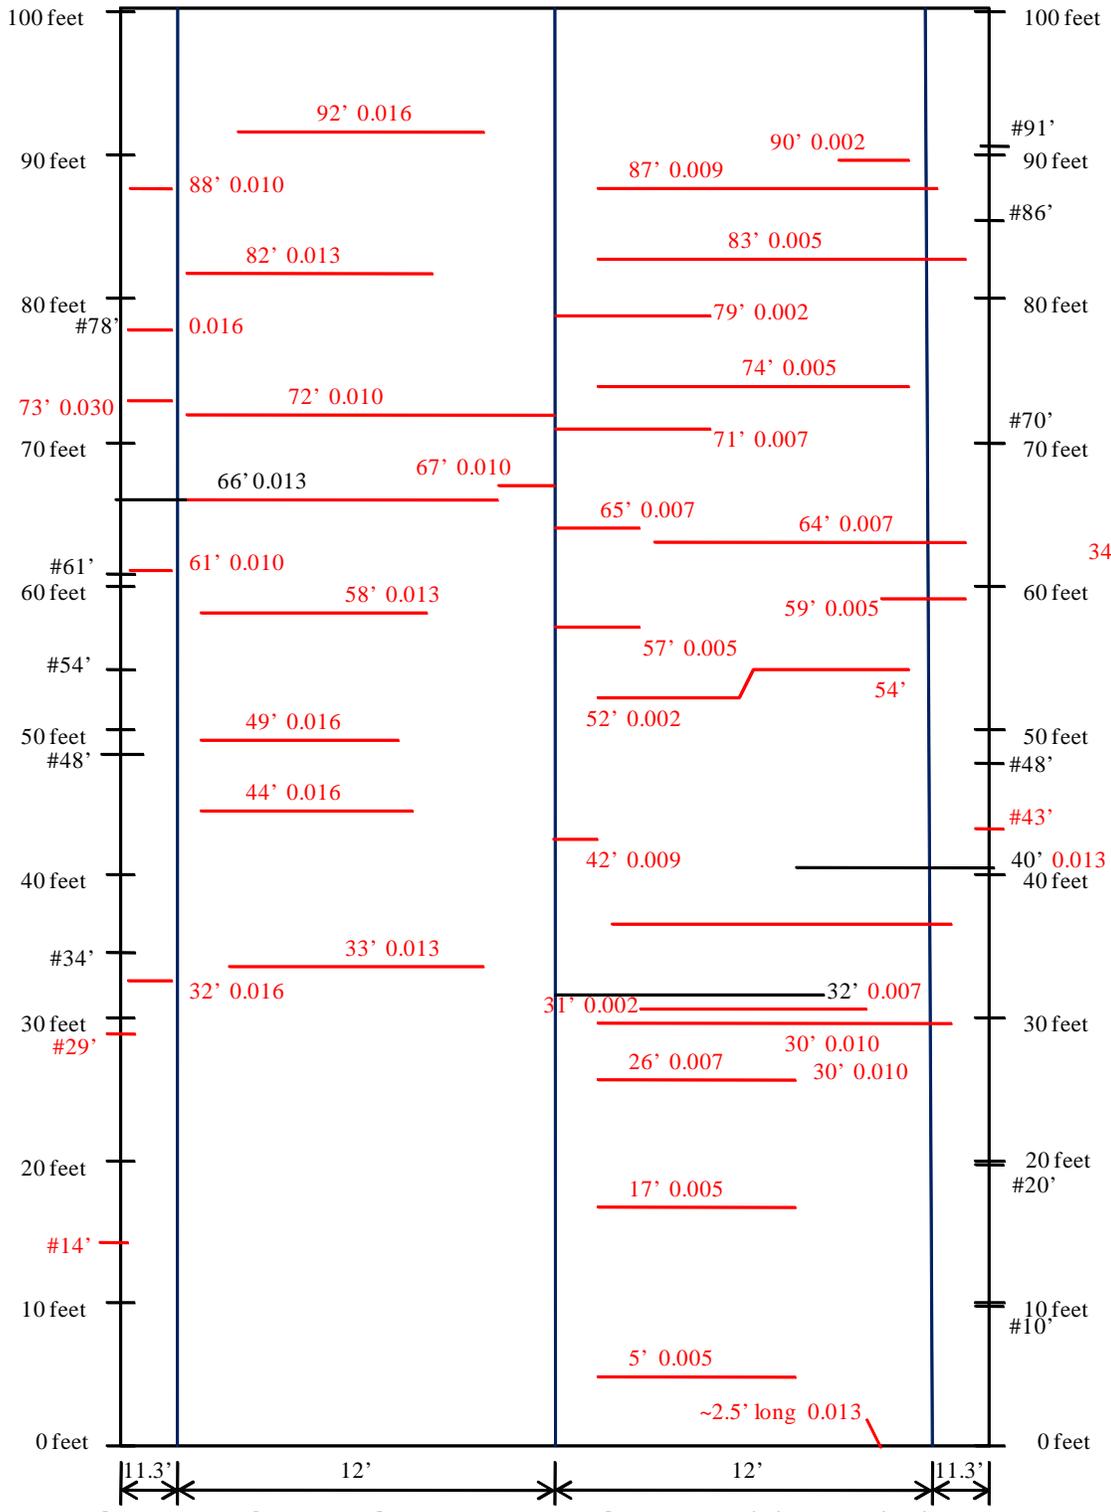
Sangamon County – SN# 084 -0065 – Surveyed 5/7/2001, 8/15/2001

The initial survey of the westbound lane showed 33 hairline transverse cracks.

The initial survey of the eastbound lane showed 21 hairline transverse cracks.

The “#” symbol represents cracks in the parapet only.

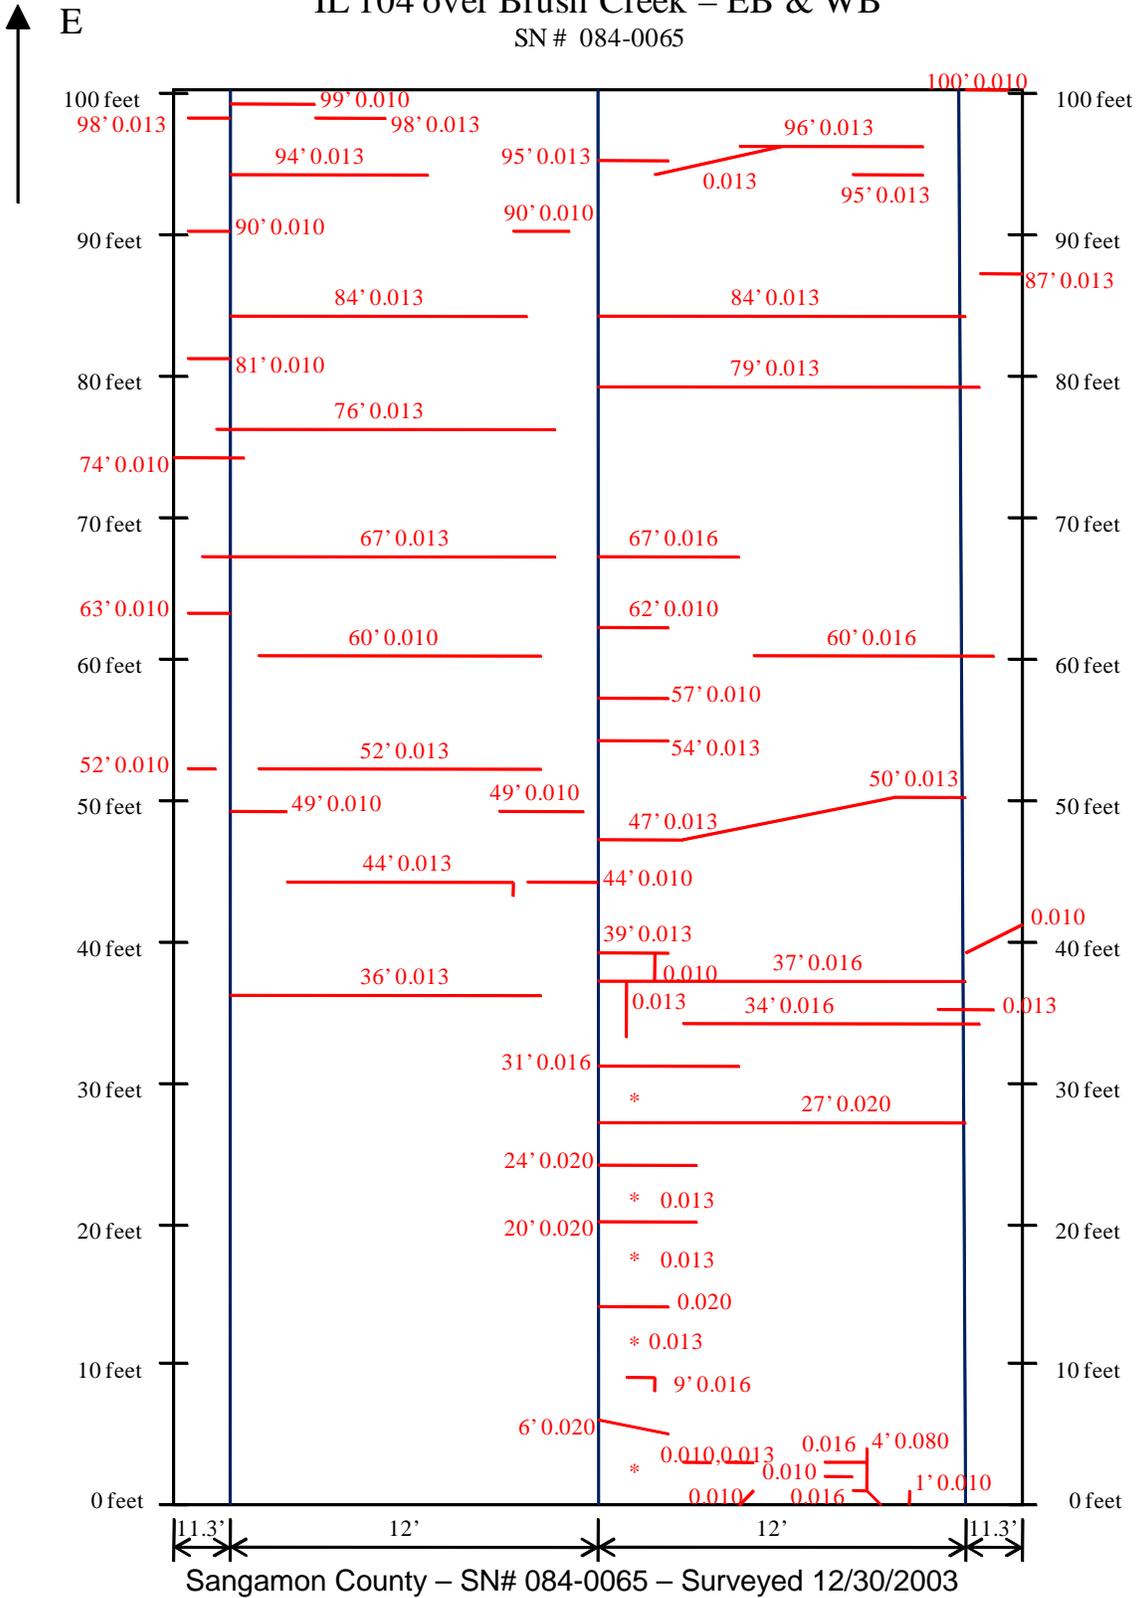
IL 104 over Brush Creek – EB & WB  
SN # 084-0065

\* Denotes areas of interconnected hairline cracks, sometimes resembling a spider web.

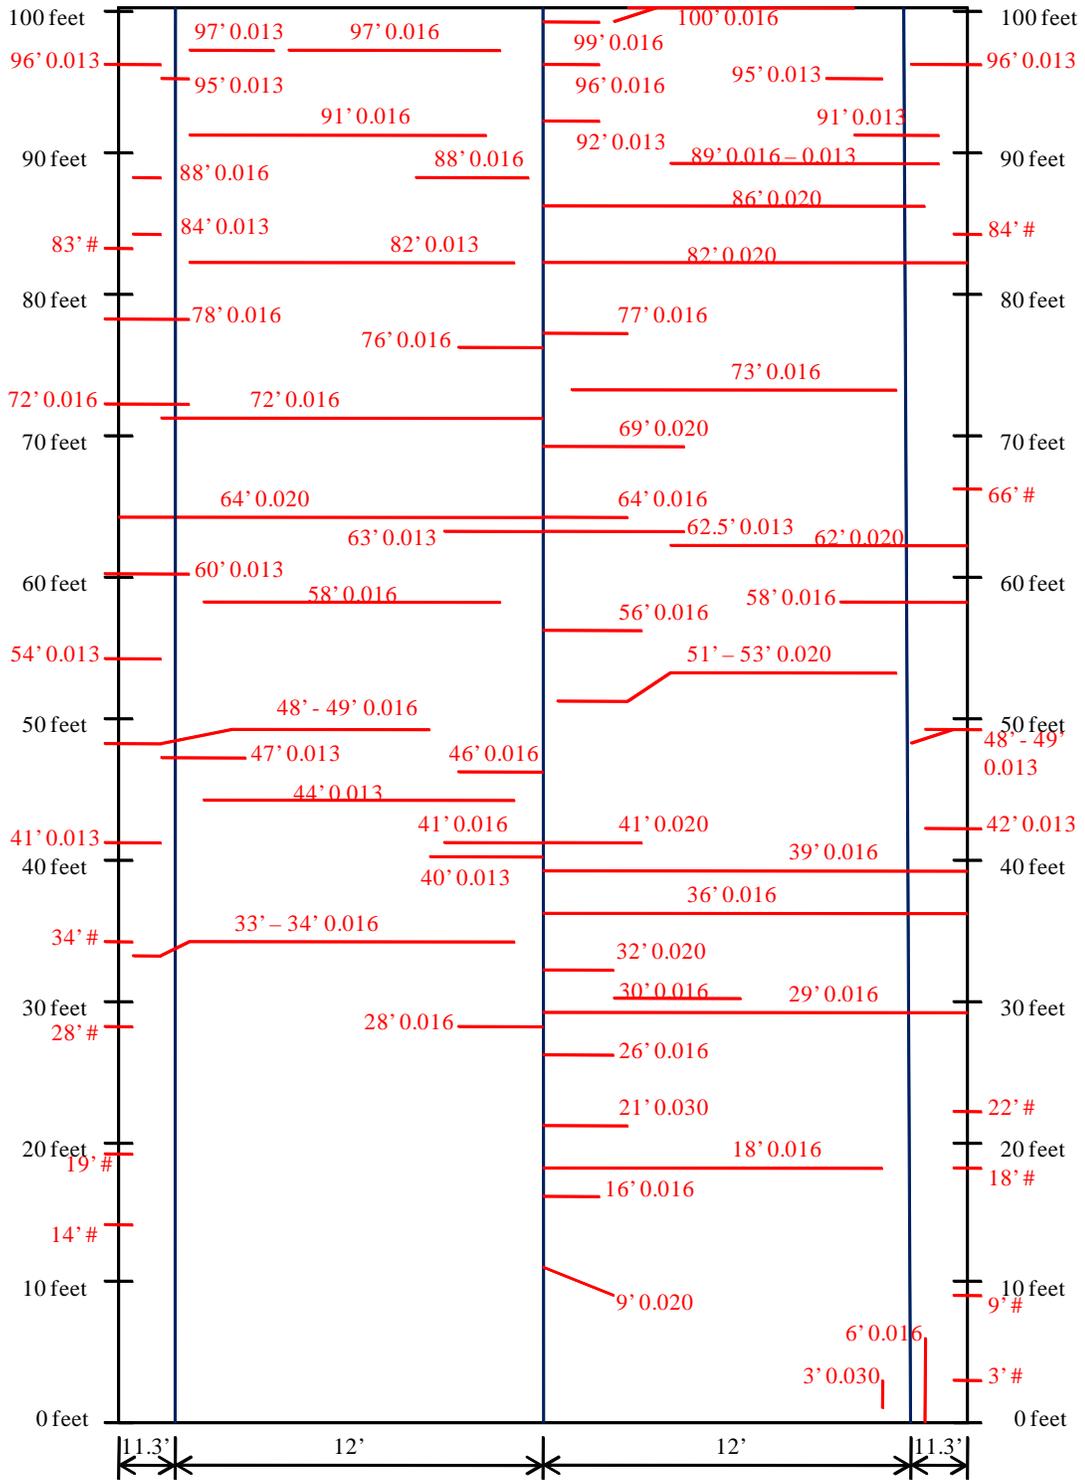
Sangamon County – SN# 084-0065 – Surveyed 9/26/2005

Map cracking was observed in the eastbound lane near the centerline from 9' to 89'.

The “#” symbol represents cracks in the parapet only.

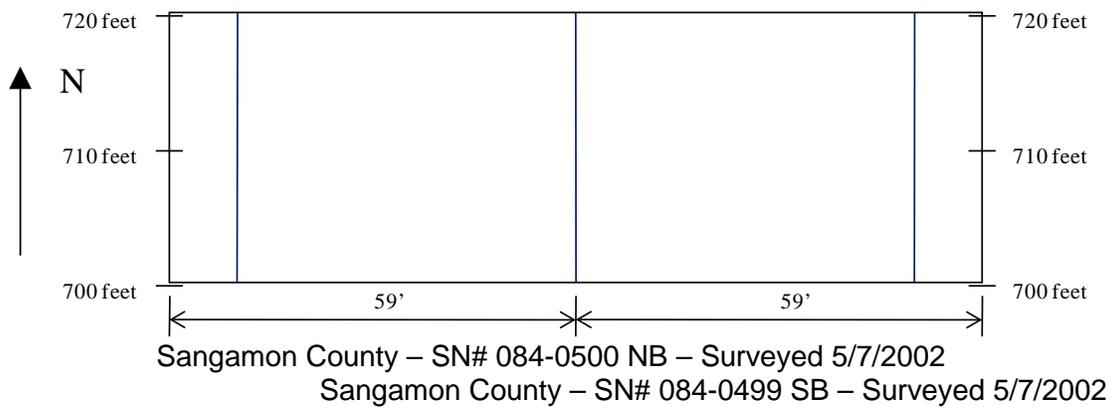
## I-55 over Lake Springfield

The “#” symbol represents cracks in the parapet only.

This bridge deck was poured on various days. The last pour date was 4/5/2002.
