EVALUATION OF WELDED WIRE FABRIC IN
BITUMINOUS CONCRETE RESURFACING

W. Emmitt Chastain, Sr., Engineer of Research and Development
R. H. Mitchell, Research Engineer

Illinois Division of Highways

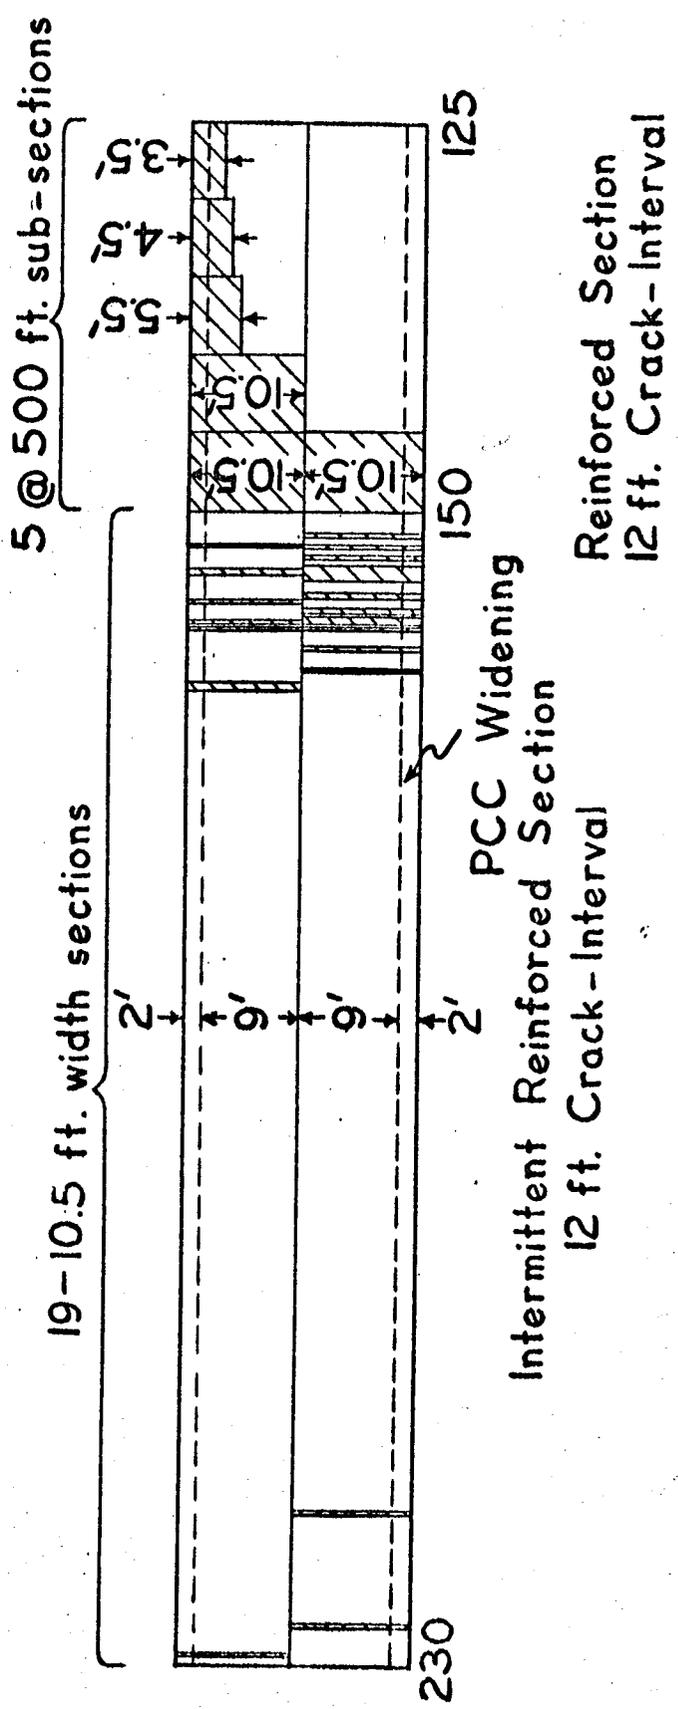
Figure 4. Details of project layout

The condition survey of the old portland cement concrete pavement prior to resurfacing revealed numerous wide transverse cracks and associated spalling and faulting. There were two general transverse crack-intervals, one at nearly 50 feet, between Stations 51 and 86, and the other at approximately 10 to 15 feet, between Stations 86 and 230 (see Figure 4). No reason was found for the wide difference in crack interval between the two locations.
