# Metra Clybourn Station Feasibility Study

Stakeholder Advisory Group

Site Visit

Friday, August 28, 2026

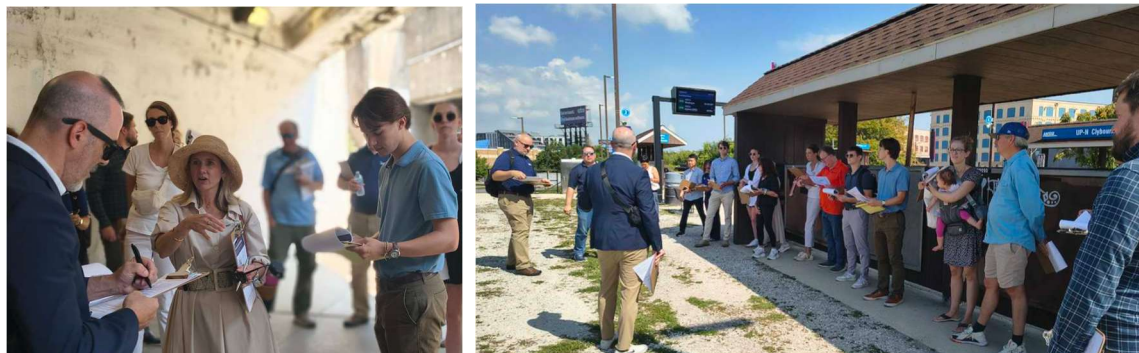
##### Stop 1 – North Armitage/Best Buy Lot

A key physical condition highlighted at this location was the lack of a direct marked crosswalk between the Best Buy area and the station parking lot – which meant the group had to walk back towards the Armitage and Ashland intersection in order to safely cross onto the side of the street where the station is located. The planned route deliberately required the group to cross at the intersection and return to the station lot so participants could experience the additional circulation required to make this connection. The discussion also focused on the overlap of multiple arrival modes within a constrained area, including bus drop-off, pedestrians, bicycles, and vehicles.

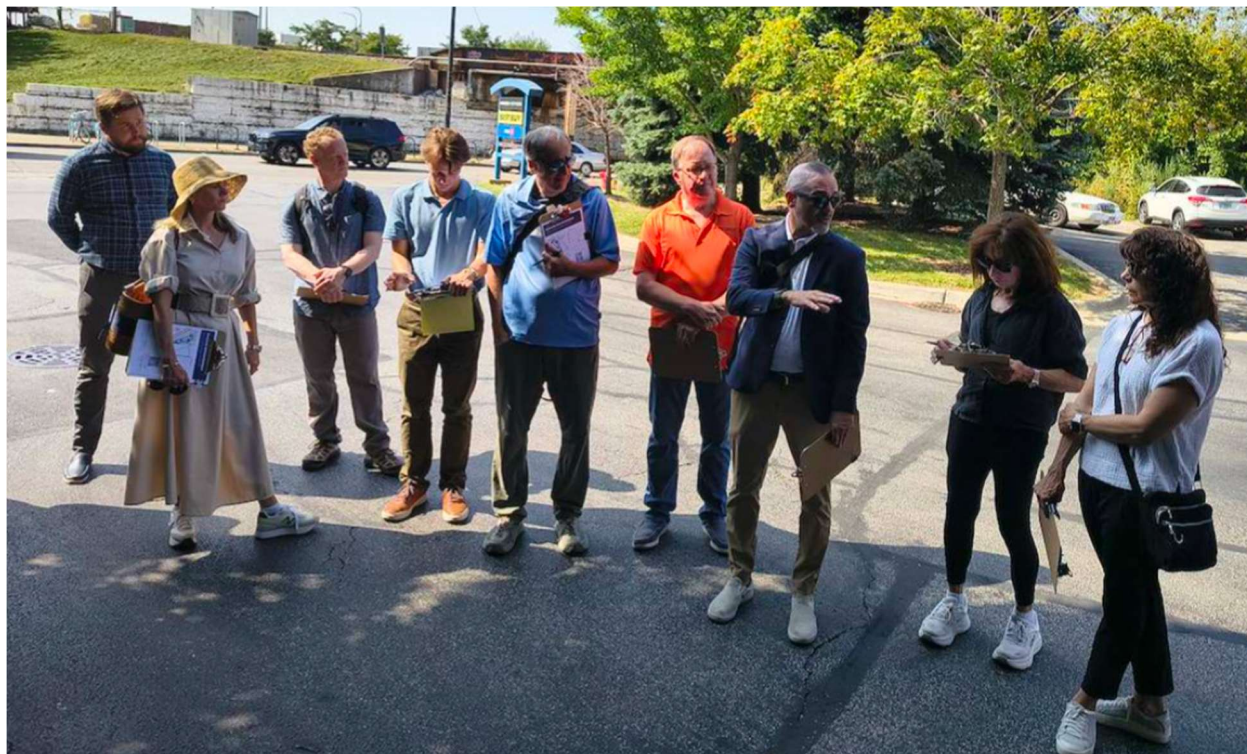
## Stop 2 – Wedge Lot and Bicycle Access

The second stop focused on the station parking area and the constrained space surrounding the primary station access points.

Participants observed the convergence of pedestrian, bicycle, and vehicle movements and examined existing bicycle parking, station entrances, tunnels, signage, and the relationship between the station and the nearby 606 Trail.

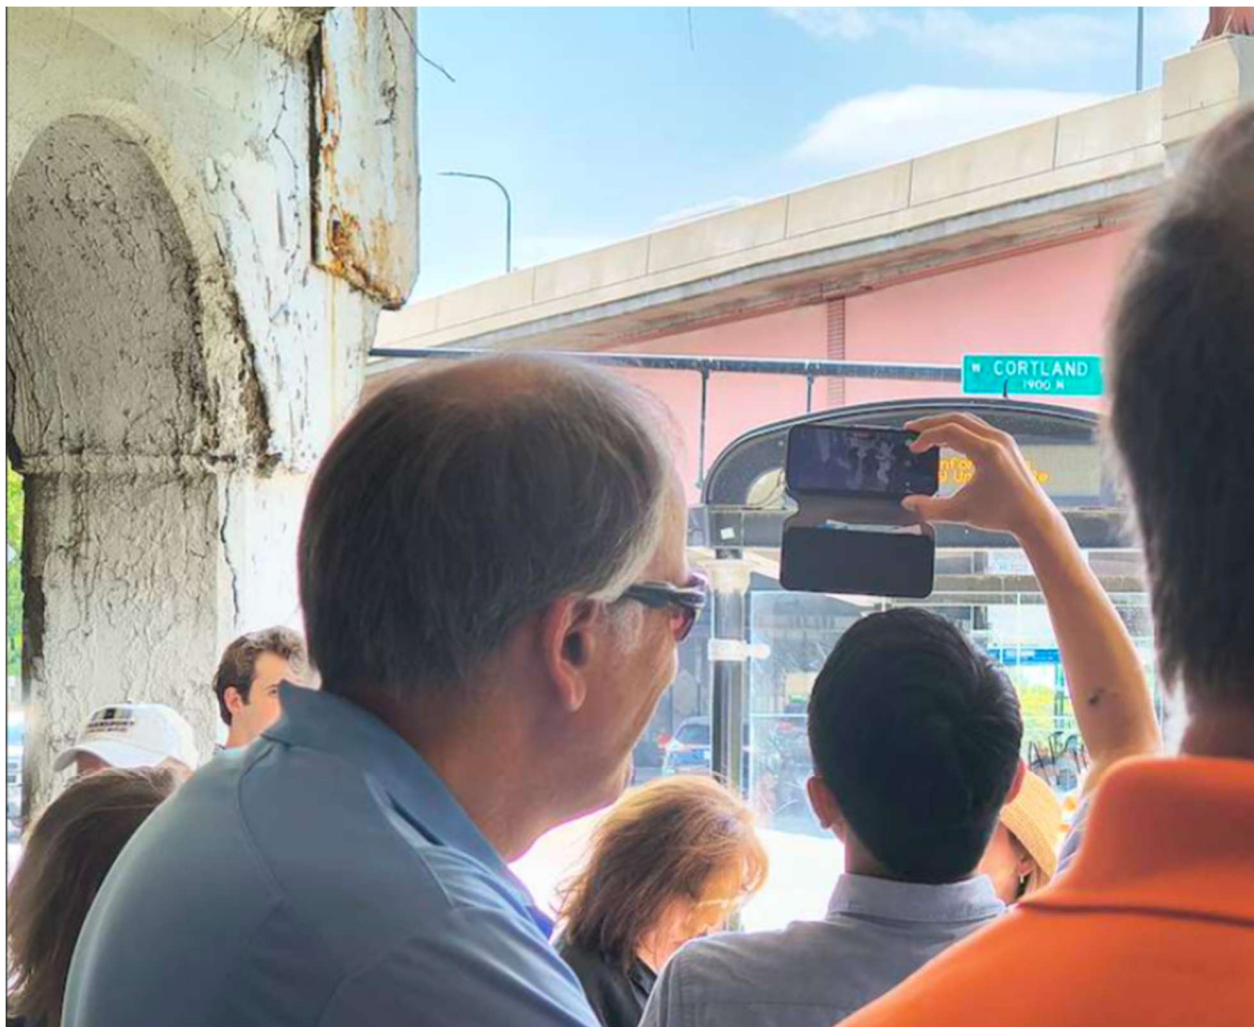
### Stop 5 – Bus and Street Connections at Ashland/Armitage

The final field stop examined the station's relationship to the surrounding street and bus network, particularly at Ashland Avenue, Armitage Avenue, and Cortland Street. Participants observed CTA bus service, bus stop signage, pedestrian crossings, sidewalk availability, lighting beneath viaducts, and the physical process of transferring between bus service and Metra.

The Study team also called attention to the visibility of bus stop signs and the presence of physical obstructions such as viaducts and bridges that may interfere with their visibility.
