# **BRIDGE CONDITION REPORT**

**STRUCTURE NUMBER: 050-0058**

**LOCATION: US Route 52 over the Fox River in  
LaSalle County**

**DATE INSPECTED: November 28, 2016**

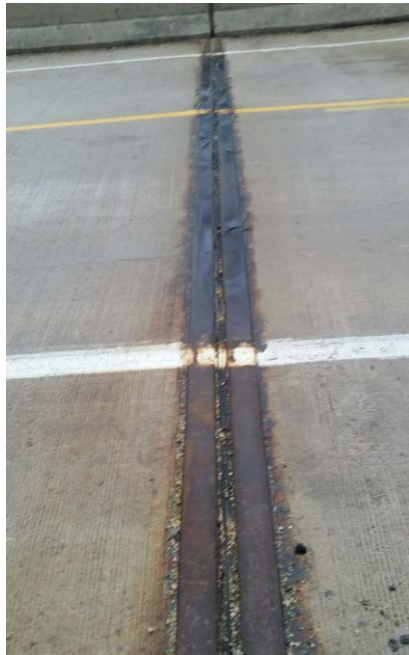
West Abutment Expansion Joint

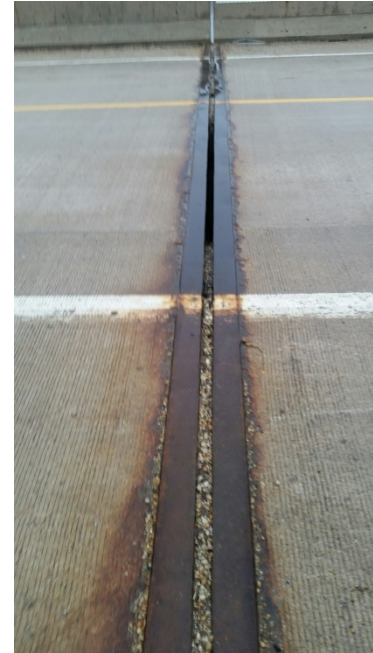
Pier 3 Expansion Joint

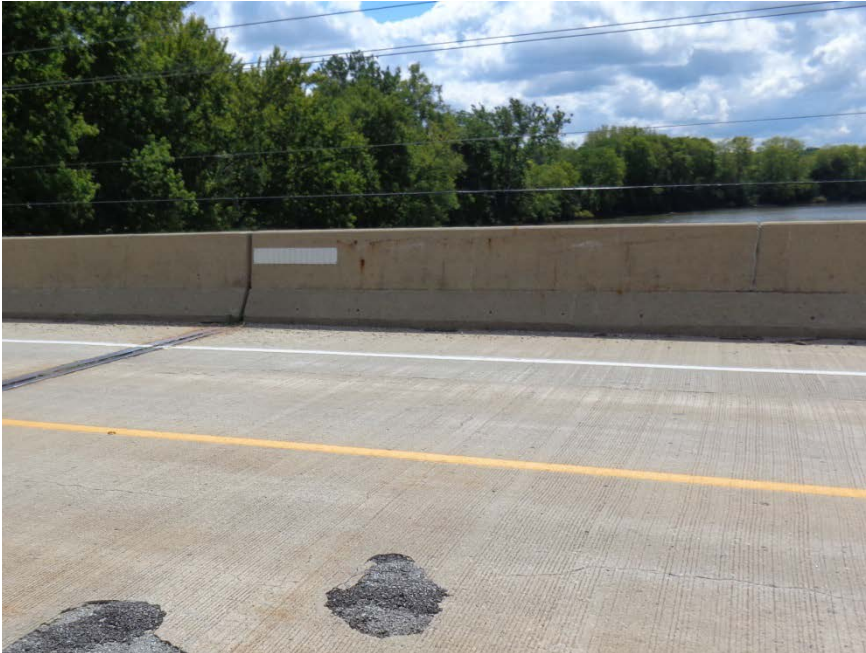
Typical Bridge Rail

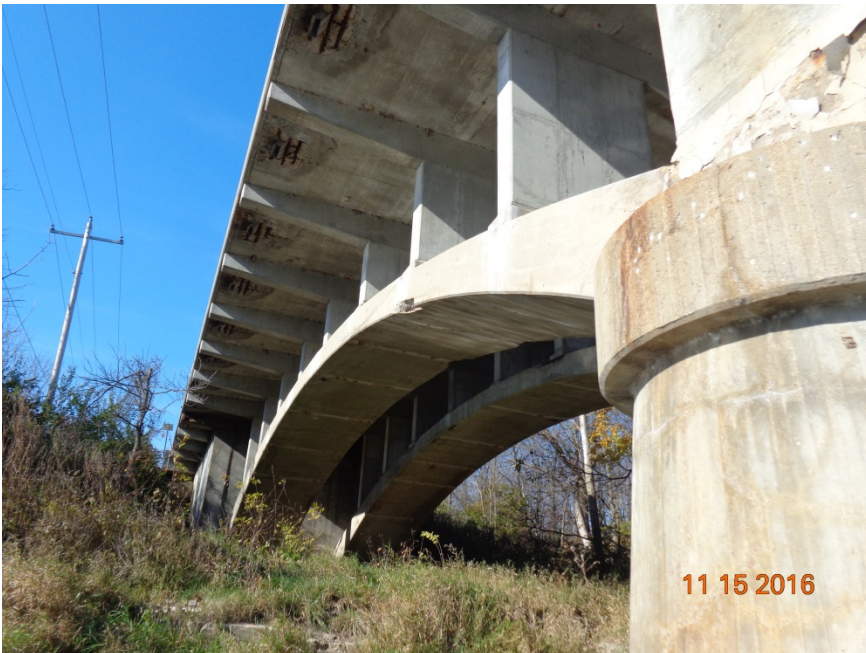
General Condition of Underside (Span 1)

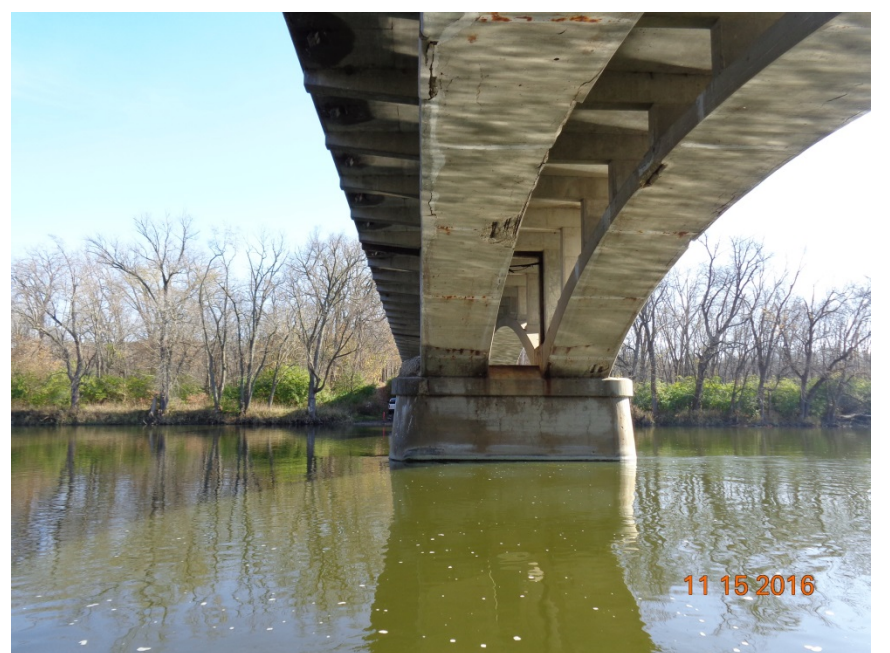
General Condition of Underside (Span 2)

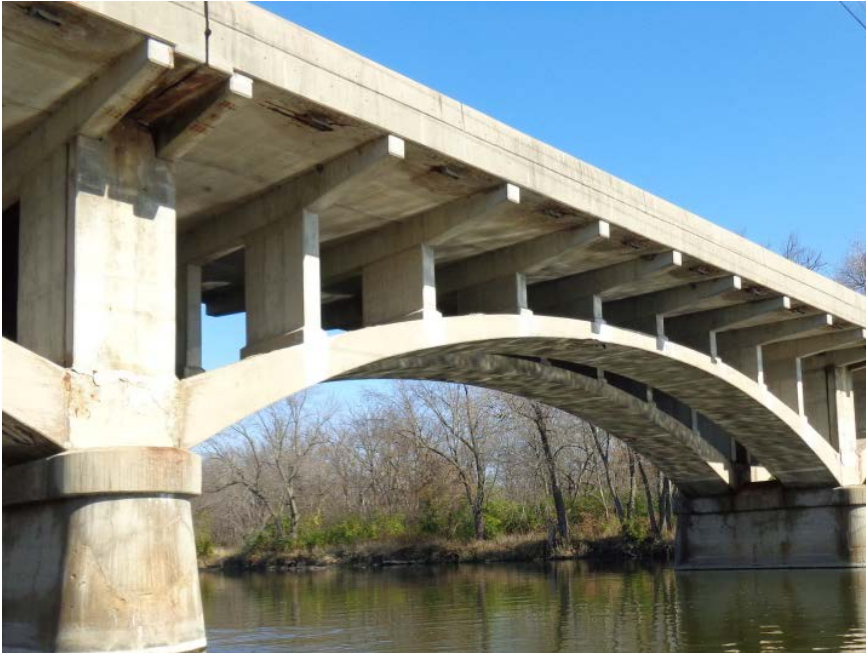
General Condition of Underside (Span 3)

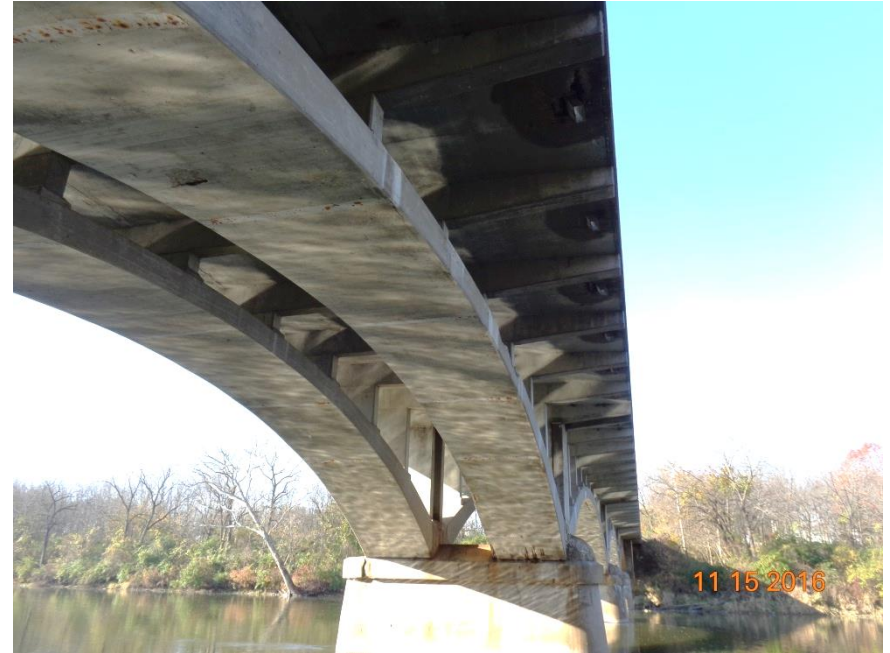
General Condition of Underside (Span 4)

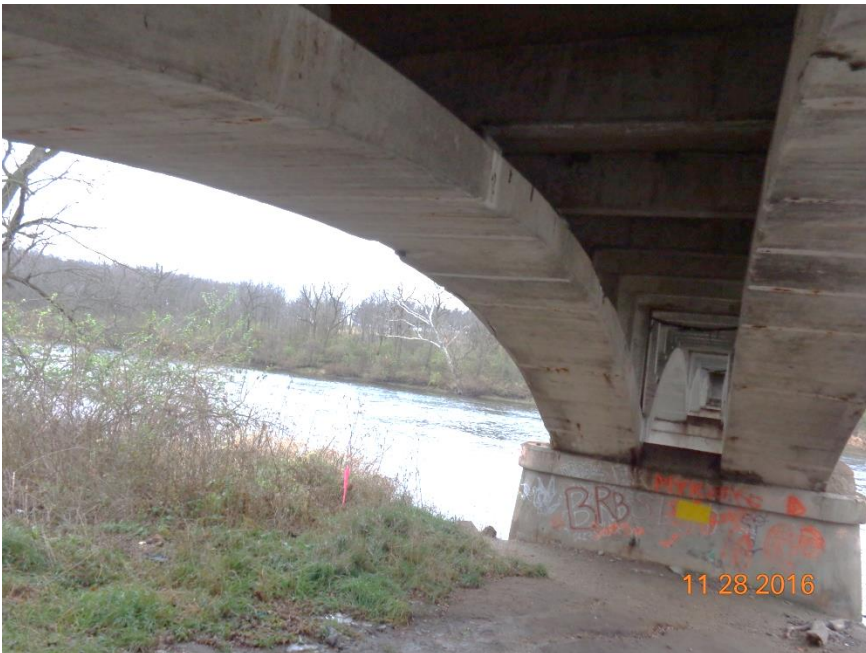
General Condition of Underside (Span 5)
