# **Investigation of Rack and Pinion**

## **Alignment of the Cass Street**

### **Movable Bridge in Joliet, Illinois**

**Physical Research Report No.129**

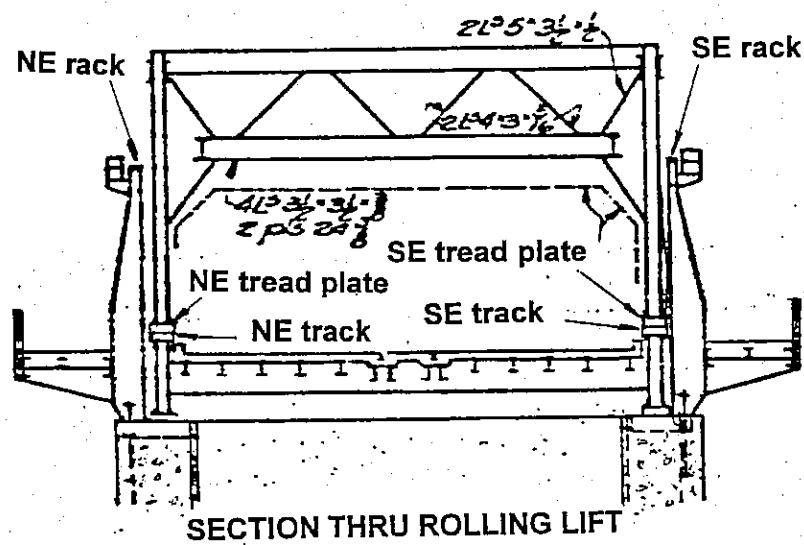
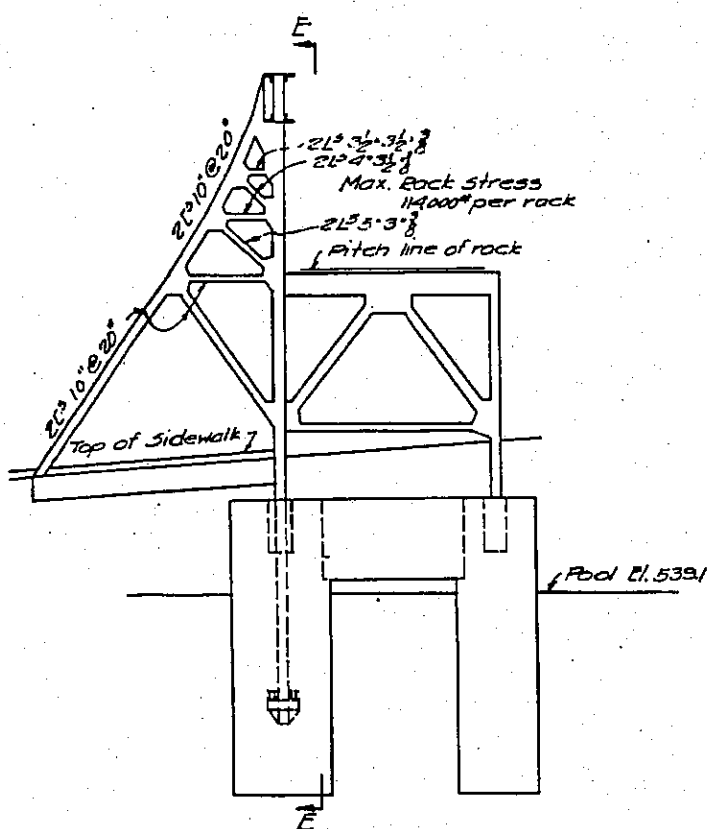
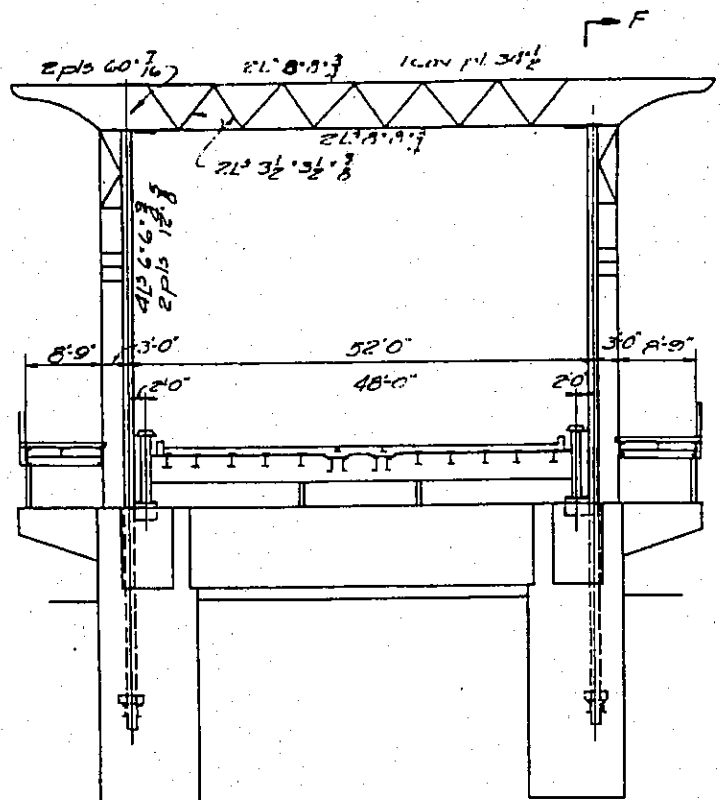
Figure 3. Rack and track supports and anchorages, and respective locations of tread plates, racks and tracks on the abutment end of the Cass St. Bridge. Adapted from 1931 plans.

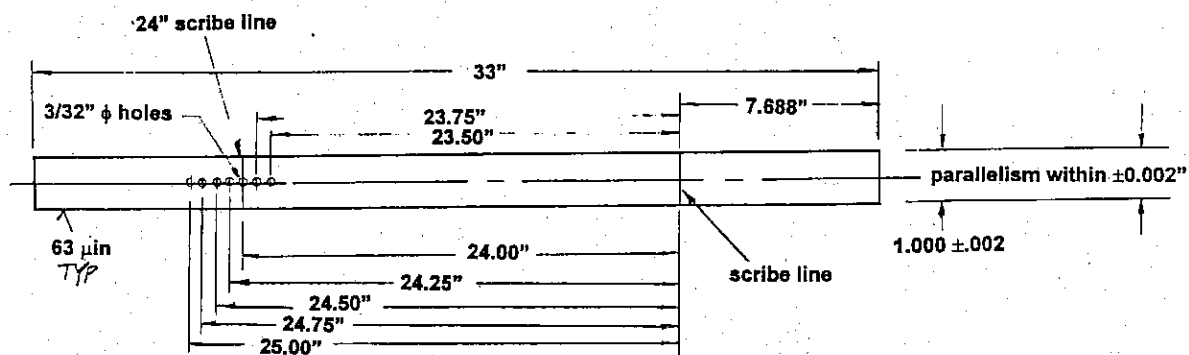
#### PLUMB LINE OFFSET BAR

However, measurements of the 24" offset on the river side of the track proved to be difficult. First, there was no means of attaching the calibrated bar to the rack, since the supporting base plate for the rack terminates flush with the forward rack element. Even after clamping the offset bar to the rack, structural elements on the bascule span interfered with the drop of the plumb line. In addition, traffic must be halted to obtain this measurement. Because the riverside measurement was not made, an extension bar should fastened to the track to make this measurement in the future.
