**EVALUATION OF HIGH PERFORMANCE  
CONCRETE BRIDGE DECKS  
AND  
OTHER EXPERIMENTAL BRIDGE  
DECKS THROUGHOUT ILLINOIS**

**PHYSICAL RESEARCH REPORT NO. 166  
December 2017**

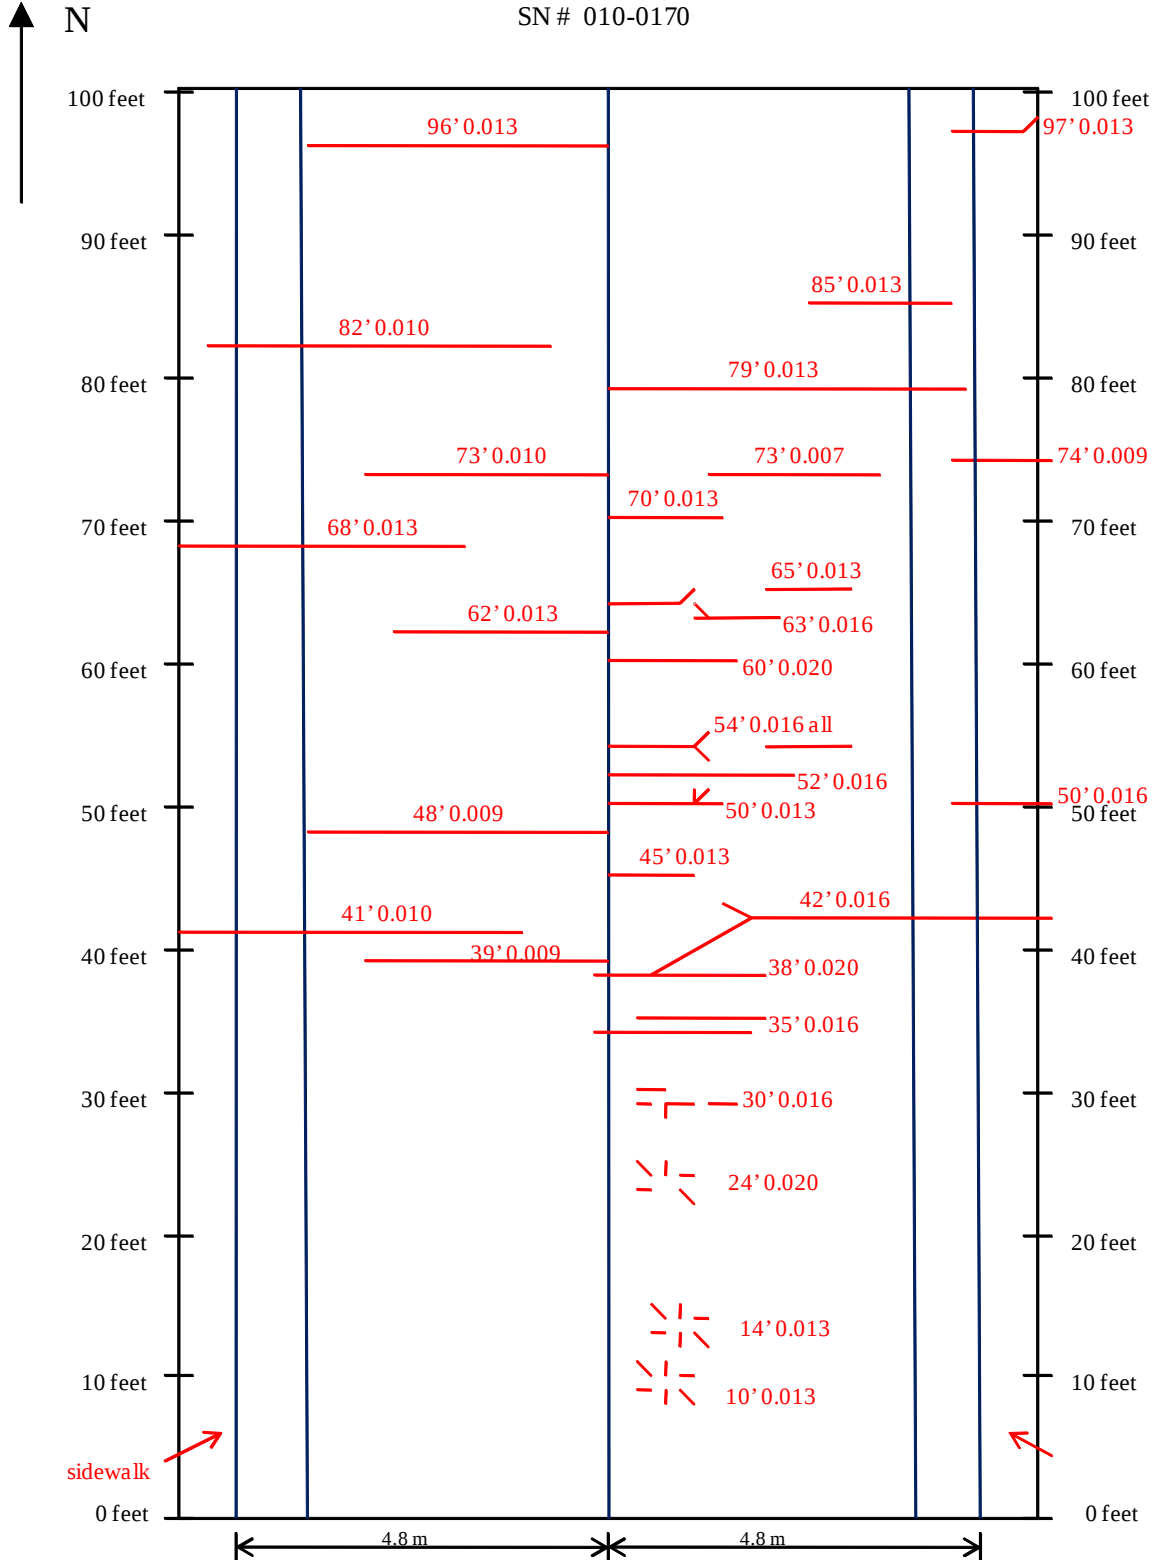
SN # 010-0170

Champaign County – SN# 010-0170 – Surveyed 9/16/2002

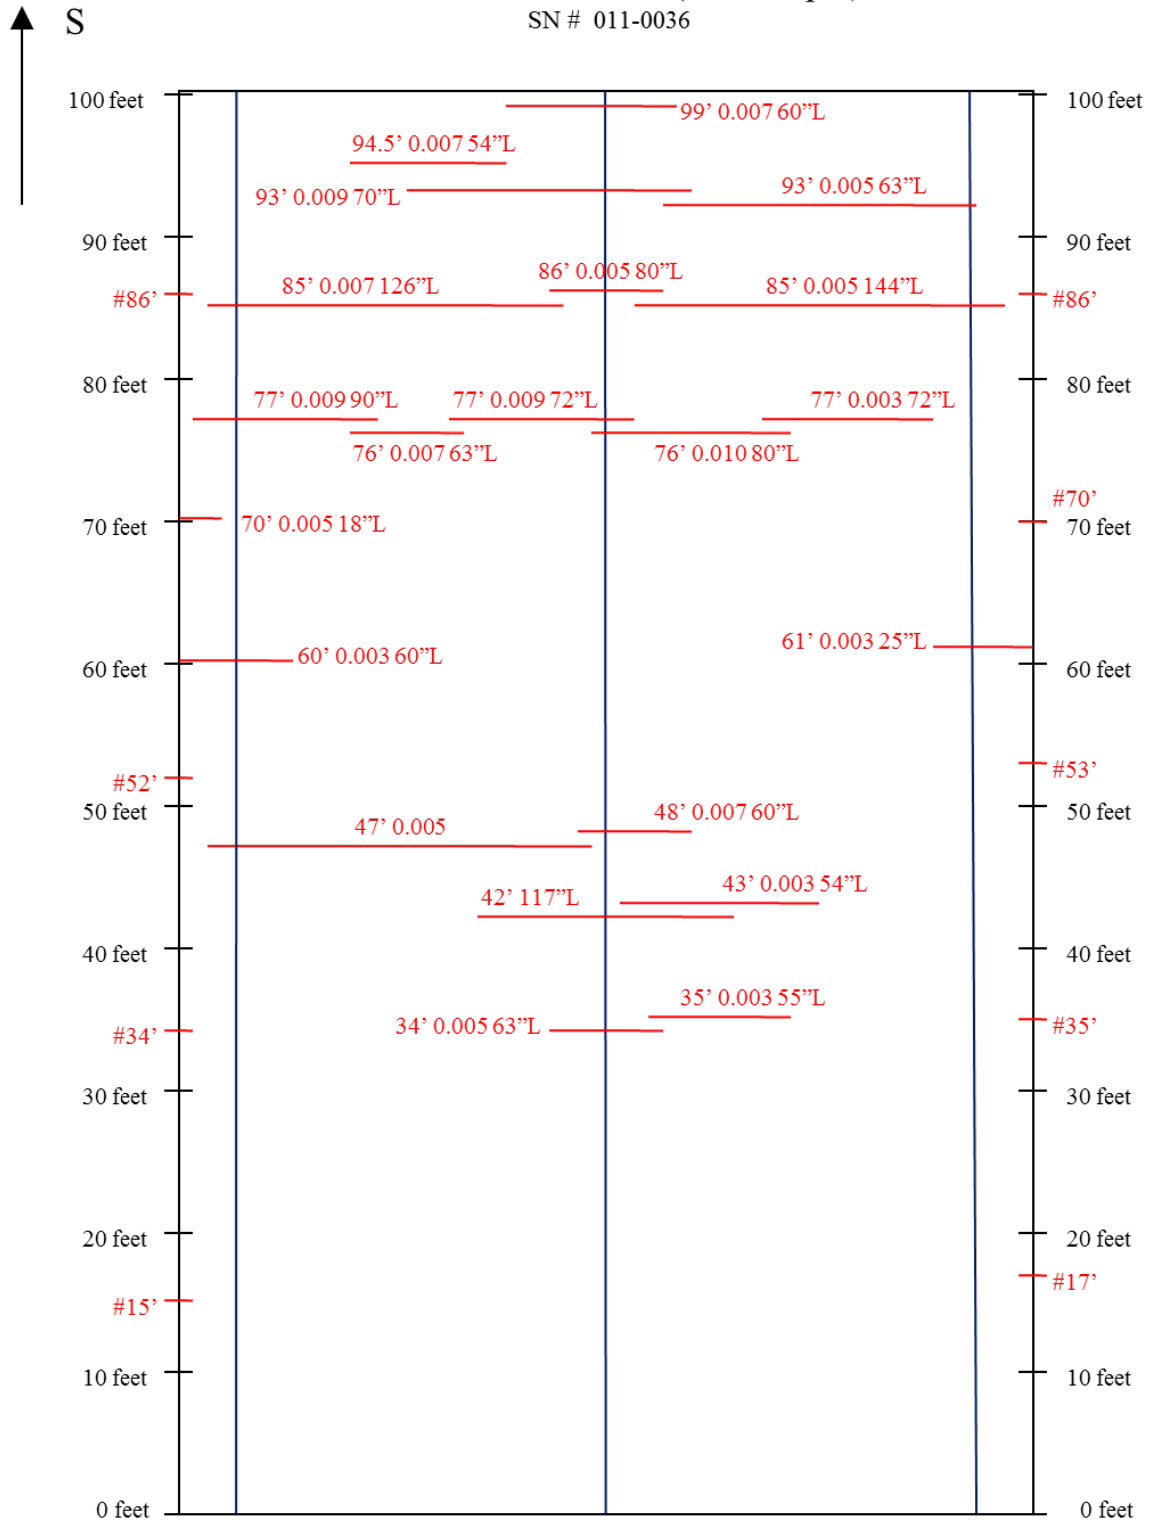
SN # 011-0036

Christian County – SN#011-0036 – Surveyed 9/16/2003

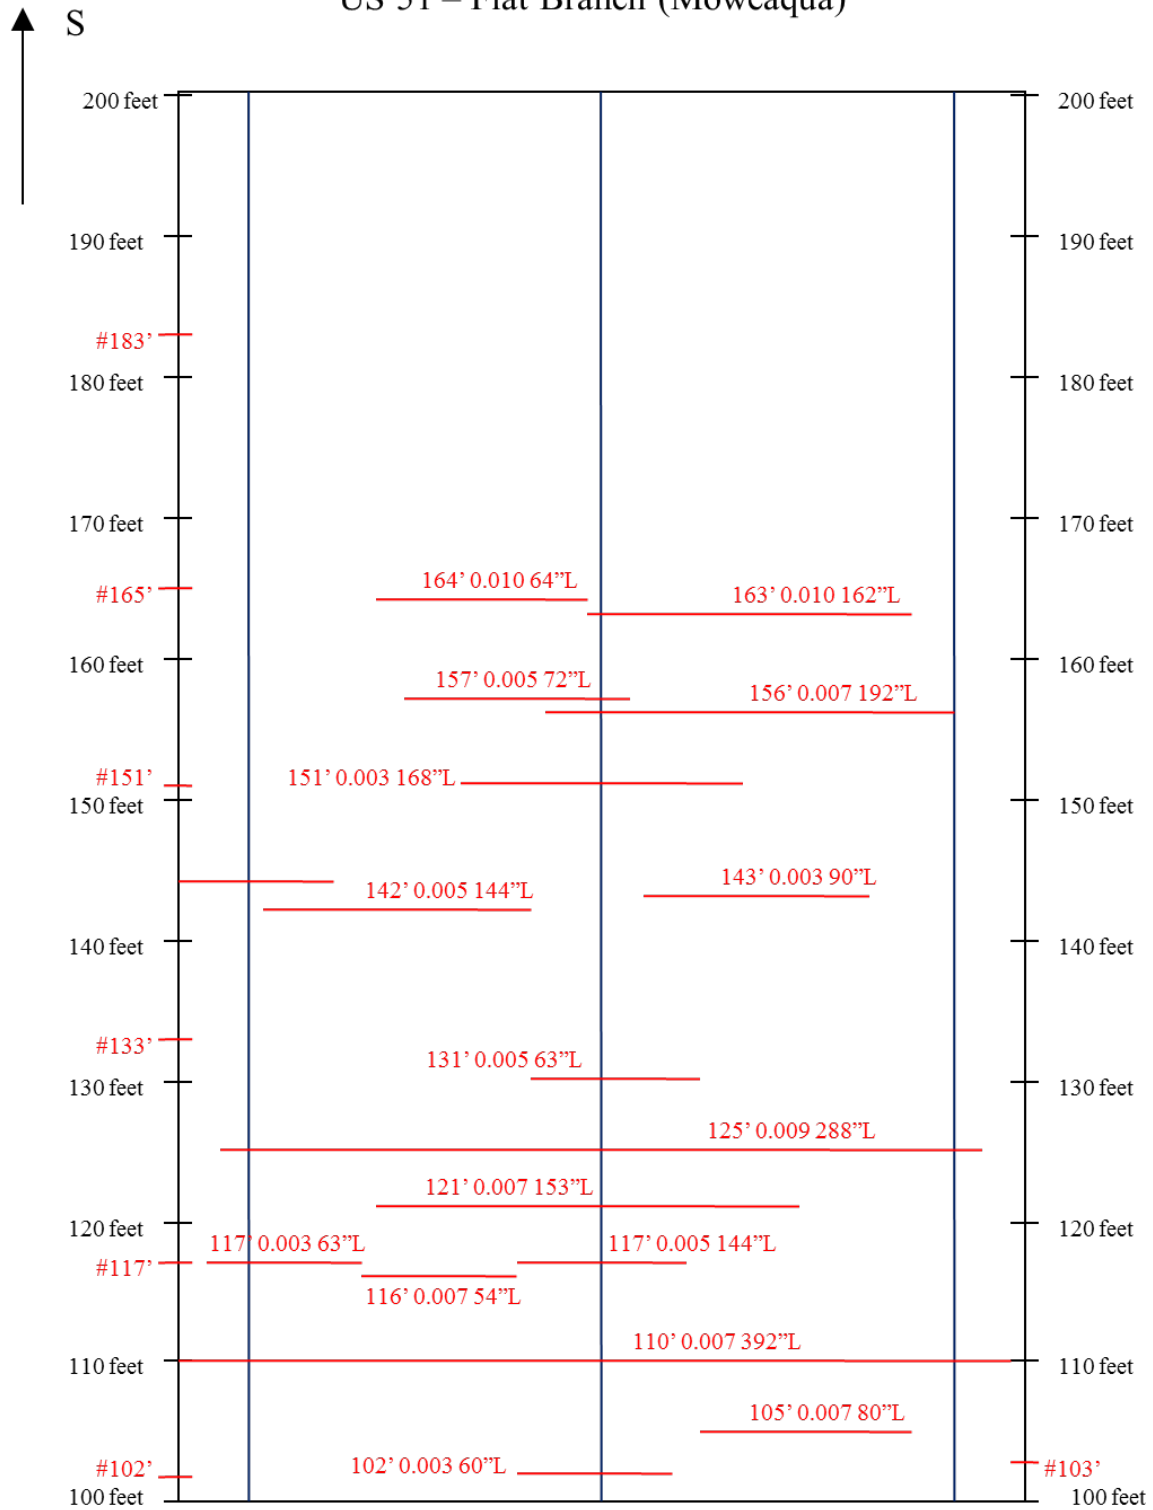
# US 51 – Flat Branch (Moweaqua)

Christian County – SN#011-0036 – 9/19/2003  
The “#” symbol represents cracks in the parapet only.

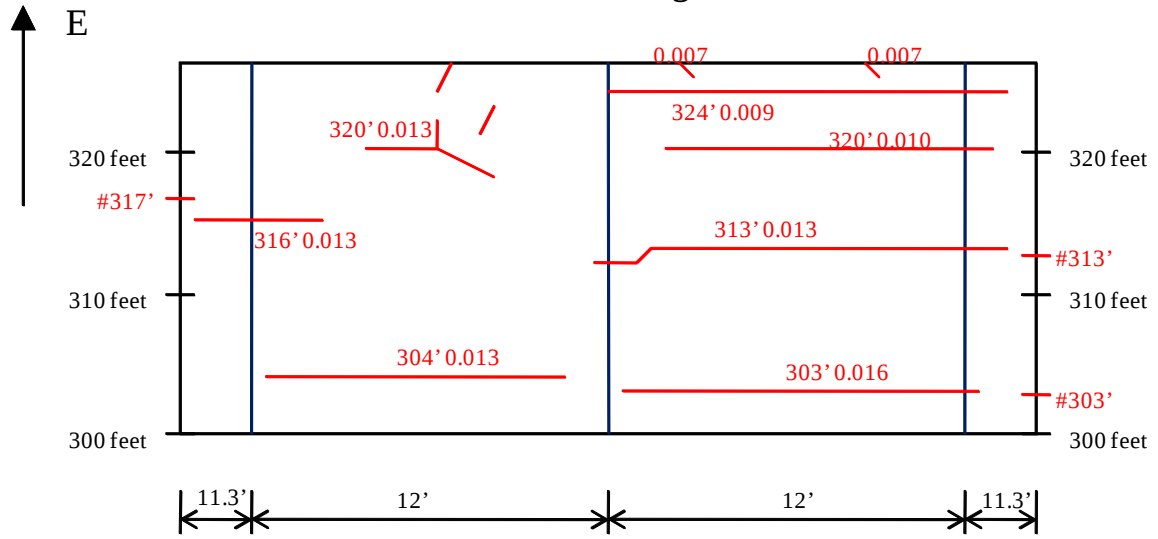
# 104 over S. Fork Sangamon River

Christian County – SN# 011-0502 – Surveyed 2002  
 The “#” symbol represents cracks in the parapet only.

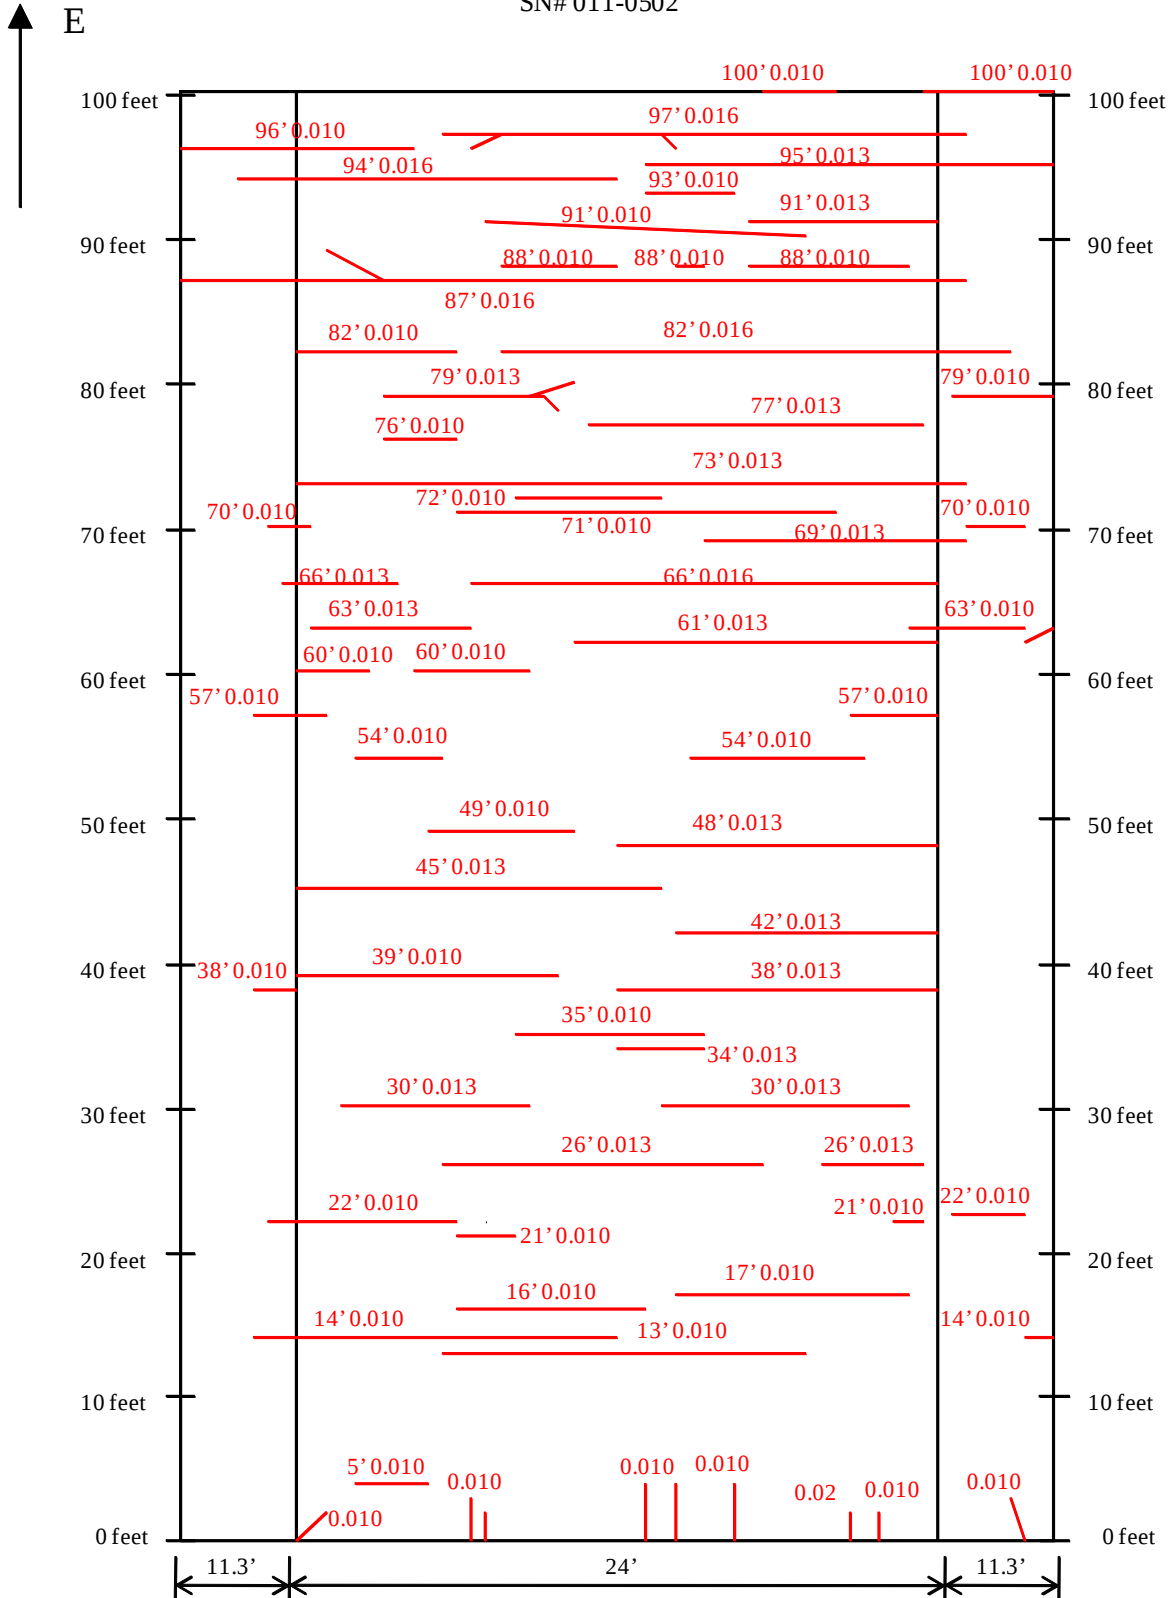
Christian County – SN# 011-0502 – Surveyed 12/30/2003

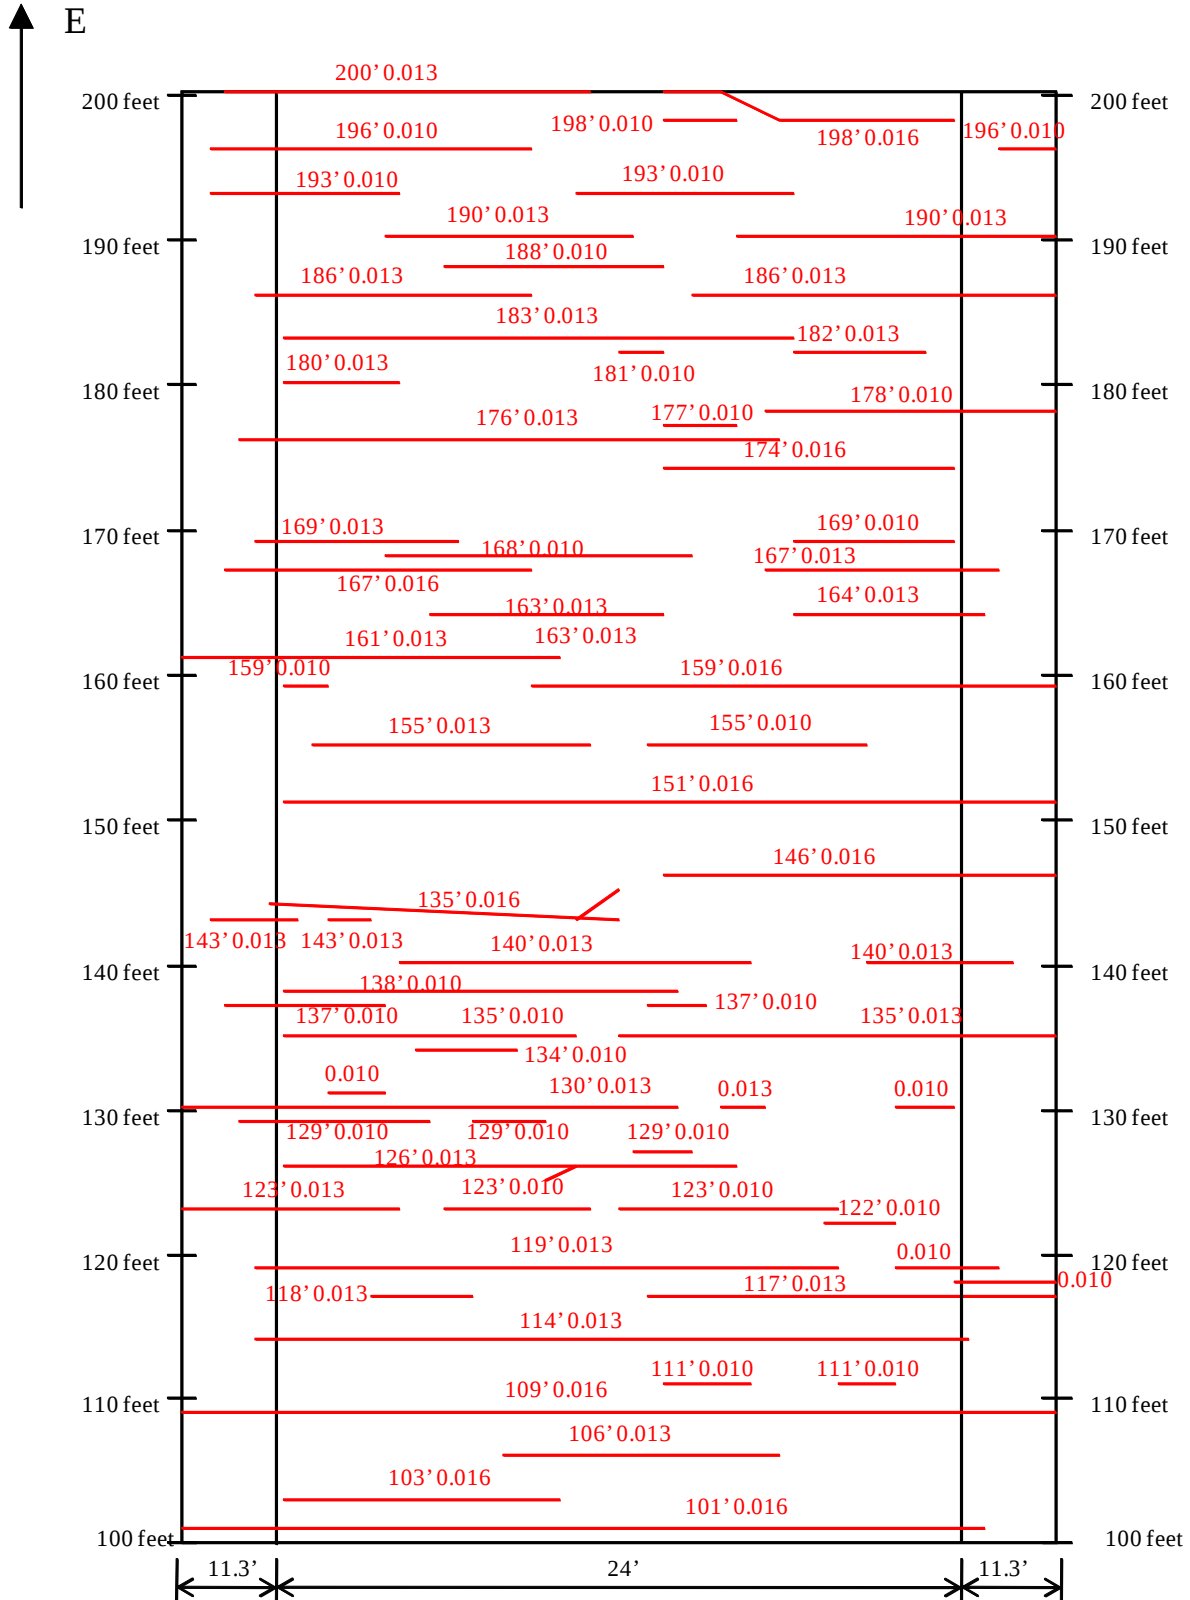
# IL 104 over South Fork Sangamon River

Christian County – SN# 011-0502 – Surveyed 12/30/2003

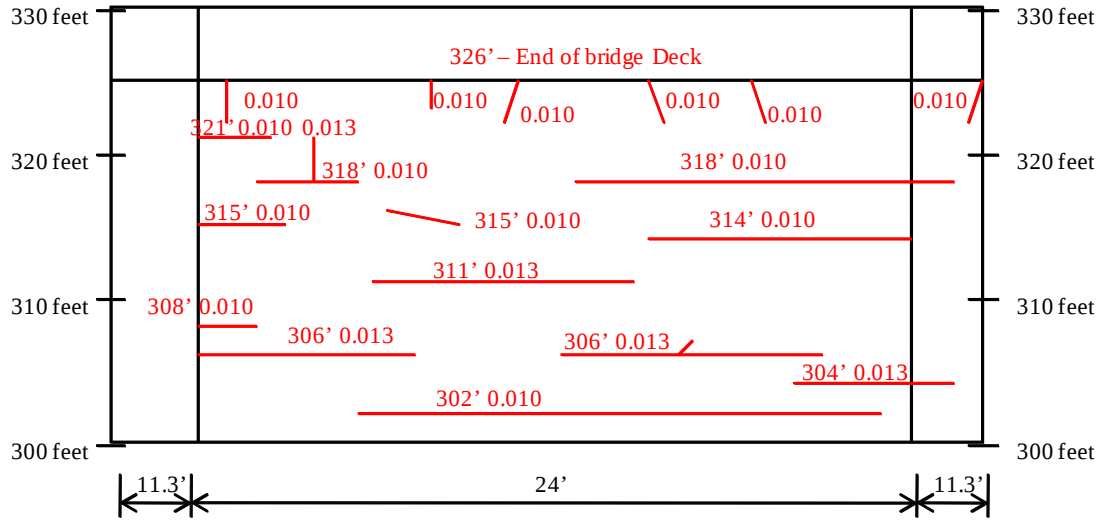
# IL 104 over South Fork Sangamon River

Christian County – SN# 011-0502 – Surveyed 12/30/2003

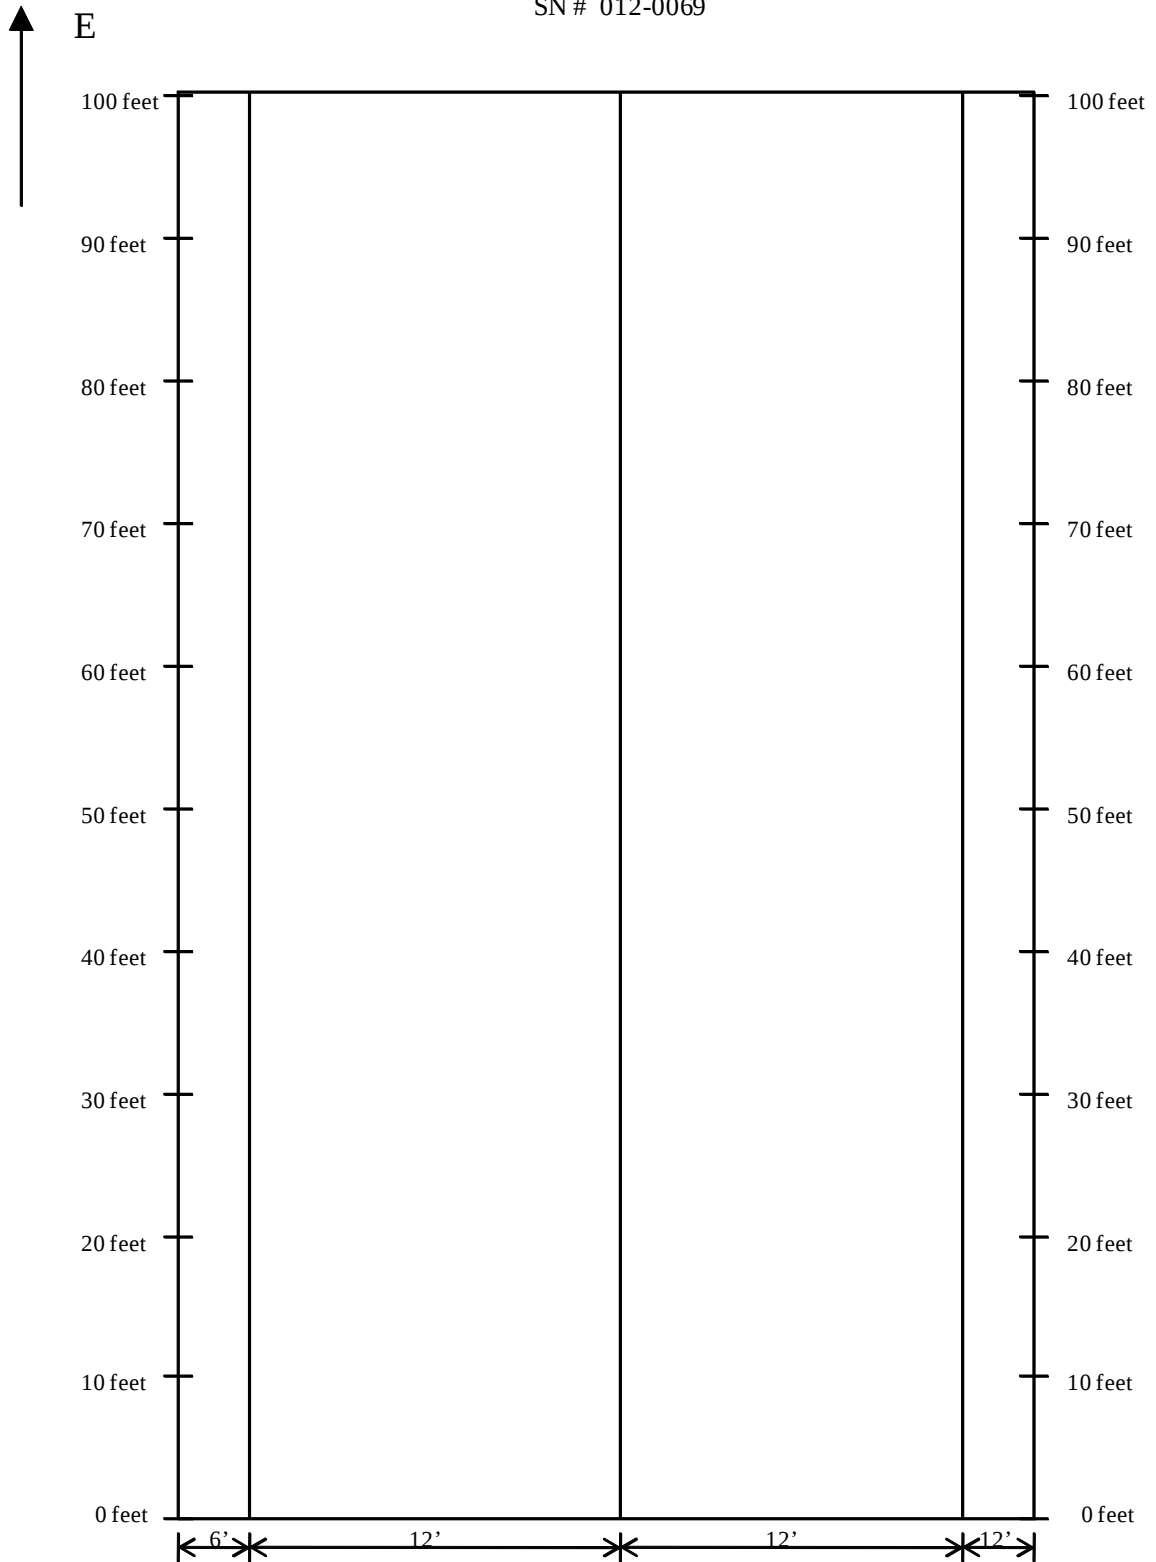
SN # 012-0069

Clark County – SN# 012-0069 – Surveyed 5/22/2002

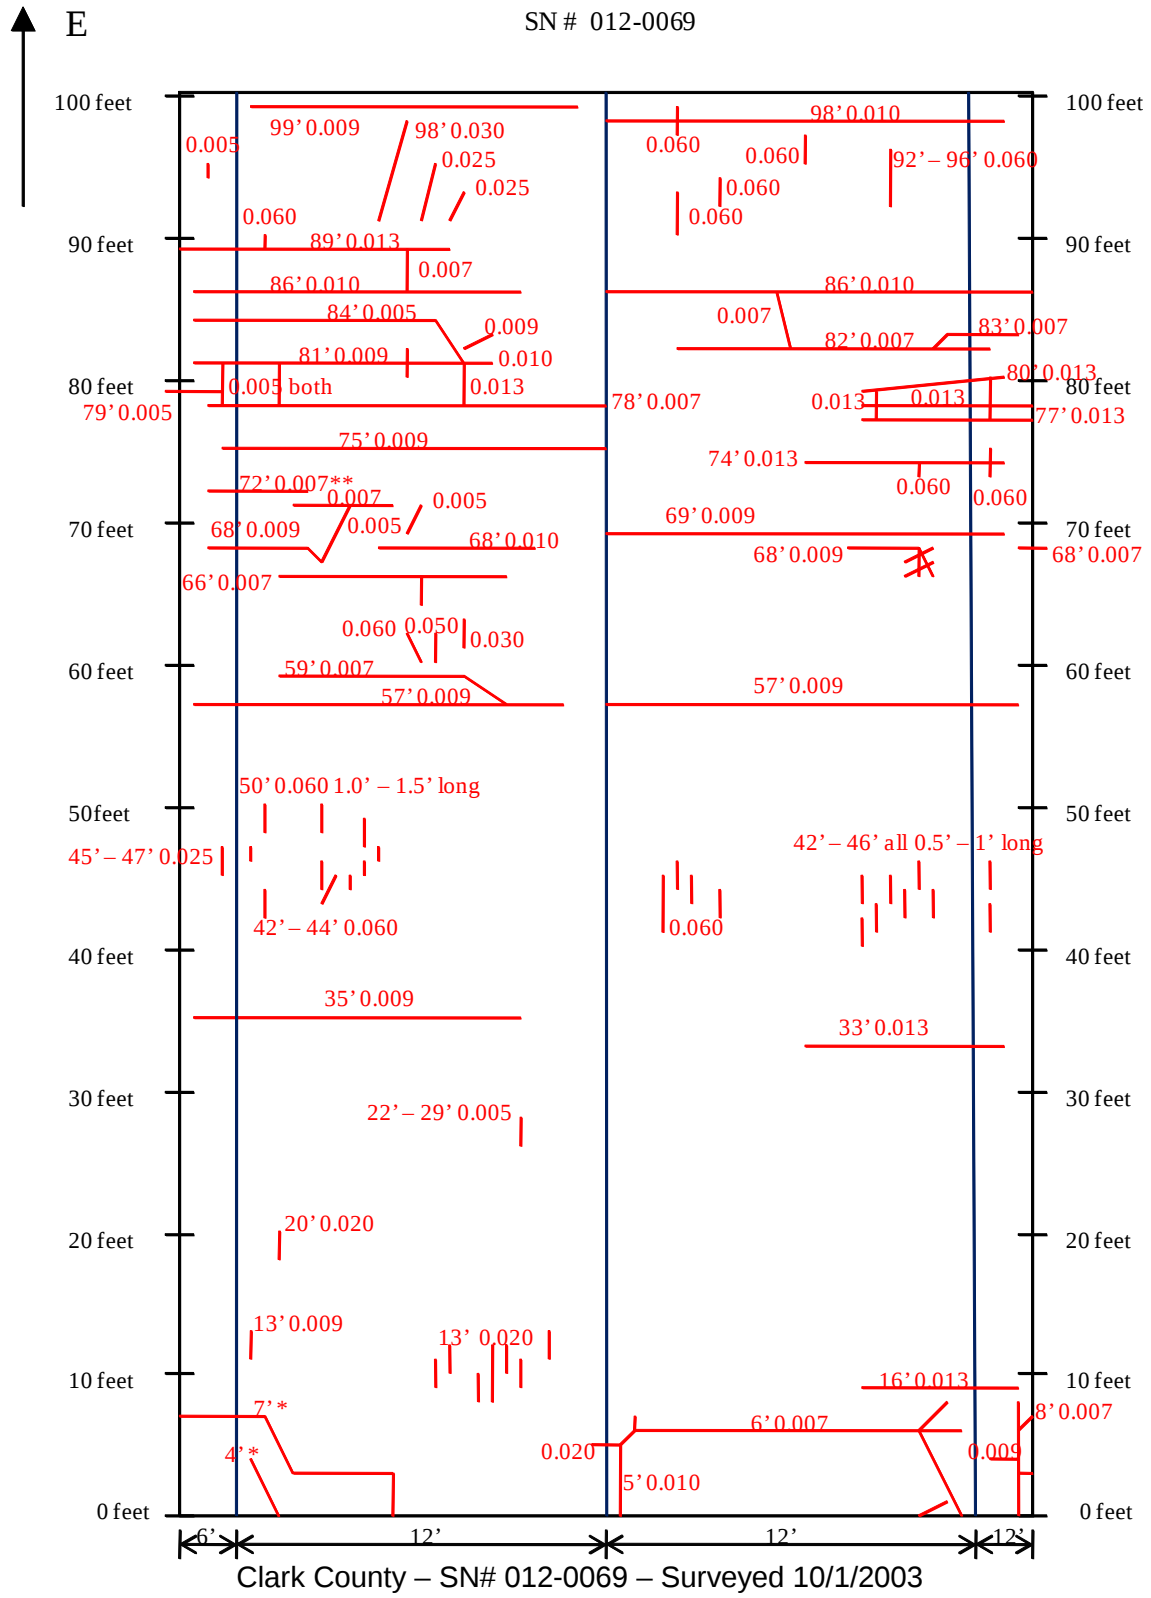
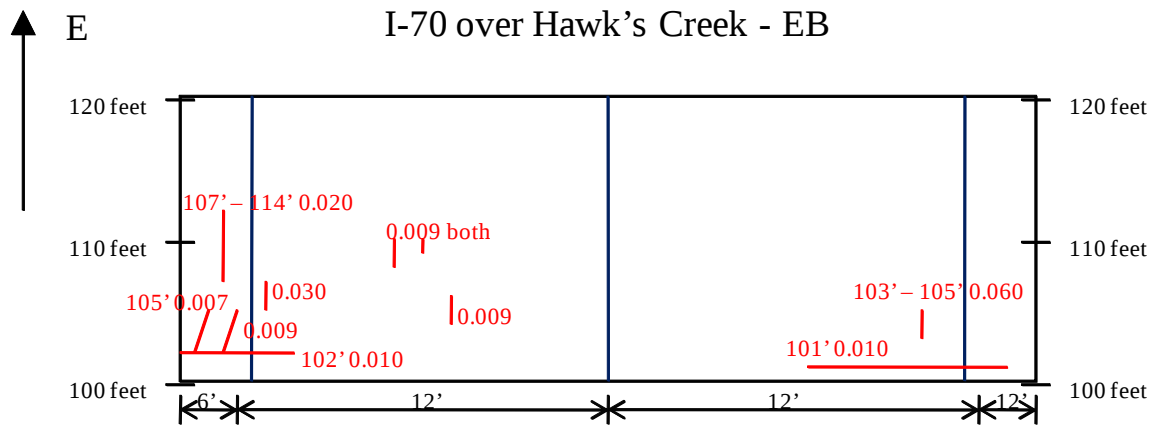
SN # 012-0069

Clark County – SN# 012-0069 – Surveyed 10/1/2003

This is a partial deck survey due to time constraints and traffic safety concerns.

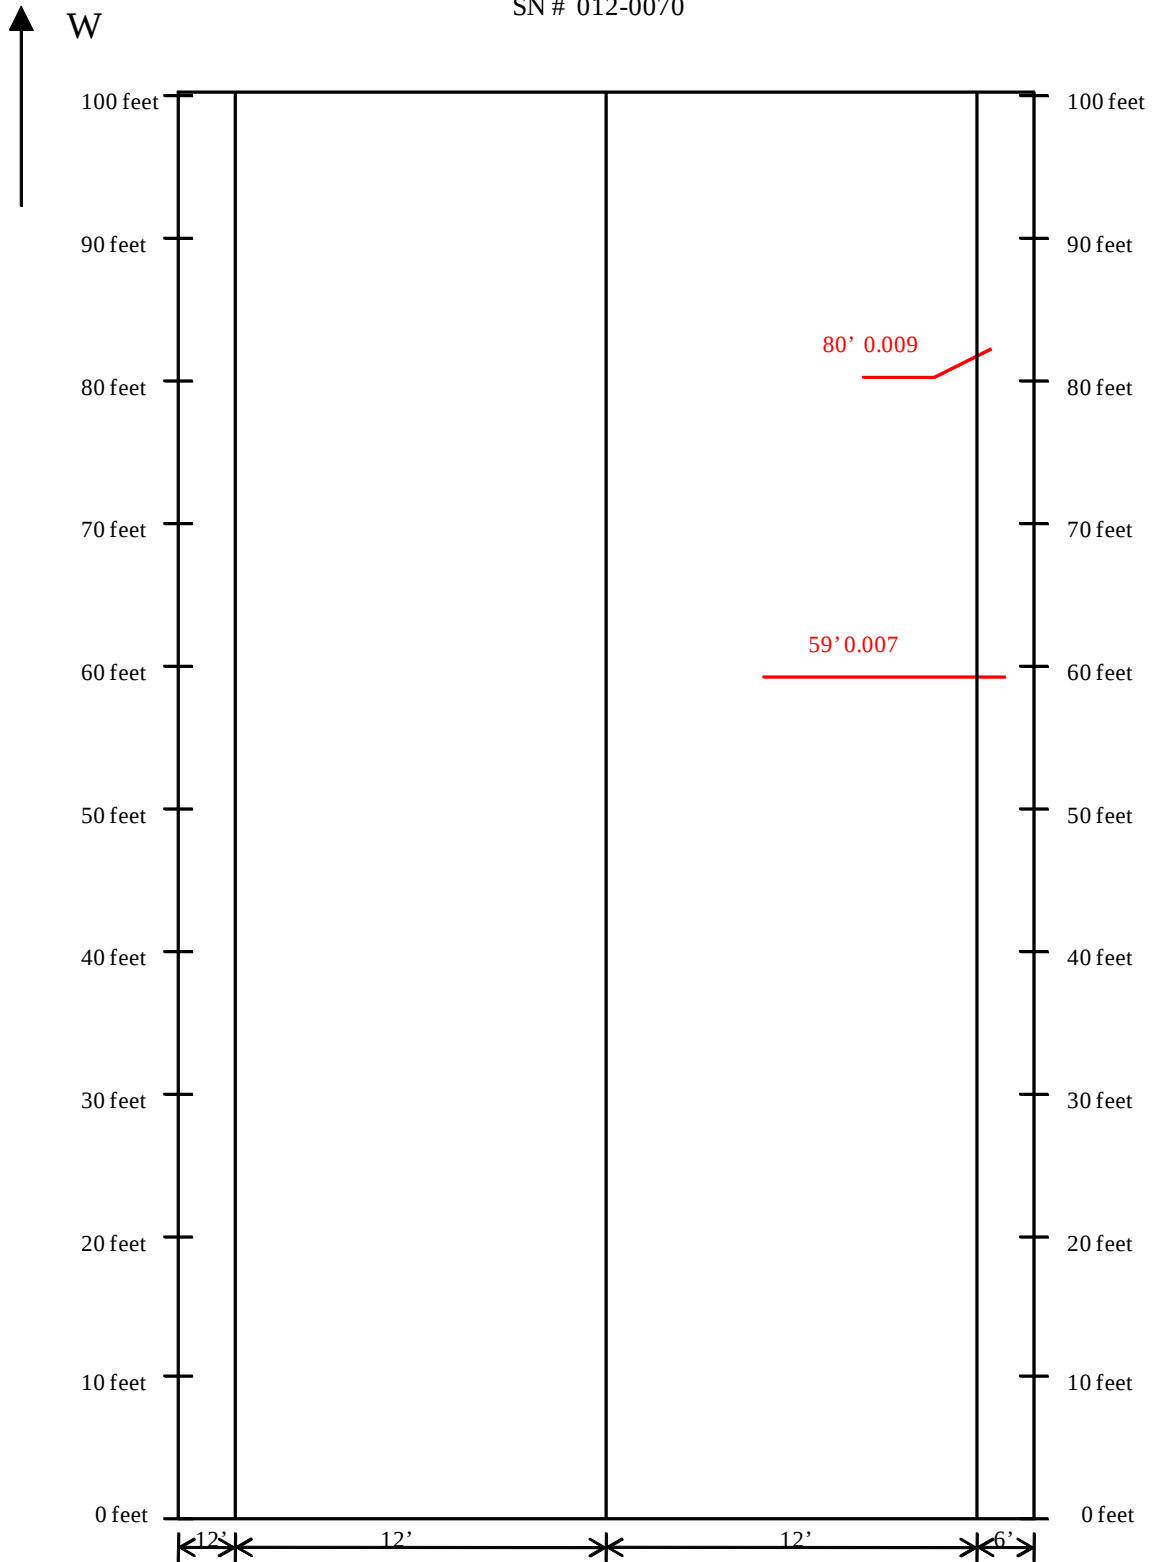
SN # 012-0070

Clark County – SN# 012-0070 – Surveyed 5/55/2002

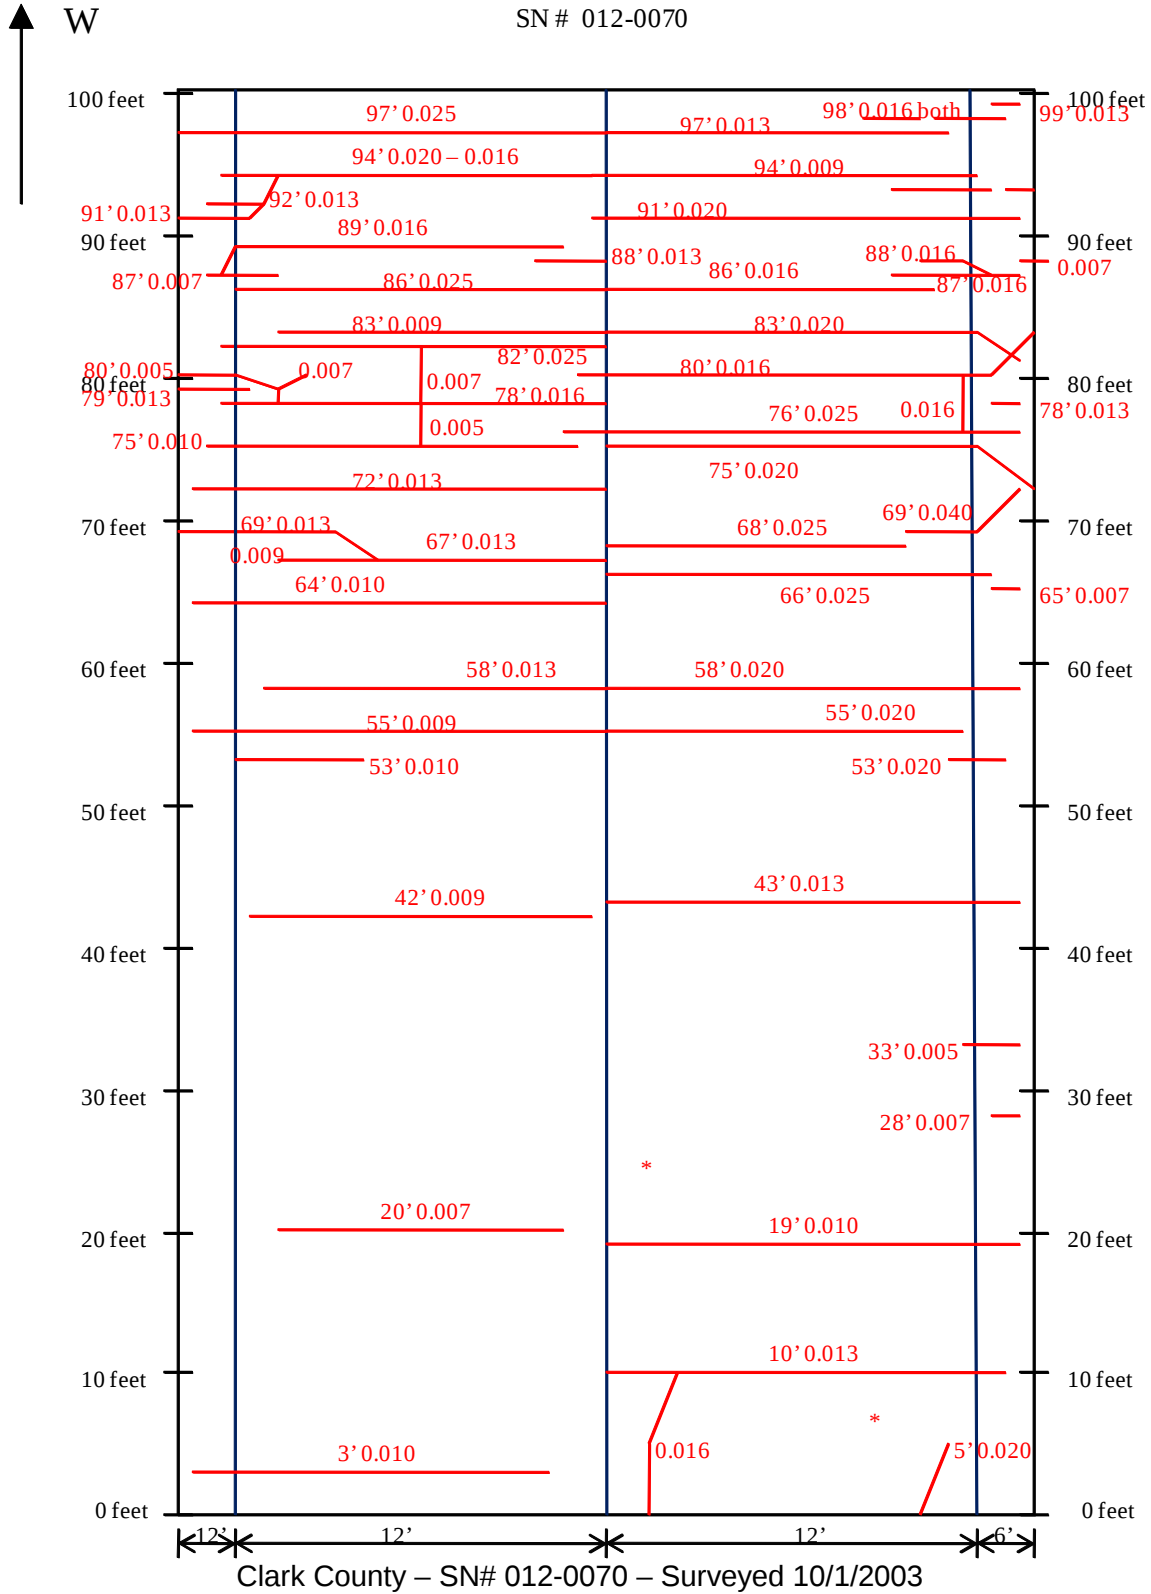
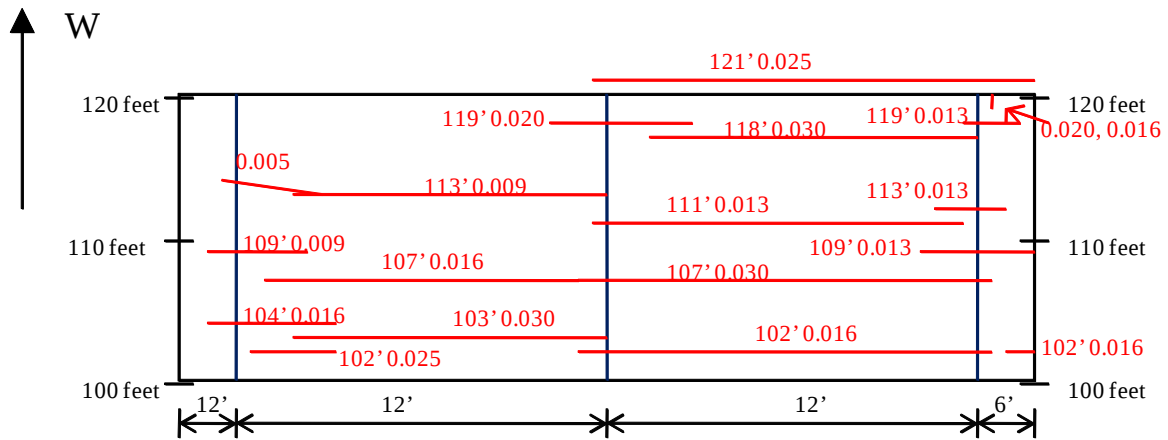
SN # 012-0070

Clark County – SN# 012-0070 – 10/1/2003

This is a partial deck survey due to time constraints and traffic concerns.

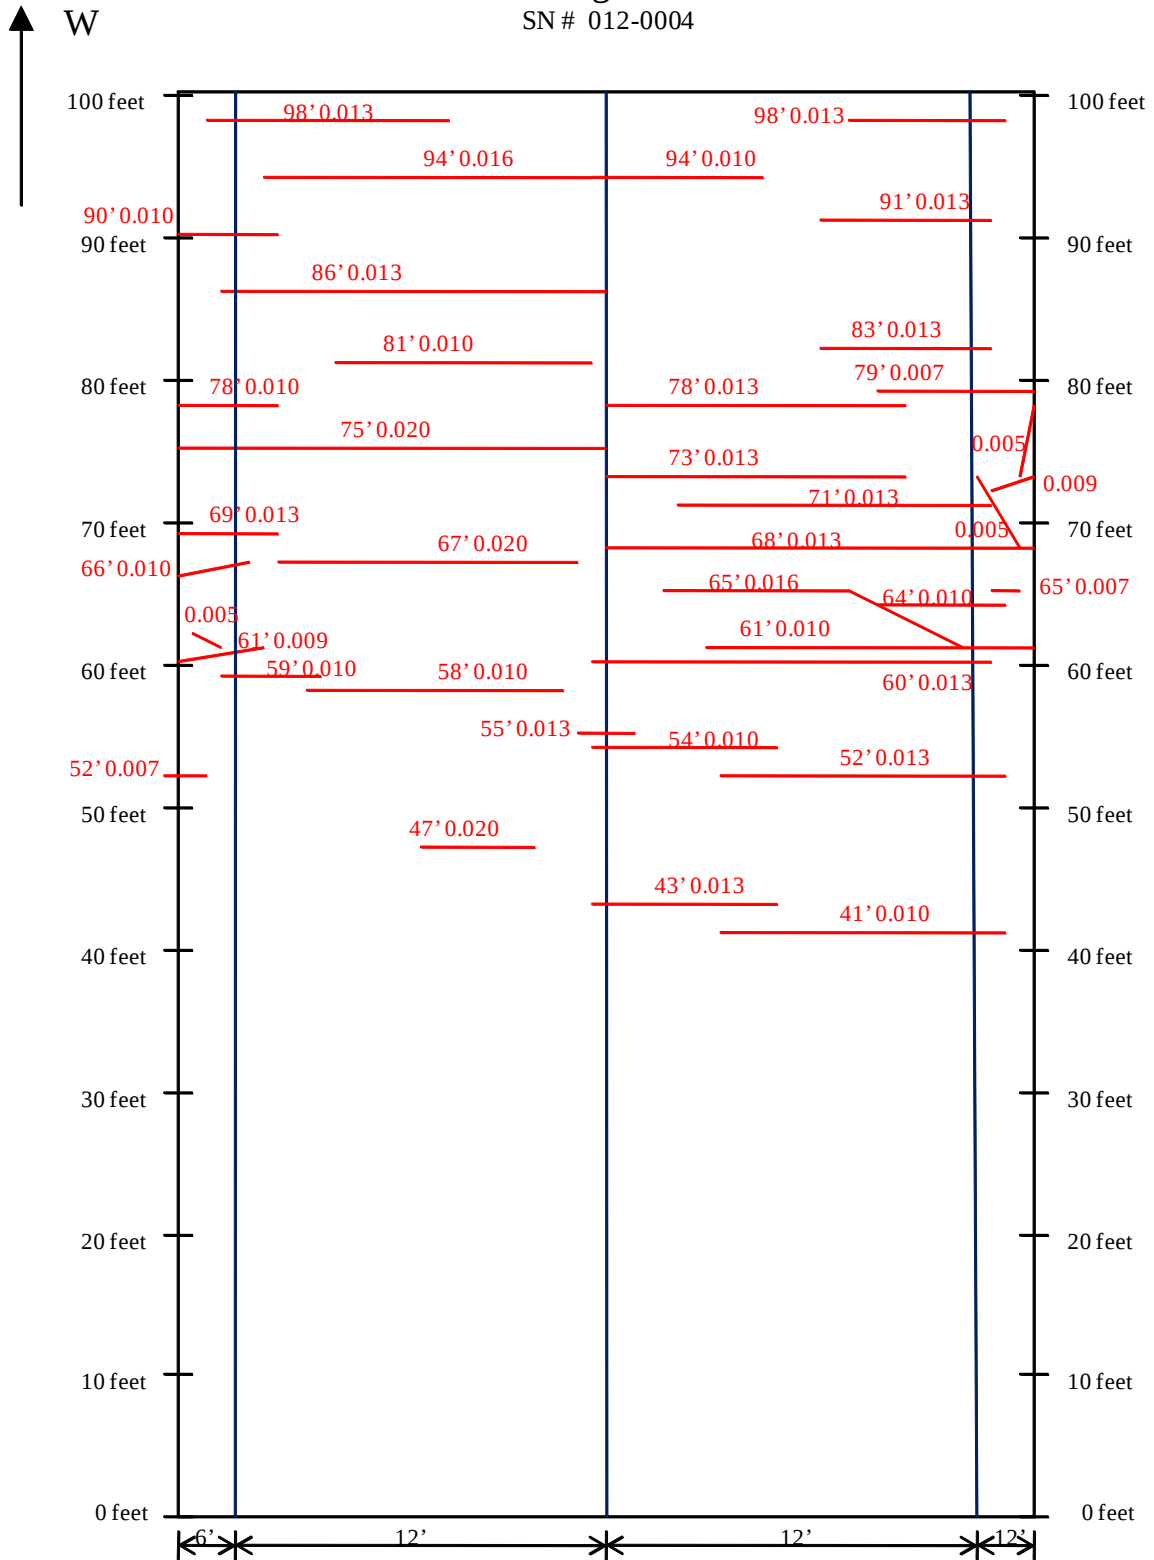
SN # 012-0004

Clark County – SN# 012-0004 – 10/2/2003
