**EVALUATION OF HIGH PERFORMANCE  
CONCRETE BRIDGE DECKS  
AND  
OTHER EXPERIMENTAL BRIDGE  
DECKS THROUGHOUT ILLINOIS**

**PHYSICAL RESEARCH REPORT NO. 166  
December 2017**

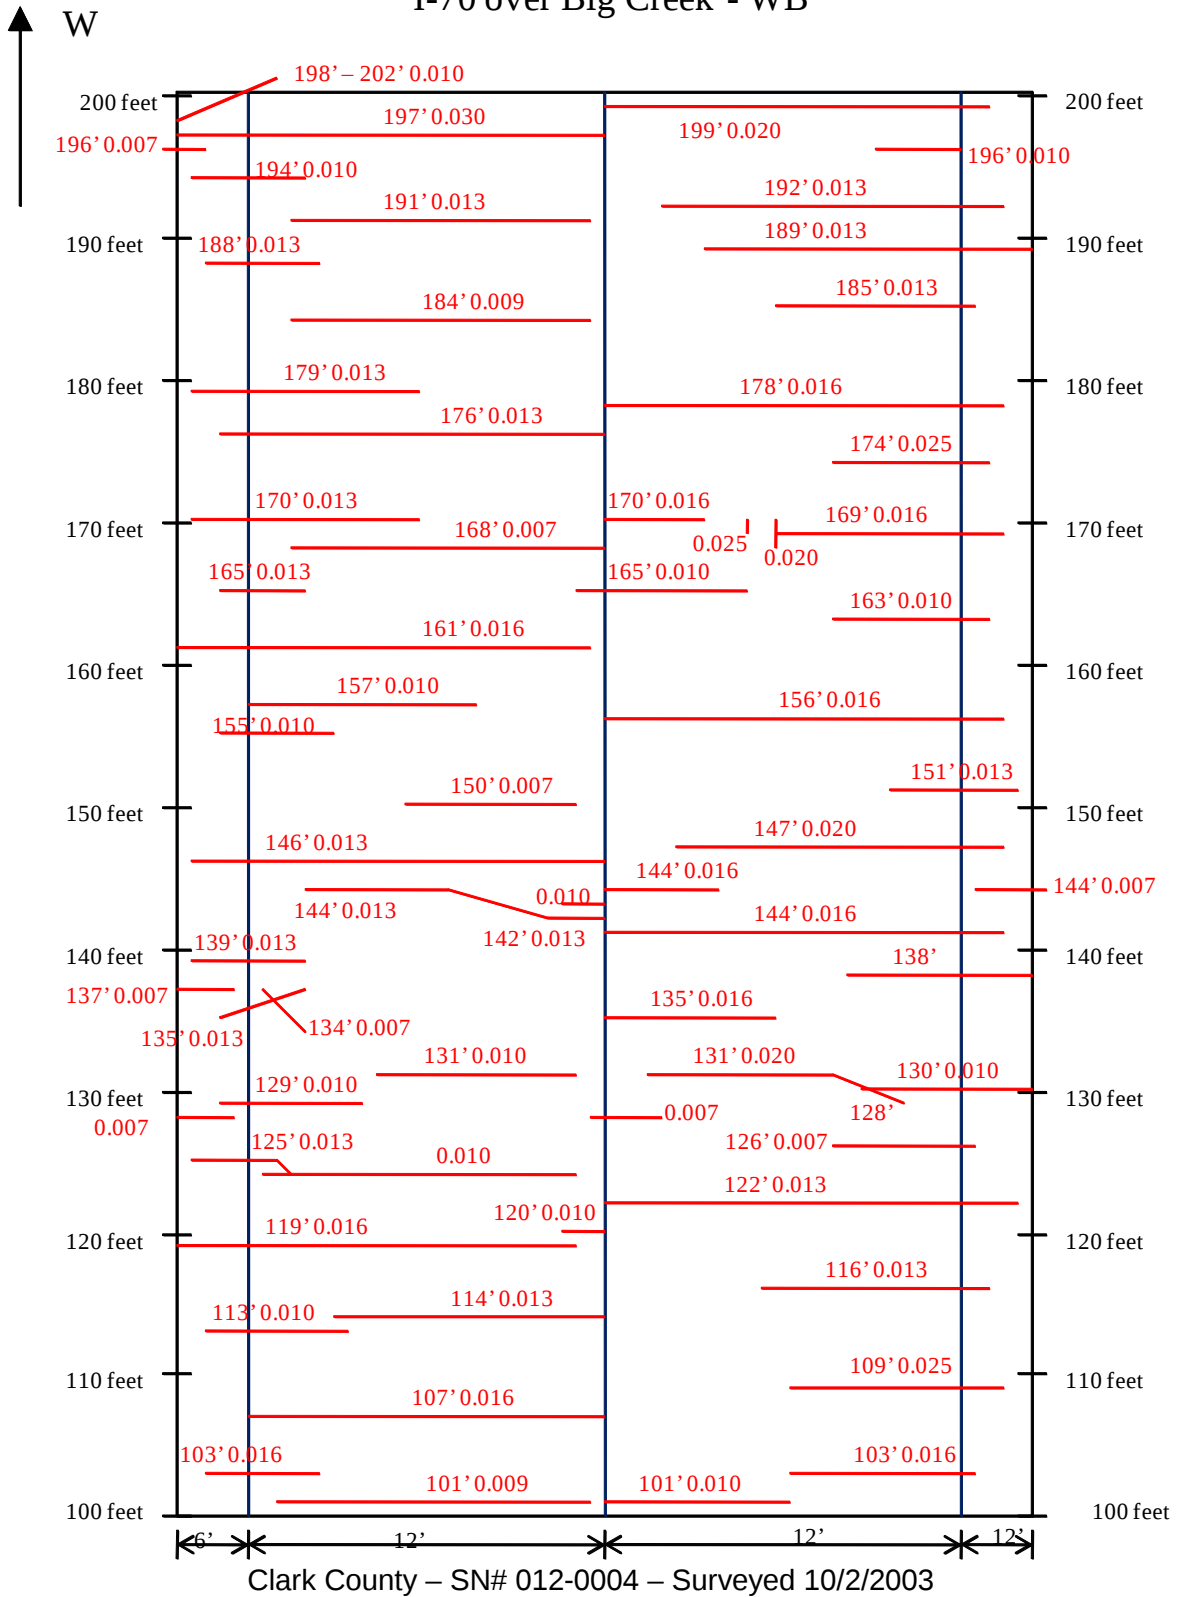
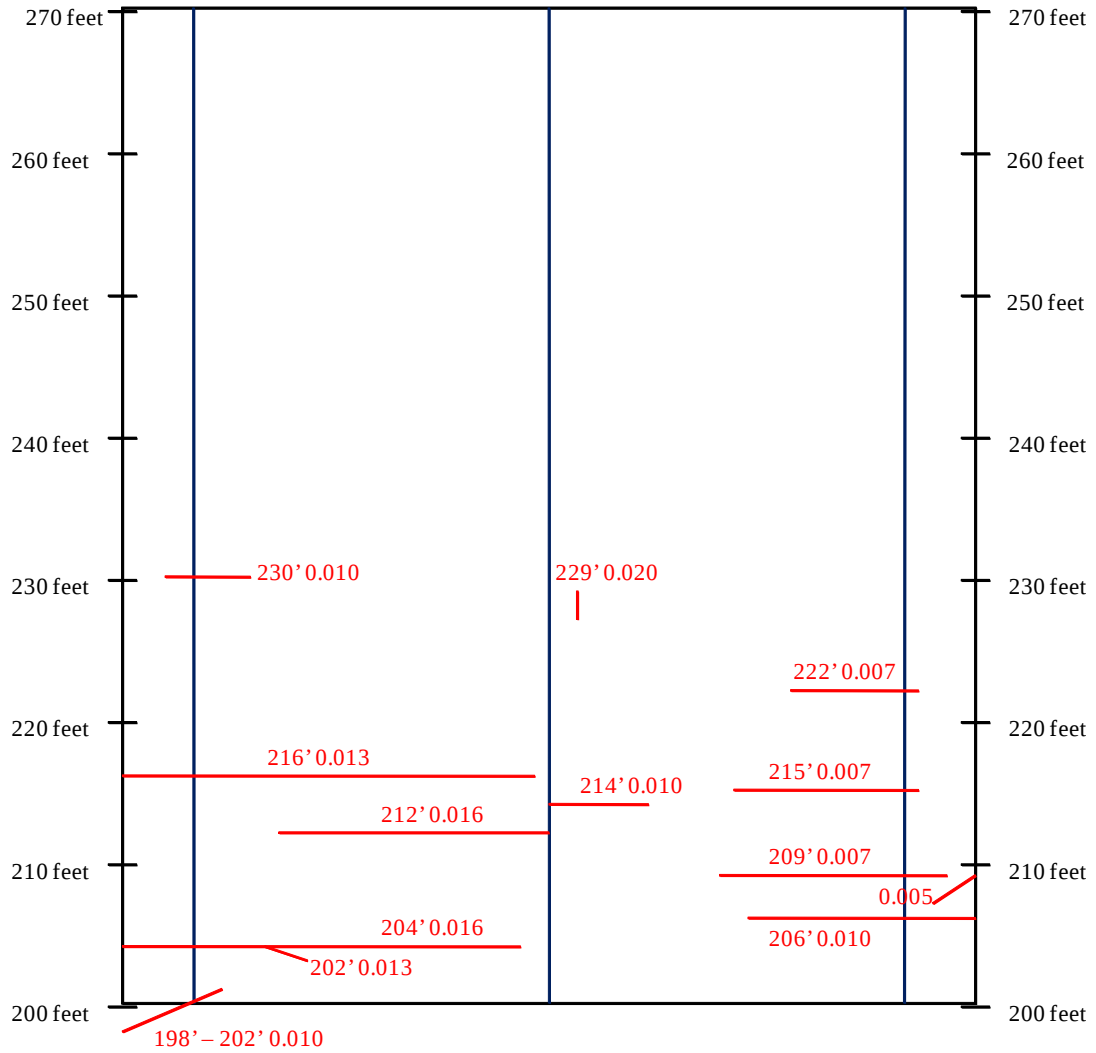
# I-70 over Big Creek - WB

Clark County – SN# 012-0004 – 10/2/2003

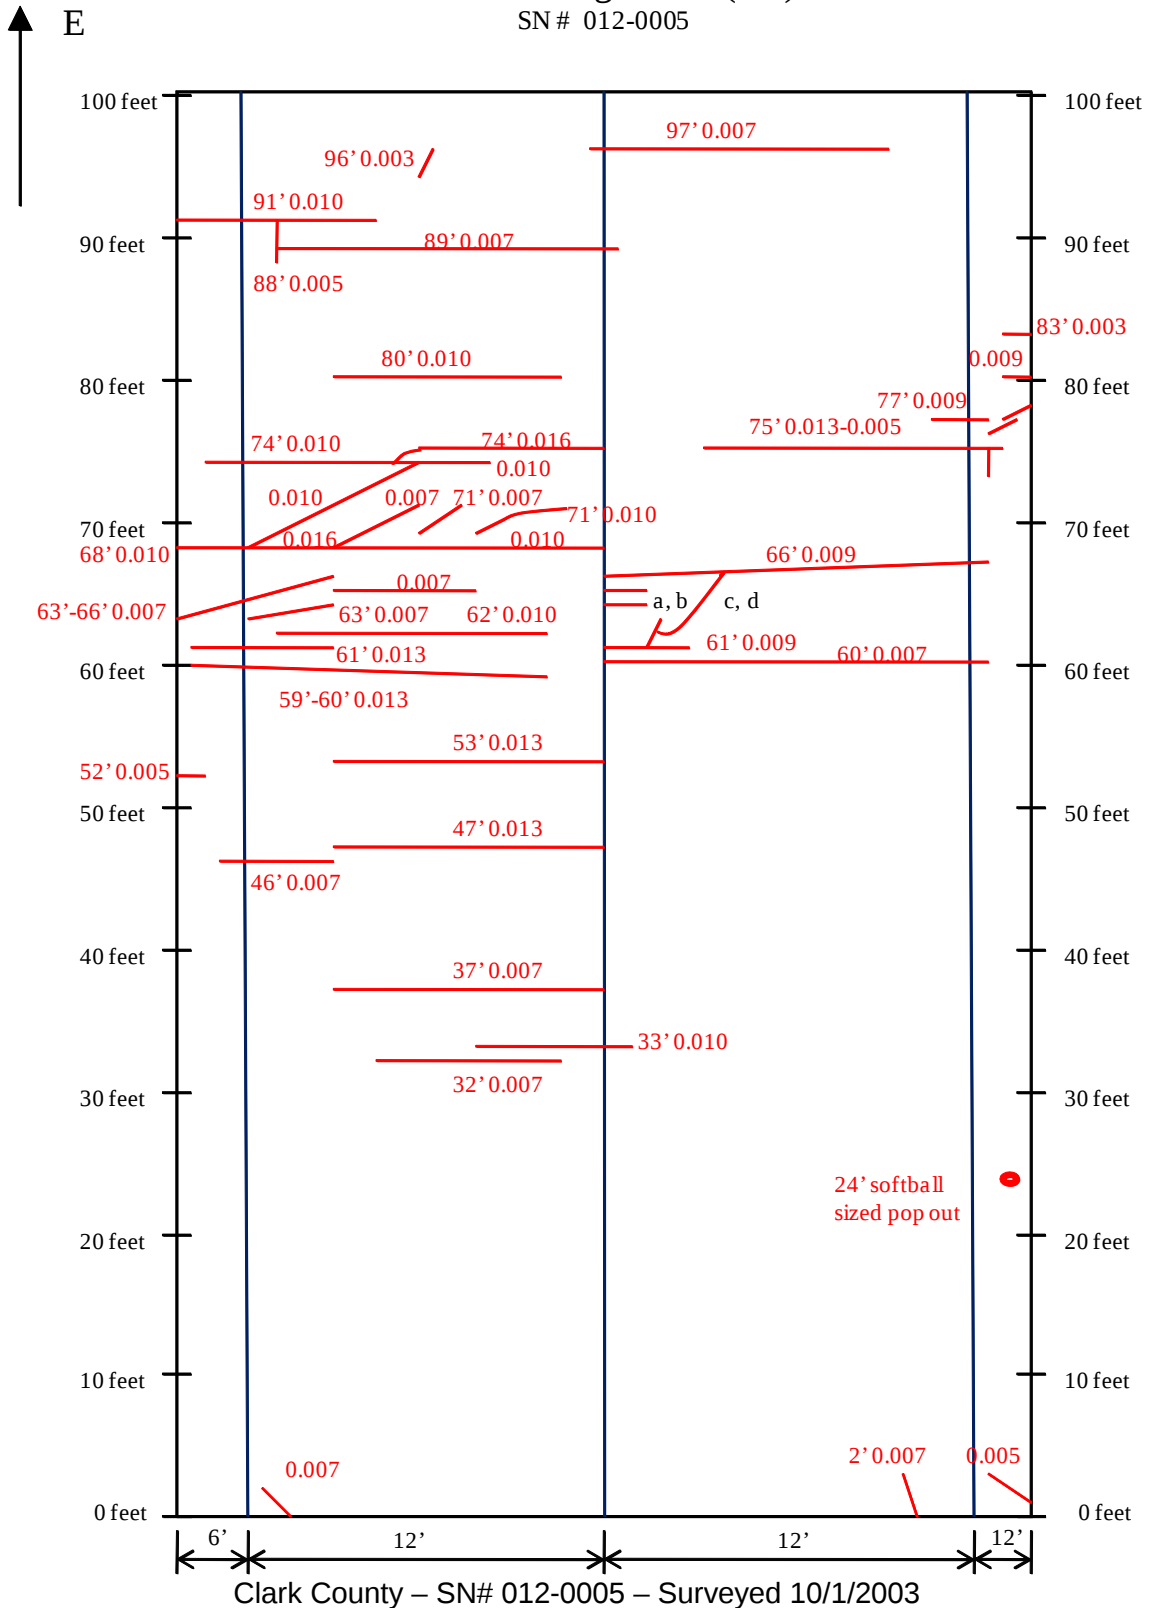
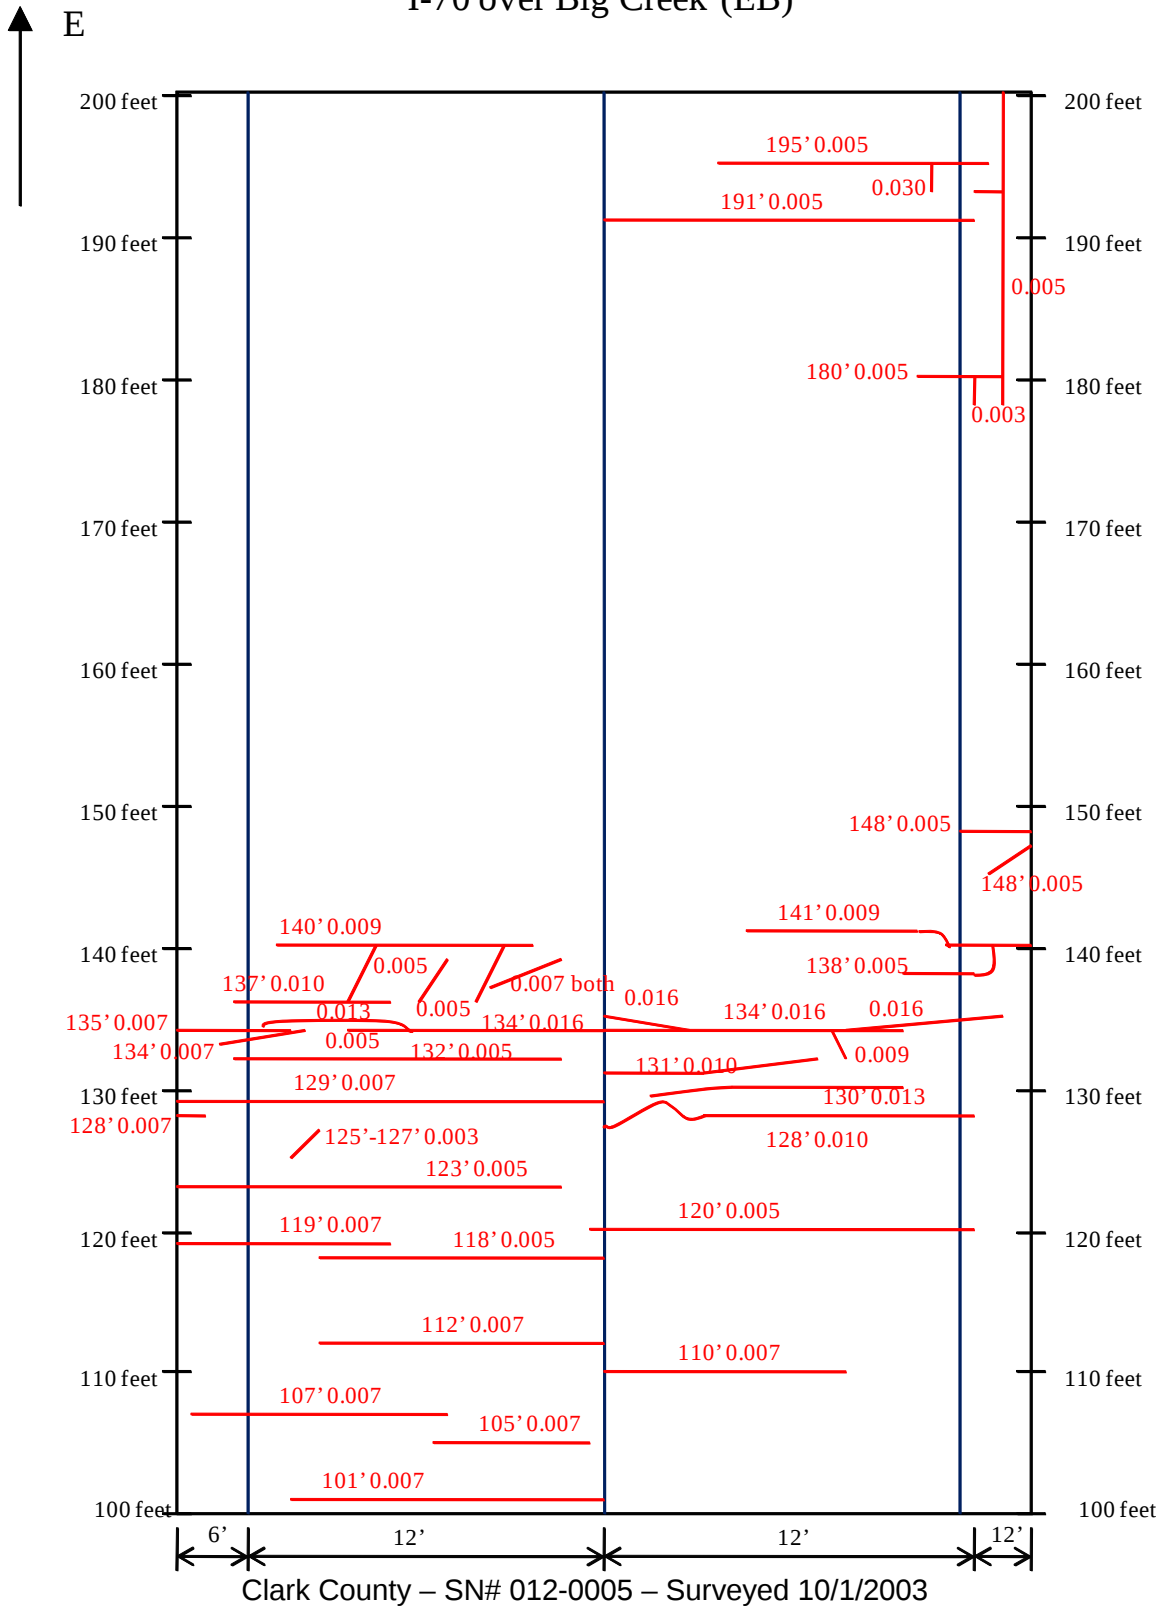
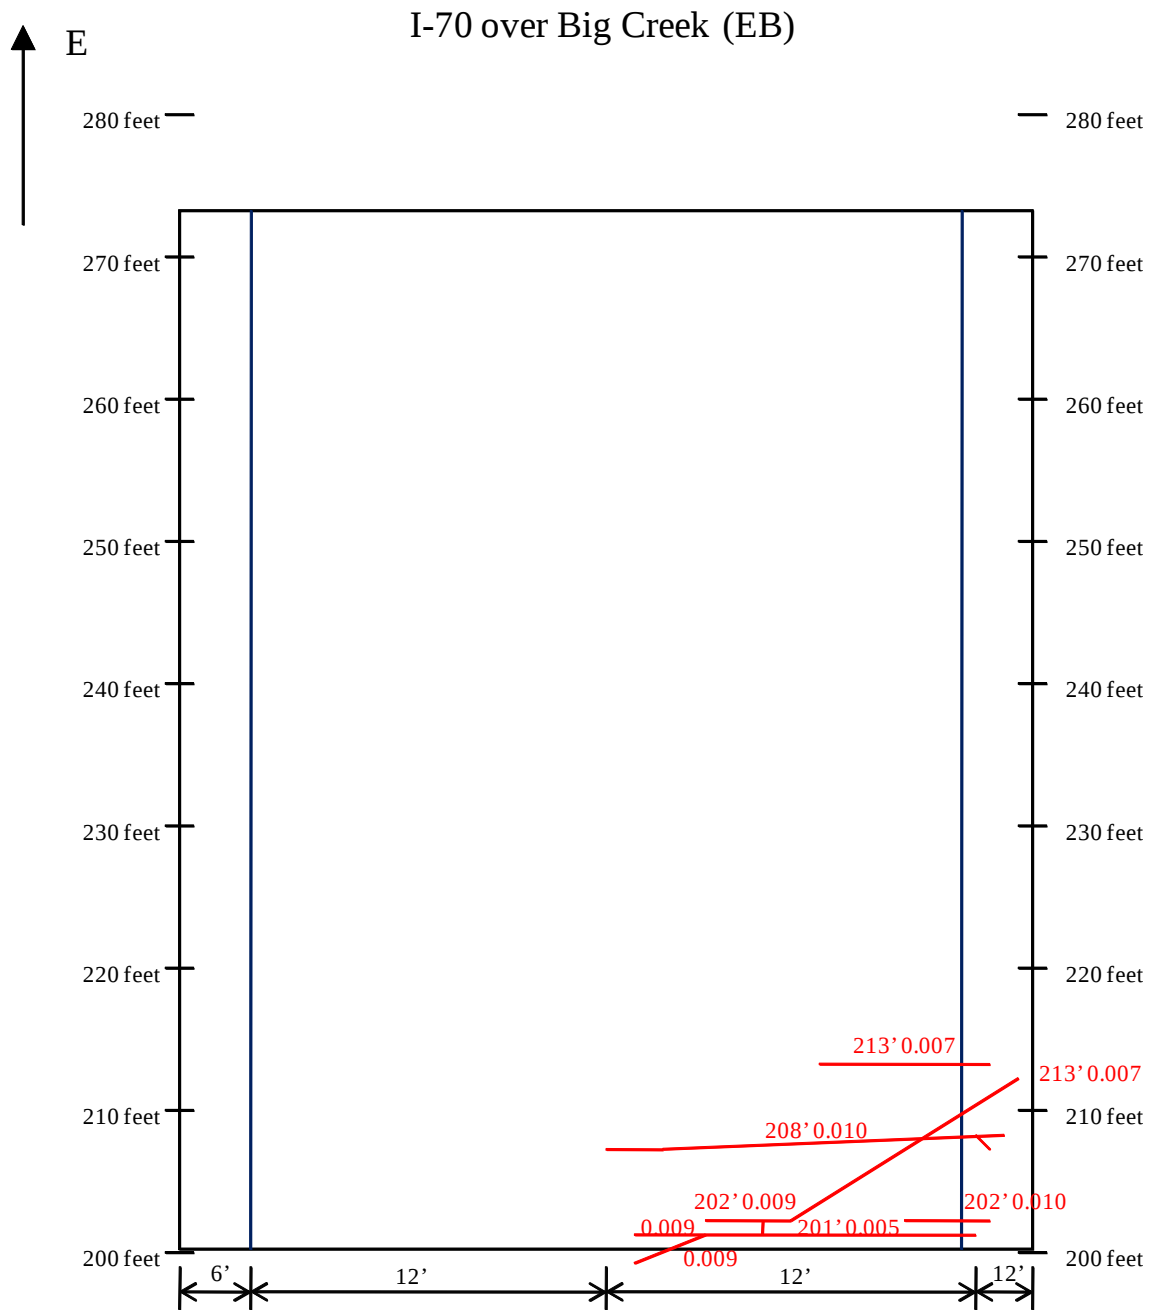
# I-70 over Big Creek (EB) SN # 012-0005

Clark County – SN# 012-0005 – Surveyed 10/1/2003  
 This survey was a partial survey due to time limitations and traffic safety.  
 $a = 0.007 @ 64'$ ;  $b = 0.009 @ 65'$ ;  $c = 0.009$ ;  $d = 0.009$

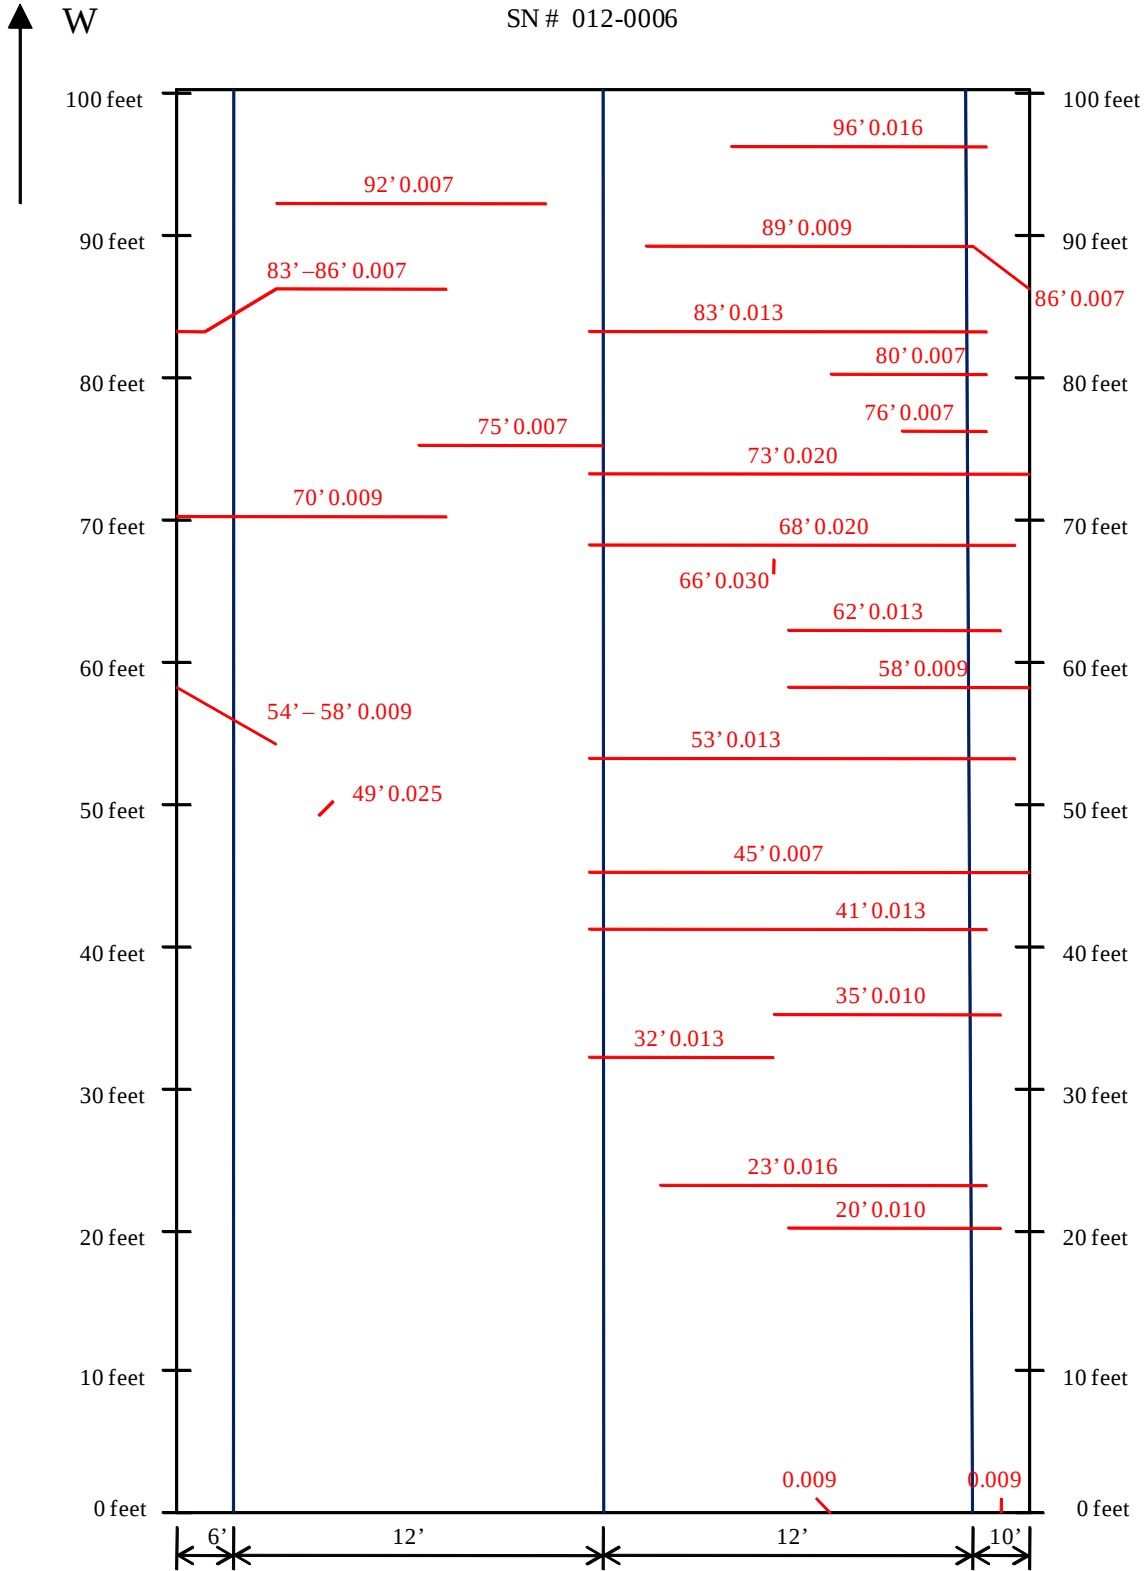
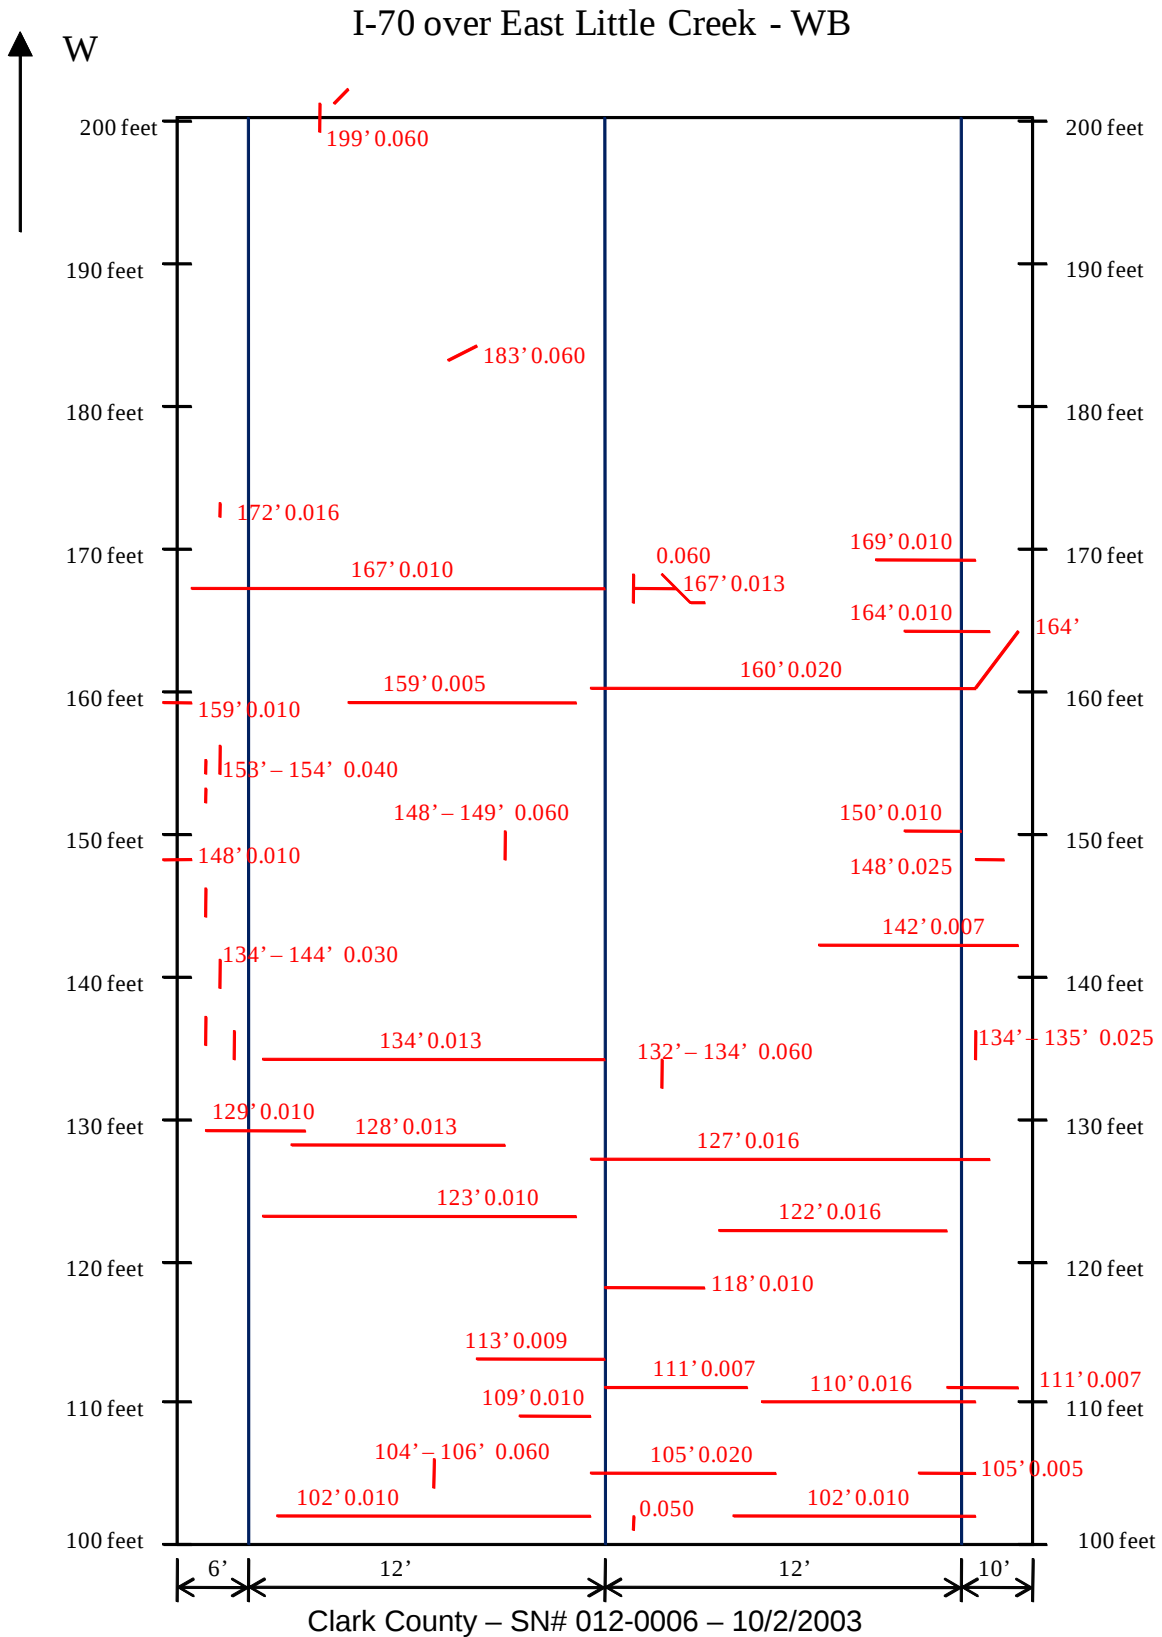
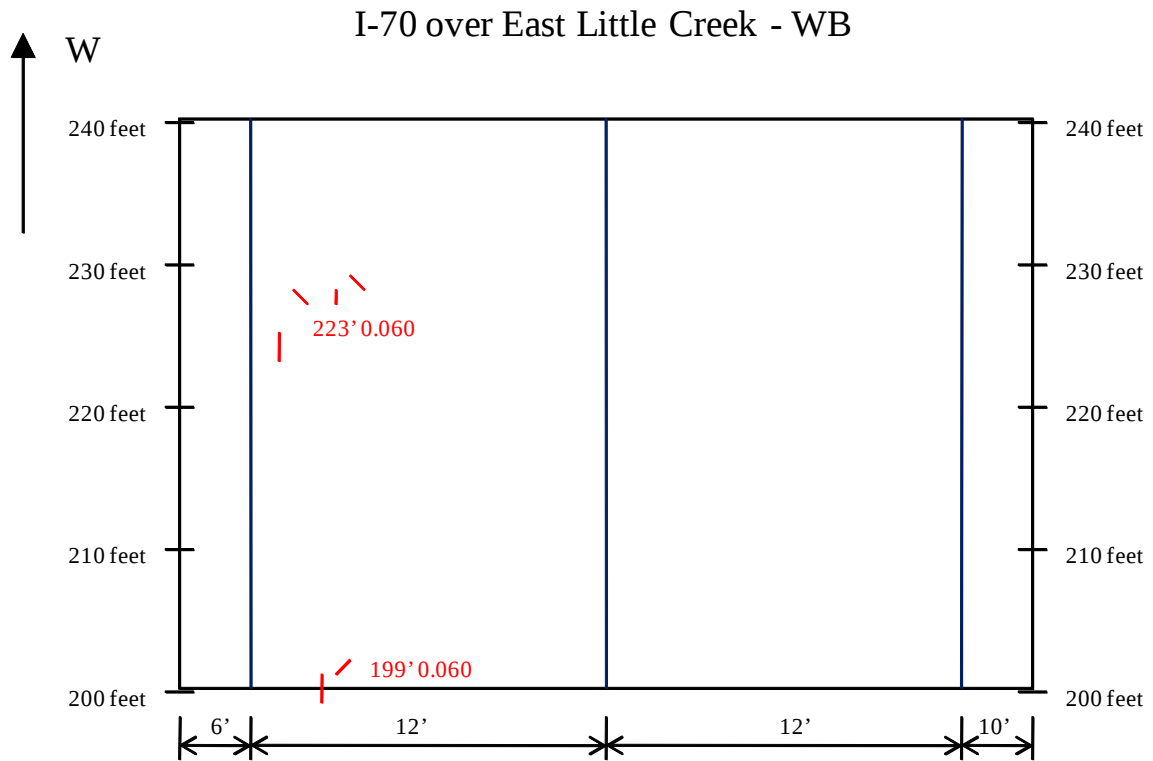
SN # 012-0006

Clark County – SN# 012-0006 – Surveyed 10/2/2003

This is a partial deck survey due to time constraints and traffic safety concerns.

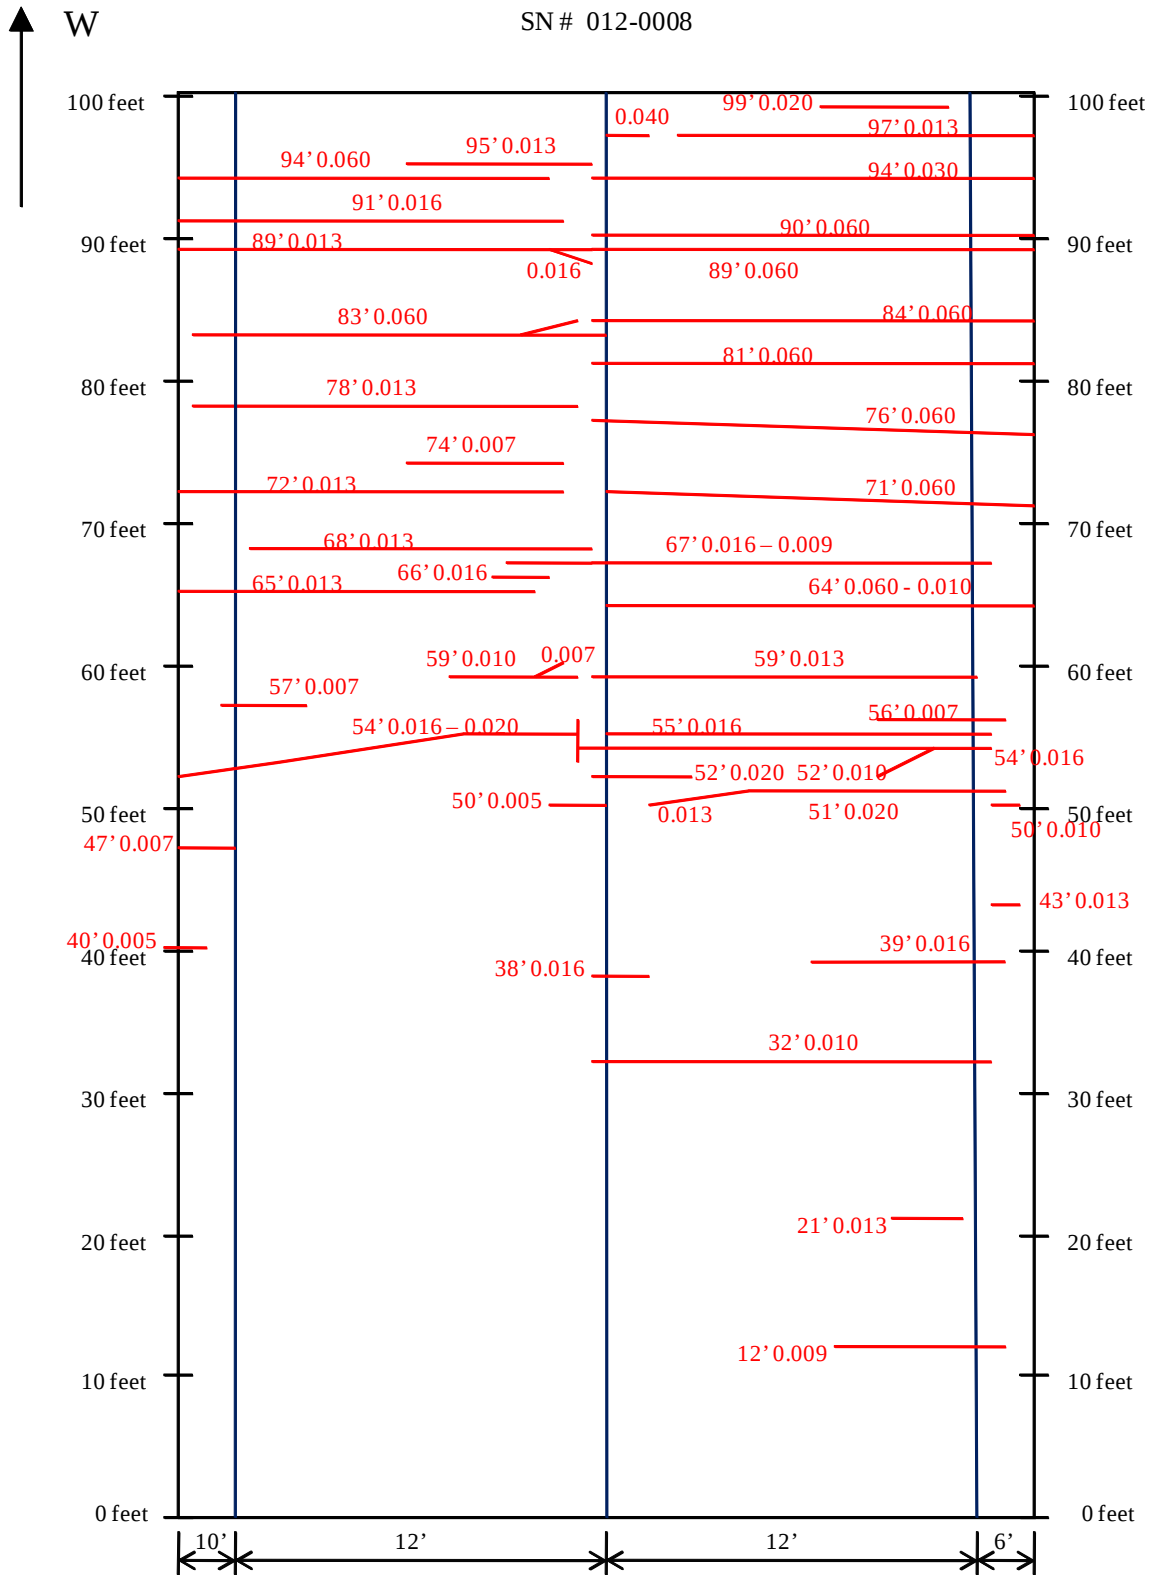
SN # 012-0008

Clark County – SN# 012-0008 – 10/1/2003

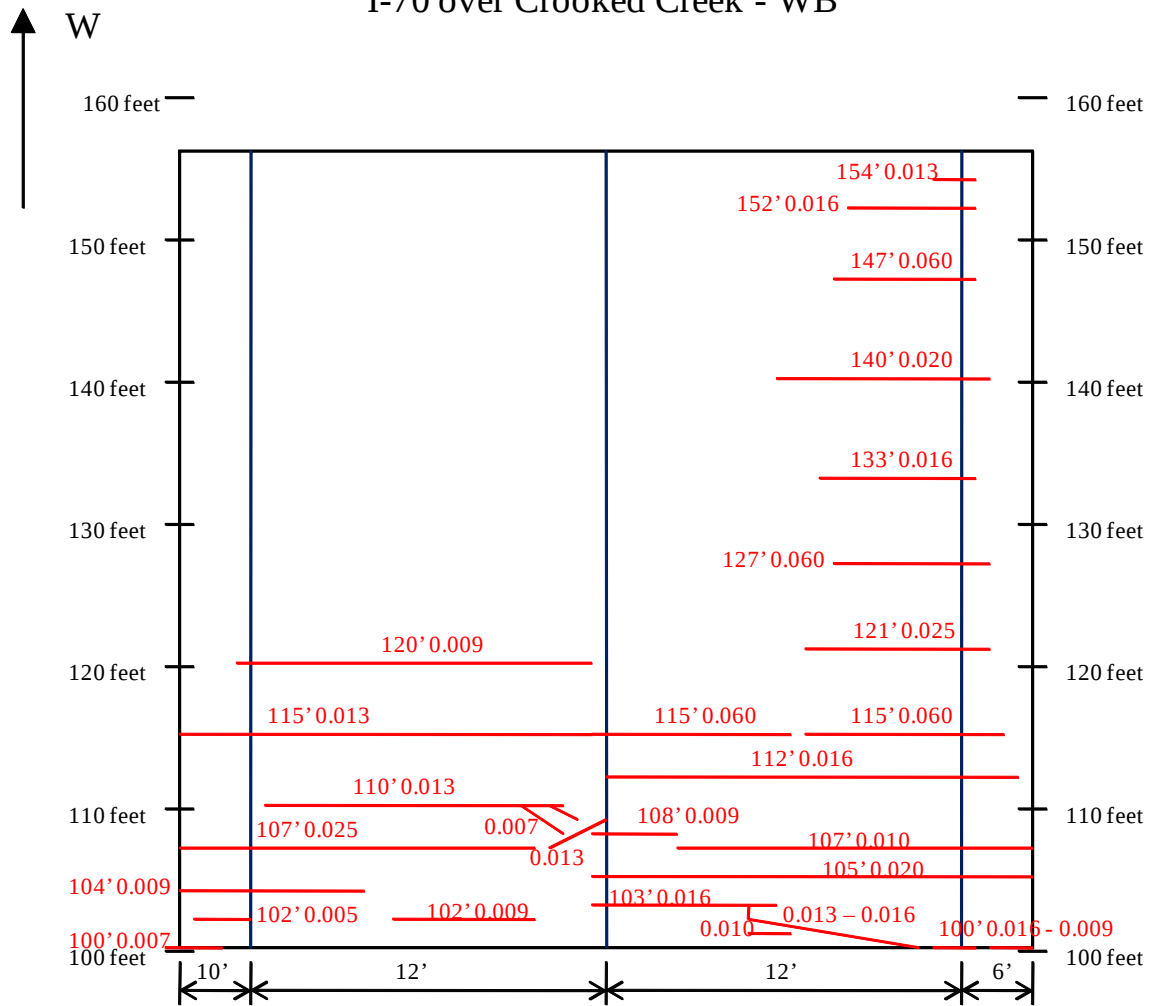
# I-70 over Crooked Creek - WB

Clark County – SN# 012-0008 – Surveyed 10/1/2003

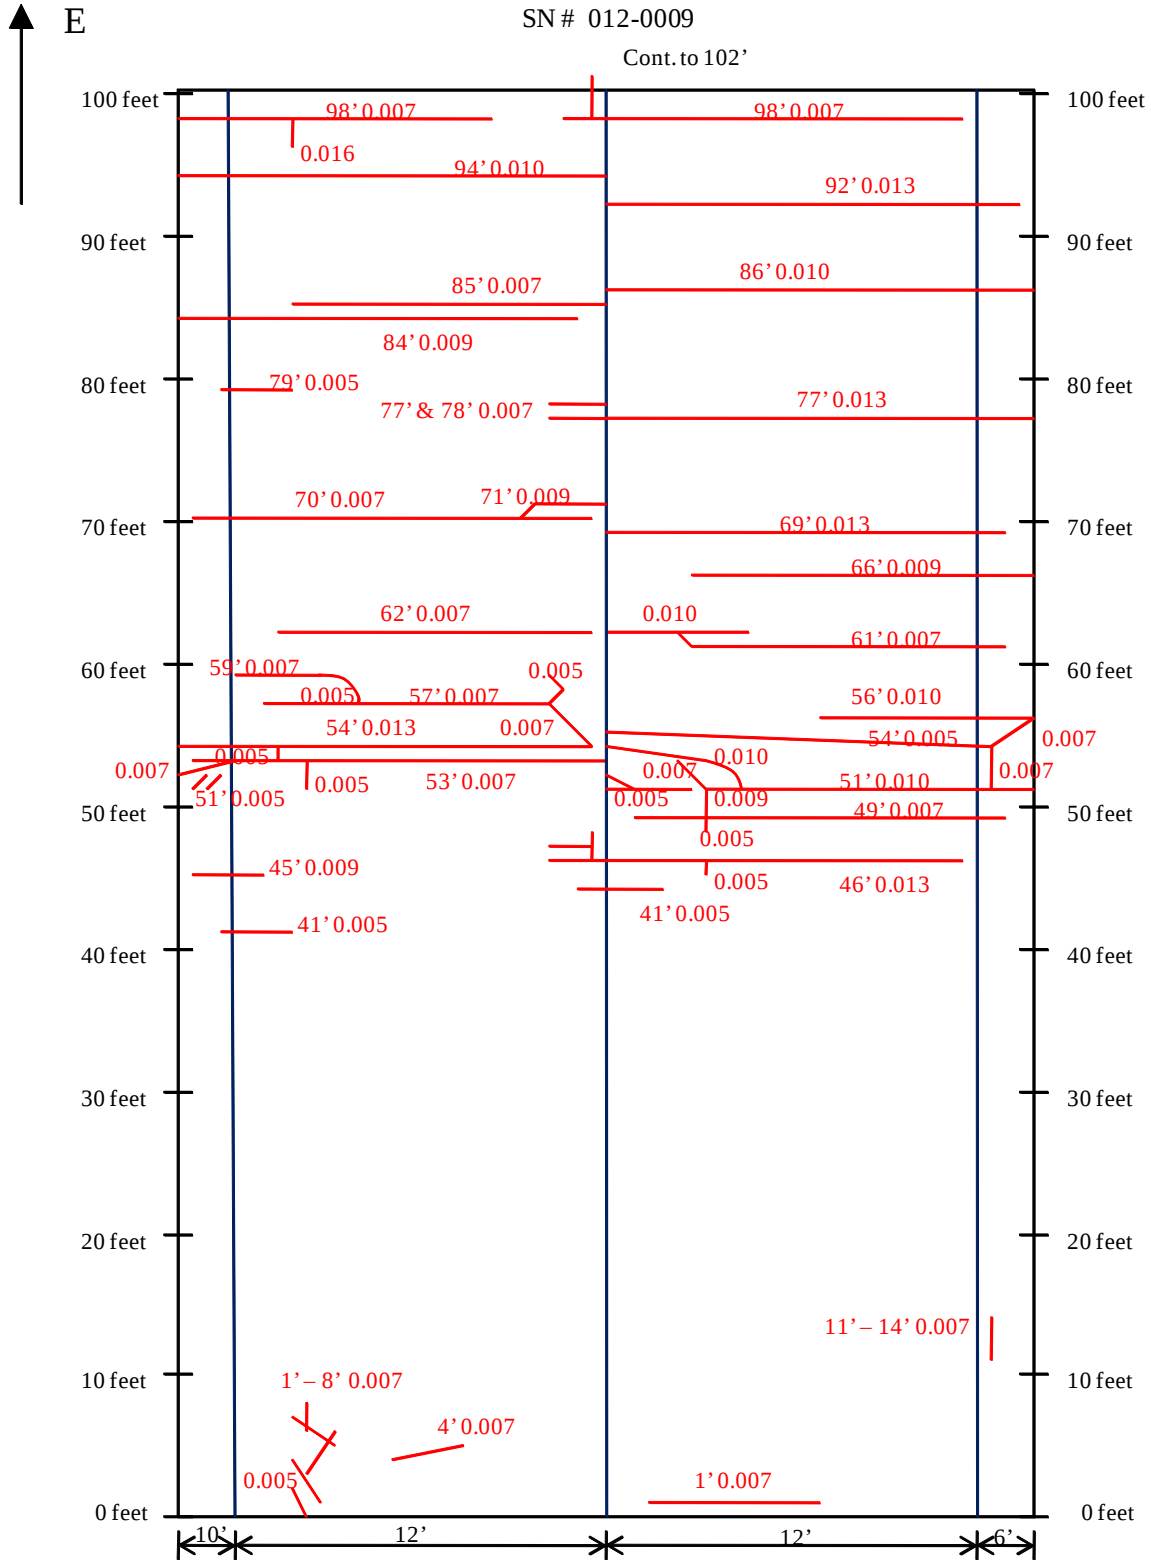
SN # 012-0009

Clark County – SN# 012-0009 – Surveyed 10/1/2003

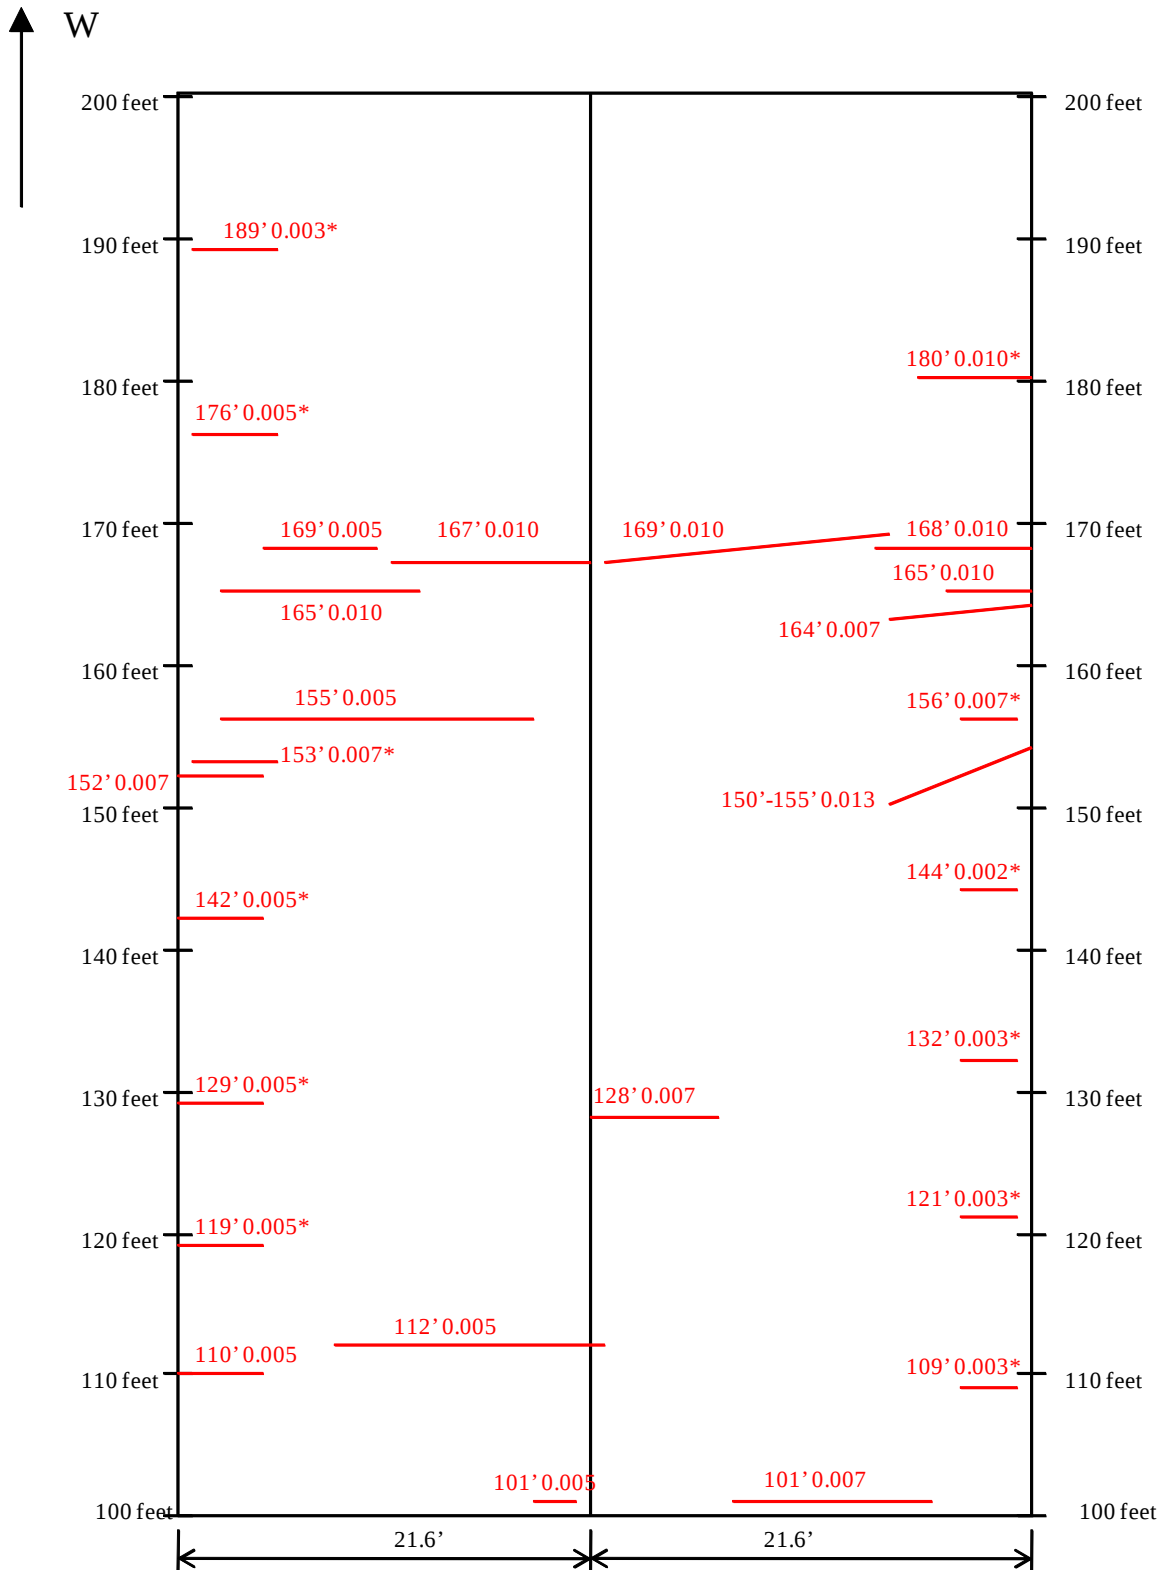
Clark County – SN# 012-0053 – Surveyed 10/1/2003

\* Crack traversed through deck drain.

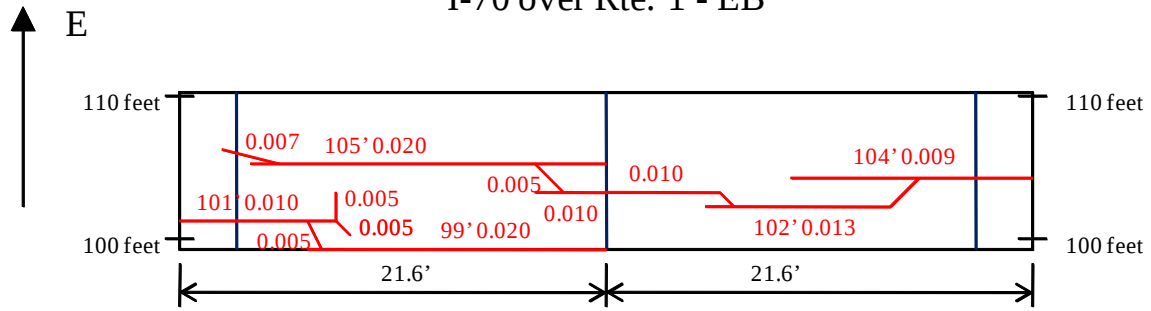
Clark County – SN# 012-0054 – Surveyed 10/1/2003

The southwest corner was chipped off.

This was a partial deck survey due to time constraints and traffic conditions.

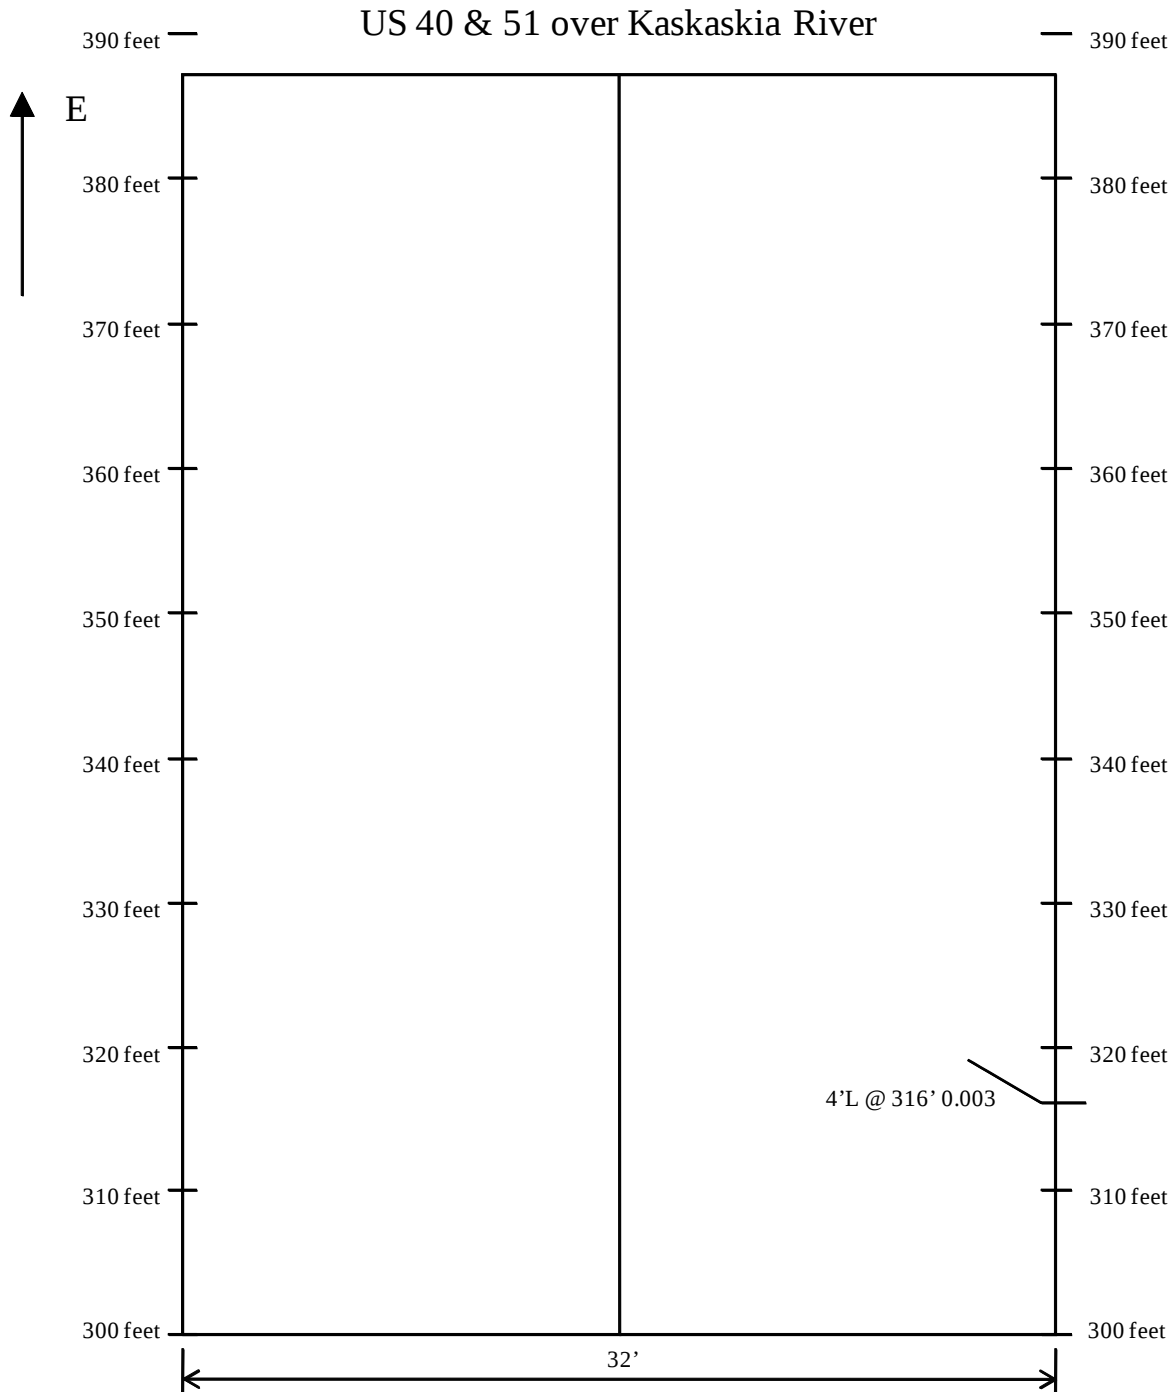
Fayette County – SN# 026-0034 – Surveyed 11/14/2002, 12/12/2002

The “#” symbol represents cracks in the parapet only.

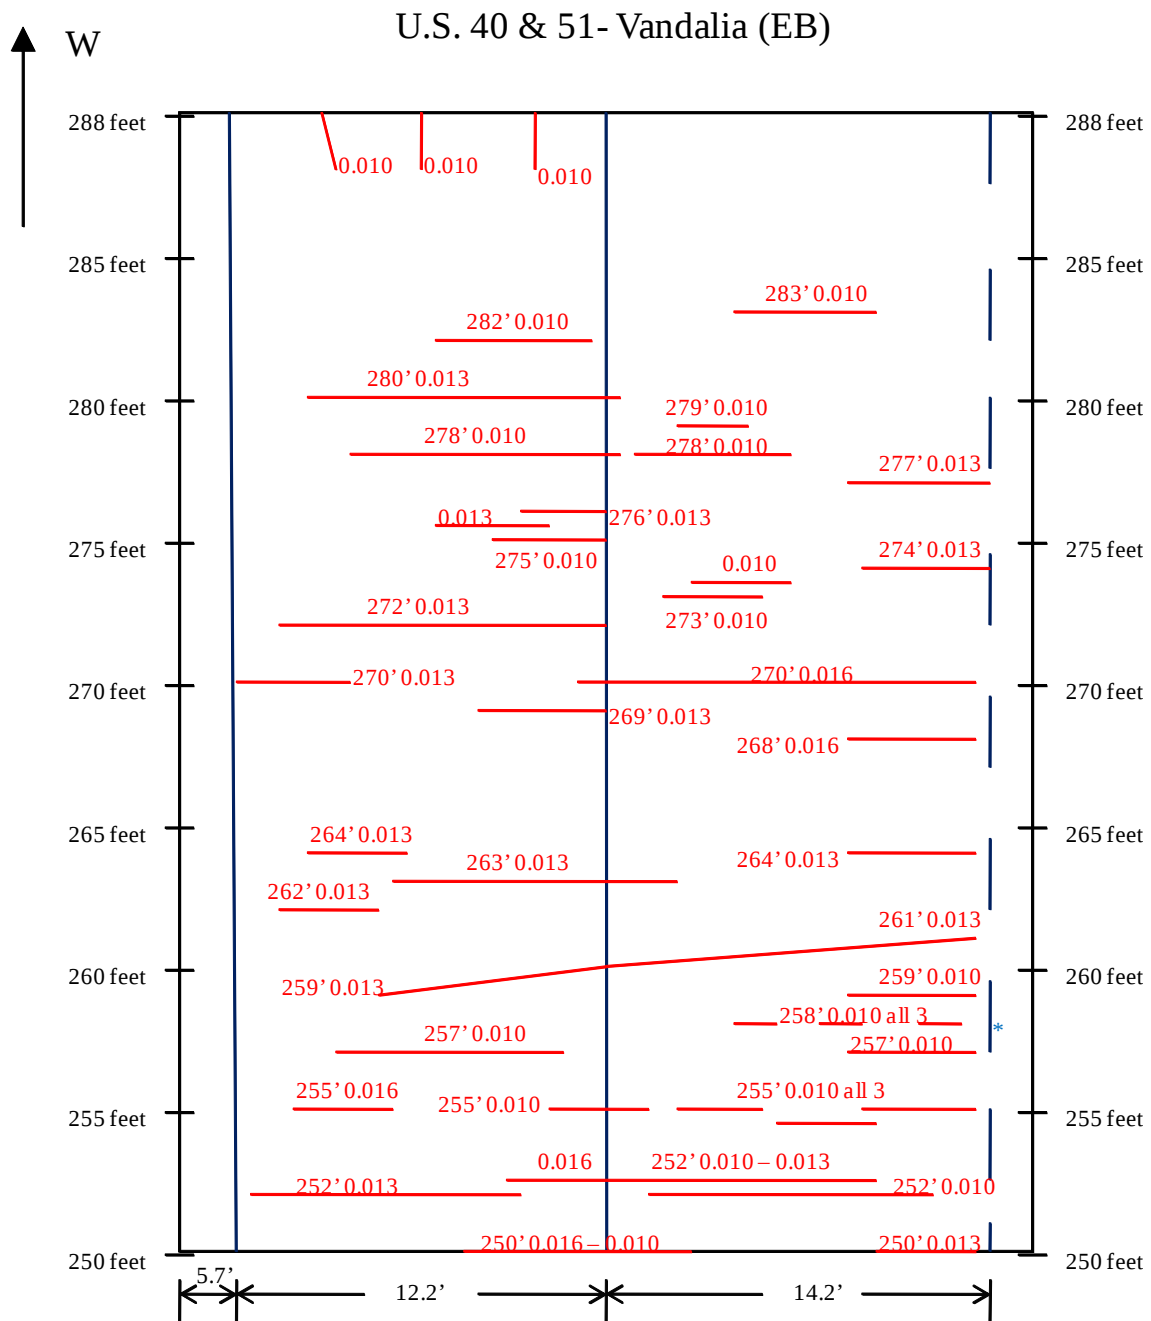
Fayette County – SN# 026-0034 – Surveyed 10/17/2008

The survey did not cover the entire deck because of time constraints.

Areas of longitudinal cracking: a= 49'- 59' 0.010, b= 48' – 55' 0.010, c= 46' – 48' 0.010, d= 43' – 48.5' 0.010, e= 42.5' - 45' 0.010, f= 42.5' – 43.5' 0.010

\* This symbol denotes areas of numerous hairline cracks located very close together. The measurements of the cracks were 0.010.
