**EVALUATION OF HIGH PERFORMANCE  
CONCRETE BRIDGE DECKS  
AND  
OTHER EXPERIMENTAL BRIDGE  
DECKS THROUGHOUT ILLINOIS**

**PHYSICAL RESEARCH REPORT NO. 166  
December 2017**

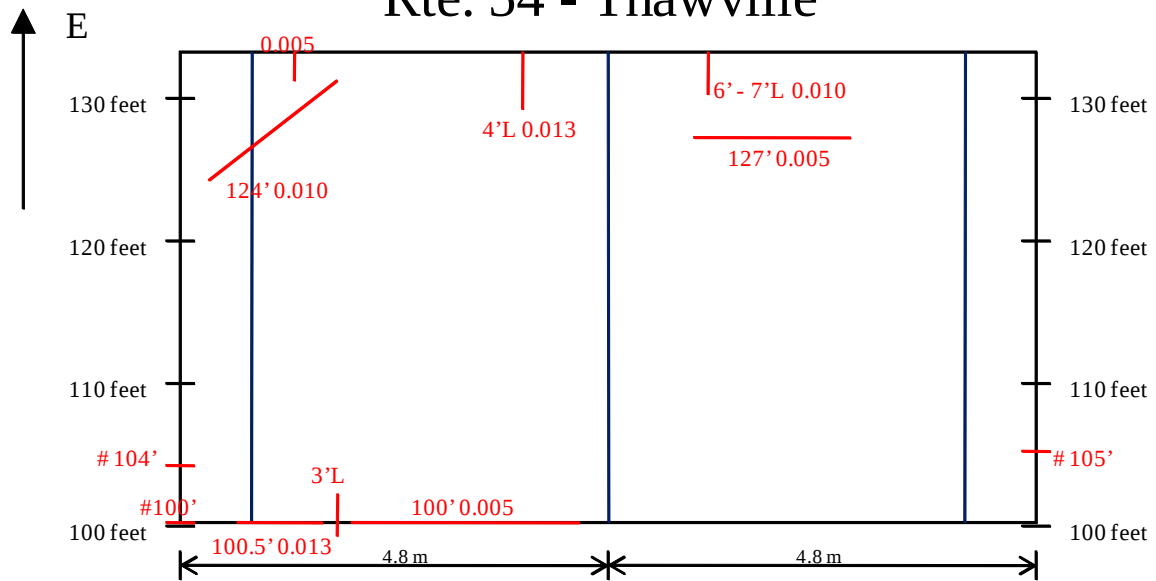
Iroquois County – SN# 038-0207 – Surveyed 11/22/2002

The “#” symbol represents cracks in the parapet only unless otherwise specified.

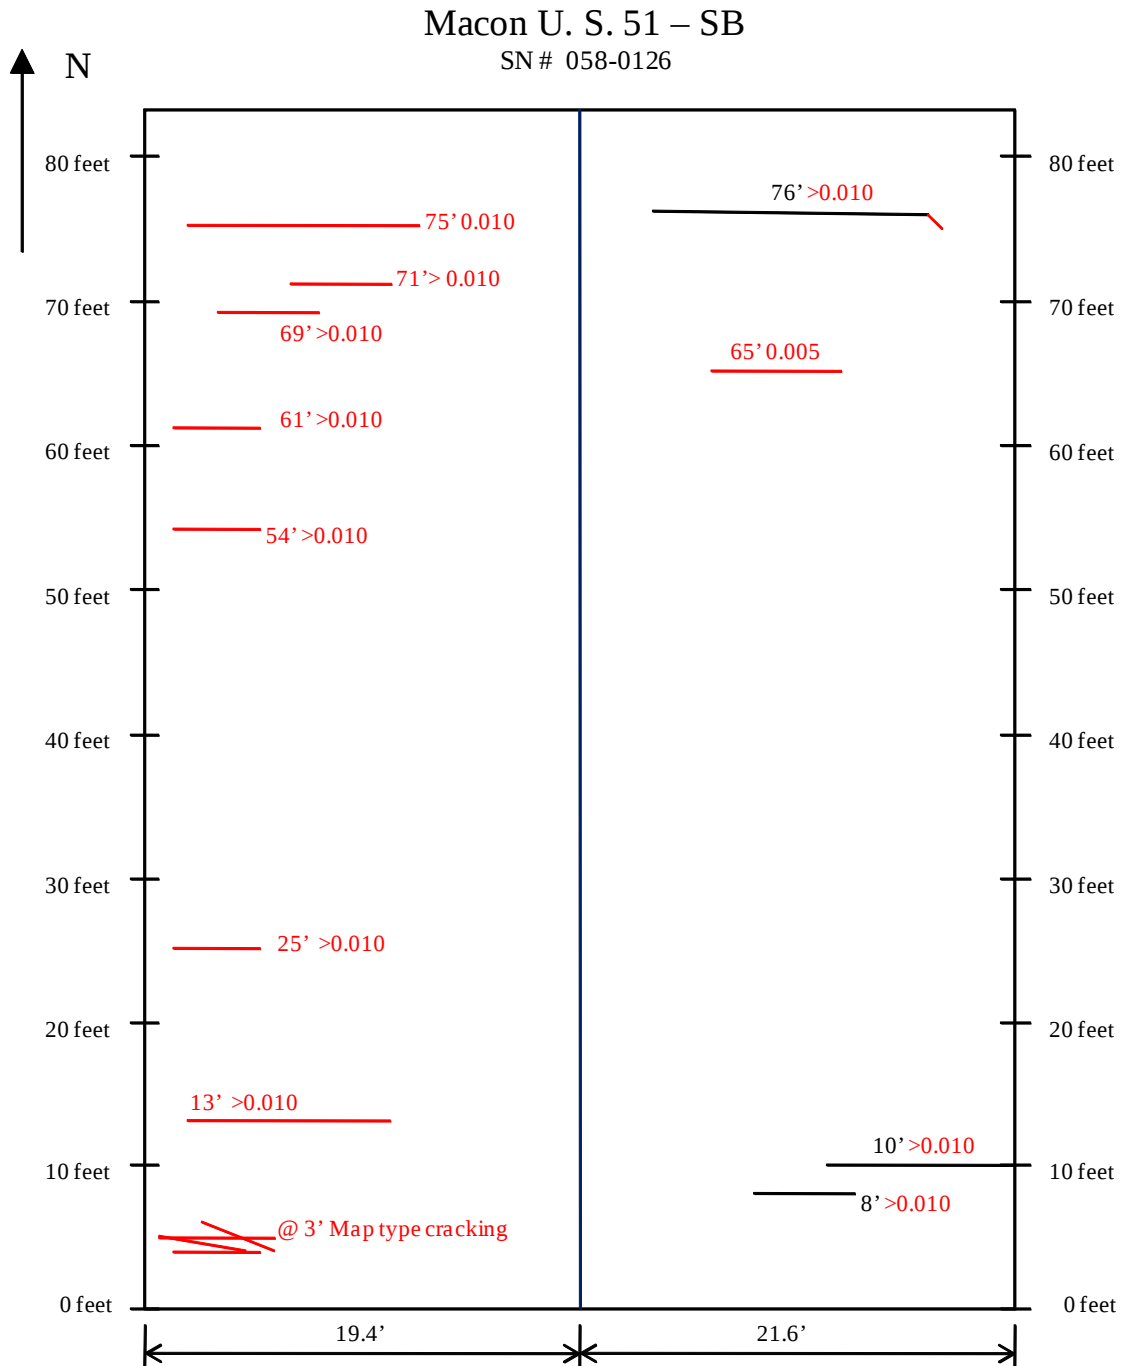
Macon County – SN# 058-0126 – Surveyed 5/7/2001, 10/19/2001  
Deck poured on October 03, 2000. No initial survey was conducted due the dirty surface.

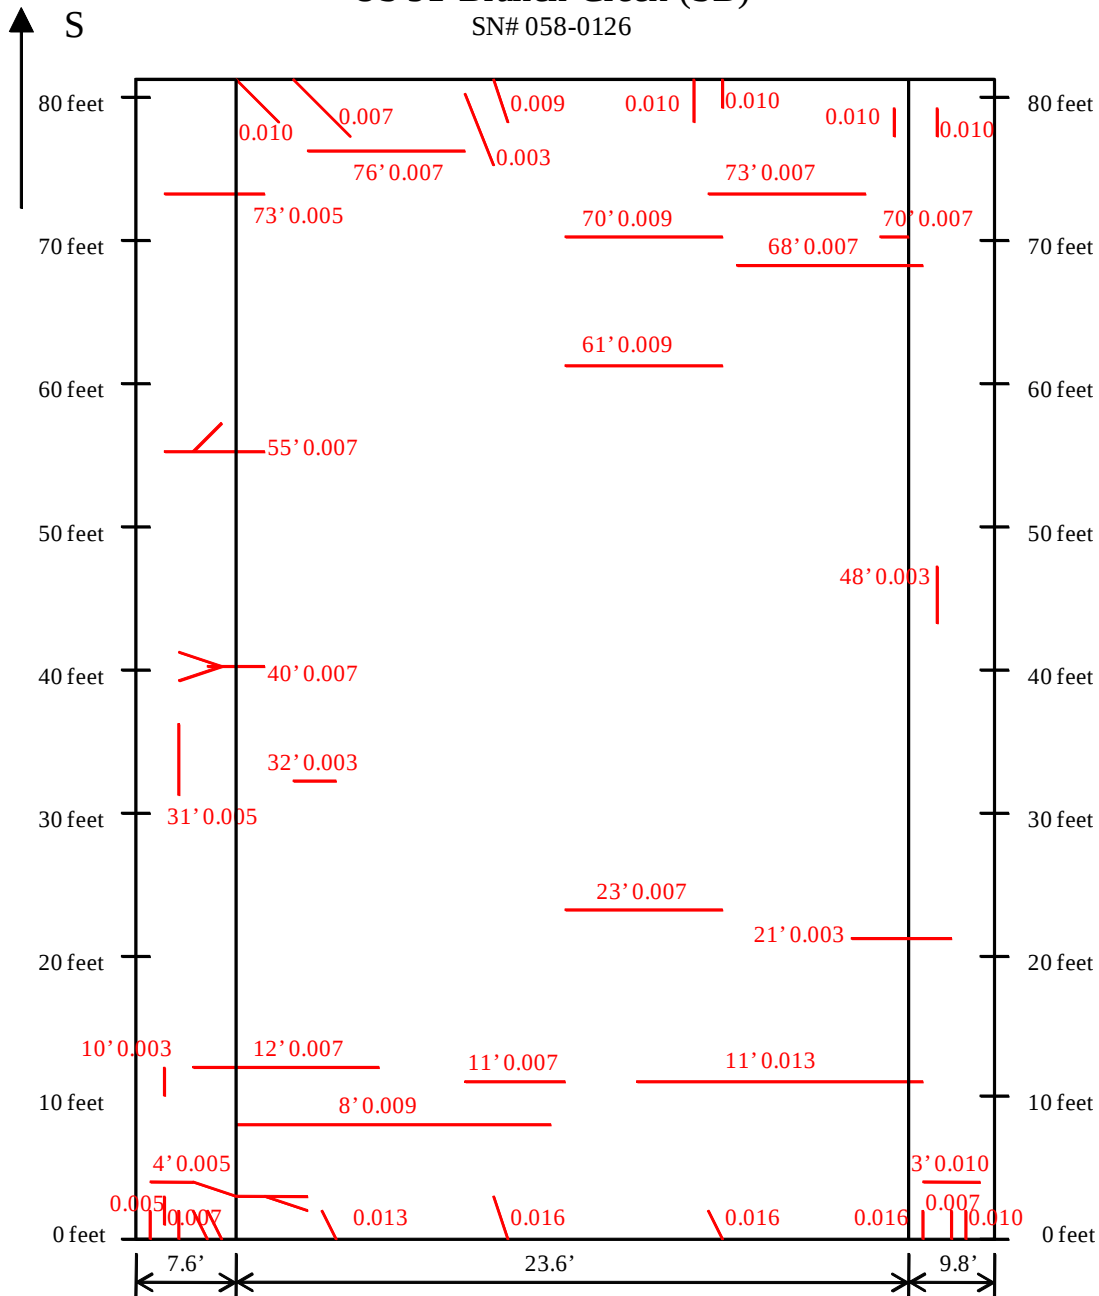
Macon County – SN# 058-0126 – Surveyed 10/7/2003  
 Footprints were noticed in the southbound lane from 48' to 57'.

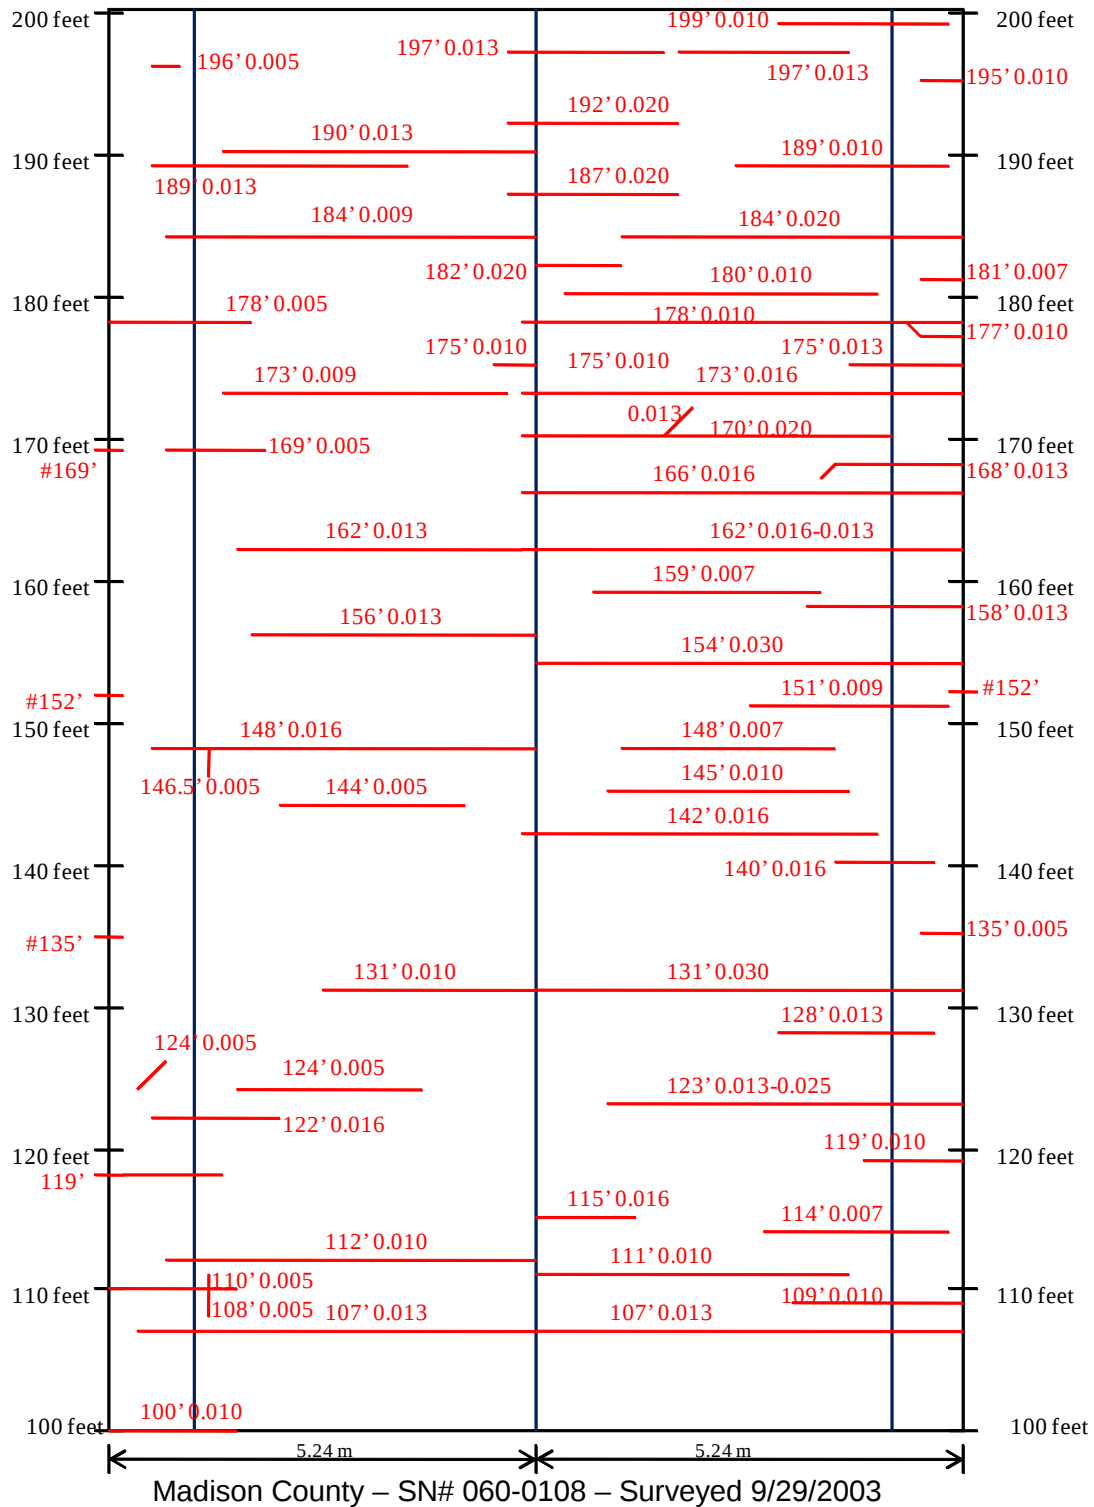
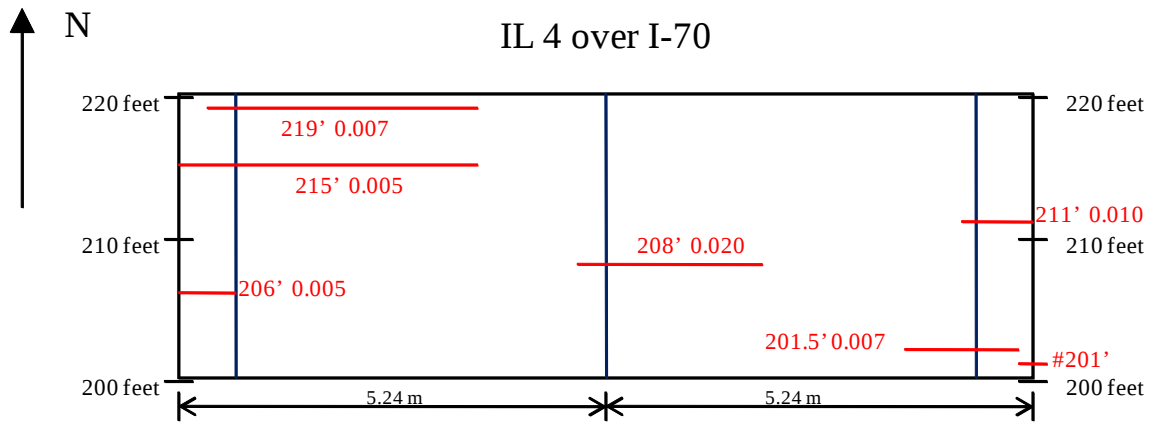
## IL 4 over I-70

Madison County – SN# 060-0108 – Surveyed 9/29/2003

This was a partial deck survey due to time constraints and traffic conditions.

The “#” symbol represents cracks in the parapet only.

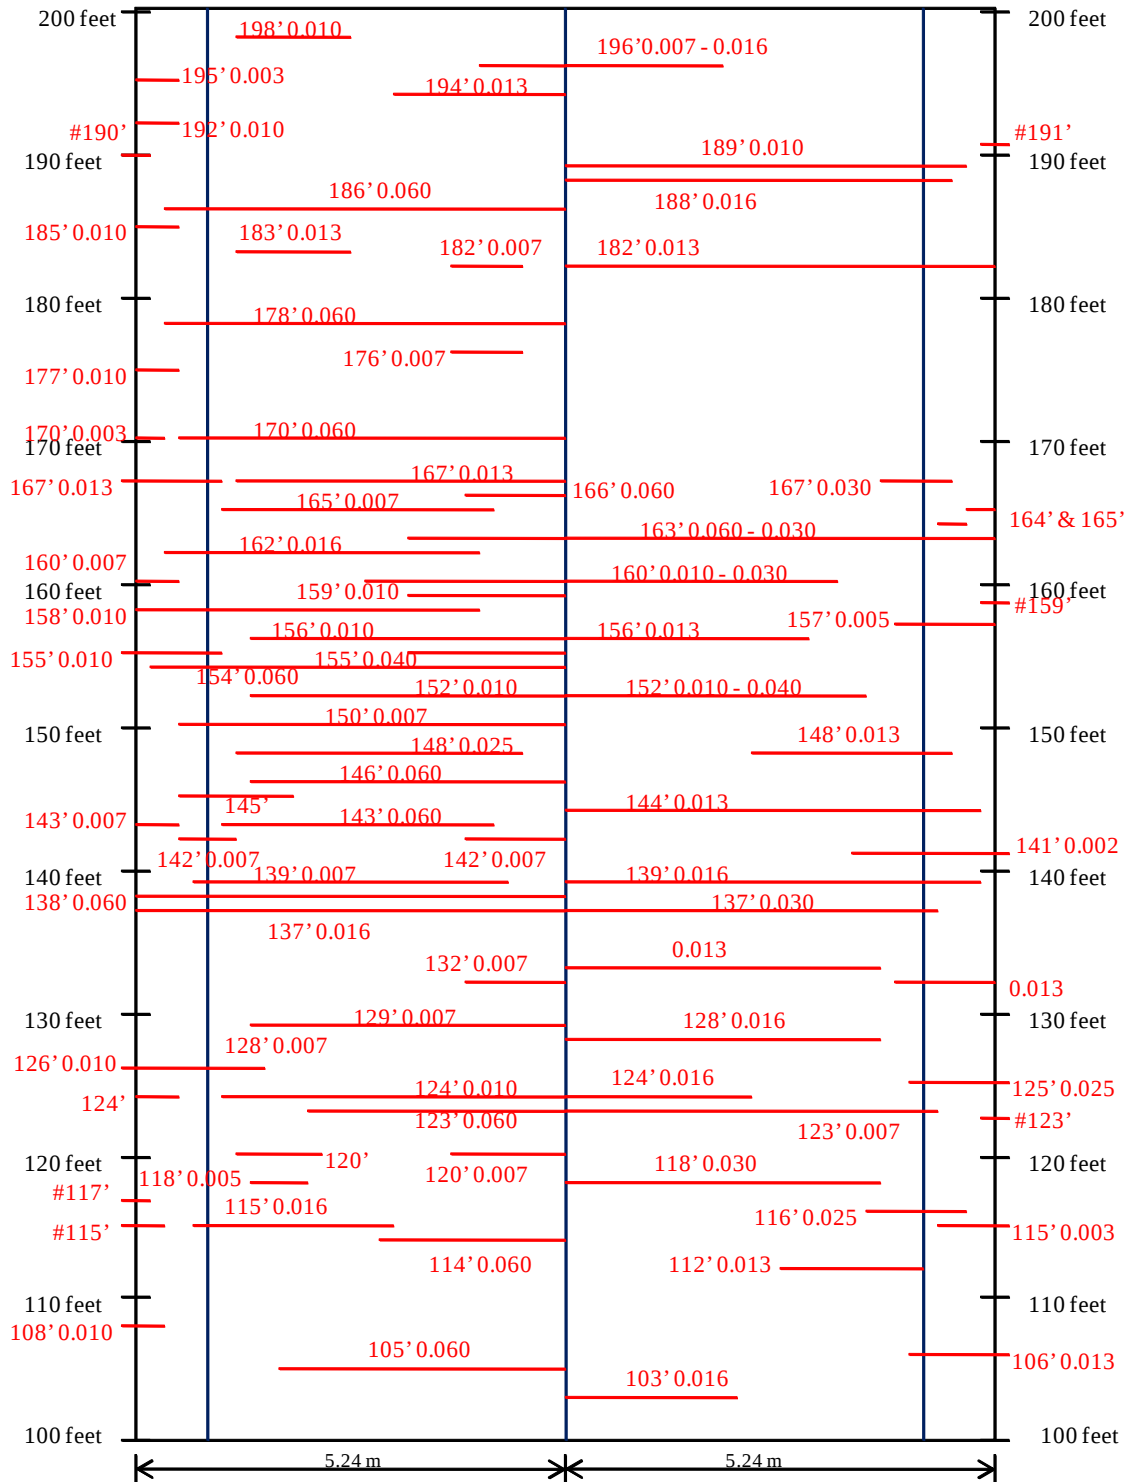
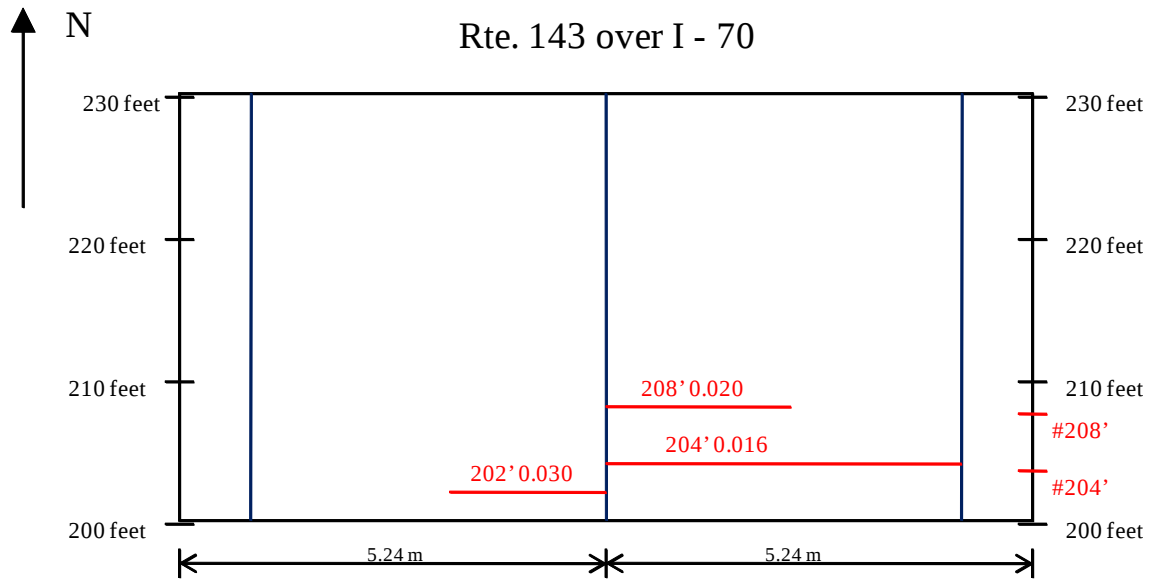
# Rte. 143 over I - 70

Madison County - SN# 060-0151 - Surveyed 8/12/2002

Madison County – SN# 060-0151 – Surveyed 8/12/2002  
 The “#” symbol represents cracks in the parapet only.

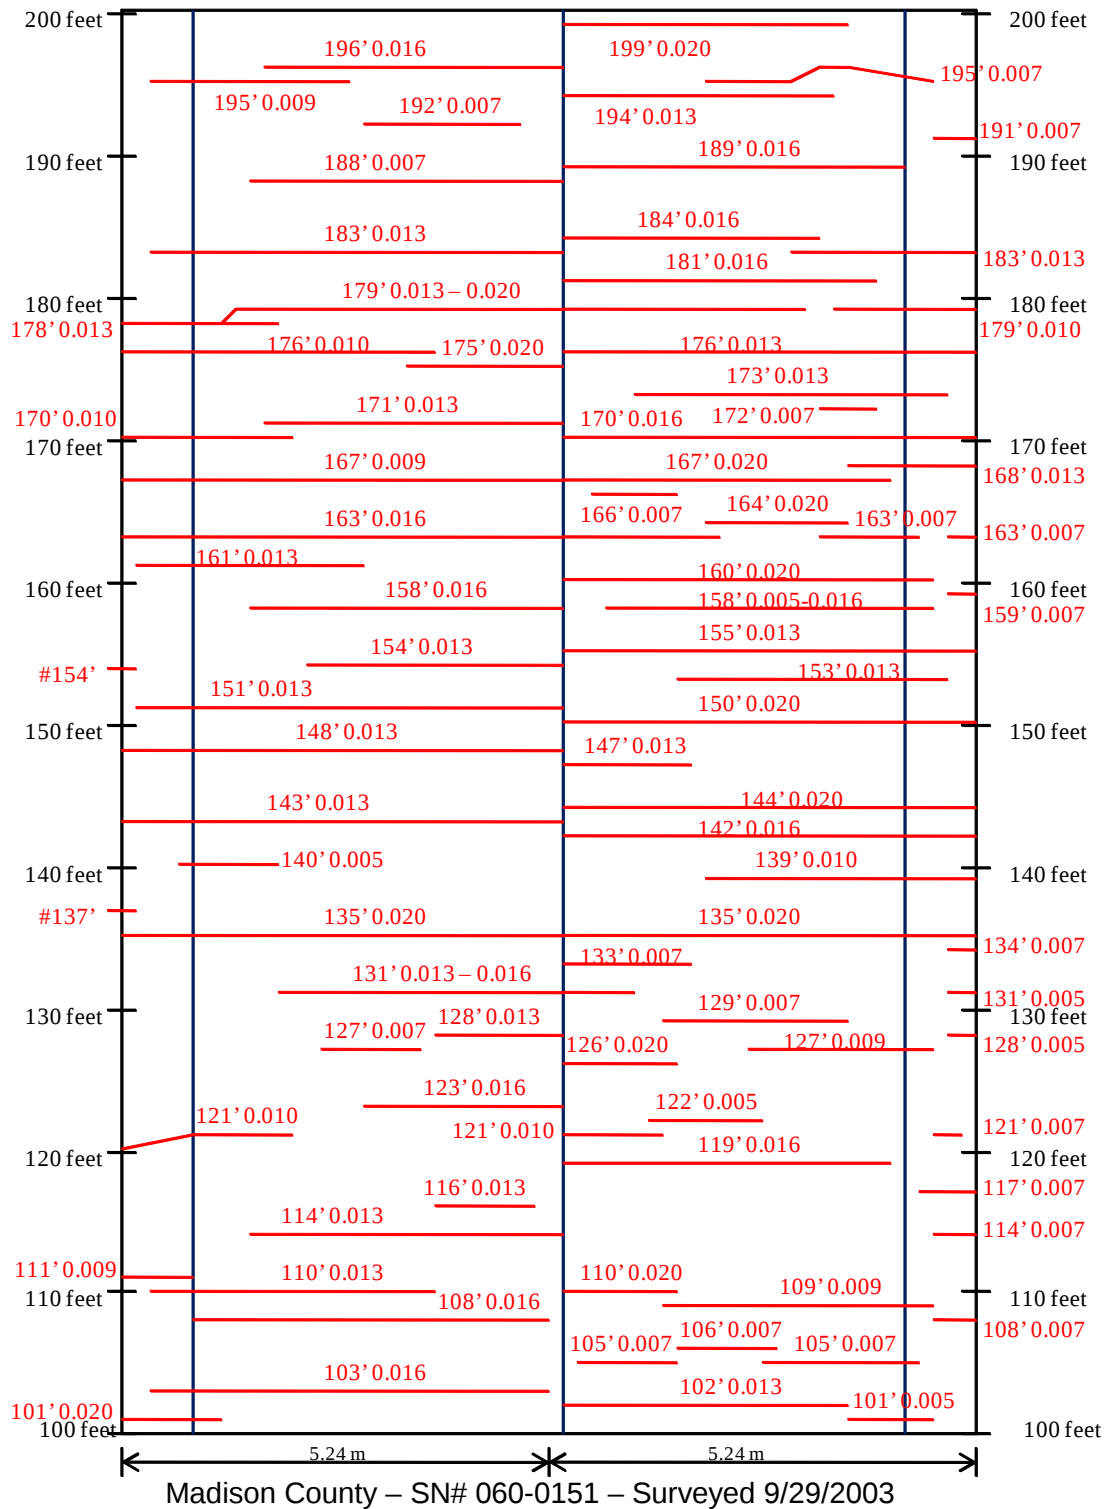
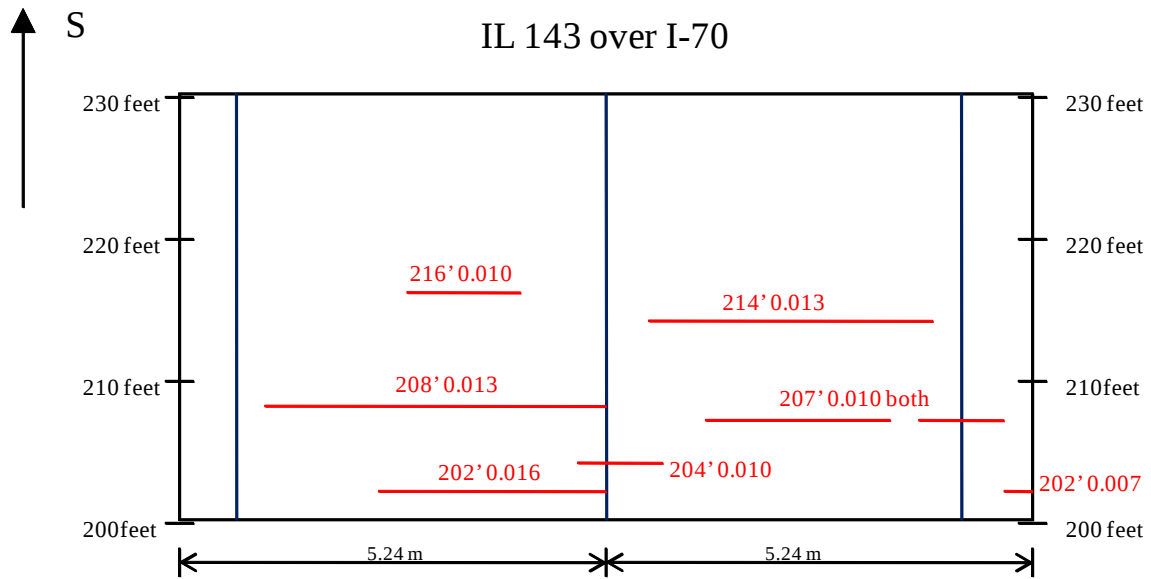
# IL 143 over I-70

Madison County – SN# 060-0151 – Surveyed 9/29/2003  
 The “#” symbol represents cracks in the parapet only.

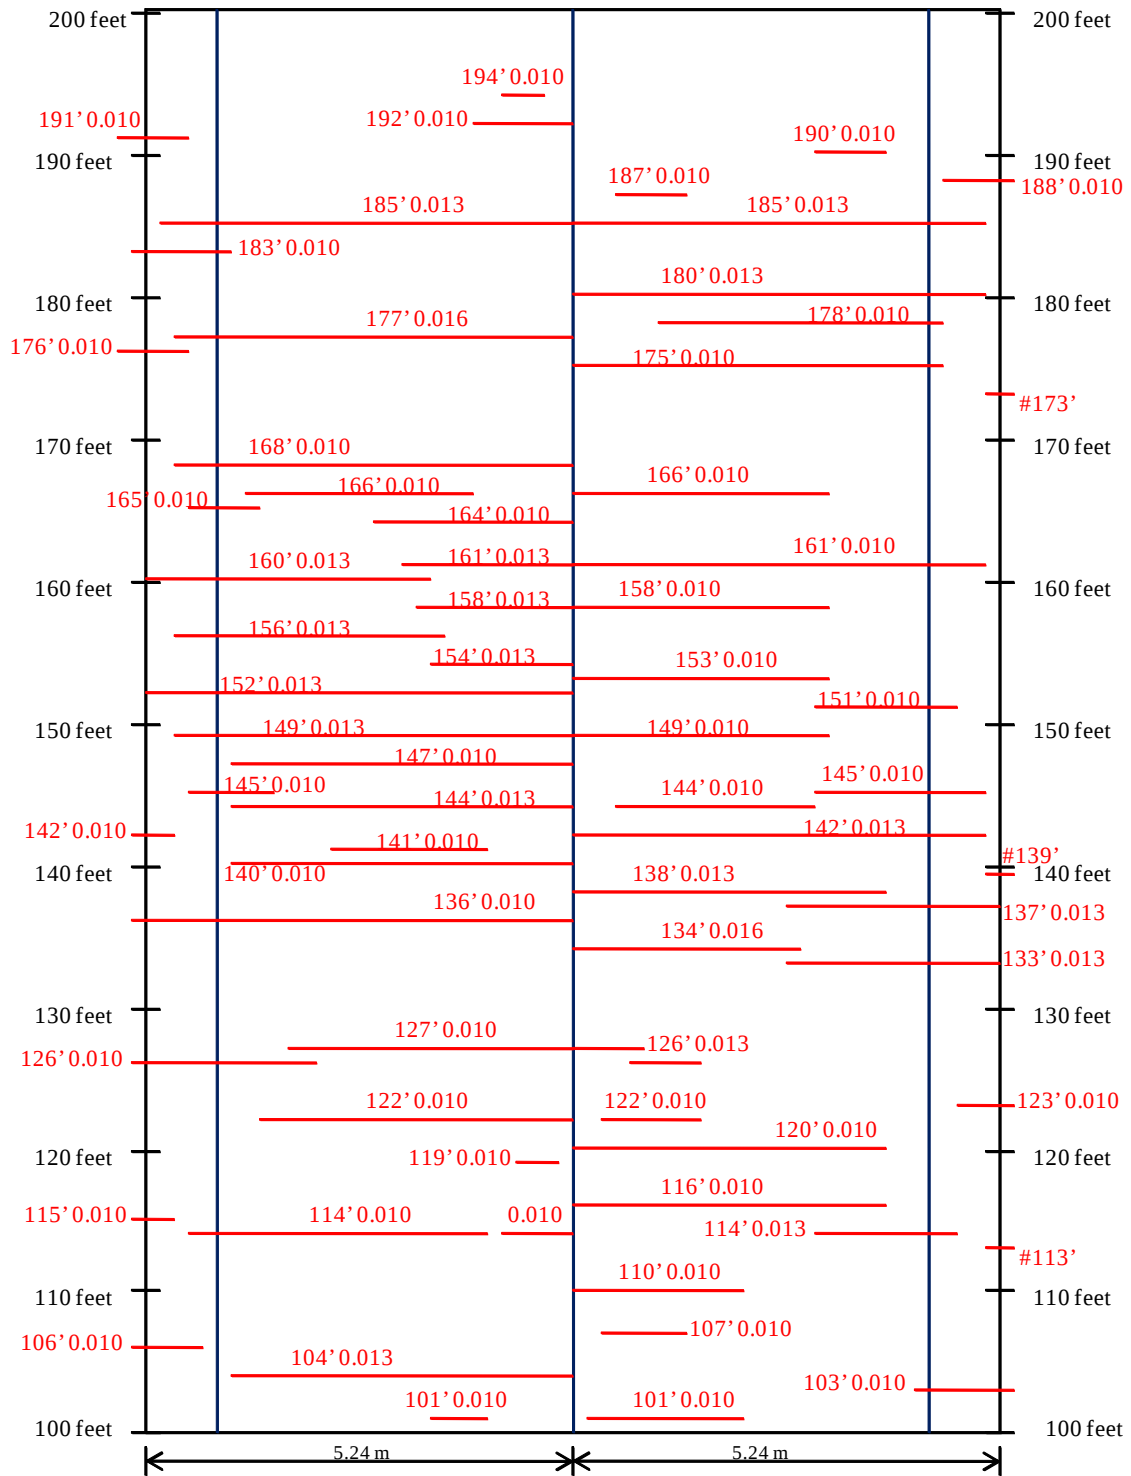
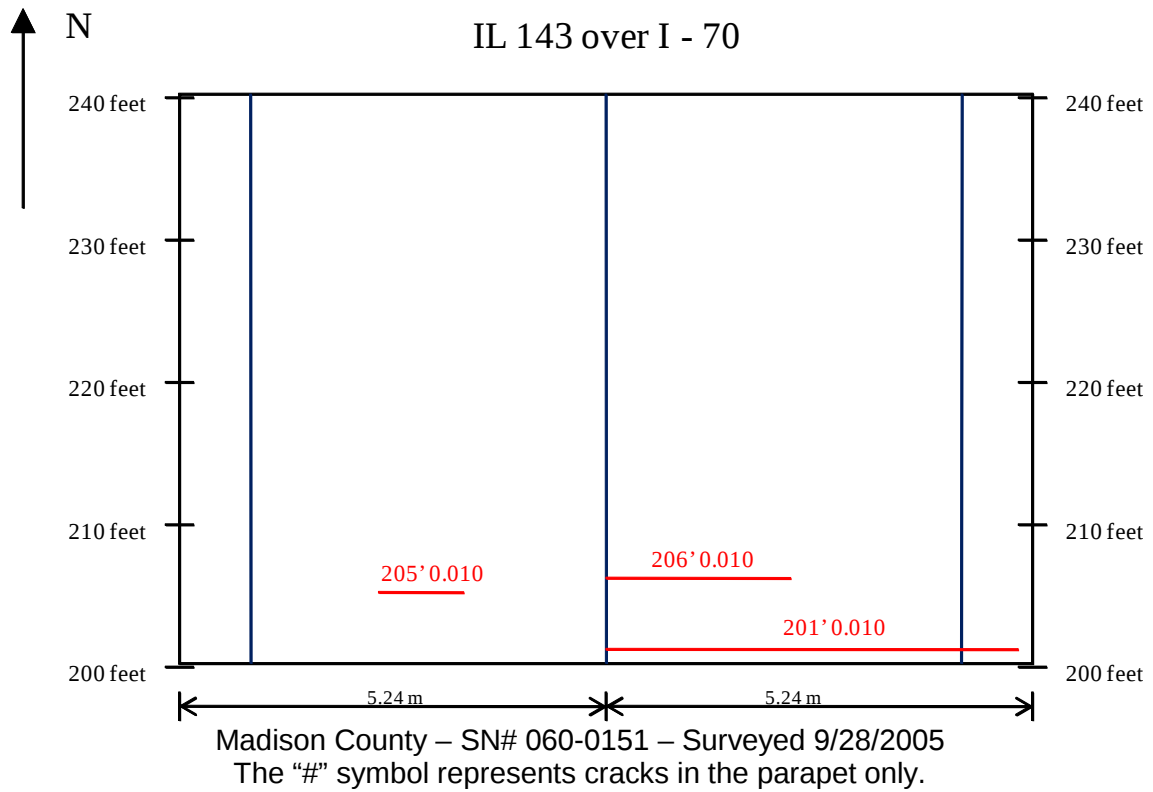
# IL 143 over I - 70

Madison County - SN# 060-0151 - Surveyed 9/28/2005

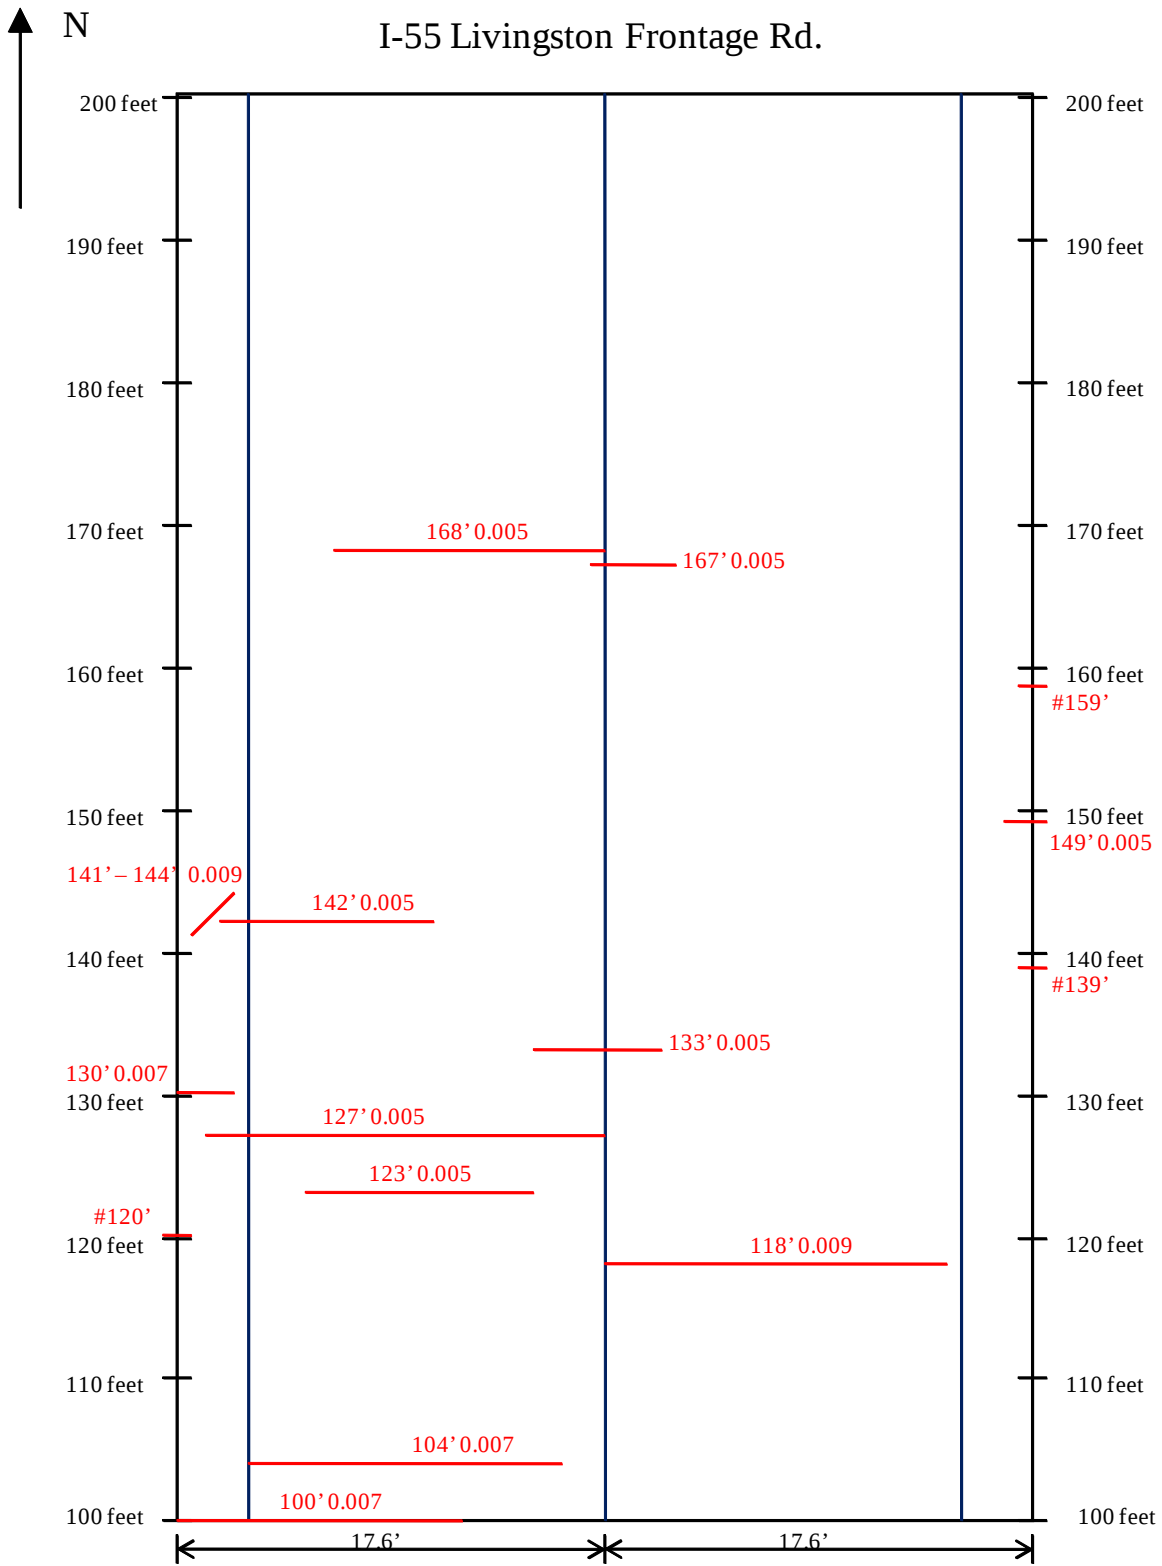
Madison County – SN# 060-0004 – Surveyed 9/29/2003  
 The “#” symbol represents cracks in the parapet only.

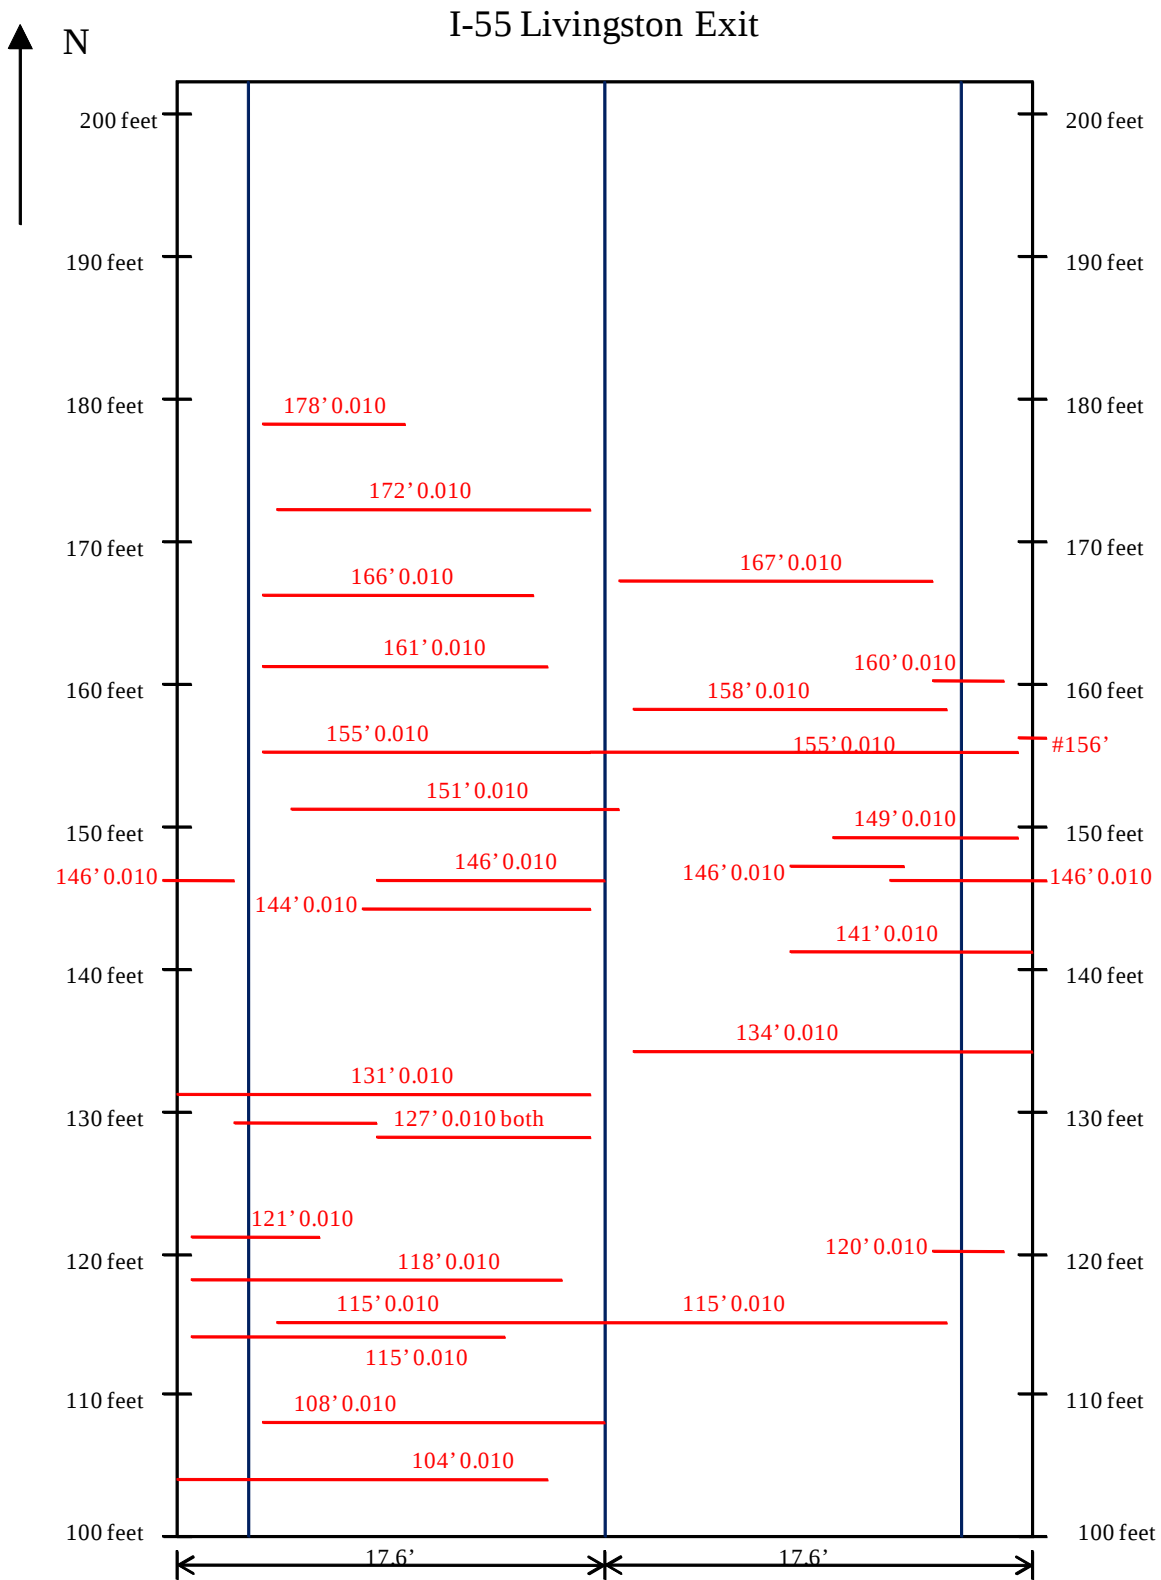
Madison County – SN# 060-0004 – Surveyed 9/28/2005  
 The “#” symbol represents cracks in the parapet only.

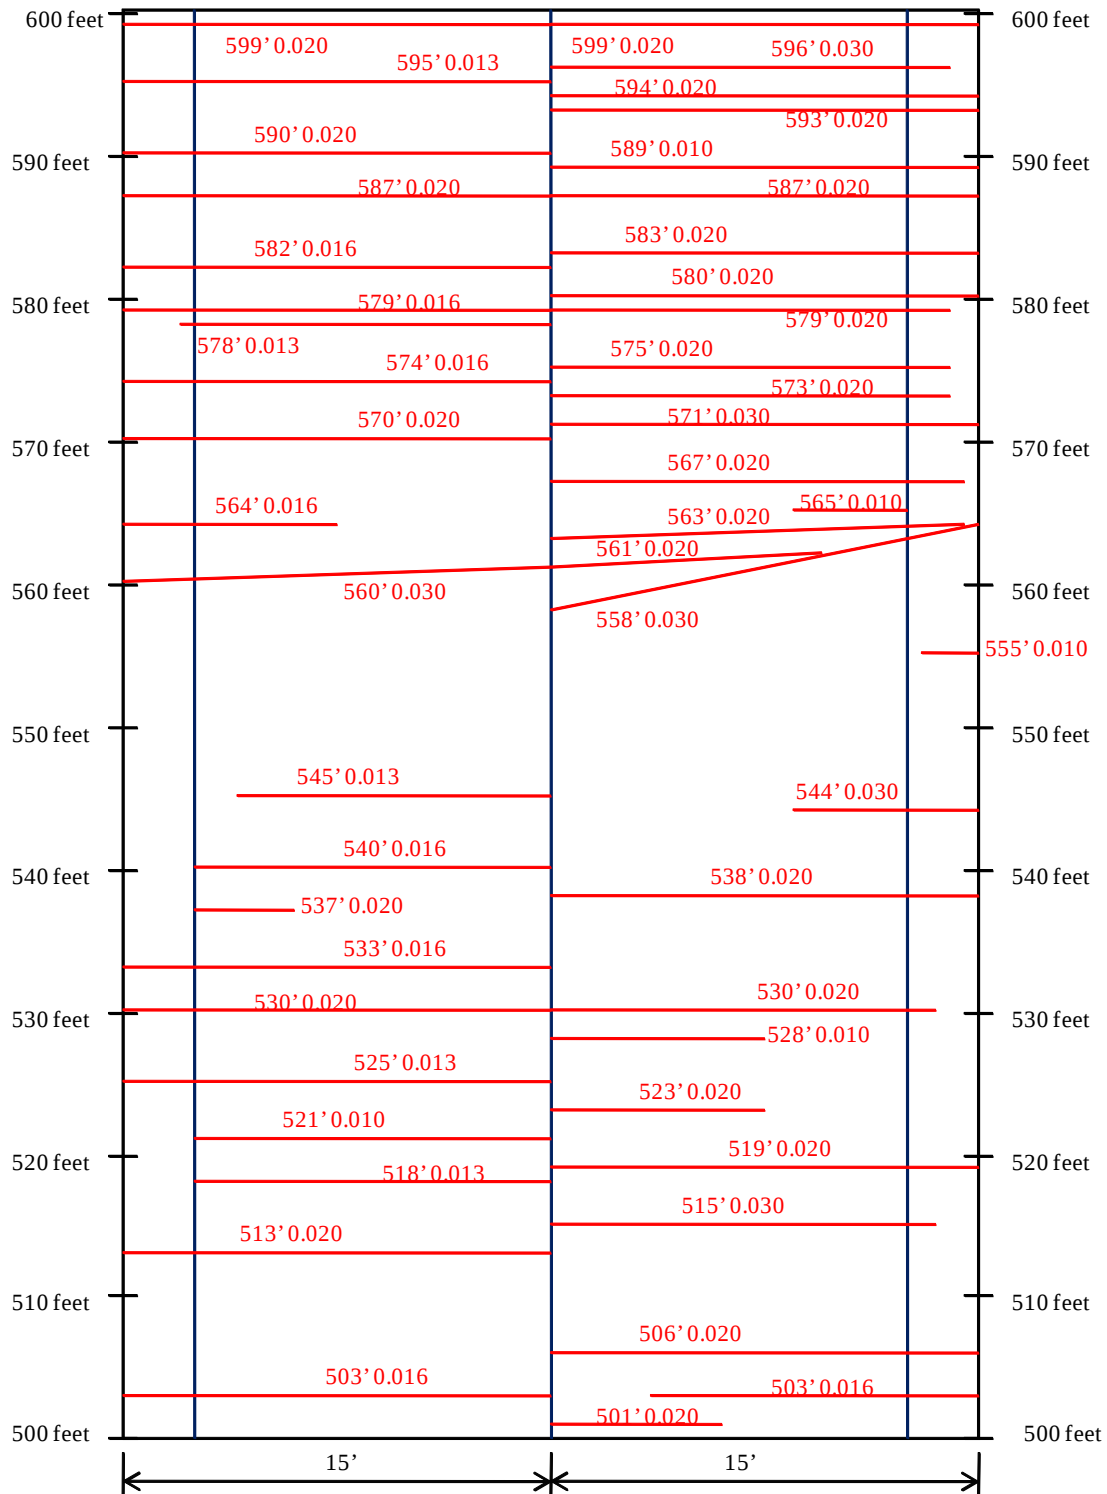
## IL 29 – Salt Creek

Mason/Menard County – SN# 065-0501 – Surveyed 1/2/2004

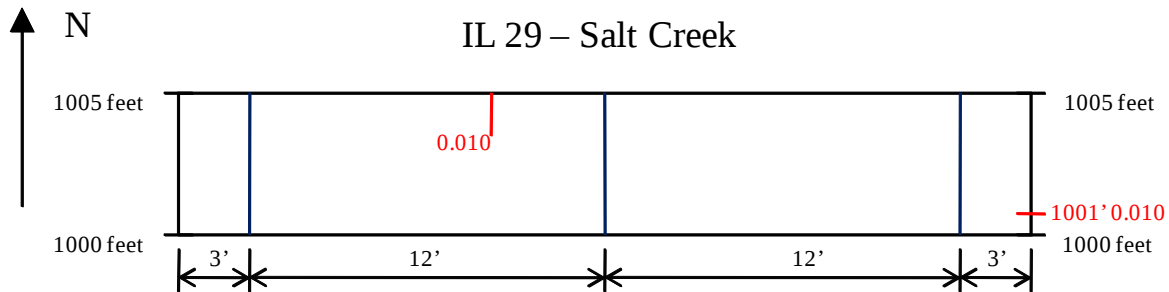
Mason/Menard County – SN# 065-0501 – Surveyed 10/2/2008, 10/20/2008

The “#” symbol represents cracks in the parapet only.

- \* Unless otherwise noted, the areas marked with this symbol contained exposed aggregate.
- A Northbound lane, from 402' – 403', the cracks measured from 0.013 – 0.016

- B Northbound lane, from 403' – 405', all the cracks measured 0.010.
  - C Northbound lane, from 412' – 413', the cracks measured from 0.010, 0.013 – 0.016.

- D Northbound lane, from 413.5' – 414', all the cracks measured 0.013.
  - E Northbound lane, from 423.5' – 425', the cracks measured from 0.010 – 0.013.

- F Northbound lane, from 577' – 581.5', the cracks measured from 0.010 – 0.013.
  - G Southbound lane, from 580' – 582', all the cracks measured 0.010.

- H Northbound lane, from 594' – 599', all the cracks measured 0.013.
  - I Northbound lane, from 597' – 600', the cracks measured from 0.010 – 0.013.

- J Southbound lane, from 601' – 607', the cracks measured from 0.010, 0.013 – 0.016.
  - K Northbound lane, from 602' – 603', the cracks measured from 0.010 – 0.013.

- L Northbound lane, from 605' – 607', all the cracks measured 0.013.
  - M Southbound lane, from 608' – 613', the cracks measured from 0.010, 0.013 – 0.016.

- N Northbound lane, from 609' – 611', all the cracks measured 0.010.
  - O Northbound lane, from 612' – 617', the cracks measured from 0.010 – 0.013.

- P Southbound lane, from 617.5' – 625', the cracks measured from 0.010 – 0.013.
  - Q Northbound lane, from 622' – 625', the cracks measured from 0.010, 0.013 – 0.016.

- R Southbound lane, from 626.5' – 629', all the cracks measured 0.010.
  - S Northbound lane, from 628' – 631', the cracks measured from 0.010 – 0.013.

- T Southbound lane, from 643' – 644', all the cracks measured 0.013.
  - U Northbound lane, around 644', all the cracks measured 0.010.
  - V Southbound lane, from 927.5' – 928', all the cracks measured 0.010.

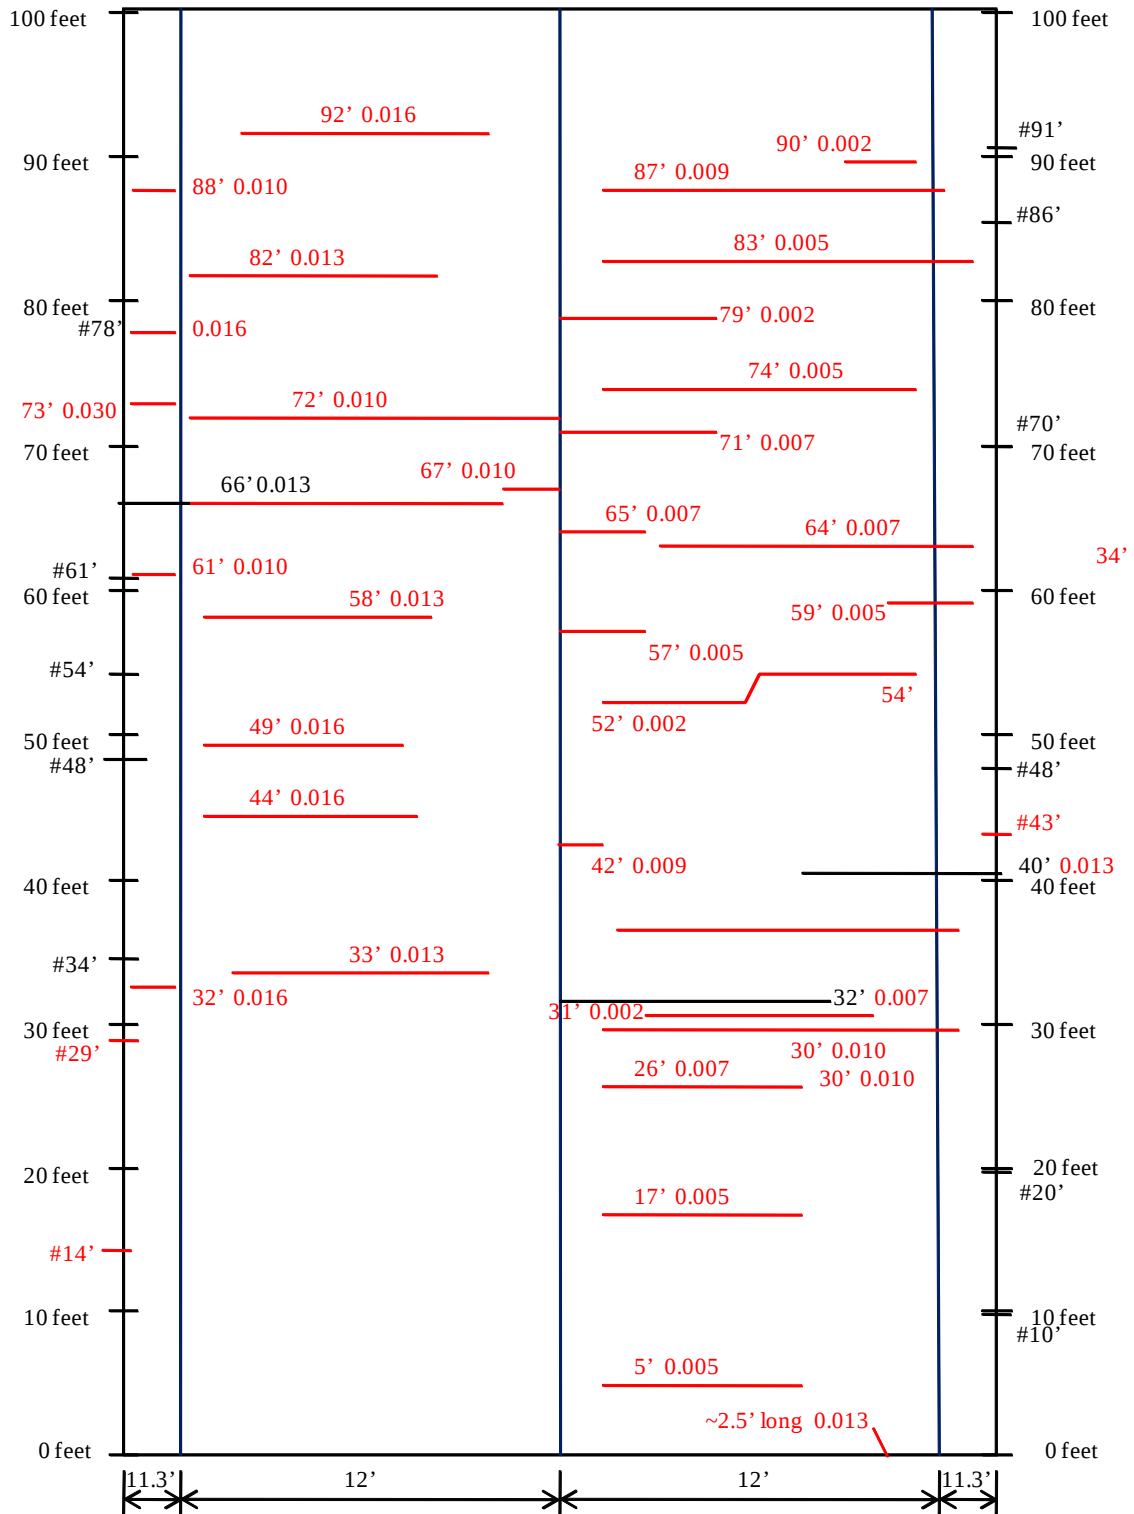
Sangamon County – SN# 084 -0065 – Surveyed 5/7/2001, 8/15/2001

The initial survey of the westbound lane showed 33 hairline transverse cracks.

The initial survey of the eastbound lane showed 21 hairline transverse cracks.

The “#” symbol represents cracks in the parapet only.

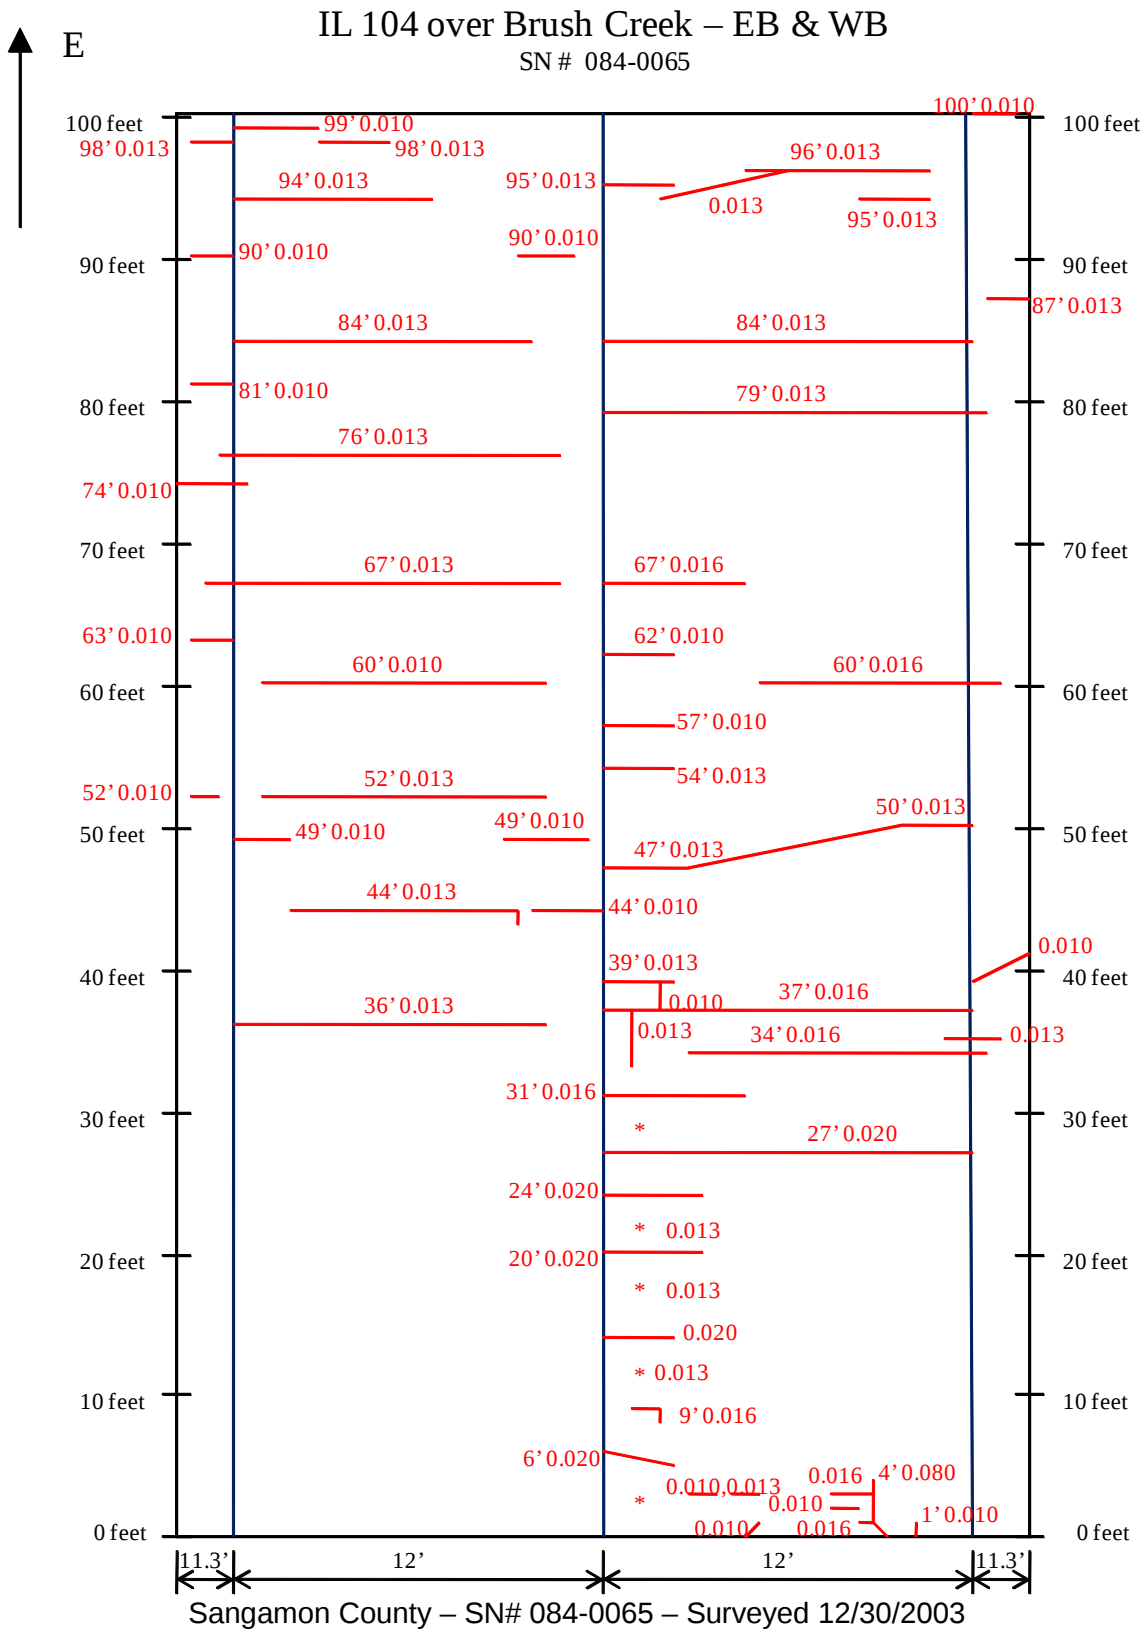
Sangamon County – SN# 084-0065 – Surveyed 12/30/2003

\* Denotes areas of interconnected hairline cracks, sometimes resembling a spider web.
