**EVALUATION OF HIGH PERFORMANCE  
CONCRETE BRIDGE DECKS  
AND  
OTHER EXPERIMENTAL BRIDGE  
DECKS THROUGHOUT ILLINOIS**

**PHYSICAL RESEARCH REPORT NO. 166  
December 2017**

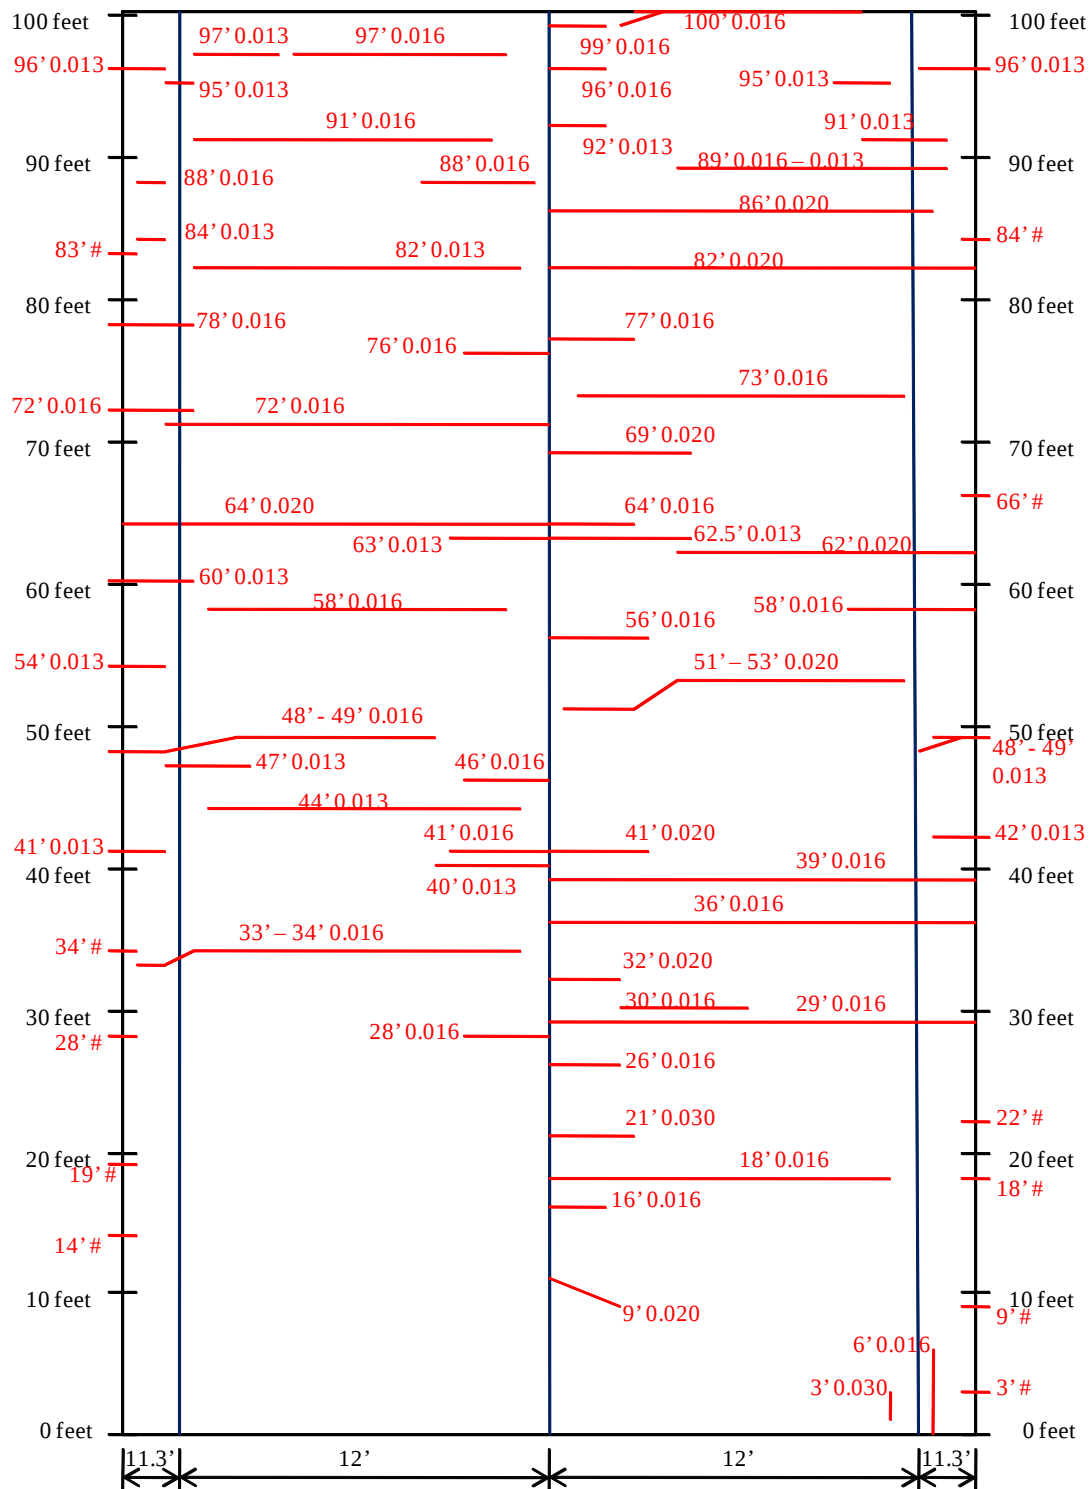
Sangamon County - SN# 084-0065 - Surveyed 9/26/2005

Sangamon County – SN# 084-0065 – Surveyed 9/26/2005  
 Map cracking was observed in the eastbound lane near the centerline from 9' to 89'.  
 The “#” symbol represents cracks in the parapet only.

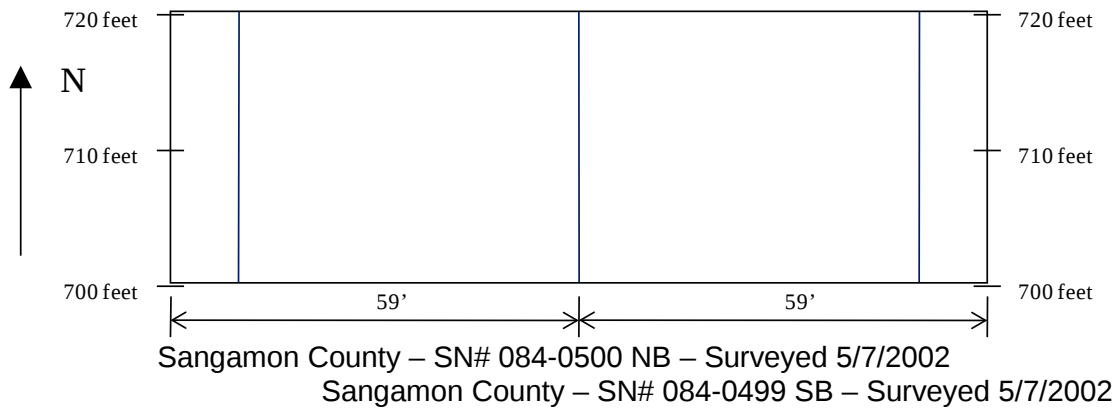
The “#” symbol represents cracks in the parapet only.

This bridge deck was poured on various days. The last pour date was 4/5/2002.
