**CULVERTS**

3/7/2024 IL NBI Refresher Course 2024

**Item 62 - Culverts**

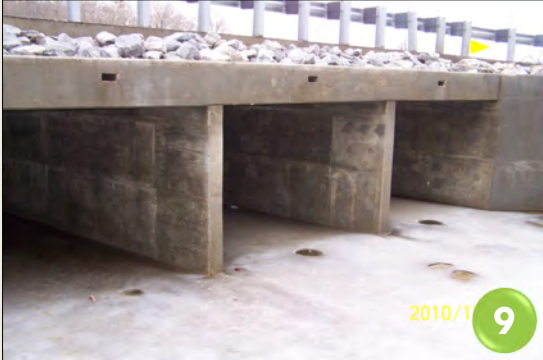
### New Construction

No Deficiencies

**EXCELLENT. No deficiencies – Allowed first inspection only**

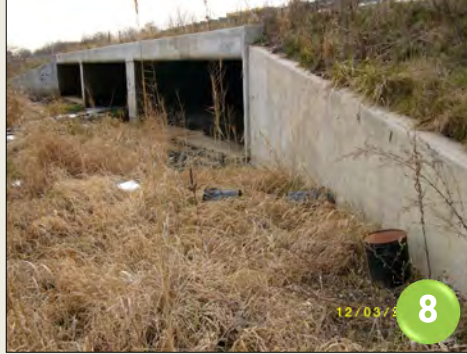
**Very Good Condition**

**No significant defects**

**VERY GOOD.** No noticeable or noteworthy deficiencies which affect the condition of the culvert, insignificant scrape marks caused by drift.

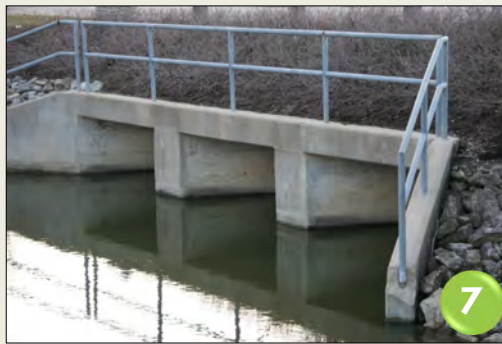
**Good Condition**

- Minor scaling
- Insignificant spalling
- No exposed reinforcement

**GOOD.** Isolated non-structural cracks up to 0.03", light scaling, and insignificant spalling which does not expose reinforcing steel, metal culverts have a smooth symmetrical curvature with superficial corrosion and no pitting, insignificant damage caused by drift with no misalignment and not requiring corrective action, some minor scour has occurred near curtain walls, wingwalls, or pipes.

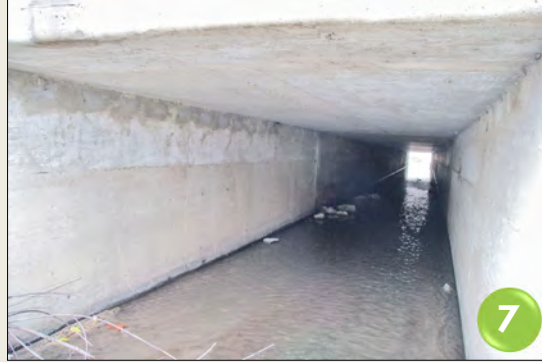
### Good Condition

- Hairline vertical cracks in center wall
- Crack spacing greater than 10'
- Light scaling present

GOOD. Isolated non-structural cracks up to 0.03", light scaling, and insignificant spalling which does not expose reinforcing steel, metal culverts have a smooth symmetrical curvature with superficial corrosion and no pitting, insignificant damage caused by drift with no misalignment and not requiring corrective action, some minor scour has occurred near curtain walls, wingwalls, or pipes.

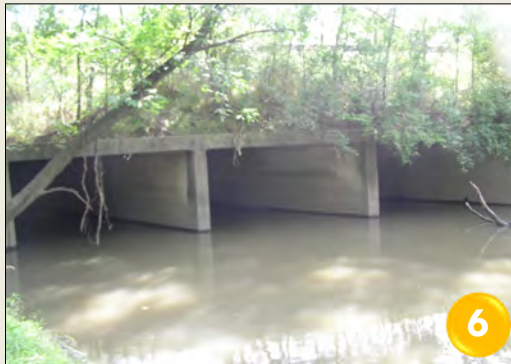
### Satisfactory Condition

- Vertical cracks in the walls with leaching
- 10' crack spacing
- Minor spalls and delaminations present on 5% of surface

SATISFACTORY. Extensive non-structural cracks up to .06" with some leaching over the majority of the top slab, spalls and delaminations may be present on up to 10% in a 6' width of the concrete or masonry walls or slabs exposing primary reinforcement with surface rust only, up to 20% of the surface area of walls and slabs may be map cracked, spalled and delaminated. Metal culverts have a smooth curvature, non-symmetrical shape, minor corrosion or measurable pitting. Local minor scour at curtain walls, wingwalls, or pipes.

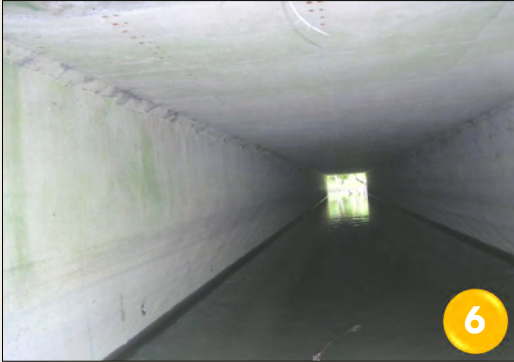
### Satisfactory Condition

- Cracks with leaching at 10' spacing
- Minor spalls and delaminations present on 3% of surface

**SATISFACTORY.** Extensive non-structural **cracks** up to .06" with some **leaching** over the majority of the top slab, **spalls and delaminations** may be present on up to 10% in a 6' width of the concrete or masonry walls or slabs exposing primary reinforcement with surface rust only, up to 20% of the surface area of walls and slabs may be map cracked, spalled and delaminated. Metal culverts have a smooth curvature, non-symmetrical shape, minor corrosion or measurable pitting. Local minor scour at curtain walls, wingwalls, or pipes.

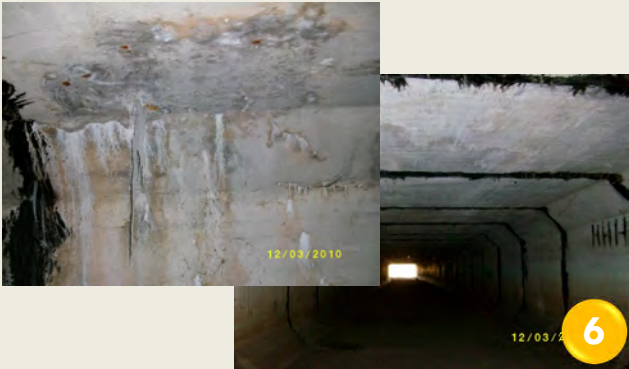
### Satisfactory Condition

Precast Culvert

- Widely spaced cracks with leaching
- Minor spalls and delaminations present on 5% of surface

**SATISFACTORY.** Extensive non-structural **cracks** up to .06" with some **leaching** over the majority of the top slab, **spalls and delaminations** may be present on up to 10% in a 6' width of the concrete or masonry walls or slabs exposing primary reinforcement with surface rust only, up to 20% of the surface area of walls and slabs may be map cracked, spalled and delaminated. Metal culverts have a smooth curvature, non-symmetrical shape, minor corrosion or measurable pitting. Local minor scour at curtain walls, wingwalls, or pipes.

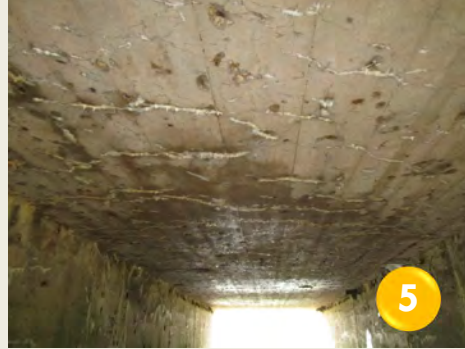
### Fair Condition

- Leaching map cracks throughout the top slab soffit
- Several small delaminations throughout

FAIR. Non-structural cracking with leaching at < 5' intervals over the majority of the slab or wall surfaces, structural cracks < 0.03" in walls or slabs, section loss of primary reinforcement up to 10% in the top slab in a 6' width, up to 10% of compression surface area spalled or delaminated on top slabs in a 6' width (tension areas may be totally spalled), up to 10% section loss of concrete or rebar in a 10' width of wall, up to 10% section loss of concrete or reinforcement steel in a 10' width of bottom slab. Metal culverts have significant distortion and deflection in no more than one section, or significant corrosion or deep pitting with up to 10% average section loss in a 10' width, minor settlement or misalignment, noticeable scour or erosion at curtain walls, wingwalls, or pipes without undermining.

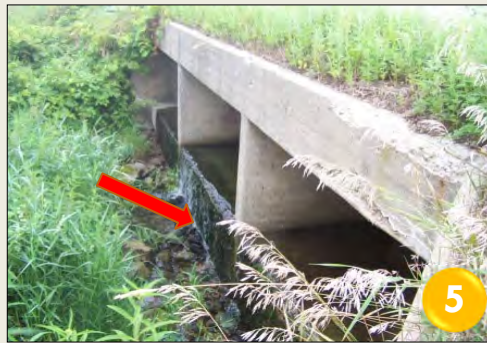
### Fair Condition

- Scour present on the downstream end
- Cutoff wall exposed, but not undermined
- Minor spalling of the headwall

FAIR. Non-structural cracking with leaching at < 5' intervals over the majority of the slab or wall surfaces, structural cracks < 0.03" in walls or slabs, section loss of primary reinforcement up to 10% in the top slab in a 6' width, up to 10% of compression surface area spalled or delaminated on top slabs in a 6' width (tension areas may be totally spalled), up to 10% section loss of concrete or rebar in a 10' width of wall, up to 10% section loss of concrete or reinforcement steel in a 10' width of bottom slab. Metal culverts have significant distortion and deflection in no more than one section, or significant corrosion or deep pitting with up to 10% average section loss in a 10' width, minor settlement or misalignment, noticeable scour or erosion at curtain walls, wingwalls, or pipes without undermining.

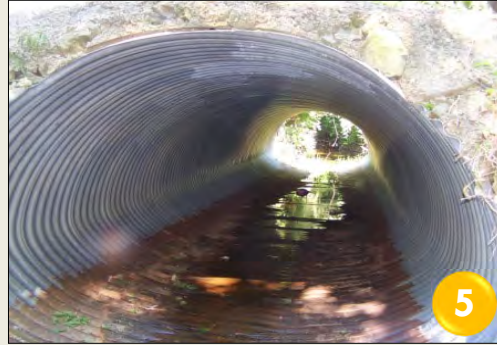
### Fair Condition

- 10% section loss along the bottom and near the water line
- Moderate distortion under the roadway

**FAIR.** Non-structural cracking with leaching at < 5' intervals over the majority of the slab or wall surfaces, structural cracks < 0.03" in walls or slabs, section loss of primary reinforcement up to 10% in the top slab in a 6' width, up to 10% of compression surface area spalled or delaminated on top slabs in a 6' width (tension areas may be totally spalled), up to 10% section loss of concrete or rebar in a 10' width of wall, up to 10% section loss of concrete or reinforcement steel in a 10' width of bottom slab. Metal culverts have significant **distortion and deflection** in no more than one section, or significant corrosion or deep pitting with **up to 10% average section loss in a 10' width**, minor settlement or misalignment, noticeable scour or erosion at curtain walls, wingwalls, or pipes without undermining.

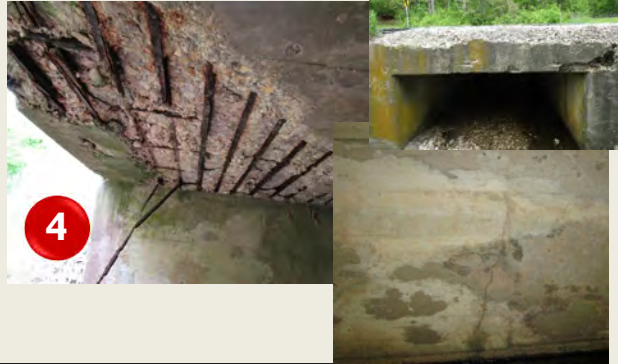
### Poor Condition

- 25% section loss of primary reinf. over 6' width
- Vertical cracks in sidewalls up to 0.125"

POOR. Structural cracks in top slab up to 0.06", structural cracks in walls up to 0.125", section loss of primary reinforcement up to 30% in the top slab in a 6' width, up to 30% of compression surface area spalled or delaminated on top slabs in a 6' width (tension areas may be totally spalled), up to 30% section loss of concrete or rebar in a 10' width of wall, up to 30% section loss of concrete or reinforcement steel in a 10' width of bottom slab. Metal culverts have significant distortion and deflection on more than one section, extensive corrosion or deep pitting throughout with up to 30% section loss in a 10' width, considerable settlement or misalignment, considerable scour or erosion at curtain walls, wingwalls or pipes with undermining.

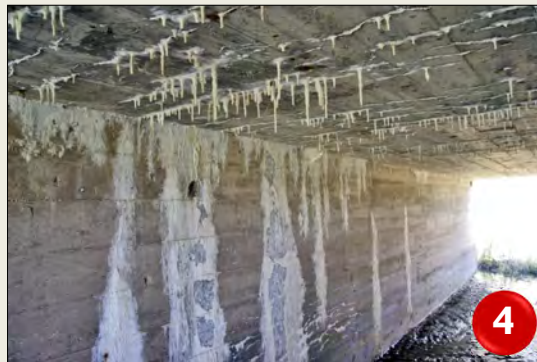
### Poor Condition

- Leaching map cracks present in top slab
- Cracks up to 0.06" in top slab
- Leaching vertical cracks in walls up to 0.125"
- Concrete cores may be needed

POOR. Structural cracks in top slab up to 0.06", structural cracks in walls up to 0.125", section loss of primary reinforcement up to 30% in the top slab in a 6' width, up to 30% of compression surface area spalled or delaminated on top slabs in a 6' width (tension areas may be totally spalled), up to 30% section loss of concrete or rebar in a 10' width of wall, up to 30% section loss of concrete or reinforcement steel in a 10' width of bottom slab. Metal culverts have significant distortion and deflection on more than one section, extensive corrosion or deep pitting throughout with up to 30% section loss in a 10' width, considerable settlement or misalignment, considerable scour or erosion at curtain walls, wingwalls or pipes with undermining.

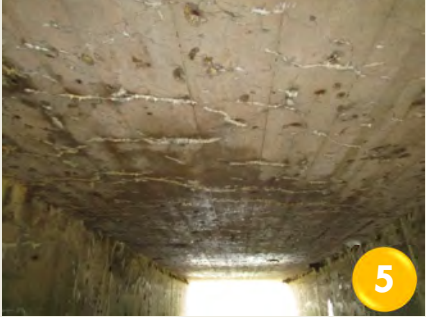
**Cracking with leaching at < 5' intervals in top slab.**  
**Spalls and delaminations on the bottom concrete slabs.**

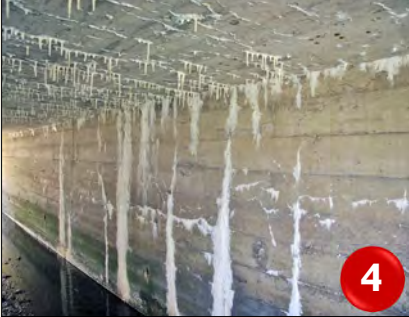
**Structural cracks up to 0.06" in top slab, heavy cracking and leaching in top slab.**  
**Structural cracks up to 0.125" in walls.**

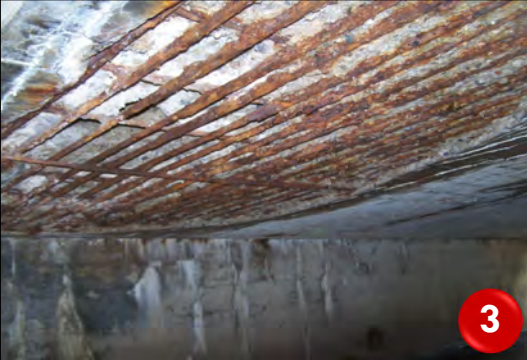
**Serious Condition**

- Large spalls present with exposed primary reinforcement
- 35% section loss in primary reinforcement
- Top slab soffit is delaminated and slightly sagging

**SERIOUS.** Any **worse or combined condition** described in condition rating "4", up to 50% loss, metal culverts have extreme **distortion and deflection** in one section (collapse), extensive corrosion, or deep pitting with scattered perforations, severe movement or differential settlement of the segments, or loss of fill. Holes may exist in walls or slabs. Integral wingwalls nearly severed from culvert. Severe undermining of curtain walls, wingwalls or pipes.

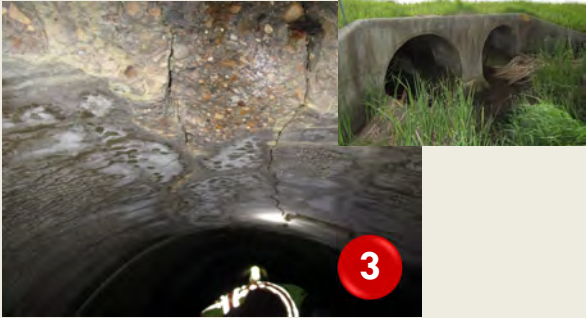
### Serious Condition

- Large double RC pipe culvert
- Structural cracks in top of pipe  $\geq 0.125''$

**SERIOUS.** Any **worse or combined condition** described in condition rating "4", up to 50% loss, metal culverts have extreme distortion and deflection in one section (collapse), extensive corrosion, or deep pitting with scattered perforations, severe movement or differential settlement of the segments, or loss of fill. Holes may exist in walls or slabs. Integral wingwalls nearly severed from culvert. Severe undermining of curtain walls, wingwalls or pipes.

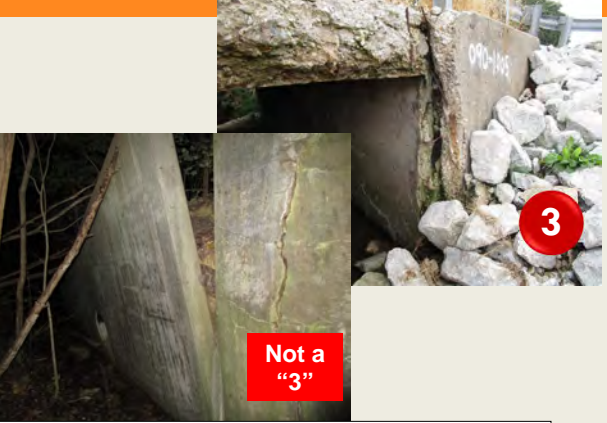
### Wingwall Distress:

- Both are failing wings
- Integral wings attachment to barrel count in the culvert rating
- Separate wings **do not**, add comment to BI Form on condition

**SERIOUS.** Any worse or combined condition described in condition rating "4", up to 50% loss, metal culverts have extreme distortion and deflection in one section (collapse), extensive corrosion, or deep pitting with scattered perforations, severe movement or differential settlement of the segments, or loss of fill. Holes may exist in walls or slabs. **Integral wingwalls nearly severed from culvert.** Severe undermining of curtain walls, wingwalls or pipes.

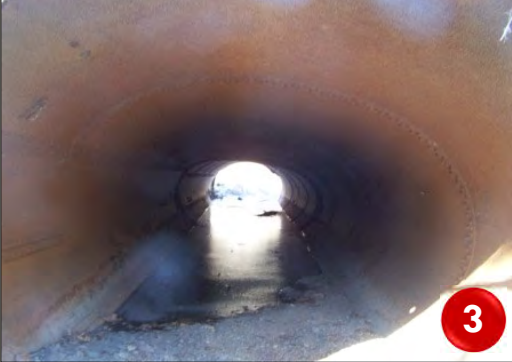
### Serious Condition

- Distortion in two sections
- Separation of sections has occurred
- Loss of fill has occurred at separation between sections

**SERIOUS.** Any worse or combined condition described in condition rating "4", up to 50% loss, metal culverts have extreme **distortion and deflection** in one section (collapse), extensive corrosion, or deep pitting with scattered perforations, severe movement or differential settlement of the segments, or **loss of fill**. Holes may exist in walls or slabs. Integral wingwalls nearly severed from culvert. Severe undermining of curtain walls, wingwalls or pipes.

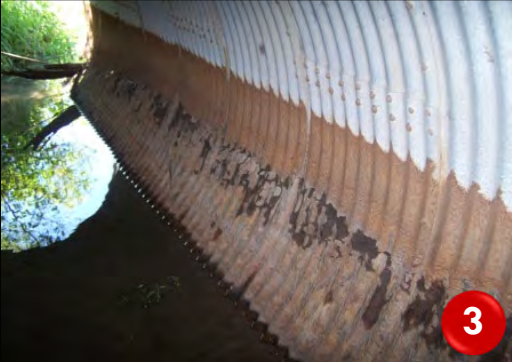
### Serious Condition

- 45% section loss along water line
- Several holes through the walls near ends of culvert

**SERIOUS.** Any **worse or combined condition** described in condition rating "4", up to 50% loss, metal culverts have extreme distortion and deflection in one section (collapse), **extensive corrosion, or deep pitting with scattered perforations**, severe movement or differential settlement of the segments, or loss of fill. Holes may exist in walls or slabs. Integral wingwalls nearly severed from culvert. Severe undermining of curtain walls, wingwalls or pipes.

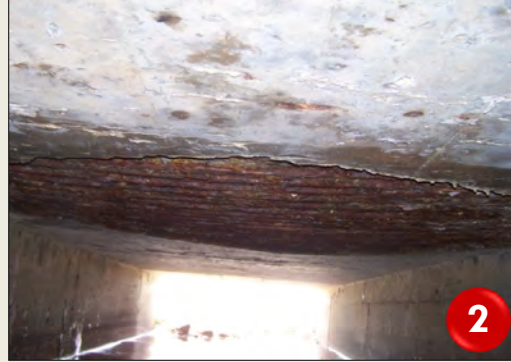
### Critical Condition

- Large spall under traffic lane with two layers of reinforcement exposed
- There is movement in the remaining slab under live load
- **Notify Bureau of Bridges and Structures immediately!**

CRITICAL. Large areas of slab or walls spalled full depth near traffic, large area of reinforcement losses greater than 50% near traffic, metal culverts have extreme **distortion and deflection** throughout with extensive perforations due to corrosion, integral wingwalls collapsed, severe settlement of roadway due to loss of fill, section of culvert may have failed and can no longer support embankment, complete undermining of curtain walls and pipes, special feature inspection will be required to keep the structure open with possible load restrictions. The Bureau of Bridges and Structures shall be notified immediately.

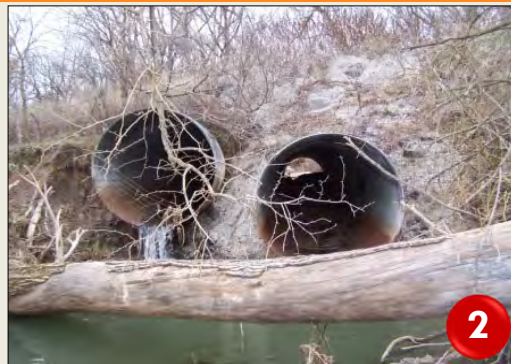
### Critical Condition

- The bottom of the east pipe has failed
- Settlement of approximately 3' has occurred
- Settlement has caused a dip in the roadway

CRITICAL. Large areas of slab or walls spalled full depth near traffic, large area of reinforcement losses greater than 50% near traffic, metal culverts have extreme **distortion and deflection** throughout with extensive perforations due to corrosion, integral wingwalls collapsed, **severe settlement of roadway** due to loss of fill, section of culvert may have failed and can no longer support embankment, complete undermining of curtain walls and pipes, special feature inspection will be required to keep the structure open with possible load restrictions. The Bureau of Bridges and Structures shall be notified immediately.

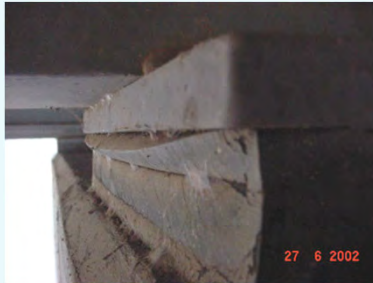
Excessive bulging

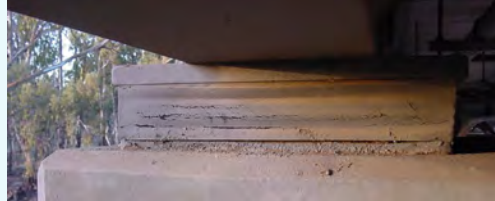
Cracking & splitting

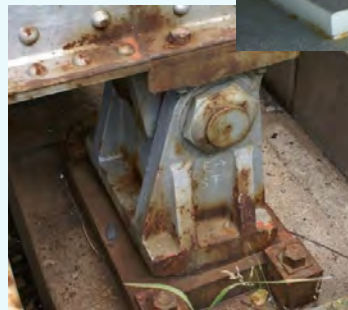
- Alignment & tilt angle
- Freedom of movement
- Full bearing surface contact
- Excessive section loss
- Anchor bolt condition

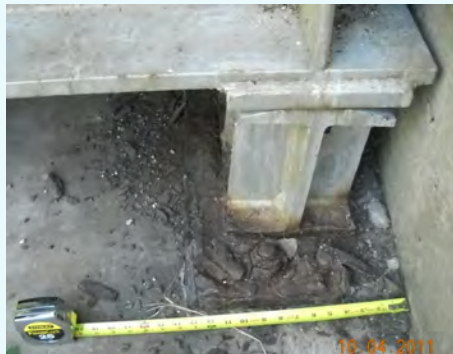
Poor alignment w/ masonry PL

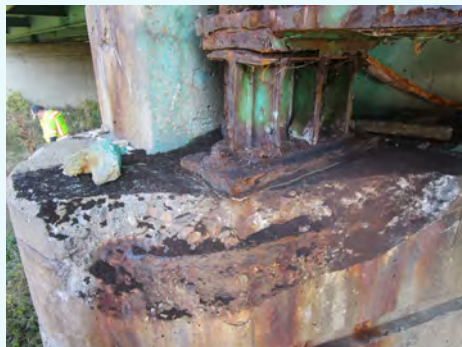
Loss of bearing on masonry of sub unit

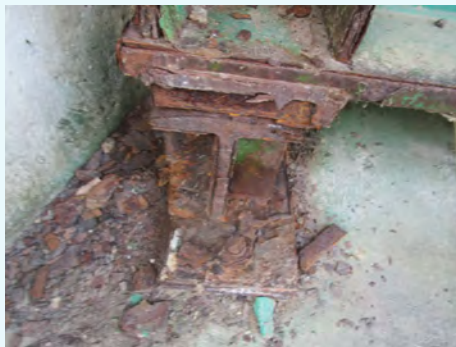
Heavy section loss of rocker bottom

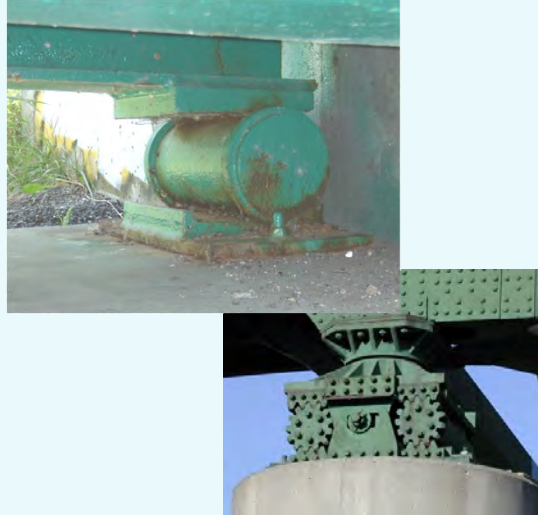
- Alignment
- Freedom of movement
- Full bearing surface contact
- Section loss
- Anchor bolt condition

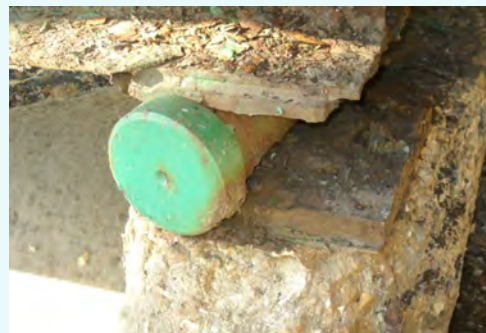
- Section loss on masonry & sole plates
- Bearing rotated out of position
- Loss of bearing area beneath masonry plate
- Check RC Sub condition rating

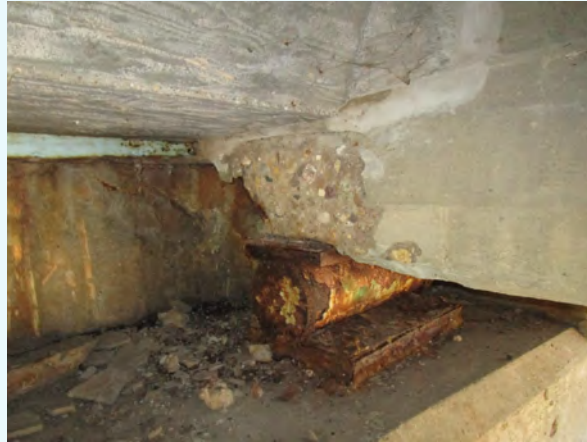
- 30% Loss of concrete bearing area above sole plate of RC T-beam
- Bearing out of position
- Check RC Super condition rating as well

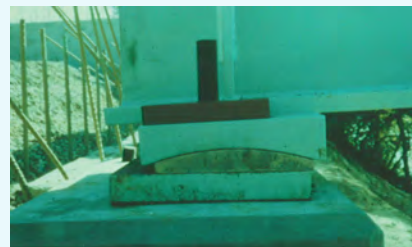
- Alignment
- Freedom of movement
- Full bearing surface contact
- Section loss
- Anchor bolt condition

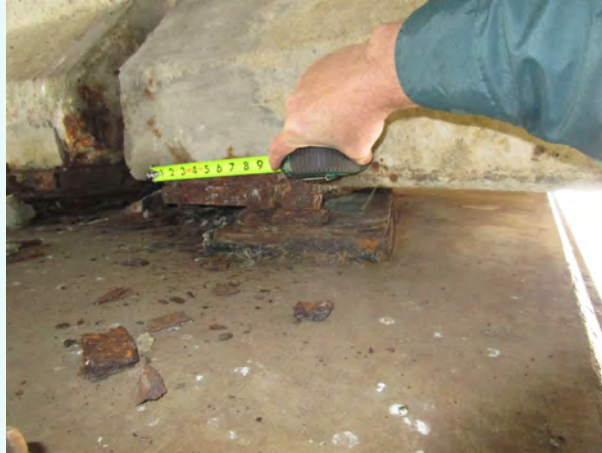
- Anchor bolt broken on one end of masonry PL
- Masonry plate rotated out of position by 7"
- Bearing moved 60% off of masonry plate

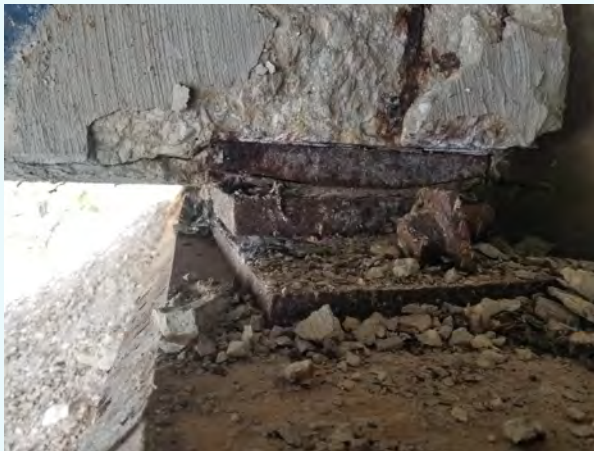
L-18

#### Significant Damage:

- Anchor bolt broken on both ends
- Concrete damage above sole plate
- Sliding surface heavily deteriorated

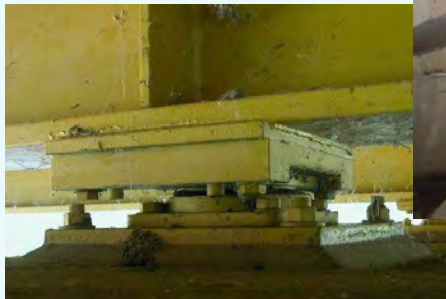
Bearing at extension limit

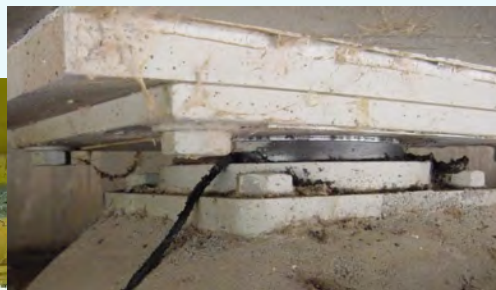
Excessive leakage of rubber

Damaged guide & rubber loss

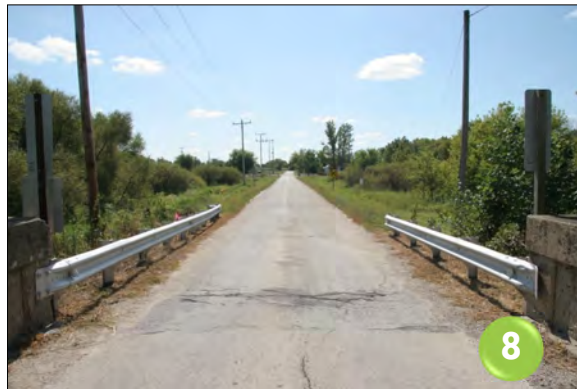
P-6

**Vertical Alignment – Relatively flat**

**Horizontal Alignment - Straight**

No reduction in operating speed

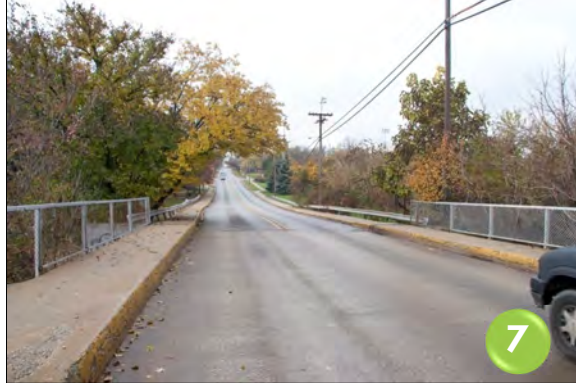
P-7

**Vertical Alignment –  
Relatively flat with  
minor curve on  
approach**

**Horizontal  
Alignment - Straight**

**Very minor reduction in operating speed**

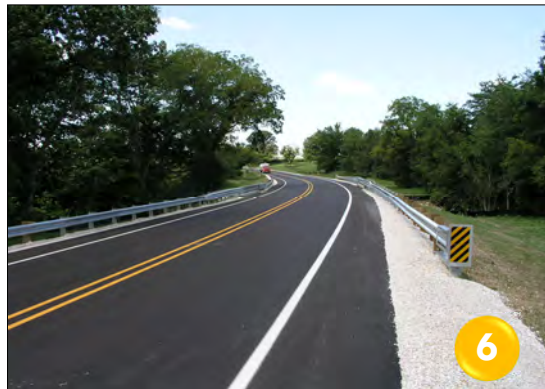
P-8

**Vertical Alignment –  
2% Grade**

**Horizontal Alignment  
– 50 mph Design  
Curve; 55 mph  
Operating Speed**

**A minor reduction in operating speed**

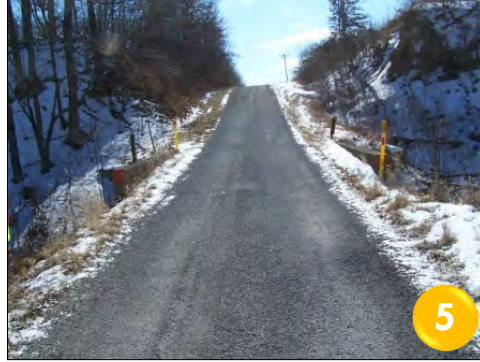
P-9

Vertical Alignment

Horizontal Alignment

Minor reduction in operating speed

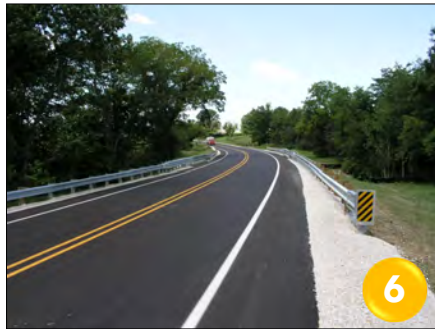
Vertical Alignment – 2% Grade

Horizontal Alignment – 50 mph Design Curve; 55 mph Operating Speed

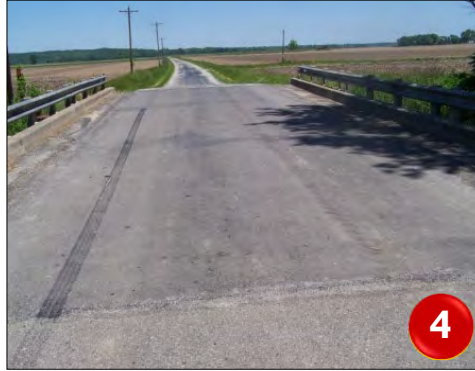
P-11

Vertical Alignment -  
Slight drop at the end  
of the bridge

Horizontal Alignment –  
Straight

Significant reduction in operating speed

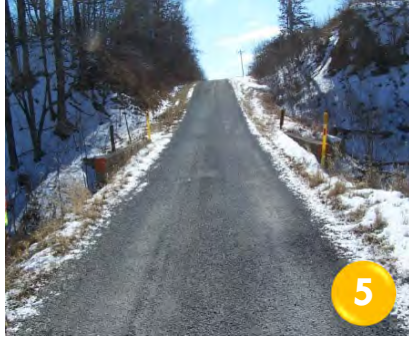
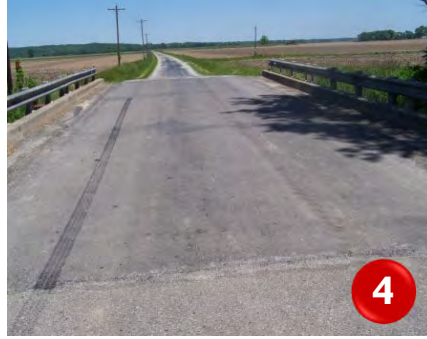
P-13

**Vertical Alignment - Slight drop at the end of the bridge**  
**Horizontal Alignment – Straight**

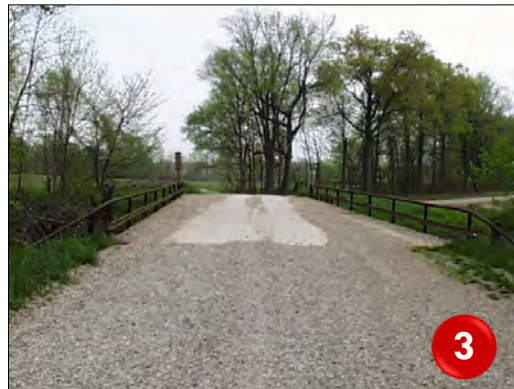
P-14

**Vertical Alignment –  
Some break at  
approaches**

**Horizontal Alignment  
– Sharp turn at bridge  
end – 15 mph**

**Substantial reduction in operating speed, intolerable**

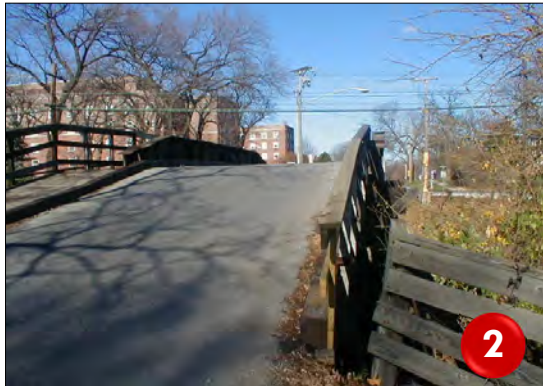
P-15

**Vertical Alignment**  
– Sharp vertical  
gradient change;  
poor sight distance

**Substantial reduction in operating speed, intolerable**

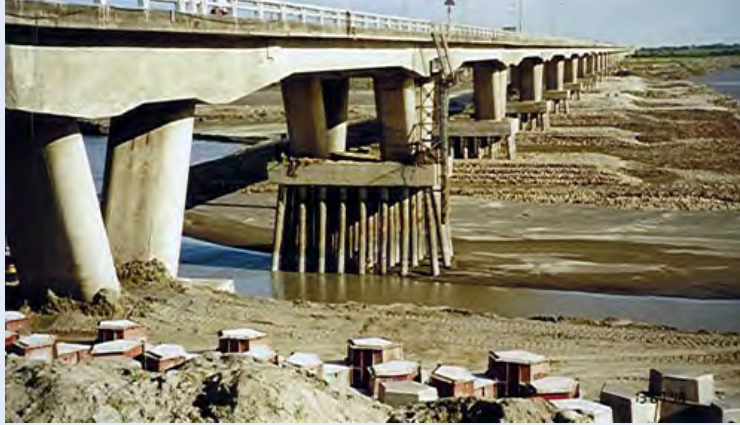
M-5

### General Scour/Degradation

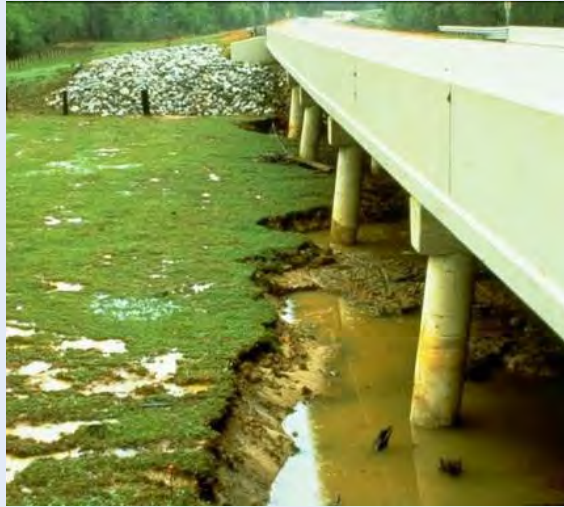
M-7

### Contraction Scour

- This is the lowering of the streambed under the bridge only, resulting from accelerated stream flow due to reduced waterway opening
- Occurs when the bridge waterway opening is restrictive
- Can be caused by:
  - Embankments
  - Debris or Vegetation
  - Substructure units
  - Ice

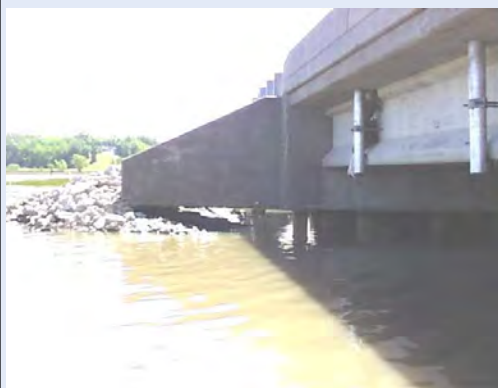
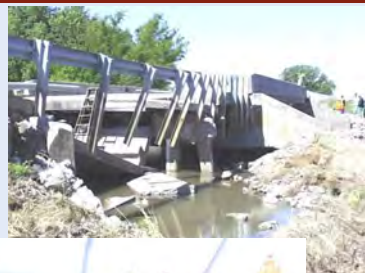
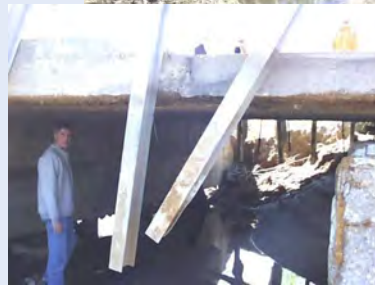
M-8

### Contraction Scour

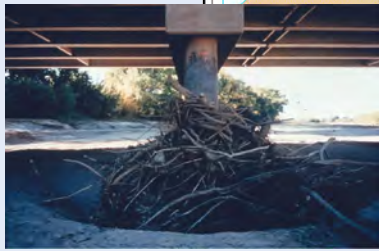
M-10

### Local Scour

(images from USGS)

- This is the lowering of the streambed adjacent to an obstruction in the waterway.
- Often much greater than general scour (up to 10 times)
- Often caused by:
  - Abutments
  - Wide, long, unusually shaped or poorly skewed piers
  - Streamflow depth (as depth increases vortex action is magnified)
  - Debris or Ice accumulation

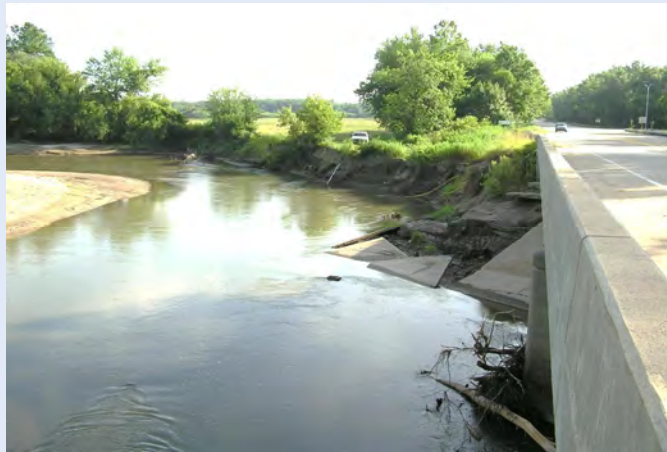
M-12

### Lateral Stream Migration

- This is the relocation of the channel over time due to lateral scour of the embankment.
- Lateral stream migration process:
  - Bank damage
  - Sloughing bank
  - Undermined bank
  - Channel misalignment

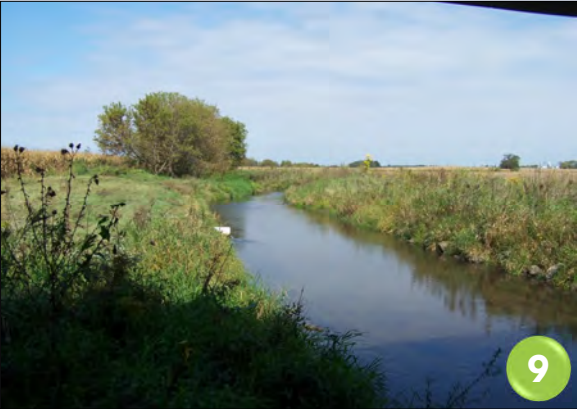
M-20

#### Excellent Condition

- The Channel is well aligned
- Banks are vegetated

**EXCELLENT. There are no noteworthy deficiencies that affect the condition of the channel.**

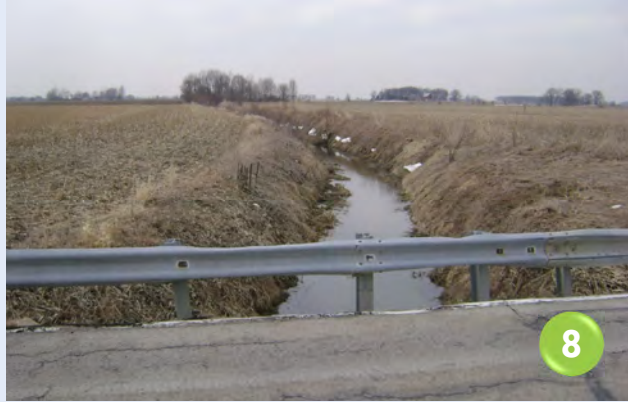
M-21

#### Very Good Condition

- The Channel is well aligned
- Banks are vegetated

**VERY GOOD.** Banks are protected or well vegetated. River control devices such as spur dikes and embankment protection are not required or are in a stable condition.

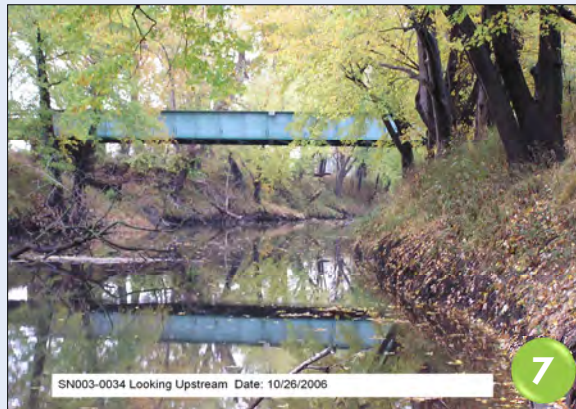
M-22

#### Good Condition

- The Channel is well aligned
- Banks are in need of minor repair with removal of fallen trees
- Drift not affecting waterway opening

**GOOD.** Bank protection is in need of minor repairs. River control devices and embankment protection have a little minor damage. Banks and/or channel may have minor amounts of **drift** not affecting the waterway opening.

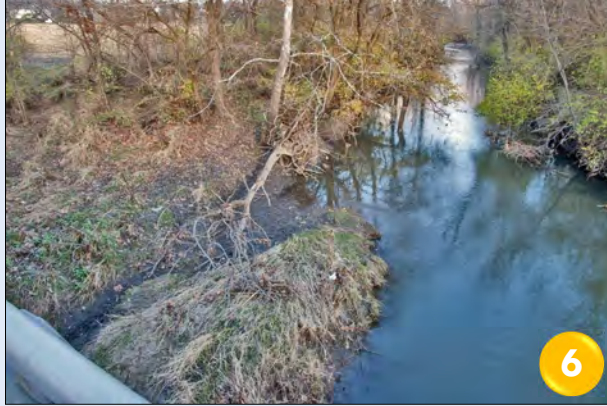
M-23

#### Satisfactory Condition

- Minor streambed movement evident
- Banks are beginning to slump

SATISFACTORY. Bank is beginning to slump. River control devices and embankment protection have widespread minor damage. There is minor streambed movement evident. Debris is restricting the waterway slightly.

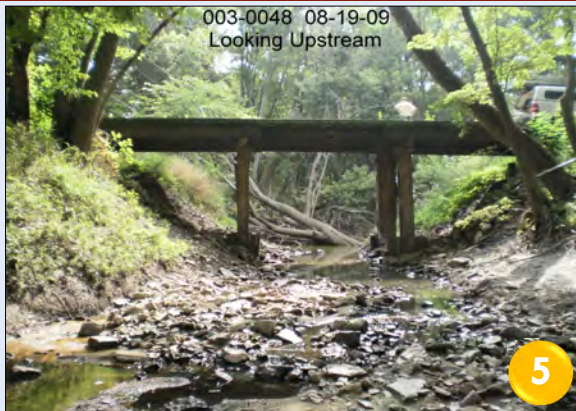
M-24

#### Fair Condition

- Bank protection is being eroded
- Fallen trees are restricting the channel

FAIR. Bank protection is being eroded. River control devices and/or embankment have major damage. Trees and brush restrict the channel.

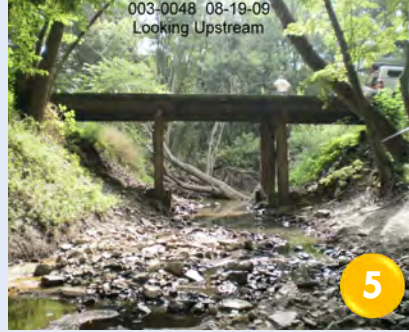
Trees and brush restrict channel.

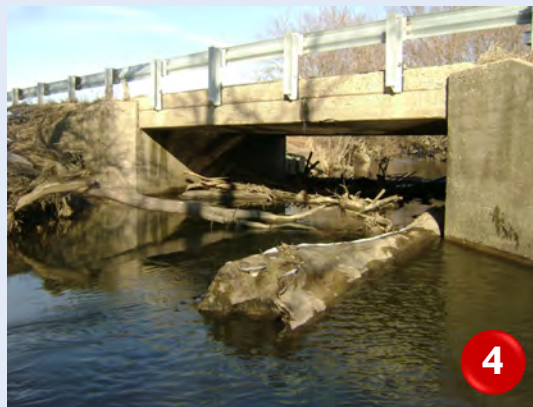
#### Poor Condition

Debris is severely restricting the waterway.

**POOR.** Bank and embankment protection is severely undermined. River control devices have severe damage. **Deposits of debris in the waterways are severely restricting the opening.**

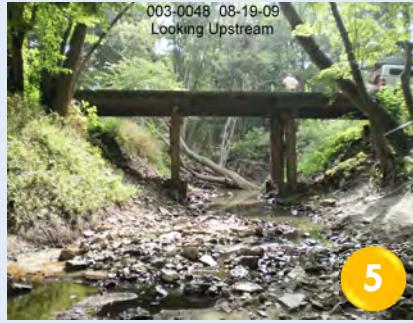
**Bank protection is being eroded.**

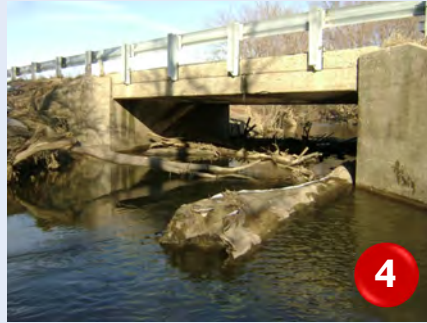
**Debris is severely restricting the waterway.**

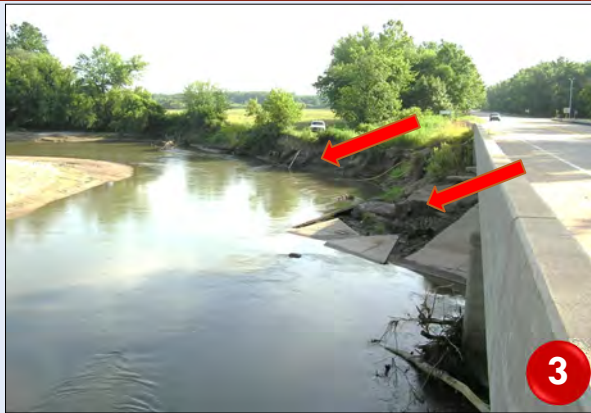
#### Serious Condition

- Channel has shifted toward road
- Bank protection has failed
- Road and abutment threatened by erosion

**SERIOUS. Bank protection has failed. River control devices have been destroyed. Streambed aggradation, degradation or lateral movement has changed the waterway to now threaten the bridge and/or approach roadway.**

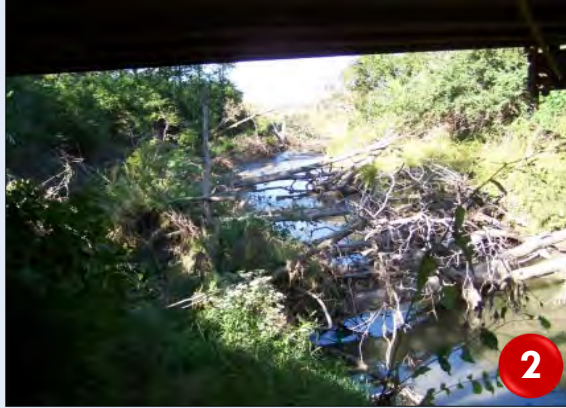
M-29

#### Critical Condition

- Photo 1 of 2
- Banks are severely eroded
- Fallen trees are blocking channel

**CRITICAL.** The waterway has changed to the extent the bridge is near a state of collapse.

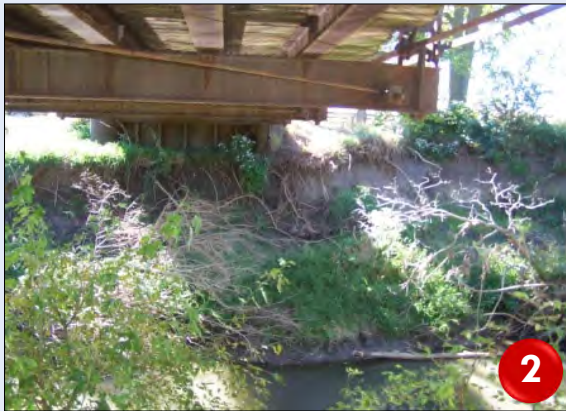
M-30

#### Critical Condition

- Photo 2 of 2
- Bank erosion and debris in stream have redirected stream flow towards abutment
- Scour is undermining abutment and exposing caissons

**CRITICAL.** The waterway has changed to the extent the bridge is near a state of collapse.
