1. Report No. FHWA/IL/PR-097		2. Government Accession No.		3. Recipient's Catalog No.	
4. Title and Subtitle Lime-Modified Soil to Increase Subgrade Stability				5. Report Date

16. Abstract This study compares the benefits during construction of a lime-modified embankment to an unmodified embankment and after the placement of subsequent pavement layers. Adverse weather conditions did not exist during construction to create the type of observations desired. Deflections, on the average, were lower and more uniform on the lime-modified embankment than on the unmodified embankment. Deflections on the CAM subbase were equal, but those on the lime-modified embankment again were more uniform. With the addition of the 10-inch pavement, no difference in average deflection or in uniformity of deflection could be detected. The subbase on the lime-modified embankment had fewer shrinkage cracks per unit length than did the subbase on the unmodified embankment. The overall smoothness of the pavements was equal for both types of embankment.

LIME-MODIFIED SOIL TO INCREASE SUBGRADE STABILITY

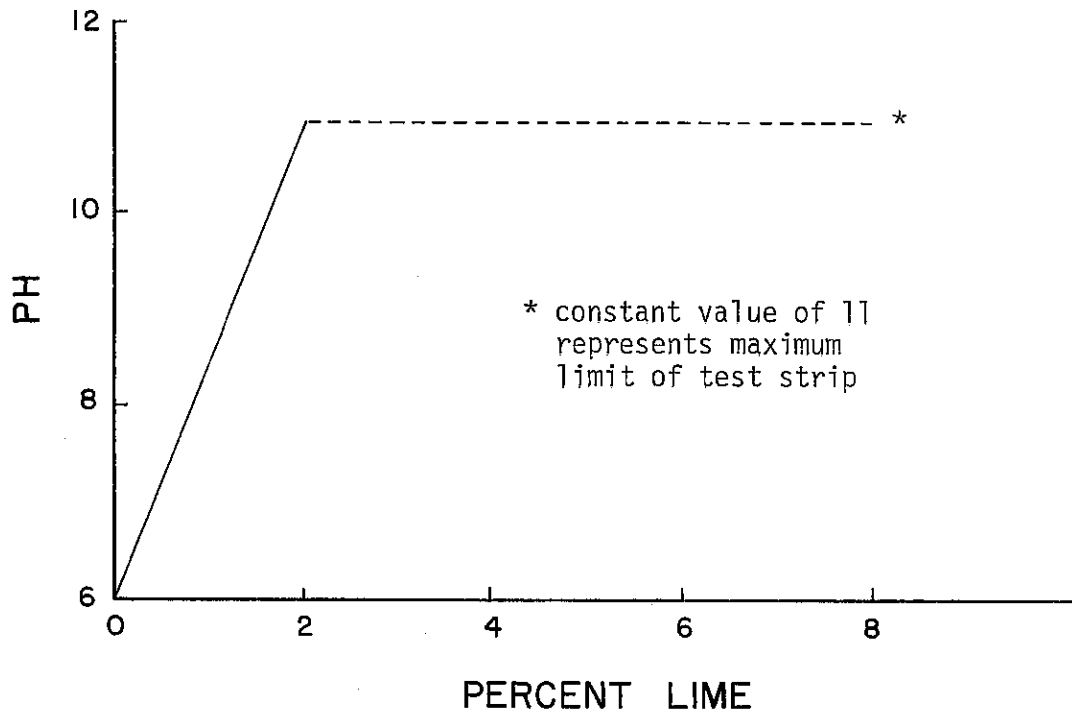
Figure 1. Soil pH versus lime content for C₁ and C₂ horizon tills

Polyhydrated lime from the same source as that used on the job was used in all tests. A pH of 12.3 is needed for pozzolanic reaction between the lime and the aluminates and silicates in the soil. Figure 1 shows the pH for C₁ and C₂ horizon tills with increasing percent of lime. The curve is flat at 11 percent because the limit of the pH test strip was 11. However, a pH rise from 6 to 11 with 2 percent indicates that strength gain from chemical reaction is probable.

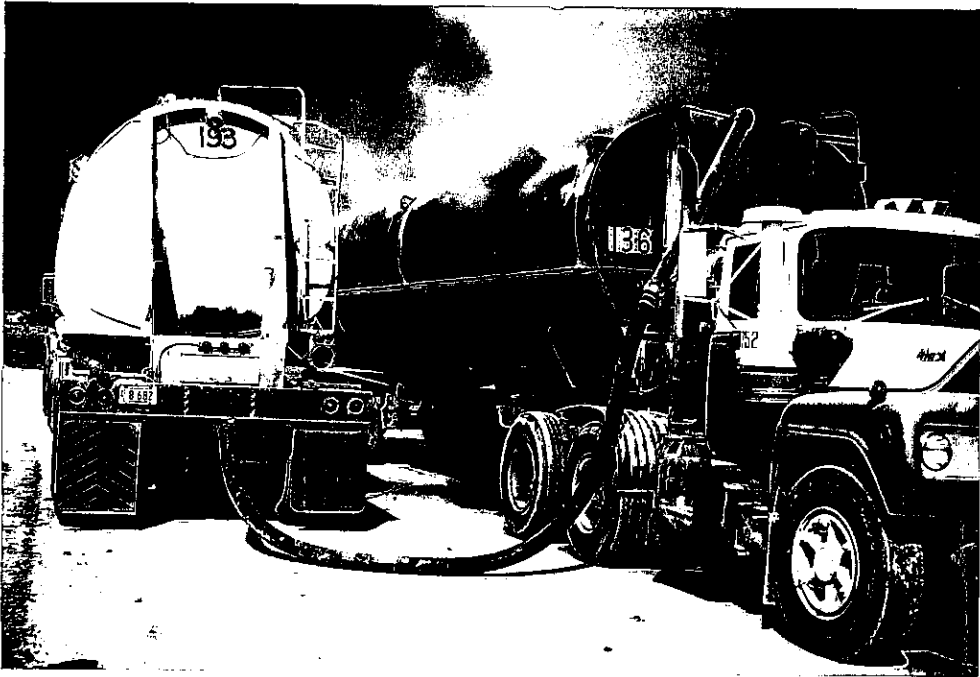
Figure 3. Transport tanker loading distributor truck for placement of lime on embankment

Figure 3 shows the method of transferring the lime from the tanker to the distributor truck. Figure 4 is a view of the canvas tubes used to place the lime on the embankment and Figure 5 shows an overall view of lime being placed on the embankment.

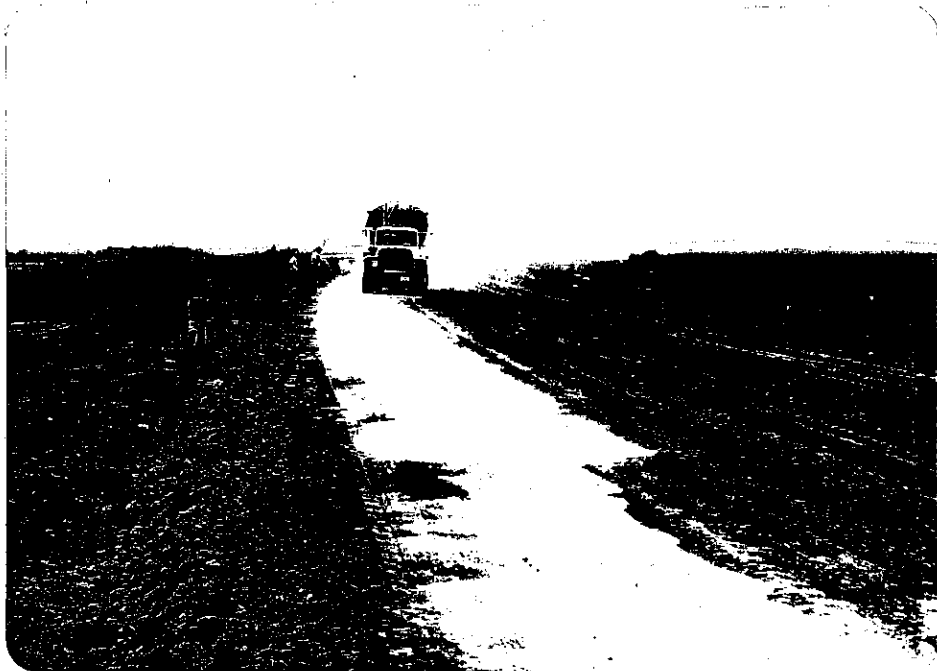
Figure 5. Lime being placed on embankment

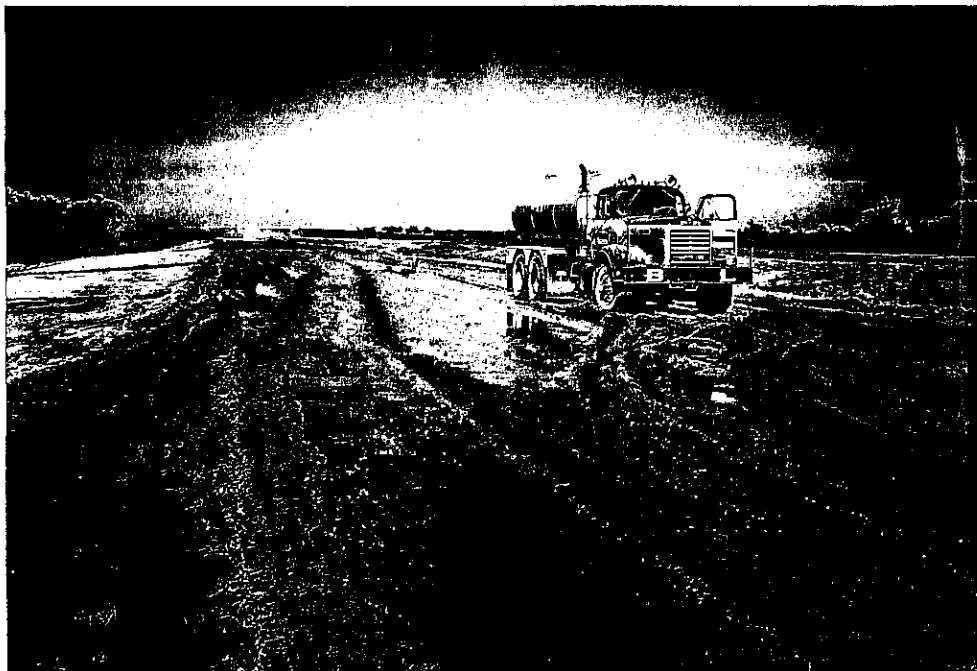
Figure 6. Water truck on embankment at completion of wetting operation

After the dry lime was placed, water trucks moved in to wet the lime prior to mixing with the soil. Normally, two water trucks were used to wet the lime. The number of loads ranged from 1 1/2 to 6 per block. Water was applied until the lime was well saturated. Some lime was lost due to over-watering, causing the lime to be washed off the embankment. Figure 6 shows a typical condition of the lime prior to mixing.
