1. Report No. FHWA/IL/PR-097		2. Government Accession No.		3. Recipient's Catalog No.	
4. Title and Subtitle Lime-Modified Soil to Increase Subgrade Stability				5. Report Date

16. Abstract This study compares the benefits during construction of a lime-modified embankment to an unmodified embankment and after the placement of subsequent pavement layers. Adverse weather conditions did not exist during construction to create the type of observations desired. Deflections, on the average, were lower and more uniform on the lime-modified embankment than on the unmodified embankment. Deflections on the CAM subbase were equal, but those on the lime-modified embankment again were more uniform. With the addition of the 10-inch pavement, no difference in average deflection or in uniformity of deflection could be detected. The subbase on the lime-modified embankment had fewer shrinkage cracks per unit length than did the subbase on the unmodified embankment. The overall smoothness of the pavements was equal for both types of embankment.

LIME-MODIFIED SOIL TO INCREASE SUBGRADE STABILITY

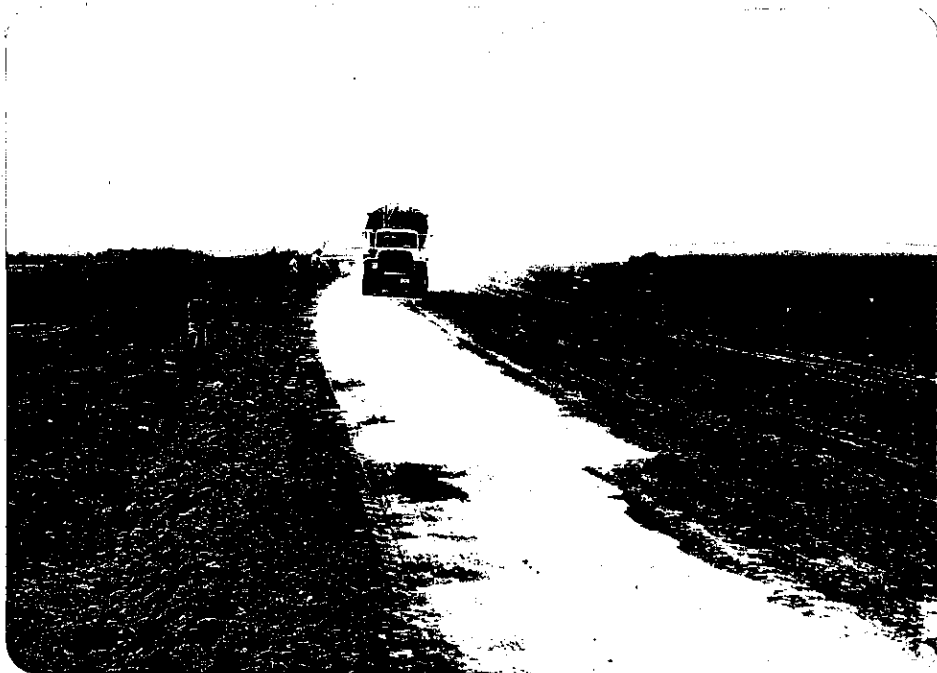
Figure 5. Lime being placed on embankment

Figure 3 shows the method of transferring the lime from the tanker to the distributor truck. Figure 4 is a view of the canvas tubes used to place the lime on the embankment and Figure 5 shows an overall view of lime being placed on the embankment.

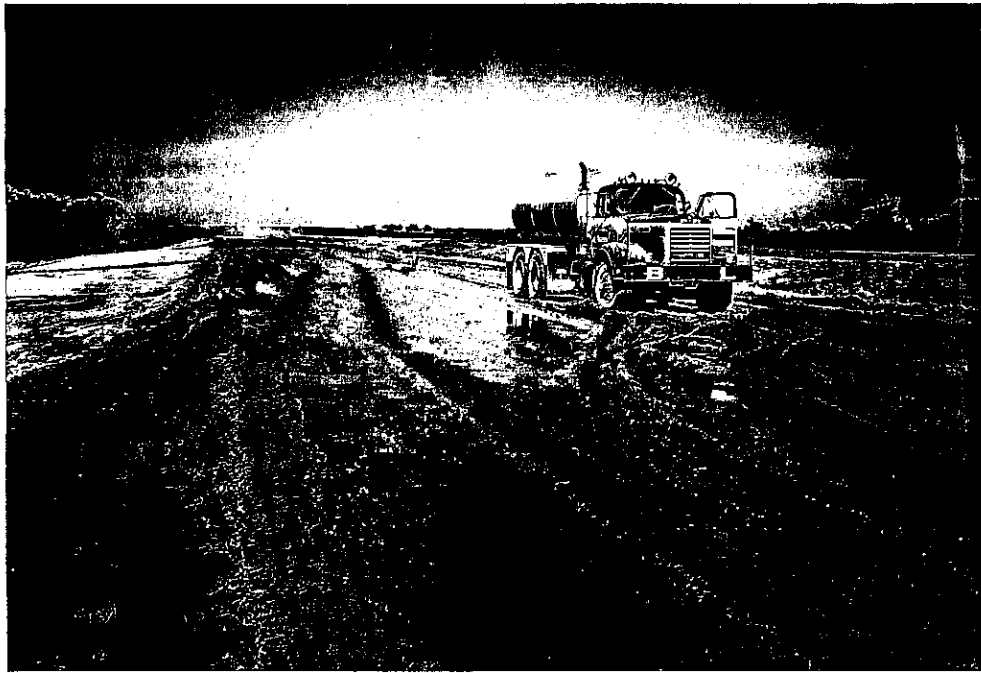
Figure 6. Water truck on embankment at completion of wetting operation

After the dry lime was placed, water trucks moved in to wet the lime prior to mixing with the soil. Normally, two water trucks were used to wet the lime. The number of loads ranged from 1 1/2 to 6 per block. Water was applied until the lime was well saturated. Some lime was lost due to over-watering, causing the lime to be washed off the embankment. Figure 6 shows a typical condition of the lime prior to mixing.

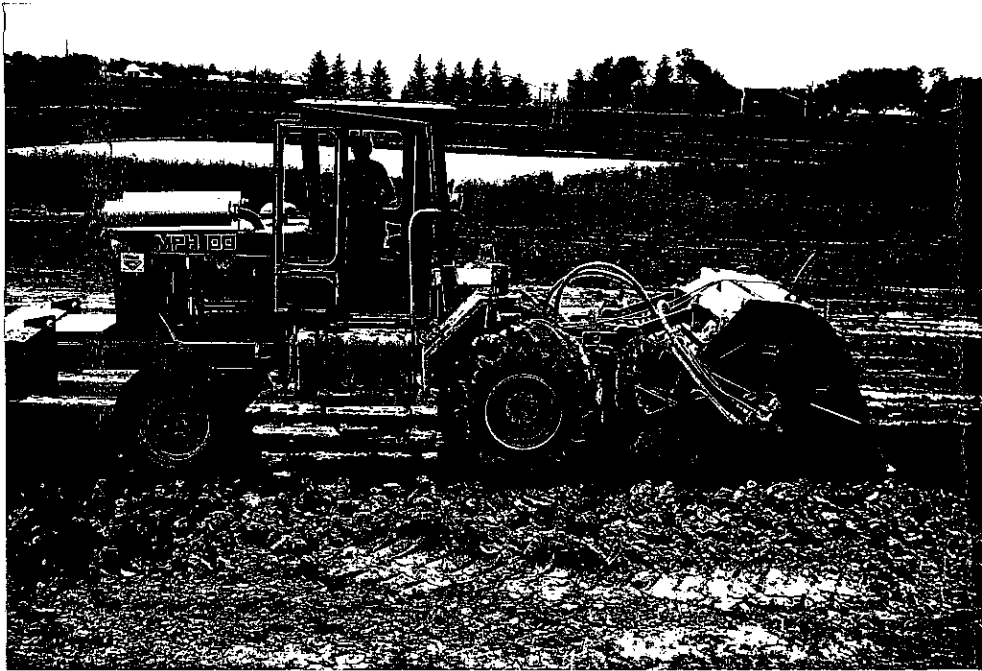
Figure 7. Tiller used at beginning of construction

Mixing was done at first by a tiller. The tiller did an excellent job of mixing the lime and soil, but was slow and broke down twice during the first three days. During the third day of operations the contractor switched to a disc to mix the lime and soil. As a comparison, the production rate from the tiller was slightly less than 3 feet per minute and the rate for the disc was slightly more than 4 feet per minute for the 42-foot-wide embankment. Figure 7 shows the tiller used and Figure 8 is a close-up view of the tiller blades.

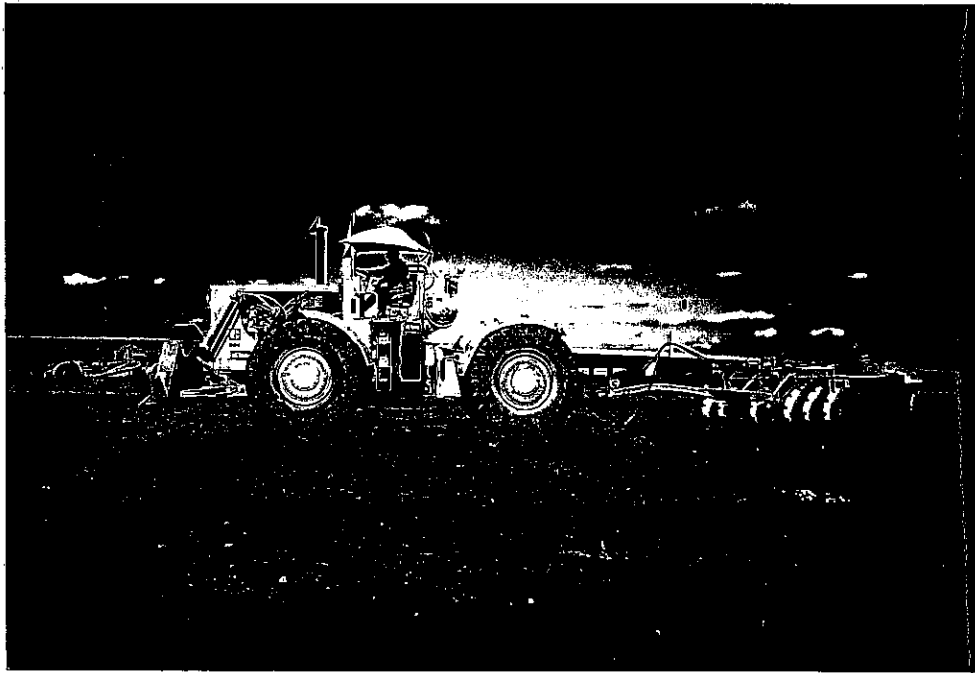
Figure 9. Disc used for majority of study

Due to the nature of the reaction of lime and soil, the process cannot be accelerated. Concentrated discing in one block did not produce a better-mixed soil and lime faster than when two or more blocks were disced as one. Therefore, discing two or more blocks at a time was beneficial. Figure 9 is a picture of the disc.

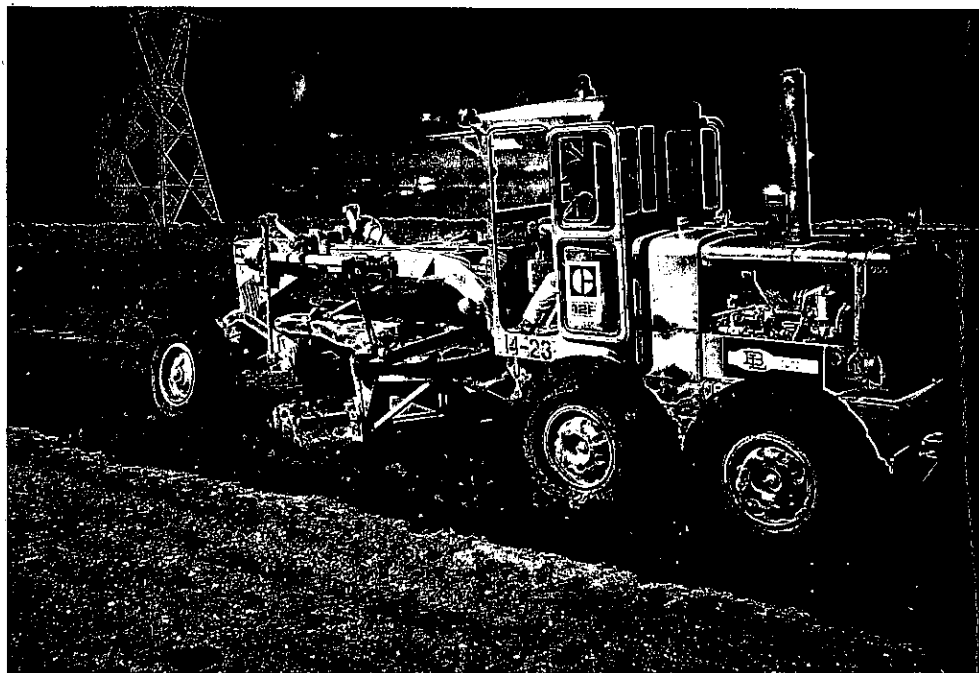
Figure 11. Motor grader scarifying soil

scarified to aid the disc in breaking up the soil for mixing. Figure 11 is a picture of a motor grader scarifying the soil.

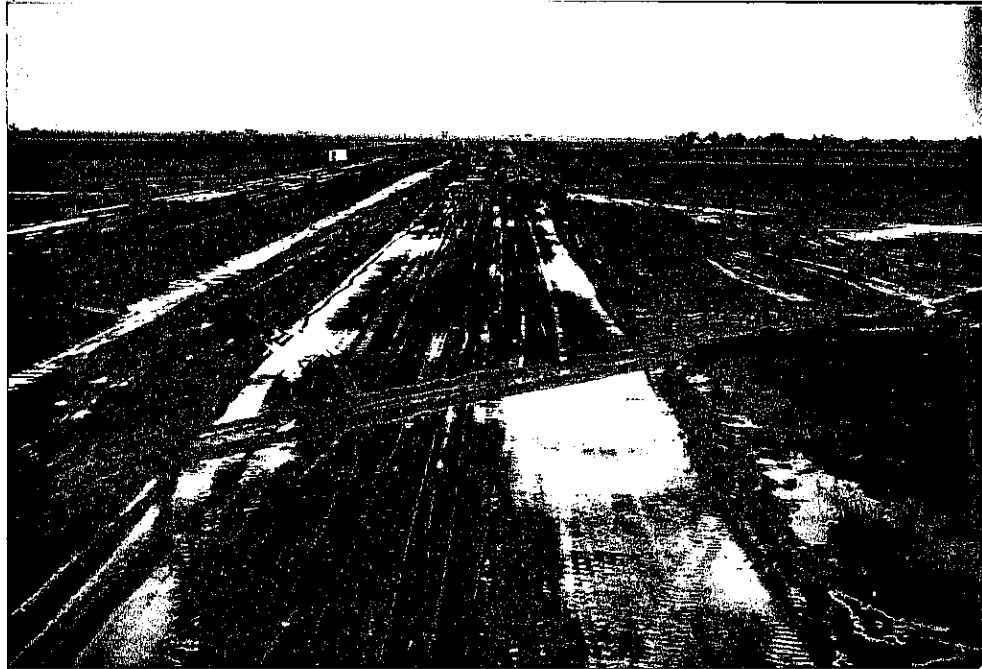
Figure 12. Water standing on lime-modified embankment after 2.7-inch rain

The second rain came late on Tuesday, July 24 and early on Wednesday, July 25 in the amount of 2.7 inches during the construction of the second lift. All construction was stopped on Wednesday, July 25 and resumed on Thursday, July 26. Figure 12 shows standing water caused by a windrow of loose material at the edge of the modified embankment. There was more standing water on the modified embankment than on the unmodified embankment due to the windrows.

For a study of this kind, unfavorable weather conditions would have been preferred. Unfortunately, the weather favored the contractor and it rained only twice during construction of the lime-modified embankment. Therefore, any benefits to the contractor from the use of lime during construction could not be documented. The only evidence of benefit to the contractor is shown in Figures 12 and 13. During a wet year, the benefits
