Introduction to Element Level Bridge Inspection

Participant Workbook (3, ½-Day Remote Version)

April 2024

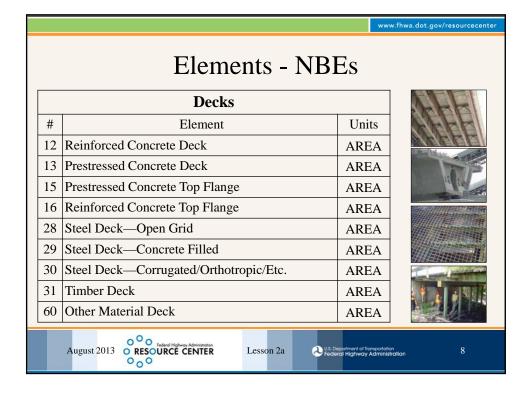
Elements - NBEs • Primary structural elements of bridges necessary to determine the overall condition and safety of the primary load carrying members • Designed to remain consistent from agency to agency across the country • FHWA plans to collect data for all NBEs

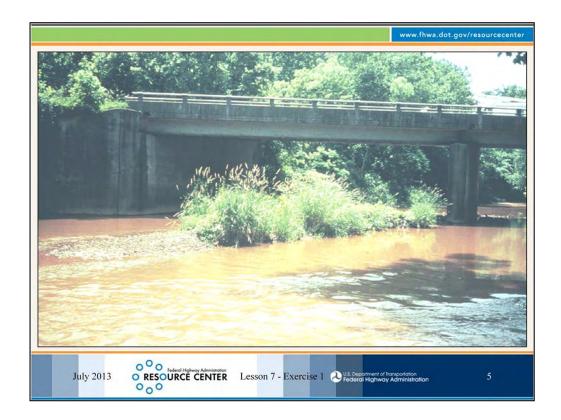
<u>Deck</u>: The deck is continuous across the pier. The bridge has a reinforced concrete deck with an out-to-out width of 30 ft. and length of 150 ft. The deck as no additional wearing surface.

<u>Superstructure</u>: This is a two span, painted steel multi-beam bridge, with each span consisting of six beams having a length of 72 ft.

<u>Substructure</u>: The two simple spans (fixed at pier, expansion at abutments) are supported by one 30 ft. long pier and two 30 ft. long abutments constructed of reinforced concrete.

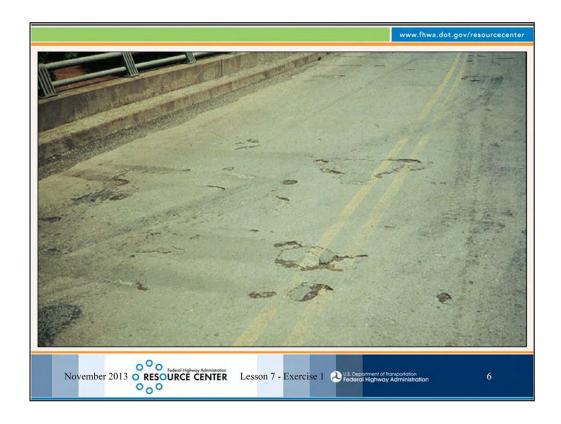
<u>Deck</u>: The top side of the deck in span 1 has 450 sq. ft. of delaminated concrete and 25 sq. ft. of spalls greater than 1 in. deep with exposed rebar having no measureable section loss. There are transverse cracks less than 0.012 in. wide at spacing greater than 3 ft. throughout spans 1 and 2.

<u>Bridge Railing</u>: The bridge railing is a combination of tubular aluminum (no protective coating) on reinforced concrete and has no noteworthy deficiencies.

<u>Joints</u>: The strip seal expansion joints are clean and functional.

Approach Slab: There are no approach slabs.

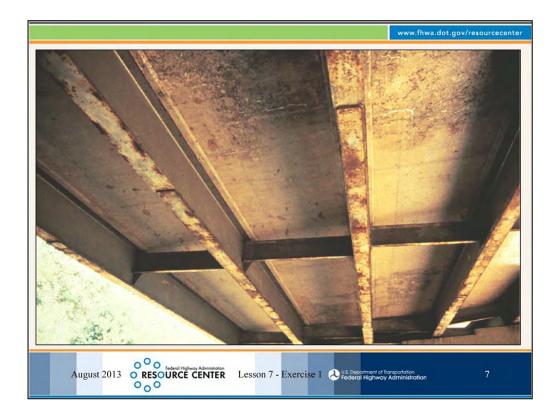
<u>Deck</u>: The underside of the deck in span 2 has cracks less than 0.012 in. wide throughout and 400 sq. ft. with heavy efflorescence and rust stains.

<u>Superstructure</u>: The steel beams have pitting to a depth of 1/16 in. on all bottom flanges throughout their entire length. The coating system is no longer effective for 10% of the steel beam coating and the rest is chalking with surface dulling, but still substantially effective. Coating area for steel beams is 10 sq. ft. per ft. length of beams. The web and top flanges have no noteworthy deficiencies. There is a 4 in. long crack in the cover plate end welds of 3 beams that were discovered during this inspection. All diaphragms are generally pitted to 1/16 in. depth with surface rust.

<u>Bearings</u>: All bearings are functioning as intended. All movable bearings have surface rust throughout and the paint system is no longer effective. All fixed bearings have surface rust on the masonry plates representing 25% of the coating area that is not effective. The remaining coating area is chalking with surface dulling, but still substantially effective. Coating area for bearings is 4 SF per bearing.

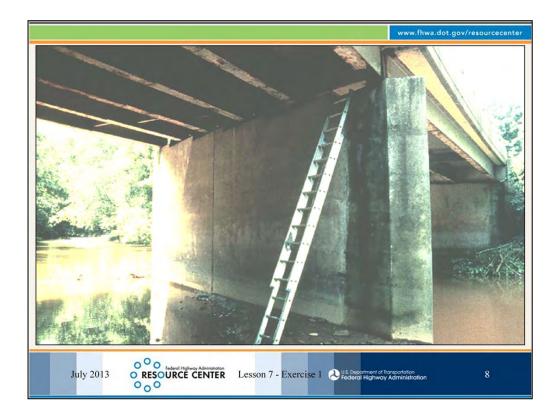
<u>Substructure</u>: The far abutment has a full height vertical crack between Beam No. 3 and No. 4 that has been present and unchanged for many years. This crack varies in width from 1/16 in. to 1/8 in. (0.06 in. to 0.12 in.)

There is scour that exceeds tolerable limits along the front face of the near abutment for a length of 28 ft. x 7 ft. wide to a depth of 4 ft. There is no undermining, the footing is not exposed, and the structure is stable.

The upstream end of the pier has sediment and debris build-up measuring 40 ft. long x 7 ft. wide x 4 ft. high. The pier has two, 1/16 inch (0.06 in.) wide vertical cracks that are full-height with efflorescence that is surface white without build-up.

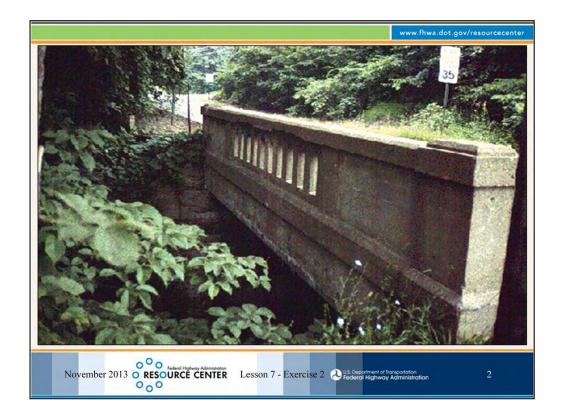
<u>Superstructure:</u> One span, reinforced concrete T-Beam. Structure length 30 ft. Width 24 ft. out-to-out.

Bridge Railing: Reinforced concrete bridge rail.

Element Quantities: The element quantity calculations are shown on slide 15.

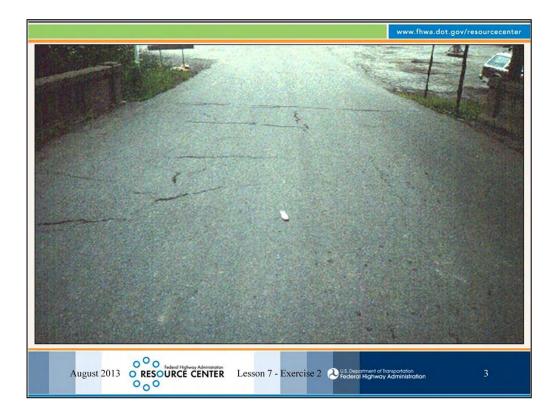
<u>Wearing Surface</u>: Asphalt wearing surface 20 ft. wide by 30 ft. long with random transverse and longitudinal cracks that vary from 1/4 in. to 3/4 in. wide over a 180 sq. ft. area. Remaining area has no noteworthy deficiencies.

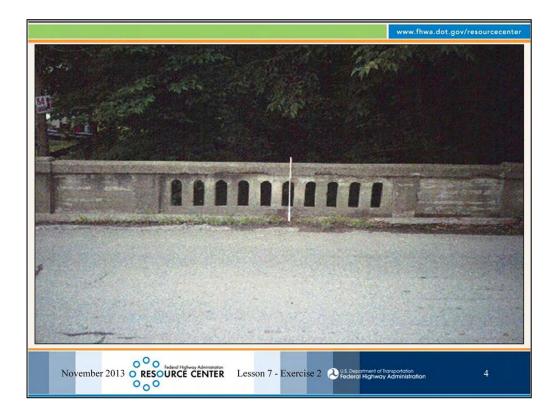
<u>Bridge Railing:</u> RC bridge railing on upstream side. Spalls less than 1 in. deep for 20 ft. with no exposed reinforcing steel. Downstream bridge rail has 15 ft of spalls less than 1 in. deep with no exposed reinforcing steel.

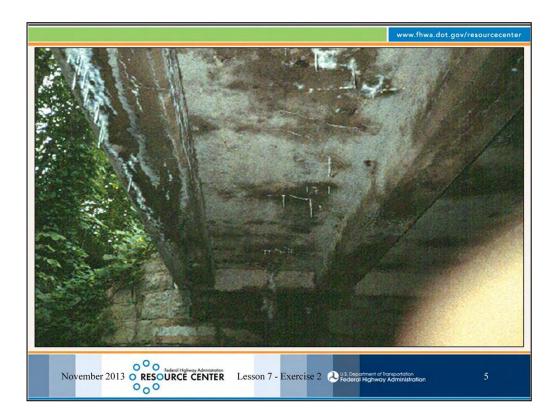
<u>Deck:</u> Underside of deck between Beams 1 and 2. Dark stained areas (80 sq. ft.) are delaminations with cracks less than 0.012 in. wide and efflorescence without rust staining.

<u>Superstructure</u>, <u>Beam 1</u>: Longitudinal 1/16 in. (0.06 in.) wide cracks throughout with heavy efflorescence and rust staining. Dark stained areas are delaminations that exist for the full length. No exposed reinforcing steel.

<u>Superstructure</u>, <u>Beam 2</u>: Longitudinal cracks up to 0.05 in. wide throughout with efflorescence and no rust staining. Dark stained areas are delaminations that exist for the full length. No exposed reinforcing steel.

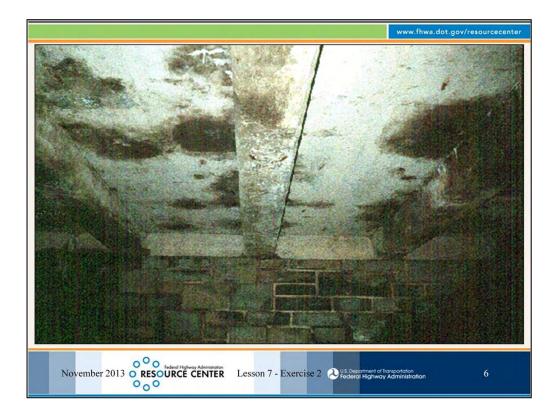
<u>Deck:</u> Underside of deck between Beams 2, 3 and 4. Dark stained areas (40 sq. ft.) are delaminations with cracks less than 0.012 in. wide and efflorescence without rust staining.

<u>Superstructure</u>, <u>Beams 3 and 4:</u> Spalling with exposed reinforcing steel (3 ft.), no section loss. Dark stained areas (40 ft.) are delaminations with cracks less than 0.012 in. wide and efflorescence without rust staining.

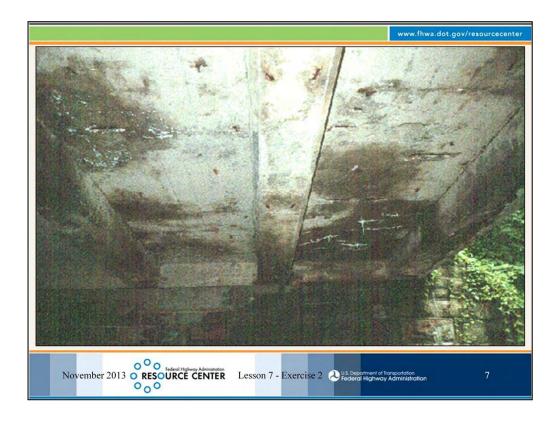
<u>Deck:</u> Underside of deck between Beams 4, 5 and 6. 1 in. to 1.5 in. deep spalls with exposed reinforcing steel (20 sq. ft.). Dark stained areas (80 sq. ft.) are delaminations with cracks less than 0.012 in. wide and efflorescence without rust staining.

<u>Superstructure</u>, <u>Beam 5</u>: Spalling with exposed reinforcing steel, but no section loss (5 ft.). Dark stained areas (20 ft.) are delaminations with cracks less than 0.012 in. wide and efflorescence without rust staining.

<u>Superstructure</u>, <u>Beam 6</u>: Longitudinal 1/16 in. (0.06 in.) wide cracks throughout with heavy efflorescence and rust staining. Dark stained areas are delaminations that exist for the full length. No exposed reinforcing steel.

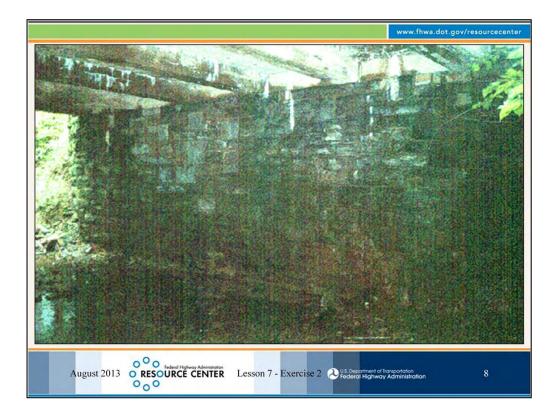
<u>Substructure</u>, <u>Abutment 1:</u> Near abutment looking downstream. Abutment face is 30 ft. long. Top half of the masonry is intact. 20 ft. of the bottom half exhibits moderate disintegration of the stone surface 4 in. to 6 in. deep with loss of mortar in more than 10% of joints. No stones are displaced. No undermining.

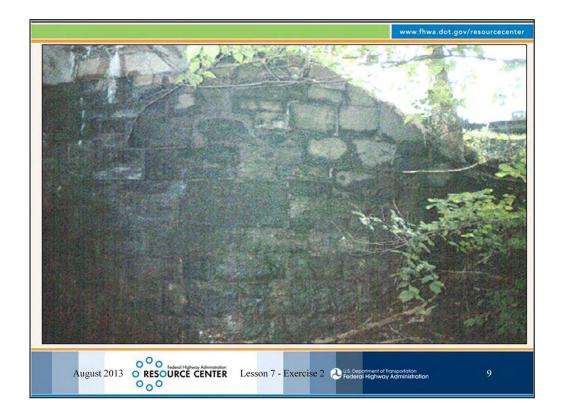
<u>Substructure</u>, <u>Abutment 1:</u> Near upstream wingwall. Wingwall is 10 ft. long and integral with abutment. 10 ft. of the bottom half exhibits moderate disintegration of the stone surface 4 in. to 6 in. deep with loss of mortar in more than 10% of joints. No stones are displaced. No undermining.

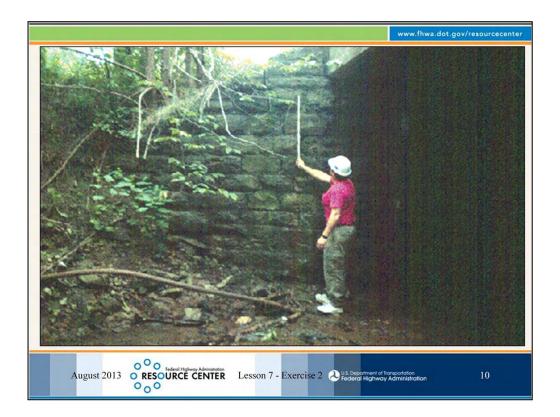
<u>Substructure</u>, <u>Abutment 1:</u> Near downstream wingwall. Wingwall is 10 ft. long and integral with abutment. Some missing joint mortar, less than 10% of total, is typical throughout. No displacement of stones.

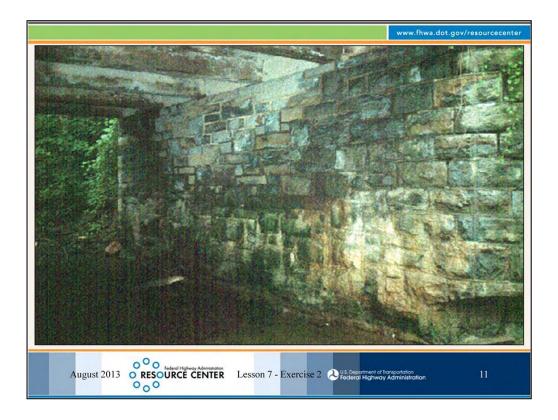
<u>Substructure</u>, <u>Abutment 2</u>: Far abutment looking upstream. Disintegration of stone at streambed level 6 in. to 10 in. deep for 3 ft. No displacement of stones.

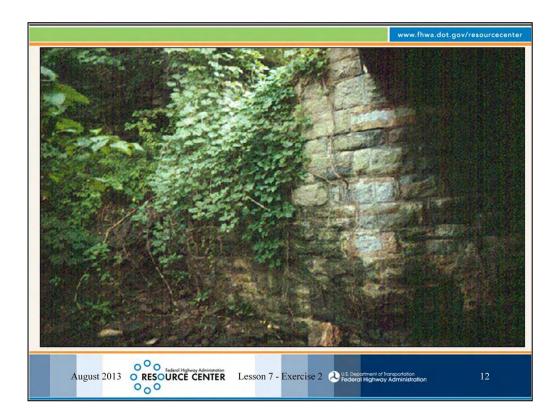
<u>Substructure</u>, <u>Abutment 2</u>: Far upstream wingwall. Wingwall is 10 ft. long and integral with abutment. Masonry intact.

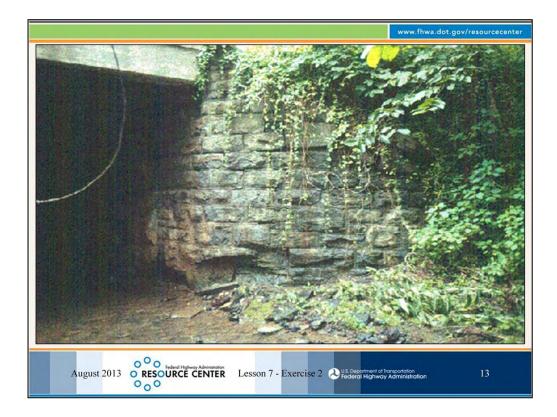
<u>Substructure</u>, <u>Abutment 2:</u> Far downstream wingwall. Wingwall is 10 ft. long and integral with abutment. Failure of stone with portions missing at streambed level for a 2 ft. length.

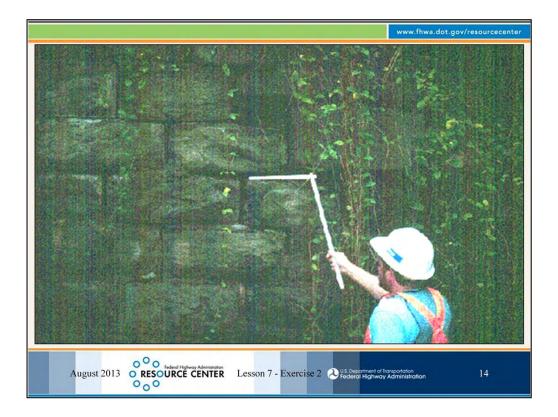
<u>Substructure</u>, <u>Abutment 2:</u> Far downstream wingwall. Complete loss of mortar in top courses throughout.

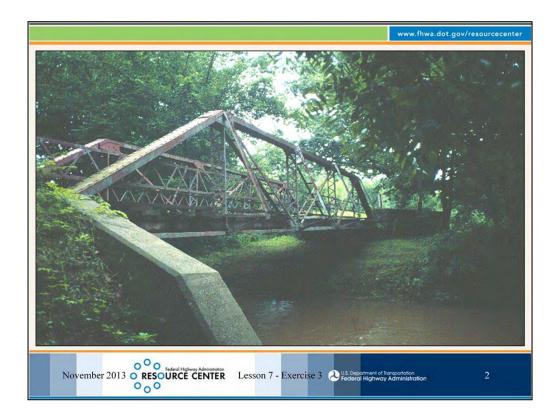
Superstructure: Simple span painted steel through truss 80 ft. long.

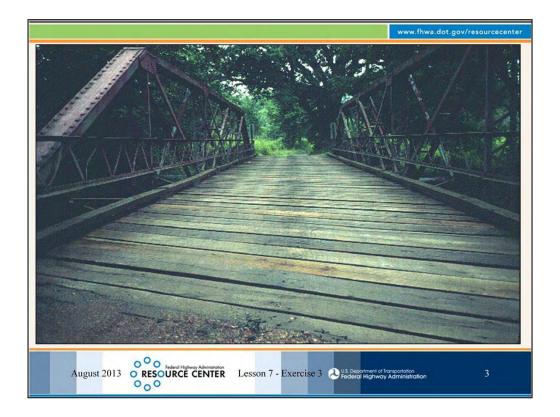
<u>Deck:</u> General view of timber deck as seen from far approach. Deck width out-to-out is 12 ft.

Bridge Rail: Painted metal bridge rail.

<u>Joints:</u> Open joint has severe debris impact over entire length preventing movement at joint.

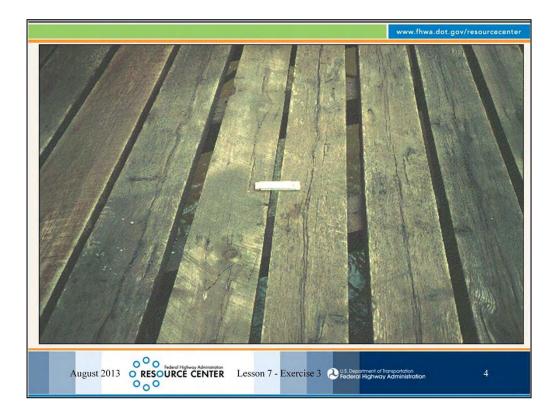
<u>Deck:</u> Typical longitudinal splitting of timber deck planks. 54 sq. ft. of deck area is affected by splits up to 3 ft. long, but deck and connections to stringers are sound under live load. Shallow checks (less than 5% depth of planks) present throughout the deck surface at spacing less than 12 in.

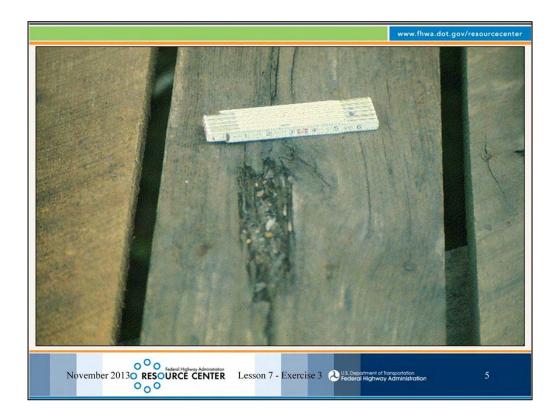
<u>Deck:</u> Decay less than 10% of the timber plank cross section adjacent to a knot hole (1 sq. ft.). This condition was the <u>only</u> spot observed on the entire deck.

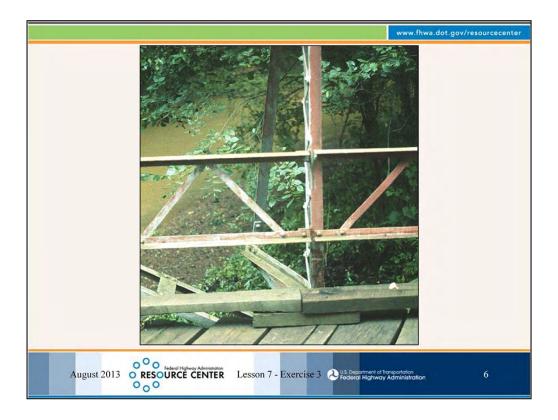
<u>Bridge Rail:</u> Painted metal bridge rail has 20 ft of freckled rust where the coating system is no longer effective. Elsewhere, the metal rail coating system has chalking, without loss of pigment, of the top coat and is substantially effective. Bridge rail coating is 2 sq. ft. per ft.

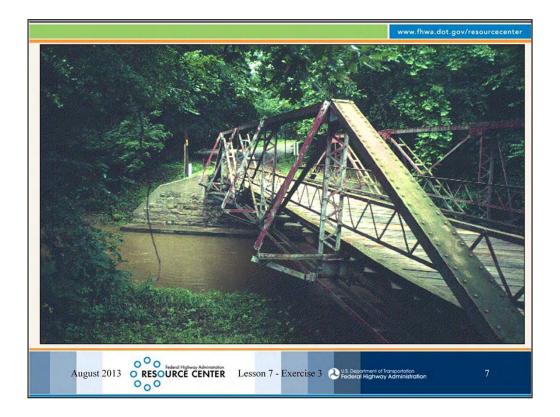
<u>Superstructure, Truss:</u> Truss coating system area is 30 sq. ft. per ft. There is 640 sq. ft. where the coating is no longer effective at protecting the steel. The remaining area of coating is substantially effective.

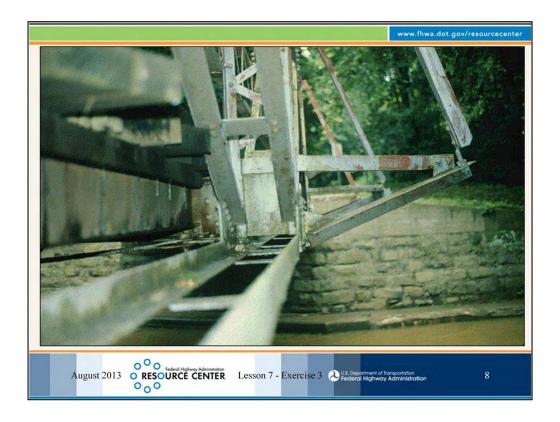
Superstructure, Truss: Truss bottom chords have 100 ft. of freckled rust.

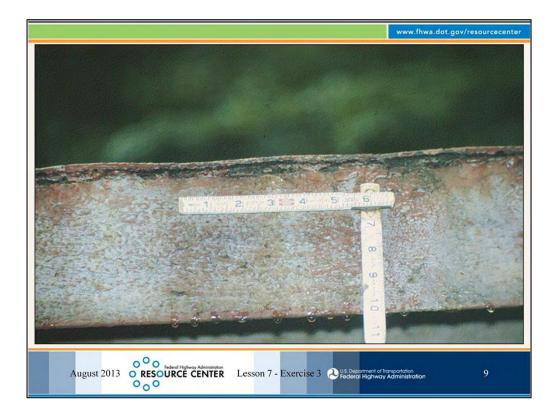
<u>Superstructure, Truss:</u> There is corrosion and section loss of the top chords and end posts with rust packing between channel member and top plate. Typical for entire length of trusses.

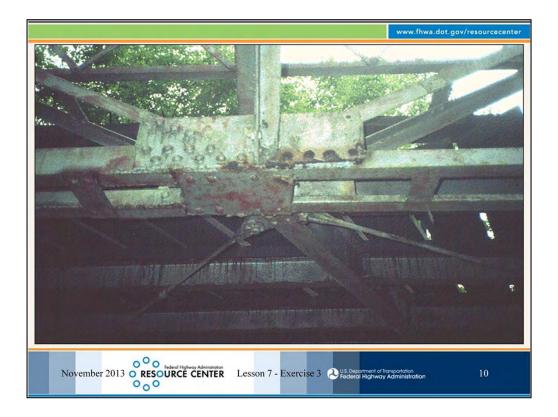
<u>Superstructure</u>, <u>Gusset Plates</u>: There are 10 gusset plate assemblies per truss. Panel point L_3 , upstream truss, field welded repair of gusset plate connection has isolated broken welds and missing connectors. All gusset plates have areas of freckled rust, but are otherwise sound.

Coating system for gusset plates has 10 sq. ft. that is no longer effective and the remaining area is substantially effective. Each gusset plate assembly has a coating area of 6 sq. ft.

"Gusset Plates" refers to gusset plate assemblies. The quantity for this element is the number of primary load path gusset plate <u>assemblies</u>. At a single panel point the quantity is one gusset plate assembly regardless of the number of individual plates at the connection point. There are 10 panel points per truss on this bridge.

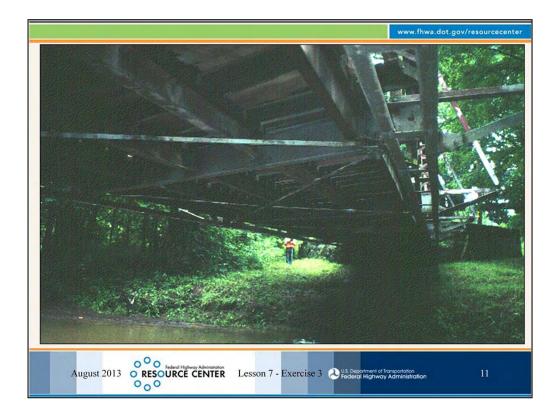
<u>Deck:</u> No additional noteworthy deficiencies on bottom side.

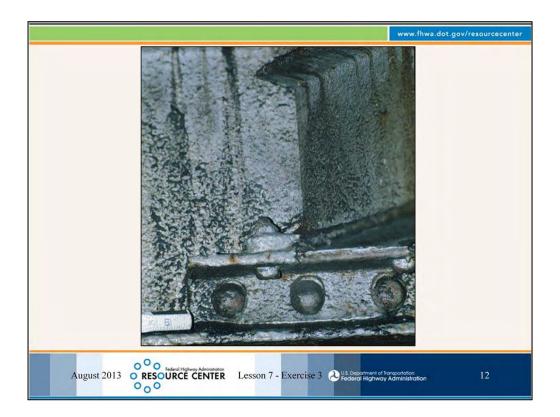
<u>Superstructure</u>, <u>Stringers</u>: Typical stringer to floorbeam connection. All connections are sound.

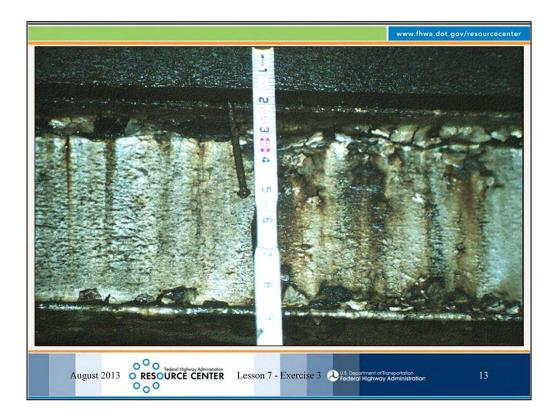
<u>Superstructure</u>, <u>Stringer</u>: Typical stringer condition. 1/16 in. section loss of top flange, on all stringers, full length. Coating system is no longer effective for 375 sq. ft. The remainder of the coating system area is substantially effective.

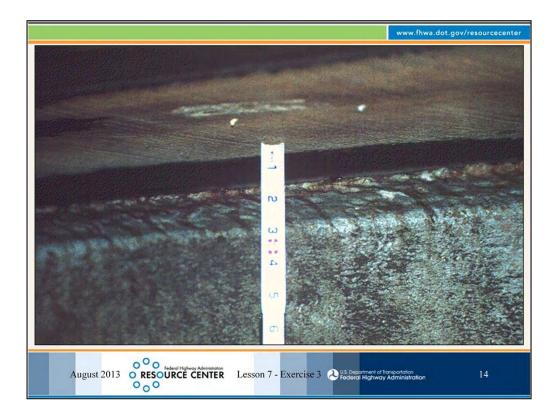
<u>Superstructure</u>, <u>Floor beams:</u> Floorbeam #0 has 1/8 in. section loss of top flange, full length. Floorbeam #5 the same. There is 30 sq. ft. of the coating that is no longer effective. There is 60 sq. ft. of the coating that is substantially effective.

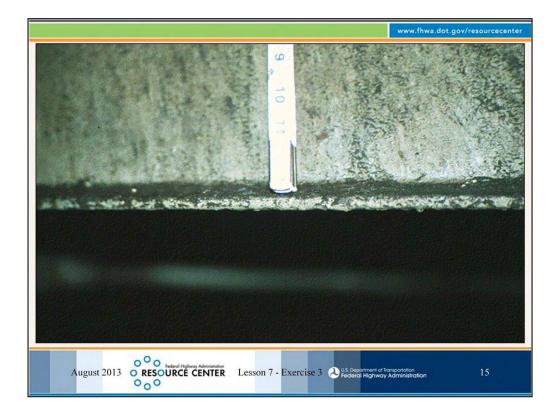
<u>Superstructure</u>, Floor beams: Floorbeam #4 has 1/16 in. pitting on bottom flange, full length. Floorbeams #1, 2 & 3 are the same. There is 60 sq. ft. of coating that is no longer effective and there is 300 sq. ft. that is substantially effective.

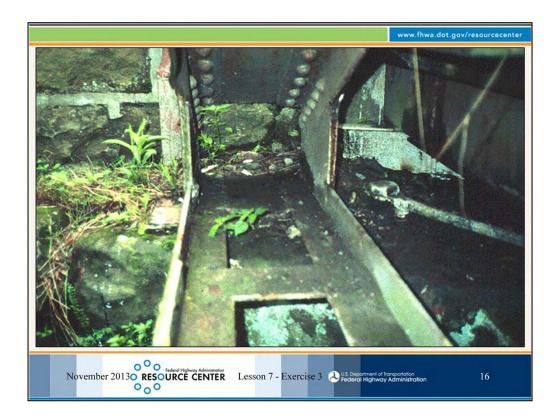
<u>Movable Bearings:</u> Near abutment upstream sliding plate expansion bearing has corrosion with section loss and coating is no longer effective. Typical condition both bearings. Coating system area for bearings is 2 sq. ft. per bearing.

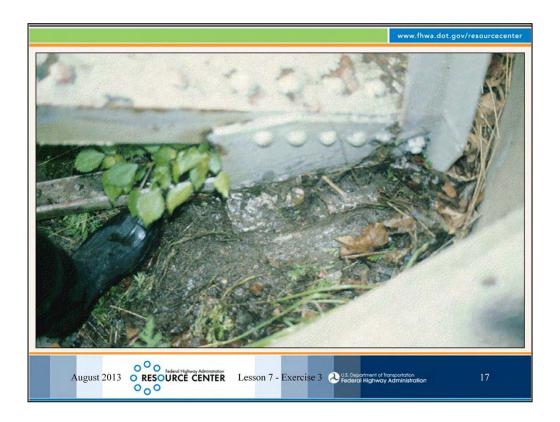
<u>Fixed Bearings:</u> Far abutment upstream fixed steel plate bearing. No noteworthy deficiencies. Coating system area for bearings is 2 sq. ft. per bearing. Coating system is substantially effective.

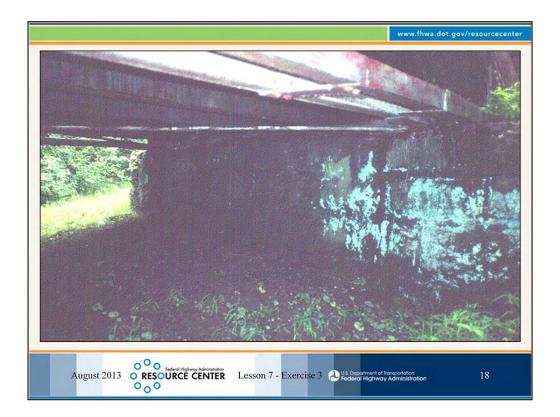
<u>Substructure</u>, <u>Abutment 1:</u> General view of near abutment. Stone masonry construction. Abutment face measures 19 ft. long. All stones and mortar joints are sound.

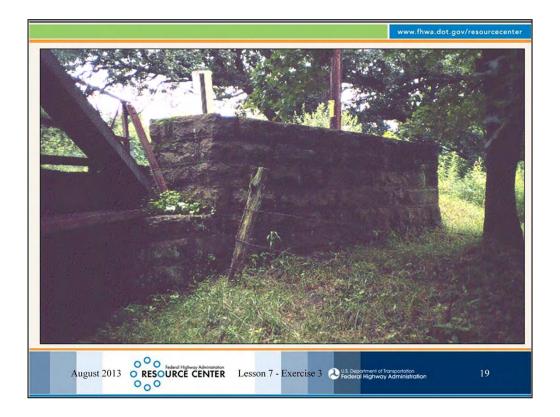
<u>Substructure</u>, <u>Abutment 1:</u> General view of left wingwall (upstream) at near abutment. Wingwall is 15 ft. long and integral with abutment. All stones and mortar joints are sound.

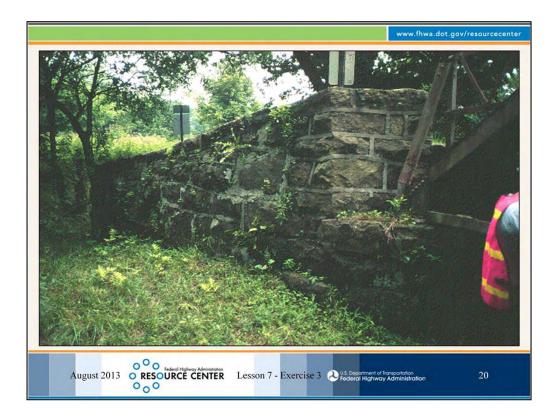
<u>Substructure</u>, <u>Abutment 1:</u> General view of right wingwall (downstream) at near abutment. Wingwall length is 20 ft. and is integral with the abutment. All stones and mortar joints are sound.

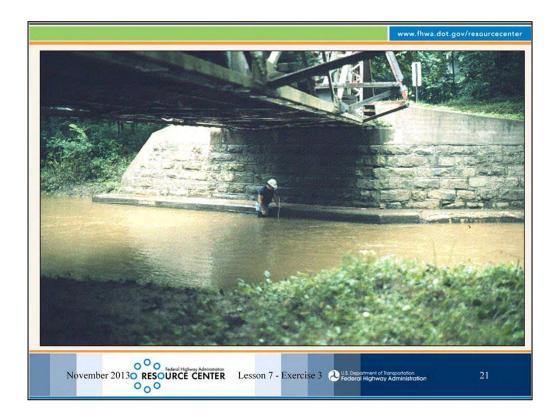
<u>Substructure</u>, <u>Abutment 2:</u> General view of far abutment. Abutment face measures 19 ft. long. Bearing seat and tops of wingwalls have been reconstructed of reinforced concrete with no noteworthy deficiencies. A concrete footing apron has been added along front face of abutment and each wingwall. Scour of the streambed for 30 ft. along the abutment and far right wingwall. No undermining and no indication of structure instability.

*Abutment-2 has a reinforced concrete addition to the top of the stone masonry. In this example both the Masonry and RC Abutment elements are used to record the conditions for each of these materials. In this case there is 108 ft. of Masonry Abutment (abutments 1 & 2) and 54 ft. of RC Abutment (abutment 2 only). Also, a RC apron has been added to the base of Abutment-2. In this example the Pile Cap/Footing element is used to record the condition of the apron.

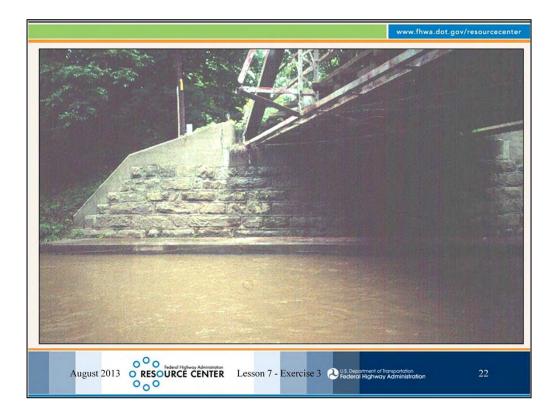
<u>Substructure</u>, <u>Abutment 2:</u> General view of left wingwall (upstream) for far abutment. Wingwall is 15 ft. long and integral with the abutment. All stones and mortar joints are sound. No scour was observed for this wingwall.

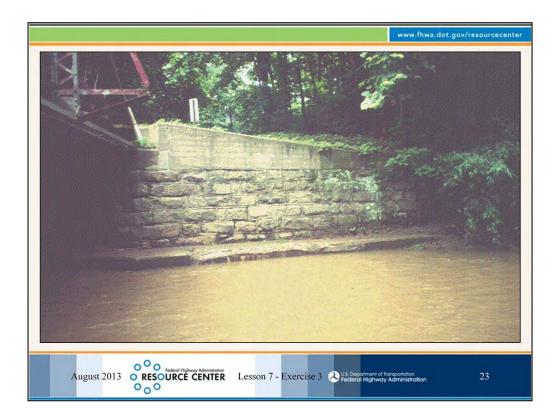
<u>Substructure</u>, <u>Abutment 2:</u> General view of right wingwall (downstream) for far abutment. Wingwall is 20 ft. long and integral with the abutment. Mortar joints are deteriorated and missing for a 5 ft. length. All stones are sound and not displaced. Spalling of the footing apron for 10 ft. length.

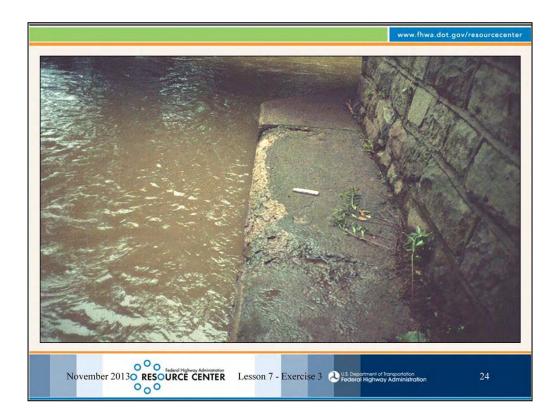
<u>Substructure</u>, <u>Abutment 2:</u> Close-up view of footing apron along front face of far abutment. Spalling greater than 6 in. diameter of footing apron for 10 ft. along the front edge. No exposed reinforcing steel.

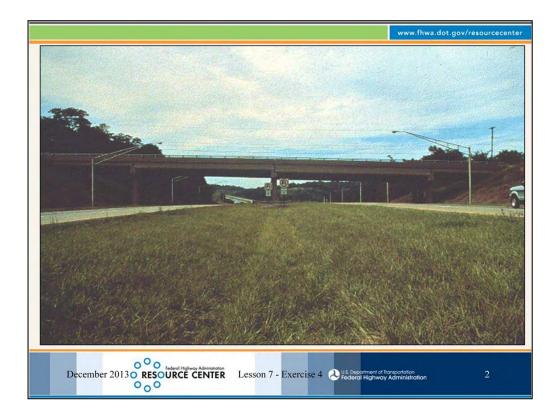
Elevation view. 4 simple spans, 8 girder lines, structure length is 270 ft.

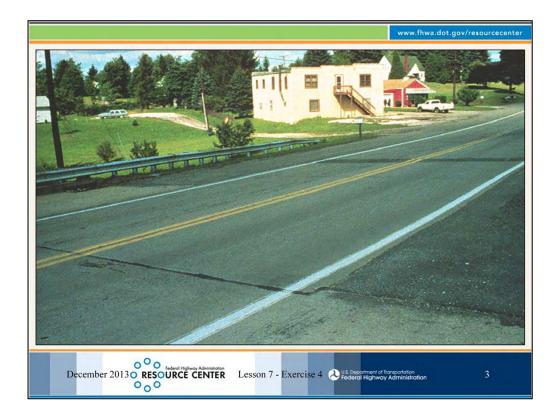
<u>Approach Slabs</u>: View of RC approach slab that is 24 ft wide by 30 ft long. There are no noteworthy deficiencies.

<u>Joints:</u> Joint at the bridge/approach slab interface has a poured sealant that is 44 ft. long. Same at other approach. There is debris partially filling 40 ft. of the joints but not effecting movement.

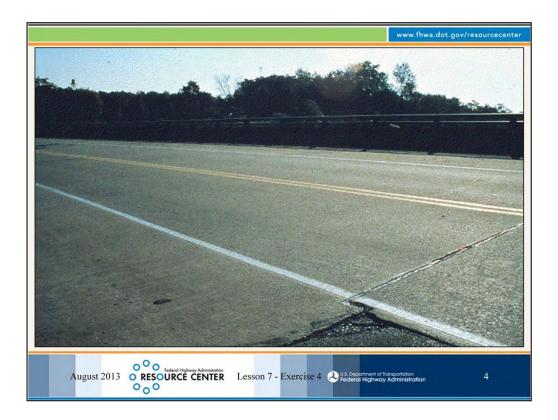
<u>Deck:</u> General view of reinforced concrete deck - Span 1. Deck width is 44 ft. out-to-out. Transverse cracks less than 0.012 inches wide at variable spacing greater than 3 ft. throughout the entire deck in all spans.

<u>Bridge Railing:</u> Combination bridge rail, reinforced concrete with aluminum top rails, no protective coating. Reinforced concrete has cracks less than 0.012 inches wide at 4 ft. spacing throughout.

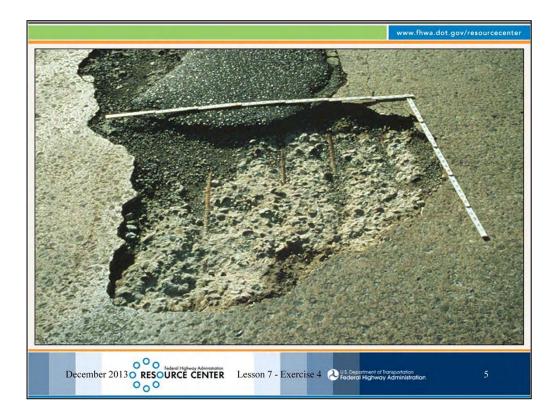
<u>Deck:</u> Spall and patch at mid-span of Span 2 left lane. Spalls greater than 1 in. deep with exposed reinforcing steel (8 sq. ft.). There is no measurable section loss on exposed reinforcing steel. Distressed patches (10 sq. ft.).

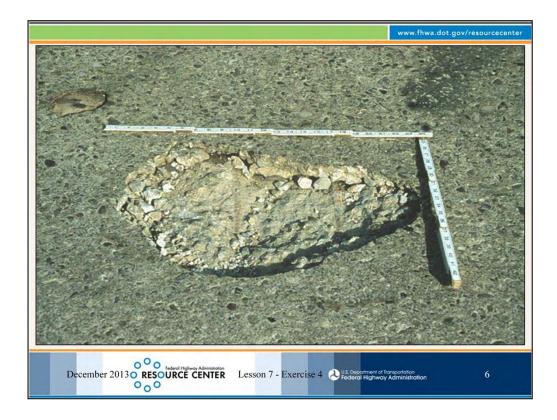
<u>Deck:</u> Spall greater than 1 in. deep with exposed reinforcing steel (4 sq. ft.) on Span 2 at mid-span right lane. There is no measurable section loss on exposed reinforcing steel.

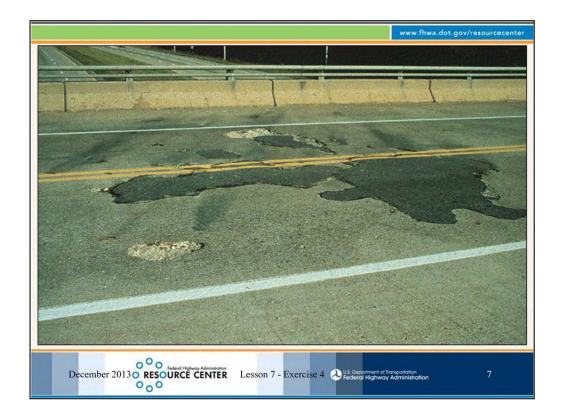
<u>Deck:</u> Spalls greater than 6 inches in diameter and distressed patches on deck Span 2. Total area of spalls is 12 sq. ft. Total area of distressed patches is 100 sq. ft.

<u>Bridge Railing:</u> Spalls greater than 1 in. deep with exposed reinforcing steel (10 ft.). There is no measurable section loss on exposed reinforcing steel.

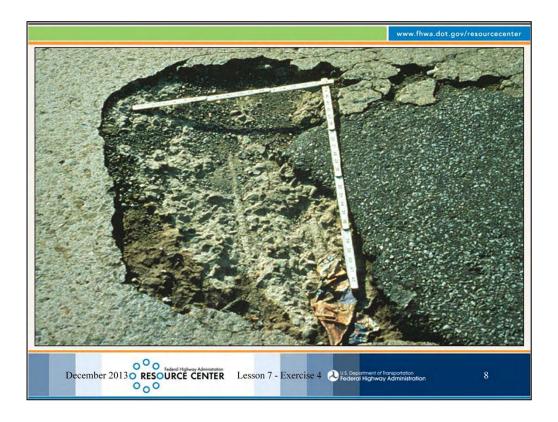
<u>Deck:</u> Span 4 at mid-span of the left lane. Spall greater than 6 in. diameter with exposed reinforcing steel (5 sq. ft.). There is no section loss of the exposed reinforcing steel. Distressed patch (7 sq. ft.)

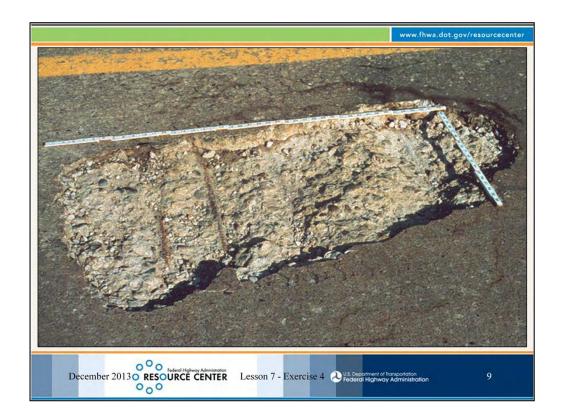
<u>Deck:</u> Span 4 at mid-span of the right lane. Spall greater than 6 in. diameter with exposed reinforcing steel (10 sq. ft.). There is no section loss of the exposed reinforcing steel.

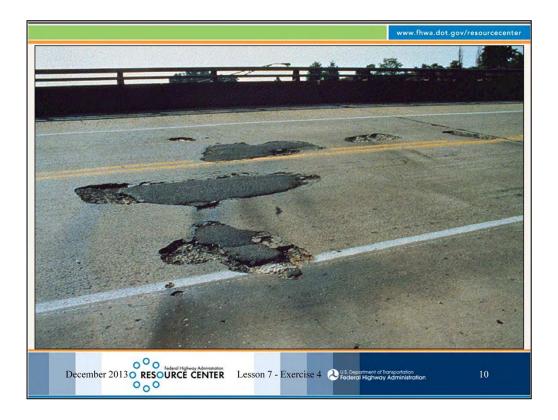
<u>Deck:</u> General view of deck Span 4. Spalls greater than 1 in. deep with exposed reinforcing steel (40 sq. ft.). There is no measurable section loss on exposed reinforcing steel. Distressed patches (60 sq. ft.).

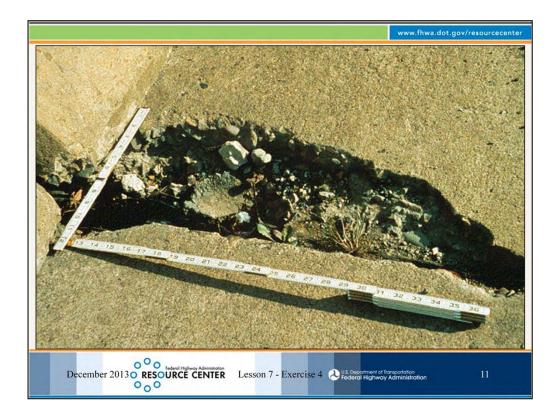
<u>Deck:</u> Spall greater than 6 in. diameter (2 sq. ft.) located at left side of deck at Bent 1 expansion joint.

<u>Joints:</u> Compression seal joint over each bent (pier) at 44 ft. long each. At left curb over Bent 1 exposed compression seal due to greater than 6 in. diameter spall extending 2 ft. from left curb. Debris build-up and moderate leakage for 10 ft. from the left curb.

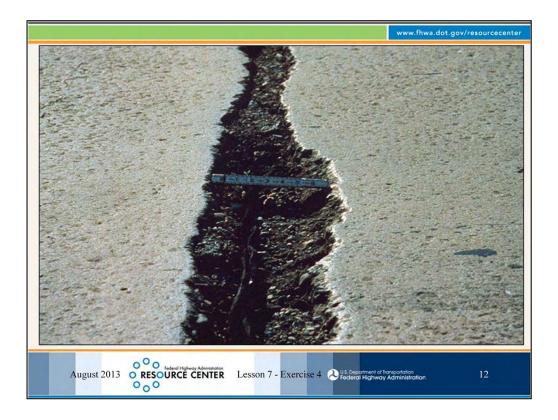
Deck: Spalling 2 inches deep along full length of Bent 3 expansion joint, 44 sq. ft.

<u>Joints:</u> Compression seal joint at Bent 3. Adjacent deck spalls 2 inches deep along full length of joint (44 ft.). Compression seal partially pulled out for 4 ft., allowing a free flow of water. Remainder adequately adhered for at least 50% of seal height and not leaking.

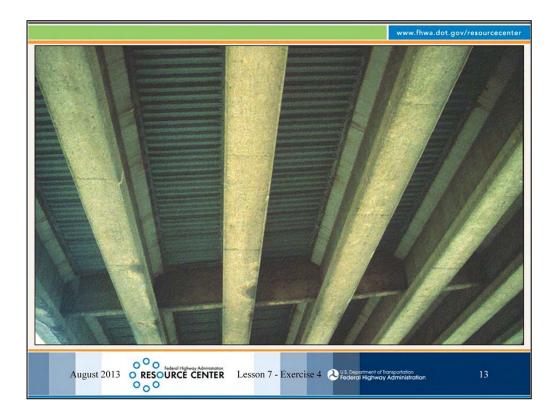
<u>Deck:</u> Typical deck underside view. Note stay-in-place forms.

Superstructure: Precast, prestressed concrete girders.

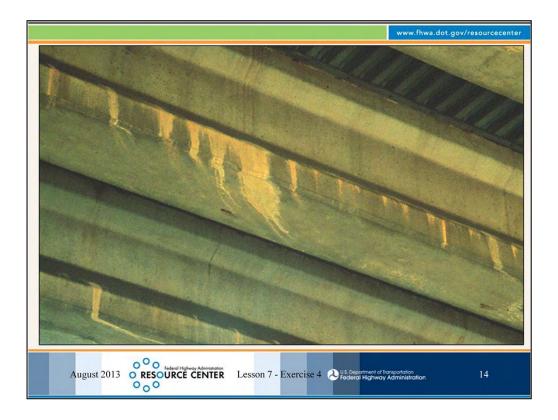
<u>Superstructure:</u> Staining of Beam 6, Span 3. Staining due to water running along the deck forms. No deterioration or efflorescence. Condition is typical for all beams in all spans.

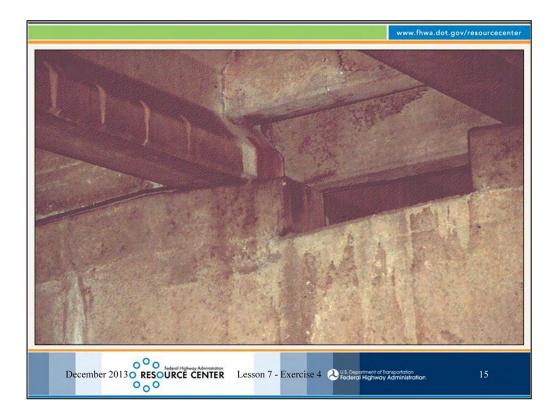
<u>Superstructure:</u> Exposed rebar without section loss at all girder ends (1 ft. for each girder end = 8 ft.) in bearing area at Bent 2. Associated spalling is 1 to 2 inches deep.

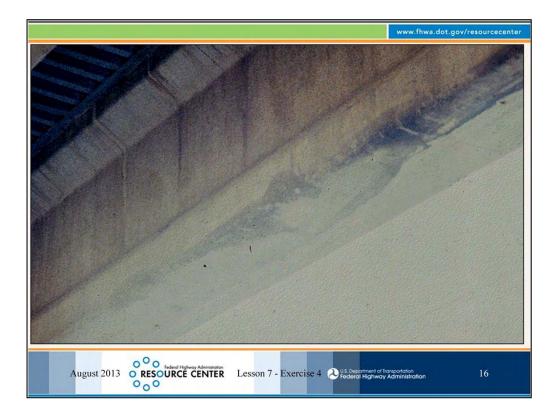
<u>Superstructure</u>: Collision damage of Beam 1 Span 3. Inside corner of beam has been broken off (less than 1 inch deep and less than 6 inches wide spall). There are no exposed strands. The affected length is 2 ft.

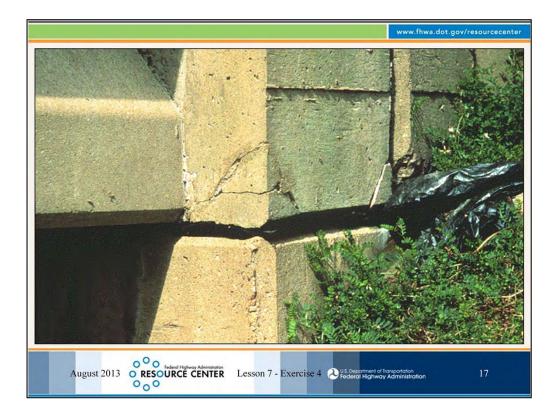
<u>Bearings:</u> Bearing area of Beam 8 at the far (east) abutment. There is minor bulging, less than 15% of thickness, of the neoprene bearing.

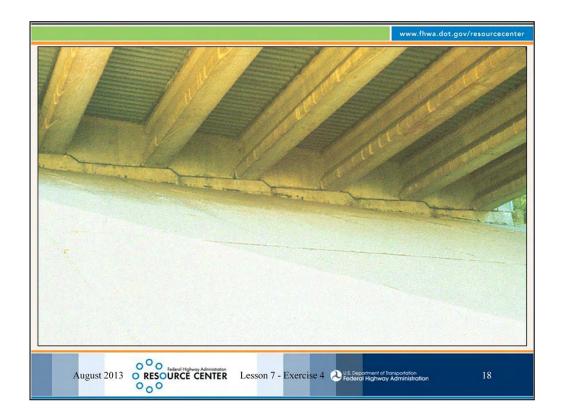
<u>Substructure</u>, <u>Abutments</u>: General view of near (west) abutment and embankment slope paving. Abutment is plumb and sound with no cracks. Far (east) abutment is similar. Both abutments are 49 ft. long.

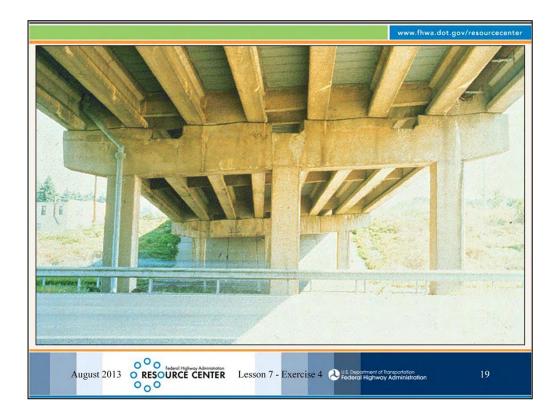
<u>Substructure, Bents:</u> General view of near (west) face of Bent 2. Bents 1 and 3 are similar. The bent cap of Bent 2 is 49 ft. long. The bent cap of Bents 1 and 3 are 50 ft. long.

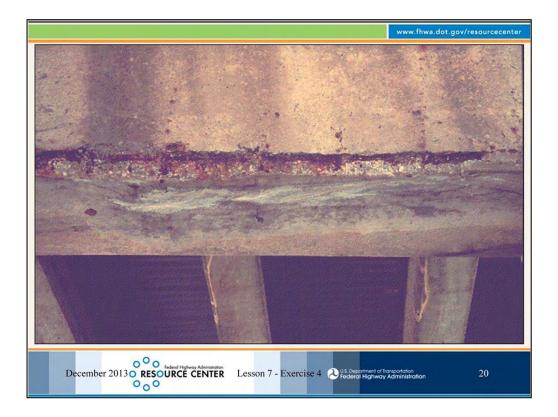
<u>Substructure</u>, <u>Bent 1:</u> The underside of Bent Cap 1 has a delaminated area 14 ft. long. There are also spalls greater than 1 in. deep over a 12 ft. length with exposed rebar. The exposed #8 rebar has 1/16 in. section loss. There are cracks less than 0.05 in. wide with light efflorescence over the same 12 ft. length.

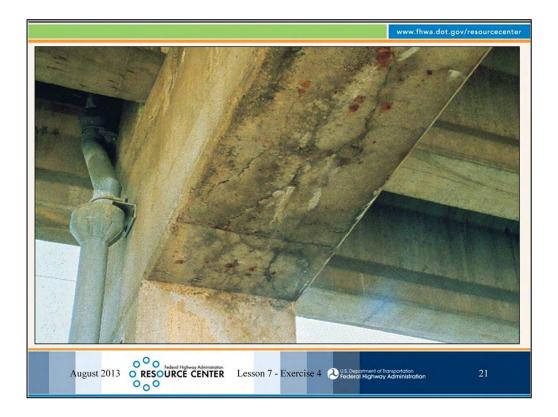
<u>Substructure</u>, <u>Bent 2</u>: Bent cap has 1/16 (0.06) in. wide cracks and rust staining near the left column of bent 2. Cracking extends for 6 ft. from the bent column.

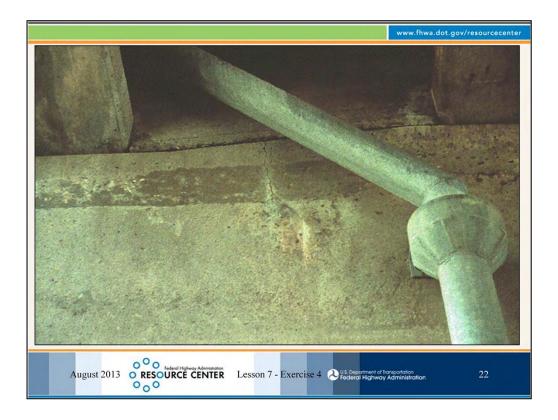
<u>Substructure</u>, <u>Bent 2</u>: Bent cap has 1/16 (0.06) in. width crack, 10 in. long above the left column of bent 2 on the near (west) face.

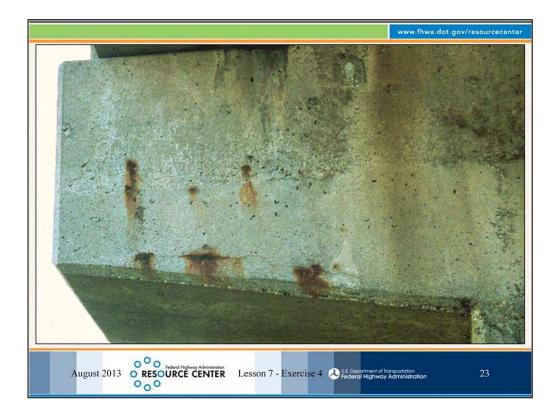
<u>Substructure</u>, <u>Bent 3</u>: Bent cap has 2 ft. long 0.04 in. wide crack and rust staining at Bent 3 on the left side of the near (west) face.

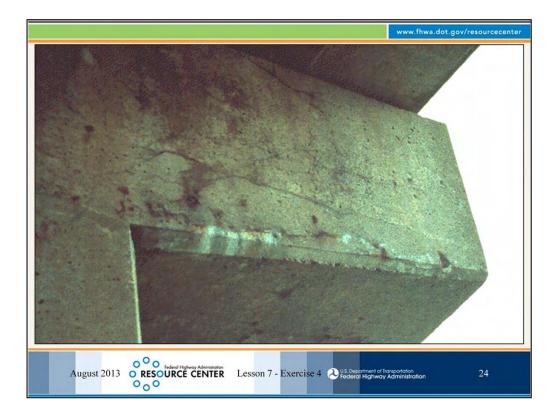
<u>Substructure</u>, <u>Bent 3</u>: Bent cap has cracks less than 0.05 inches wide and rust staining of Bent 3 for 4 ft. on the right cantilever of the near (west) face.

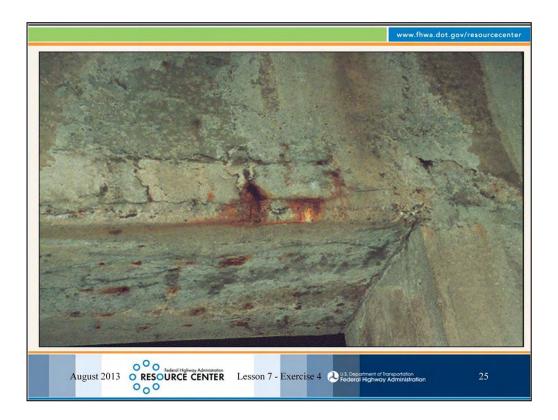
<u>Substructure</u>, <u>Bent 3</u>: Bent cap has cracks less than 0.05 inches wide and rust staining of Bent 3 for 2 ft. at the near (west) face of the center column.

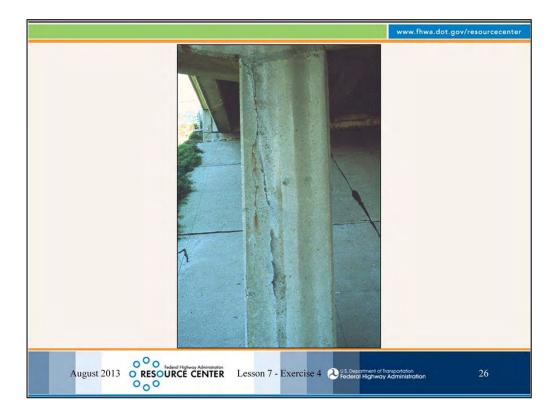
<u>Substructure</u>, <u>Bent 3:</u> Column has a 3/16 (0.19) in. wide x 11 ft. long vertical crack with rust staining on the left column of Bent 3. A previous structural review found that this crack does not effect strength or serviceability.
