## HYDRAULIC REPORT

Interstate 55 (Stevenson Expressway)

West Branch Sawmill Creek

FINAL February 2017

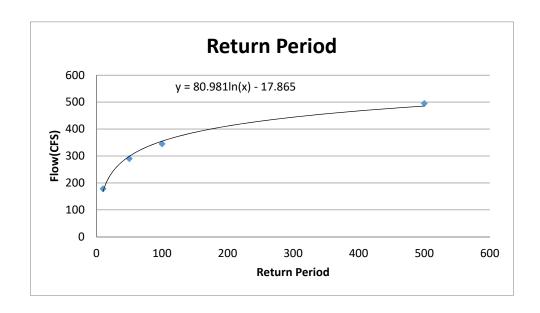
<u>Input</u>	<u>Data</u>
Return Period	Actual Q
10	178
50	290
100	345
500	495

Calculated Data			
Return Period	Actual Q	Calculated Q	
2	1	38	
10	178	169	
50	290	299	
100	345	355	
500	495	485	
52	-	302	OVT

Overtopping flow of 302 cfs determined from HEC-RAS by iteration.

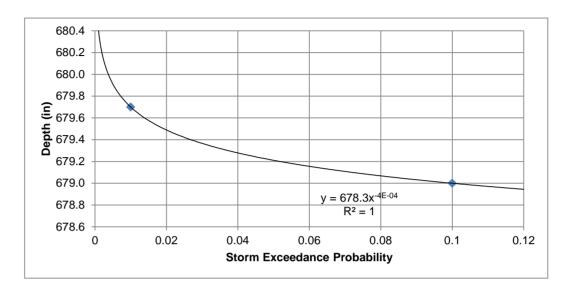
Flow Rates									
Storm Exceedance Probability	FIS WSEL (NAVD88)	Calculated WSEL							
0.5		678.5							
0.1	679.0	678.9							
0.03		679.2							
0.02		679.4							
0.01	679.7	679.6							
0.005		679.7							
0.002		680.0							
	Storm Exceedance Probability  0.5 0.1 0.03 0.02 0.01 0.005	Storm Exceedance Probability

Note: 2-, 30-, and 200-year WSELs interpolated/extrapolated using a power regression trendline.

West Branch Sawmill Creek starting WSELs from DuPage County FIS Wards Creek flood profile, March 2007

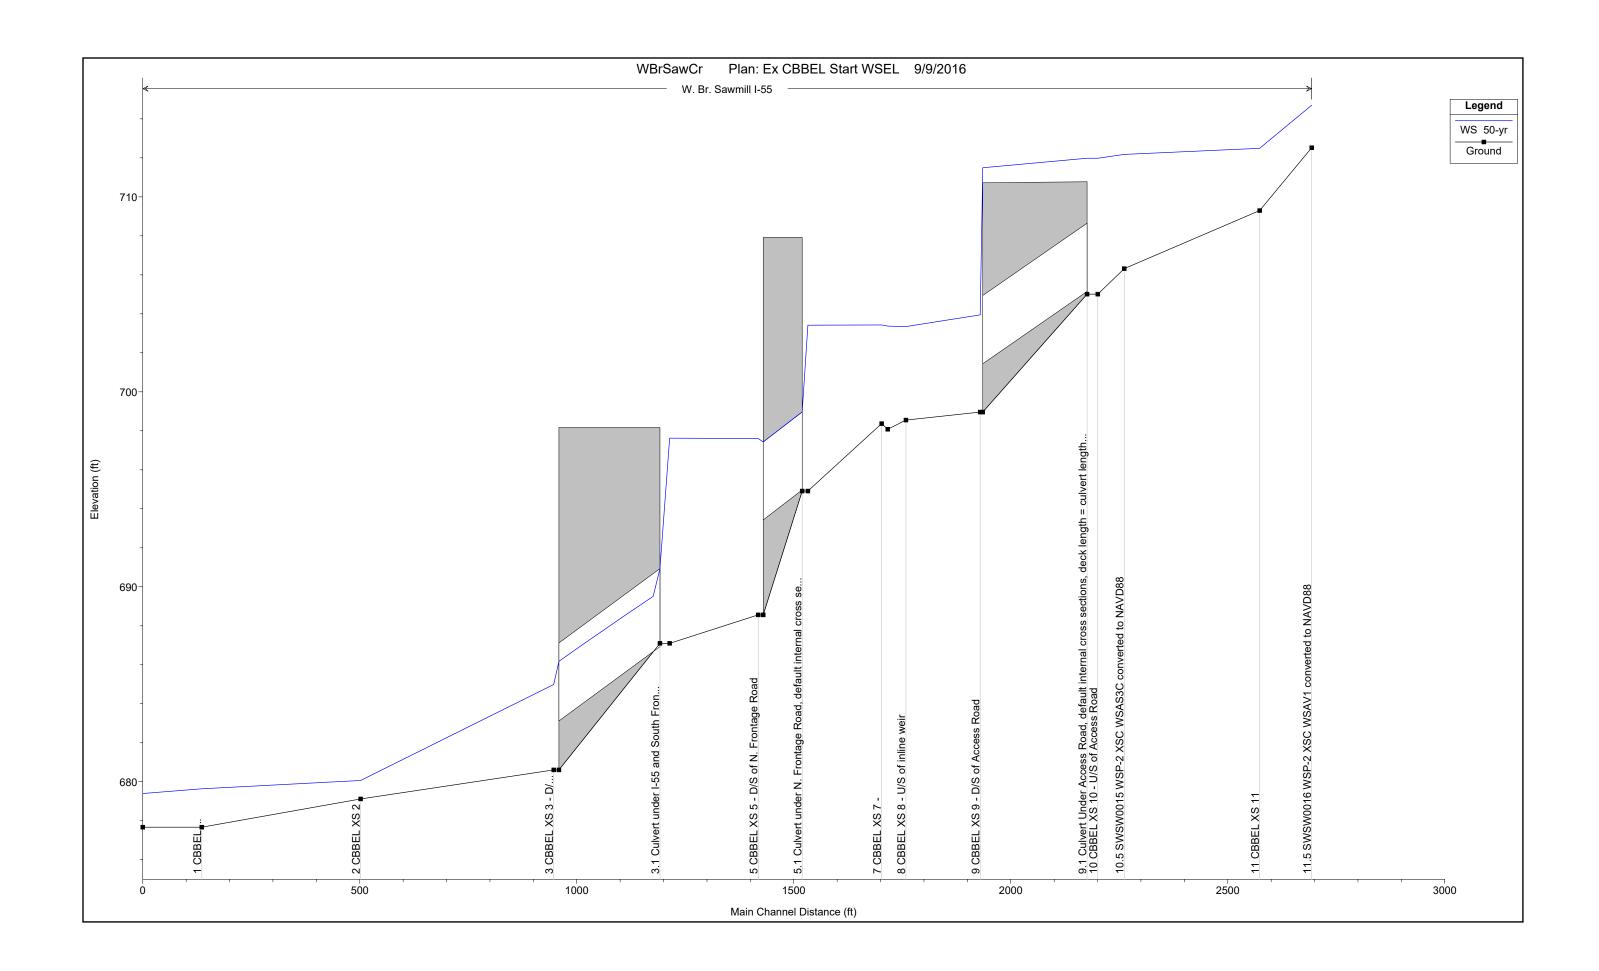
Reach	River Sta	Profile	E.G. Elev	W.S. Elev	Vel Head	Frctn Loss	C & E Loss	Q Left	Q Channel	Q Right	Top Width
			(ft)	(ft)	(ft)	(ft)	(ft)	(cfs)	(cfs)	(cfs)	(ft)
I-55	11.5	50-yr	714.91	714.70	0.20	1.44	0.07	3.74	182.00	59.26	49.50
I-55	11	50-yr	713.40	712.49	0.91	0.80	0.25		245.00		17.99
I-55	10.5	50-yr	712.27	712.18	0.09	0.08	0.03	40.21	219.83	29.96	56.13
I-55	10	50-yr	712.16	711.98	0.18			50.96	172.31	66.73	51.83
I-55	9.1		Culvert								
I-55	9	50-yr	704.69	703.94	0.75	0.84	0.25		290.00		26.11
I-55	8	50-yr	703.60	703.35	0.25	0.06	0.04	64.44	224.98	0.58	56.86
I-55	7.5	50-yr	703.51	703.37	0.13	0.01	0.03		113.48	176.52	57.10
I-55	7	50-yr	703.47	703.43	0.04	0.02	0.01		288.18	1.82	52.79
I-55	6	50-yr	703.44	703.42	0.02				290.00		119.46
I-55	5.1		Culvert								
I-55	5	50-yr	697.68	697.61	0.08	0.01	0.03		290.00		34.73
I-55	4	50-yr	697.63	697.62	0.01			36.86	238.49	14.65	586.97
I-55	3.1		Culvert								
I-55	3	50-yr	685.40	684.99	0.41	5.01	0.09		290.00		20.61

I-55	2	50-yr	680.29	680.07	0.22	0.14	0.06		21.39	268.61	178.69
I-55	1	50-yr	679.65	679.64	0.01	0.18	0.01	2.73	174.68	112.59	433.98
I-55	0.15	50-yr	679.46	679.40	0.06			6.21	477.55	296.25	409.27

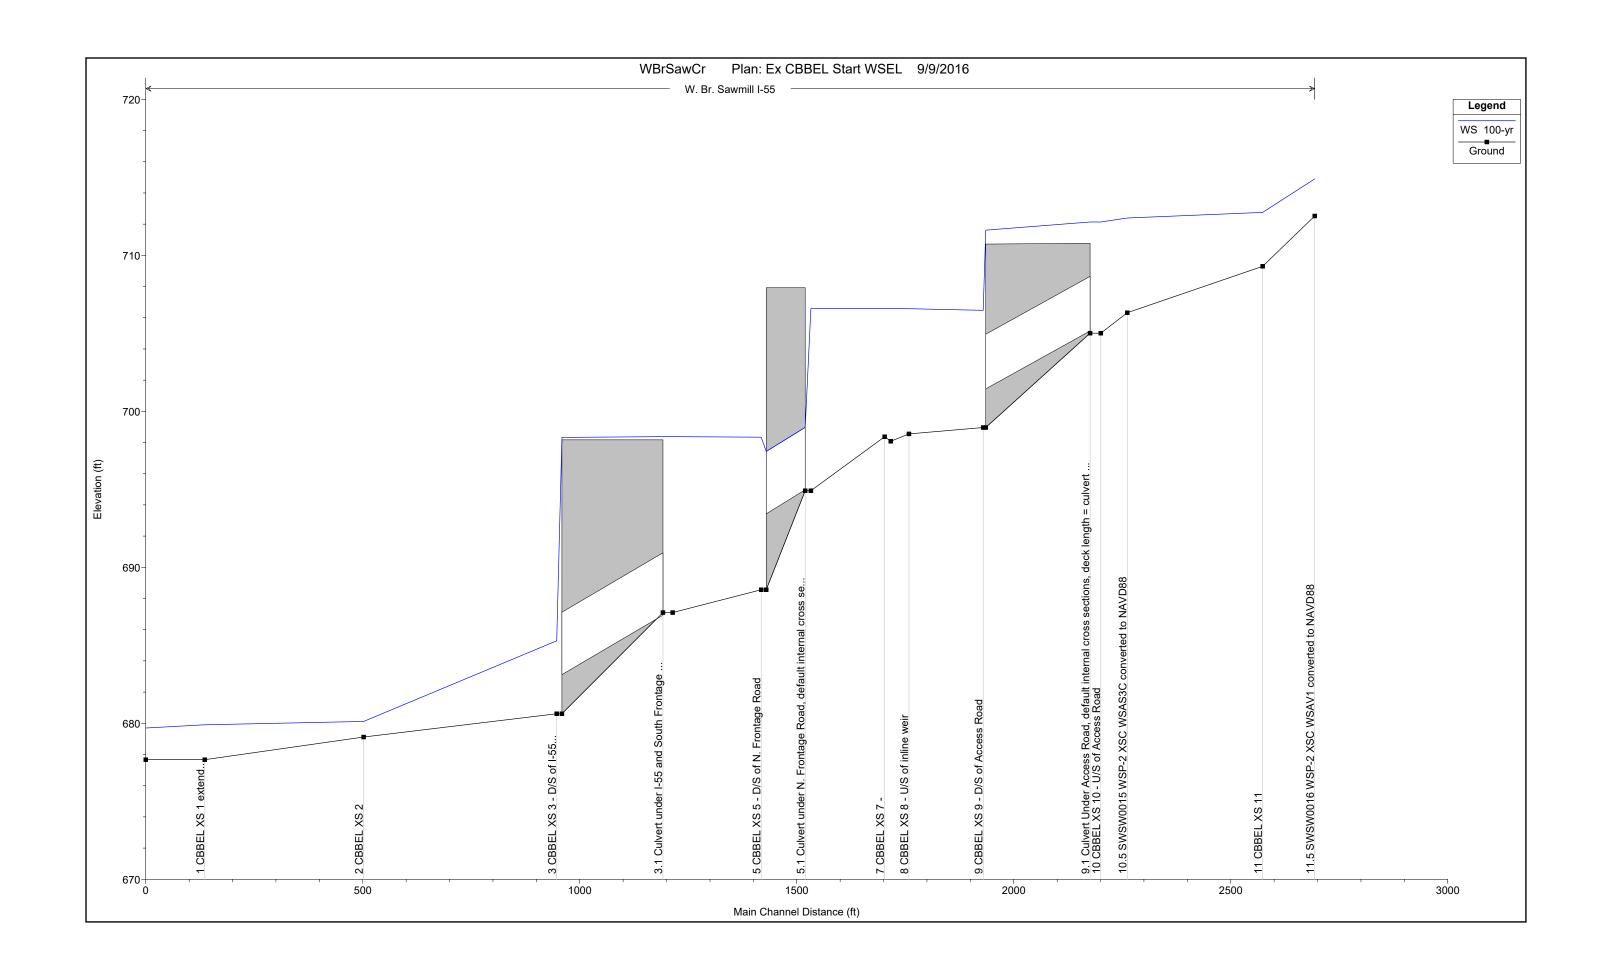
Reach	River Sta	Profile	E.G. Elev	W.S. Elev	Vel Head	Frctn Loss	C & E Loss	Q Left	Q Channel	Q Right	Top Width
			(ft)	(ft)	(ft)	(ft)	(ft)	(cfs)	(cfs)	(cfs)	(ft)
I-55	11.5	100-yr	715.12	714.90	0.22	1.34	0.07	5.64	211.83	72.53	51.02
I-55	11	100-yr	713.71	712.75	0.96	0.87	0.25		290.00		19.31
I-55	10.5	100-yr	712.50	712.39	0.11	0.10	0.04	52.70	253.77	38.53	59.23
I-55	10	100-yr	712.37	712.14	0.23			62.96	201.49	80.55	54.80
I-55	9.1		Culvert								
I-55	9	100-yr	706.90	706.48	0.43	0.10	0.20		345.00		32.97
I-55	8	100-yr	706.61	706.58	0.03	0.00	0.00	137.96	195.61	11.43	81.53
I-55	7.5	100-yr	706.61	706.58	0.03	0.00	0.00		45.75	299.25	77.67
I-55	7	100-yr	706.60	706.59	0.02	0.01	0.00	3.00	325.42	16.58	84.48
I-55	6	100-yr	706.60	706.58	0.02				345.00		149.02
I-55	5.1		Culvert								
I-55	5	100-yr	698.43	698.34	0.09	0.01	0.04		345.00		39.68
I-55	4	100-yr	698.38	698.38	0.00			31.01	199.54	114.44	1063.10
I-55	3.1		Culvert

I-55	3	100-yr	685.78	685.29	0.49	5.28	0.12		345.00		21.12
I-55	2	100-yr	680.37	680.12	0.25	0.12	0.07		24.30	320.70	181.14
I-55	1	100-yr	679.91	679.90	0.01	0.15	0.00	3.78	204.09	137.13	461.10
I-55	0.15	100-yr	679.75	679.70	0.05			9.02	553.68	360.30	440.19

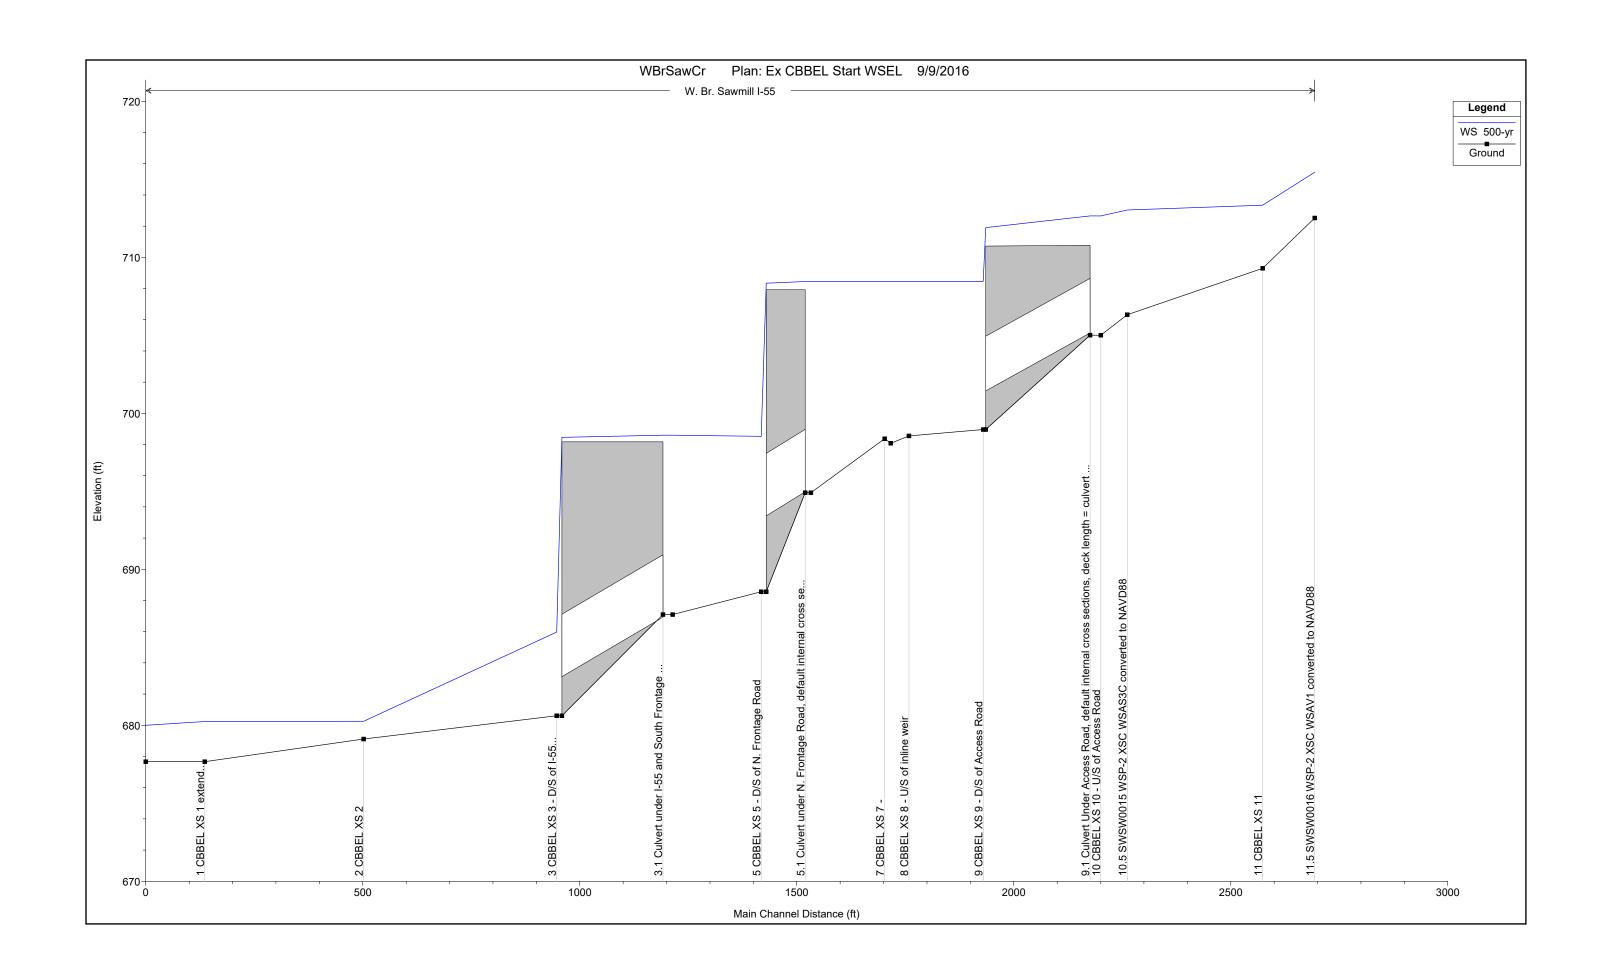
Reach	River Sta	Profile	E.G. Elev	W.S. Elev	Vel Head	Frctn Loss	C & E Loss	Q Left	Q Channel	Q Right	Top Width
			(ft)	(ft)	(ft)	(ft)	(ft)	(cfs)	(cfs)	(cfs)	(ft)
I-55	11.5	500-yr	715.70	715.46	0.24	1.14	0.09	13.09	294.39	112.51	55.22
I-55	11	500-yr	714.47	713.34	1.13	0.95	0.30		420.00		22.27
I-55	10.5	500-yr	713.17	713.04	0.14	0.12	0.06	96.78	336.45	61.77	73.63
I-55	10	500-yr	712.99	712.66	0.34			100.00	272.30	122.70	66.29
I-55	9.1		Culvert								
I-55	9	500-yr	708.54	708.46	0.07	0.05	0.02		491.95	3.05	49.75
I-55	8	500-yr	708.47	708.44	0.03	0.00	0.00	213.29	253.85	27.86	100.34
I-55	7.5	500-yr	708.47	708.44	0.02	0.00	0.00	0.29	53.91	440.79	95.90
I-55	7	500-yr	708.46	708.45	0.02	0.00	0.01	11.65	446.63	36.72	102.88
I-55	6	500-yr	708.45	708.45	0.00			13.09	468.62	13.29	168.10
I-55	5.1		Culvert								
I-55	5	500-yr	698.70	698.53	0.18	0.01	0.08		495.00		40.90
I-55	4	500-yr	698.60	698.60	0.01			41.38	265.85	187.77	1069.50

I-55	3.1		Culvert								
I-55	3	500-yr	686.69	685.98	0.71	5.92	0.20		495.00		23.89
I-55	2	500-yr	680.56	680.25	0.31	0.13	0.09		32.20	462.80	187.33
I-55	1	500-yr	680.25	680.24	0.01	0.17	0.01	6.29	281.66	207.05	473.25
I-55	0.15	500-yr	680.07	680.00	0.07			14.86	758.03	517.11	471.10

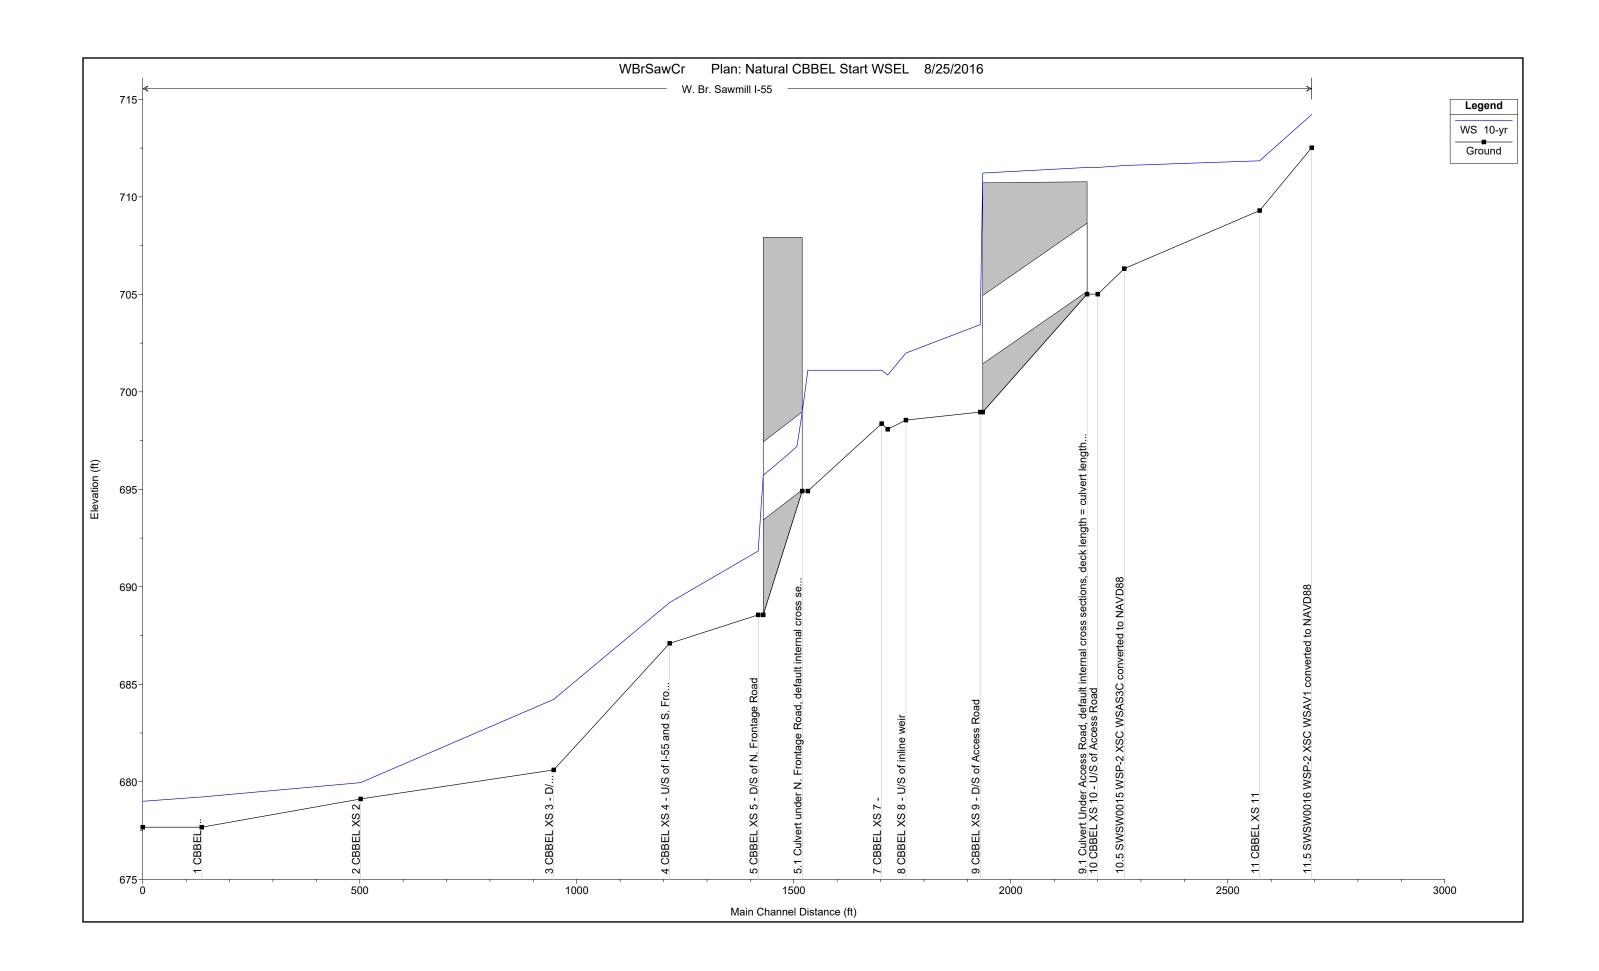
Reach	River Sta	Profile	E.G. Elev	W.S. Elev	Vel Head	Frctn Loss	C & E Loss	Q Left	Q Channel	Q Right	Top Width
			(ft)	(ft)	(ft)	(ft)	(ft)	(cfs)	(cfs)	(cfs)	(ft)
I-55	11.5	10-yr	714.39	714.22	0.17	1.75	0.06	0.90	116.14	31.95	45.88
I-55	11	10-yr	712.59	711.85	0.74	0.61	0.21		149.00		14.80
I-55	10.5	10-yr	711.67	711.61	0.06	0.05	0.01	17.98	145.94	14.08	47.88
I-55	10	10-yr	711.60	711.51	0.09			28.37	110.86	38.78	43.48
I-55	9.1		Culvert								
I-55	9	10-yr	703.81	703.45	0.36	1.08	0.09		178.00		24.76
I-55	8	10-yr	702.64	701.99	0.65	0.77	0.03	2.42	175.58		38.43
I-55	7.5	10-yr	701.41	700.86	0.55	0.07	0.14		178.00		12.32
I-55	7	10-yr	701.20	701.11	0.09	0.04	0.04		178.00		40.06
I-55	6	10-yr	701.12	701.11	0.02				178.00		104.71
I-55	5.1		Culvert								
I-55	5	10-yr	692.22	691.83	0.39	2.51	0.03		178.00		19.79
I-55	4	10-yr	689.68	689.19	0.49	2.15	0.13	4.55	173.45		39.51
I-55	3	10-yr	684.45	684.23	0.23	4.32	0.02		178.00		19.31

I-55	2	10-yr	680.11	679.96	0.15	0.13	0.04		15.03	162.97	171.82
I-55	1	10-yr	679.23	679.22	0.00	0.18	0.00	1.22	110.28	66.50	390.96
I-55	0.15	10-yr	679.04	679.00	0.04			2.60	300.41	174.99	368.05

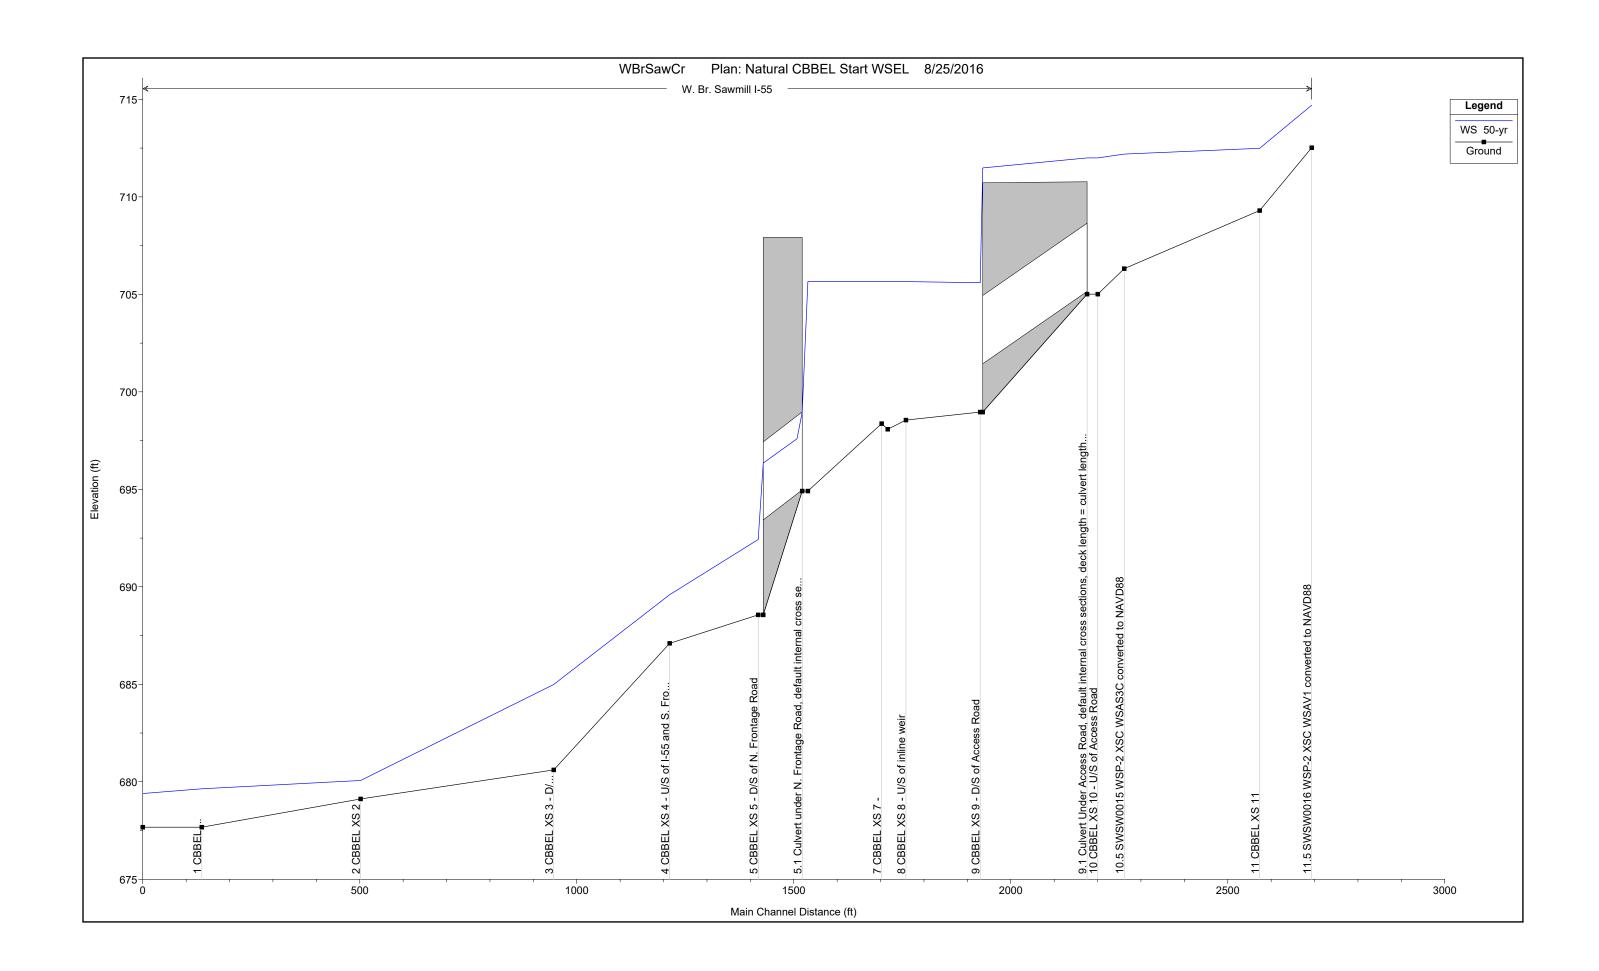
Reach	River Sta	Profile	E.G. Elev	W.S. Elev	Vel Head	Frctn Loss	C & E Loss	Q Left	Q Channel	Q Right	Top Width
			(ft)	(ft)	(ft)	(ft)	(ft)	(cfs)	(cfs)	(cfs)	(ft)
I-55	11.5	50-yr	714.91	714.70	0.20	1.44	0.07	3.74	182.00	59.26	49.50
I-55	11	50-yr	713.40	712.49	0.91	0.79	0.25		245.00		17.99
I-55	10.5	50-yr	712.28	712.19	0.09	0.08	0.03	40.47	219.42	30.11	56.32
I-55	10	50-yr	712.17	712.00	0.18			51.15	172.02	66.83	52.13
I-55	9.1		Culvert								
I-55	9	50-yr	705.99	705.60	0.40	0.12	0.18		290.00		30.59
I-55	8	50-yr	705.69	705.65	0.04	0.00	0.00	108.66	174.50	6.83	73.32
I-55	7.5	50-yr	705.69	705.66	0.03	0.00	0.00		46.26	243.74	72.10
I-55	7	50-yr	705.68	705.67	0.02	0.01	0.00	1.01	278.99	10.00	75.38
I-55	6	50-yr	705.67	705.66	0.01				290.00		139.62
I-55	5.1		Culvert								
I-55	5	50-yr	693.06	692.42	0.63	2.82	0.00		290.00		20.84
I-55	4	50-yr	690.23	689.59	0.63	2.35	0.15	18.73	271.27		41.55
I-55	3	50-yr	685.33	684.99	0.34	5.00	0.04		290.00		20.61

I-55	2	50-yr	680.29	680.07	0.22	0.14	0.06		21.39	268.61	178.69
I-55	1	50-yr	679.65	679.64	0.01	0.18	0.01	2.73	174.68	112.59	433.98
I-55	0.15	50-yr	679.46	679.40	0.06			6.21	477.55	296.25	409.27

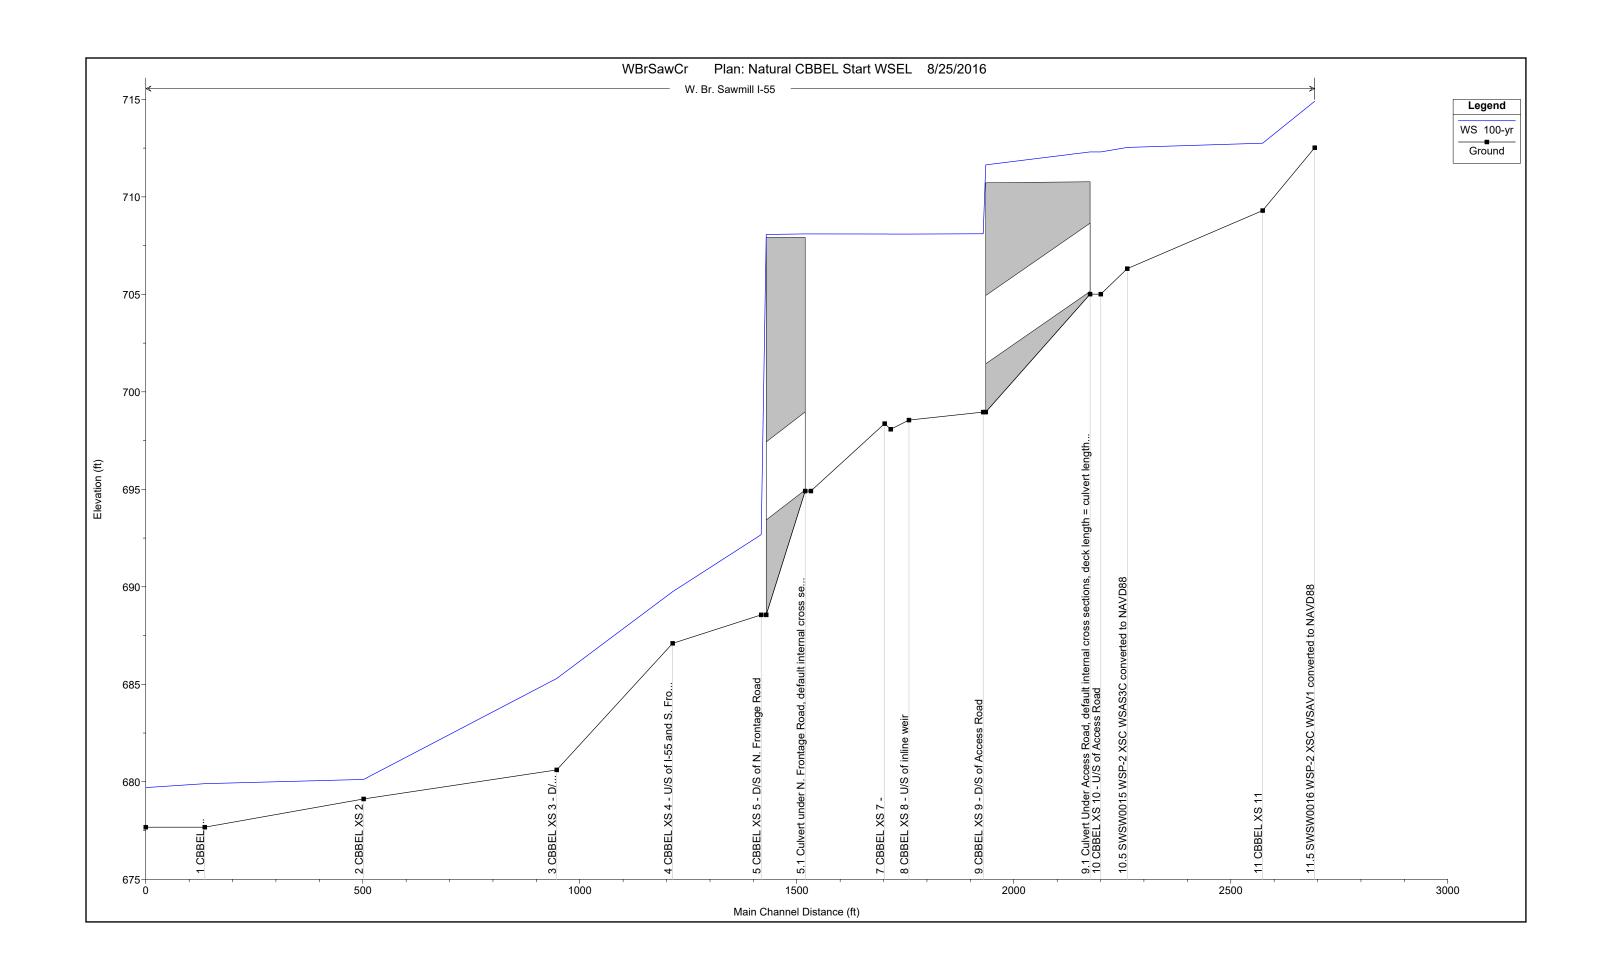
Reach	River Sta	Profile	E.G. Elev	W.S. Elev	Vel Head	Frctn Loss	C & E Loss	Q Left	Q Channel	Q Right	Top Width
			(ft)	(ft)	(ft)	(ft)	(ft)	(cfs)	(cfs)	(cfs)	(ft)
I-55	11.5	100-yr	715.12	714.90	0.22	1.34	0.07	5.64	211.83	72.53	51.02
I-55	11	100-yr	713.71	712.75	0.96	0.78	0.26		290.00		19.31
I-55	10.5	100-yr	712.63	712.53	0.10	0.09	0.03	56.06	249.80	39.14	62.20
I-55	10	100-yr	712.51	712.31	0.21			64.99	197.91	82.10	58.48
I-55	9.1		Culvert								
I-55	9	100-yr	708.15	708.11	0.04	0.03	0.01		343.88	1.12	46.47
I-55	8	100-yr	708.11	708.09	0.02	0.00	0.00	147.06	180.10	17.85	96.74
I-55	7.5	100-yr	708.11	708.09	0.01	0.00	0.00	0.09	38.50	306.42	91.32
I-55	7	100-yr	708.10	708.09	0.01	0.00	0.00	7.04	313.91	24.04	99.14
I-55	6	100-yr	708.10	708.10	0.00			8.51	327.88	8.61	164.50
I-55	5.1		Culvert								
I-55	5	100-yr	693.43	692.68	0.75	2.94	0.02		345.00		21.44
I-55	4	100-yr	690.46	689.75	0.71	2.46	0.16	26.60	318.40		42.35

I-55	3	100-yr	685.69	685.30	0.40	5.28	0.04		345.00		21.13
I-55	2	100-yr	680.37	680.12	0.25	0.12	0.07		24.30	320.70	181.14
I-55	1	100-yr	679.91	679.90	0.01	0.15	0.00	3.78	204.09	137.13	461.10
I-55	0.15	100-yr	679.75	679.70	0.05			9.02	553.68	360.30	440.19

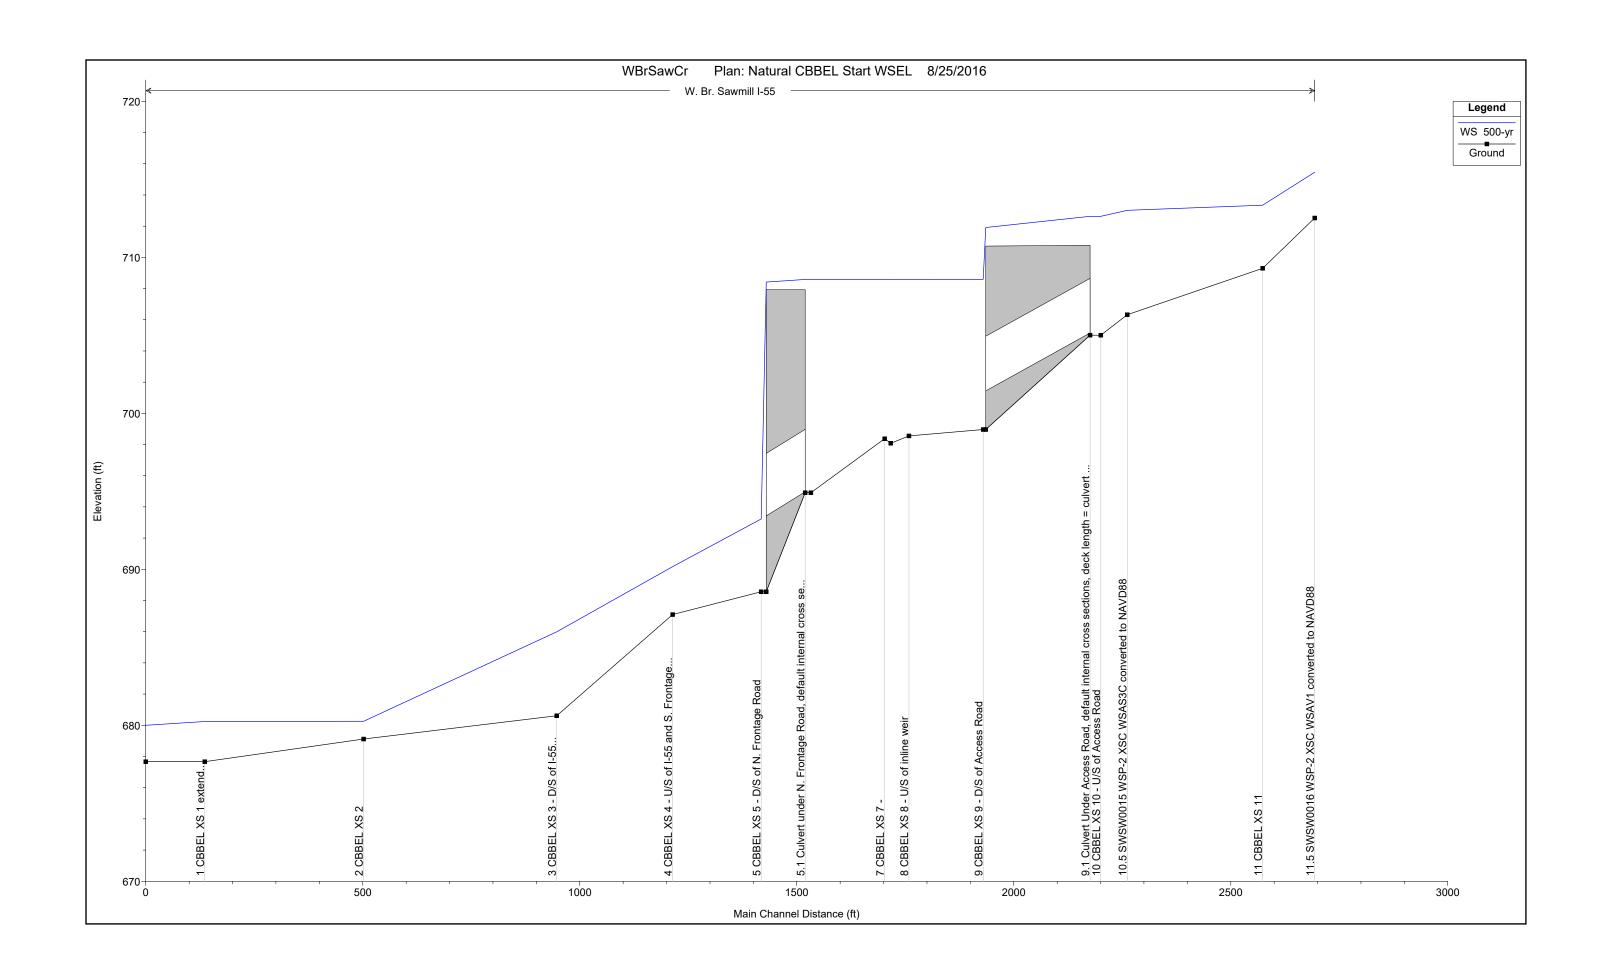
Reach	River Sta	Profile	E.G. Elev	W.S. Elev	Vel Head	Frctn Loss	C & E Loss	Q Left	Q Channel	Q Right	Top Width
			(ft)	(ft)	(ft)	(ft)	(ft)	(cfs)	(cfs)	(cfs)	(ft)
I-55	11.5	500-yr	715.70	715.46	0.24	1.14	0.09	13.09	294.39	112.51	55.22
I-55	11	500-yr	714.47	713.34	1.13	0.97	0.30		420.00		22.27
I-55	10.5	500-yr	713.16	713.02	0.14	0.12	0.06	96.18	337.35	61.47	73.19
I-55	10	500-yr	712.97	712.63	0.34			99.44	273.26	122.31	65.67
I-55	9.1		Culvert								
I-55	9	500-yr	708.66	708.59	0.07	0.04	0.02	0.00	491.34	3.66	51.41
I-55	8	500-yr	708.60	708.57	0.03	0.00	0.00	214.10	252.17	28.73	101.70
I-55	7.5	500-yr	708.60	708.57	0.02	0.00	0.00	0.38	53.45	441.17	97.62
I-55	7	500-yr	708.59	708.58	0.02	0.00	0.01	12.24	445.21	37.55	104.27
I-55	6	500-yr	708.58	708.58	0.00			13.42	467.94	13.64	169.43
I-55	5.1		Culvert								
I-55	5	500-yr	694.33	693.23	1.10	3.18	0.12		495.00		22.88
I-55	4	500-yr	691.03	690.17	0.86	2.67	0.15	51.44	443.56		44.47

I-55	3	500-yr	686.54	685.99	0.55	5.90	0.07	0.03	494.97		24.09
I-55	2	500-yr	680.56	680.25	0.31	0.13	0.09		32.20	462.80	187.33
I-55	1	500-yr	680.25	680.24	0.01	0.17	0.01	6.29	281.66	207.05	473.25
I-55	0.15	500-yr	680.07	680.00	0.07			14.86	758.03	517.11	471.10
