Movable Bridge Engineering

**Pavement Technology Advisory
Maintenance, Repair and Rehabilitation Series
PTA-M5 (Eff. 12/2014)
DECEMBER 2014**

Proper alignment, fit, and materials keep bridges — and traffic — moving.

Christopher Hahin, MetE, CorrE, P.E.

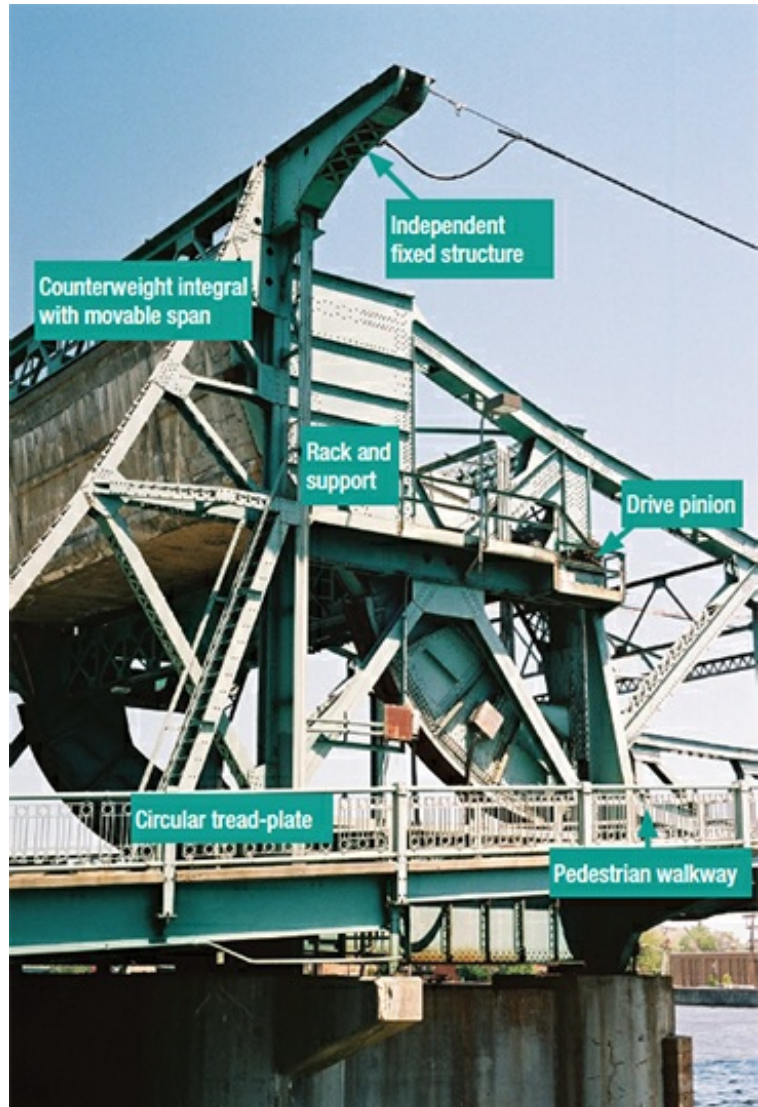
Figure 1: The principal components of a rolling lift bridge. The tracks and racks are not connected within a highly rigid common frame with respect to the movable portion of the bridge.

A rolling lift bridge is a structure that rolls on tracks. The principal components of a rolling lift bridge are (1) a counterweight for each span and (2) rolling tread plates that are joined to (3) semi-circular sector plate assemblies that have (4) a drive pinion located right in the center of each sector circle (Figure 1). Drive machinery is housed inside this movable structure that rolls on two separate tracks. Each track has steel cones called pintles bolted to it that act as drive cogs for the tread plates, which have socket holes spaced on the same travel distance as the pindle spacing (Figure 2). This permits the tread plate to move forward uniformly and in a directly linear fashion.

There is no actual “common frame” of the machinery inside the movable portion of the bridge with respect to the independent tracks, racks, and pintles, which leads to misalignment. The term “common frame” is defined as a very rigid housing by which gears transfer mechanical forces without excessive variation of position, thereby providing alignment, proper mesh, and translation of motion. There are multiple sources of misalignment caused by the separation of the drive system with respect to the tracks on which the movable portion of the bridge rolls, and the racks by which span motion is induced.

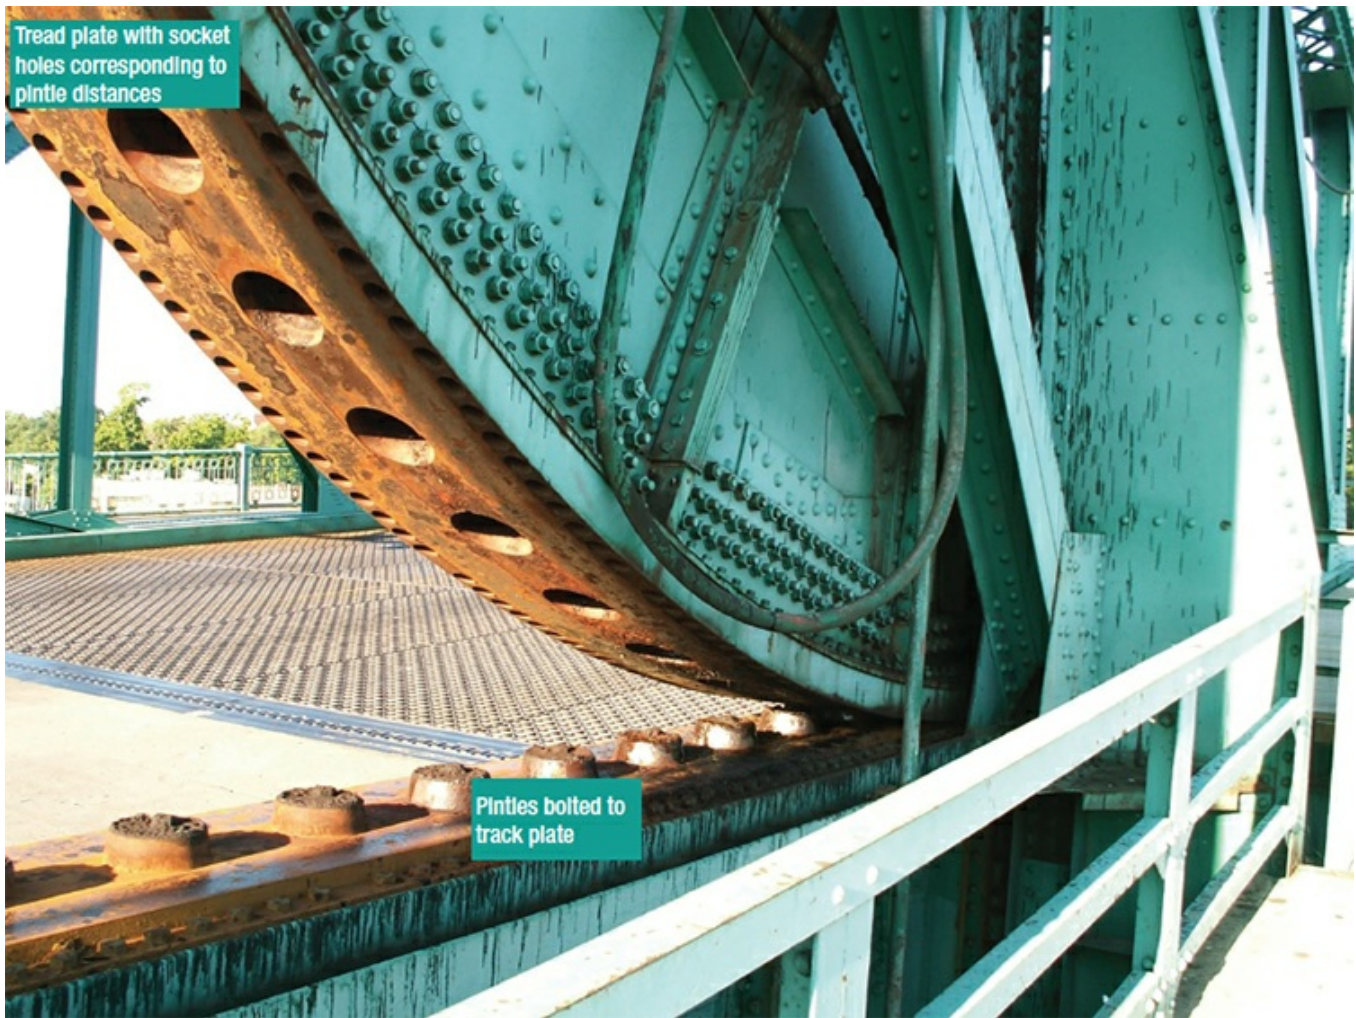
Figure 2: The track uses pintles to establish correspondence with the movable tread plate to permit straight line motion of the pinion gear. The circular tread plate enables raising and lowering of the bridge span. The position correspondence of these pintles is critical to ensure proper closure of the bridge.

Pintle misalignment is also problematic. If the pintles are not in perfect correspondence on one side of the track versus the opposite side, this can also lead to misalignment and improper clearance at the center locks. An out-of-correspondence pintle displacement of $\frac{3}{8}$ inch for a 35-foot-wide track for a span of 100 feet results in 1.07 inches of transverse center lock displacement.

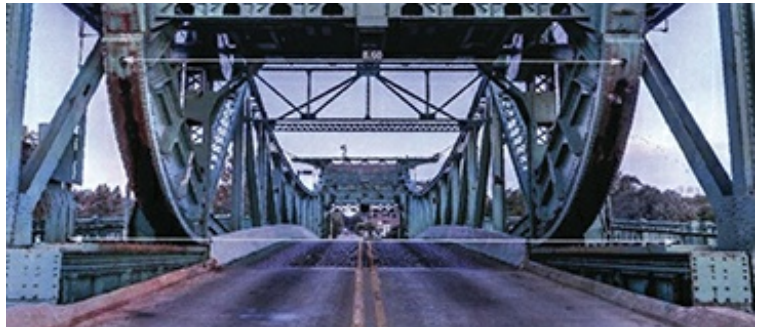
Figure 3: From this longitudinal view of a rolling lift bridge obtained by laser scanning, it is apparent that tracks, tread plates, pintles, and racks must have complete parallelism to provide good operation and closure. The photo shows differences in the centers of the pintles versus the tread plate sockets, leading to clashing when they interface. Photo: Falk PLI

The layout of each track must be completely parallel on one side of the bridge versus the other. For example, this means when bridge traffic runs east and west, the north and south track plates must be completely parallel. The importance of parallelism is shown in Figure 5. Each track plate must also be collinear with the other side of the river, so that when the east and west spans close, there is proper correspondence for center locking and uniformity of clearance. This is particularly important if finger joints are used for closure.

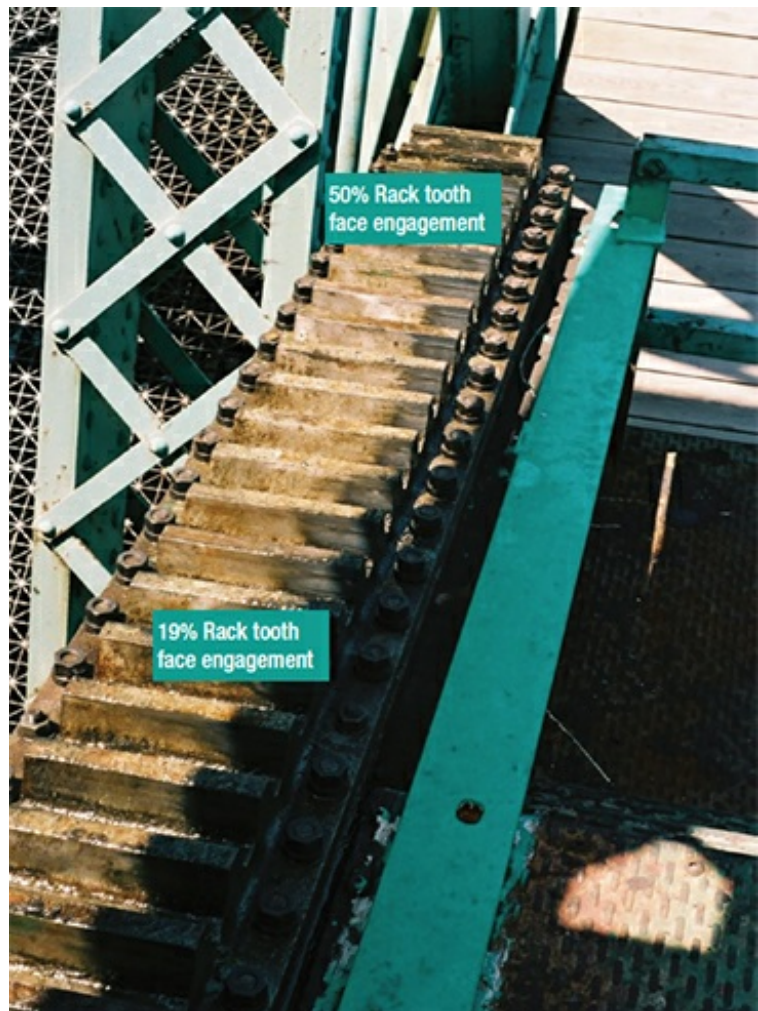
Figure 4: A rack section showing signs of major misalignment of the pinion gear with the rack section. Continued operation would have caused severe wear and high tooth stresses. This situation resulted in abnormal main drive pinion bearing wear, but was reset by repositioning the rack to correct the misalignment. Shims were also added to correct the pitch line mismatch.

Pinion drive shaft alignment is important, whereby each shaft must be collinear with its counterpart on the opposite track side. A misaligned shaft can result in insufficient pinion gear tooth contact with the rack, as shown in Figure 6. This misalignment is probably the most critical of all because if tooth stresses are too high, fatigue or outright tooth rupture can jam or stop bridge operation. If the balance is markedly weighted toward the span and teeth rupture, this would result in a load transfer to the pinion gear on the opposite side rack. If the remaining single rack and pinion cannot sustain the entire balance load while the span is in motion, it could lead to machinery brake overload. A jammed span leaf could result in blockage of the channel.

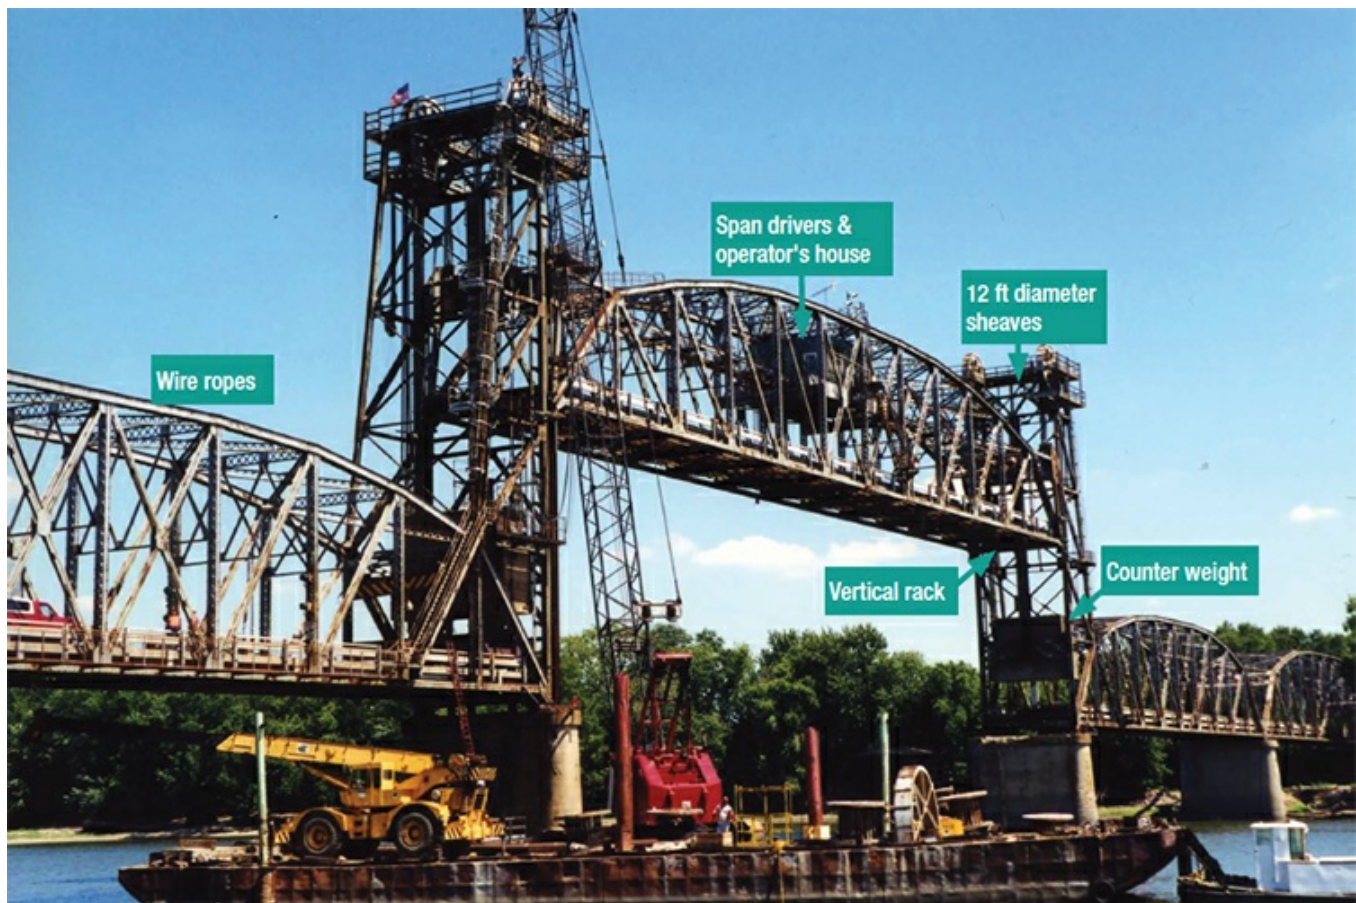
Figure 5: Major components of a vertical lift bridge with a span drive motor located in the operator's house. The bridge is raised and lowered by shaft drives acting upon vertical racks on each tower. In this picture, new triple-web sheaves are replacing the severely cracked cast steel sheaves that had been in operation for 65 years.

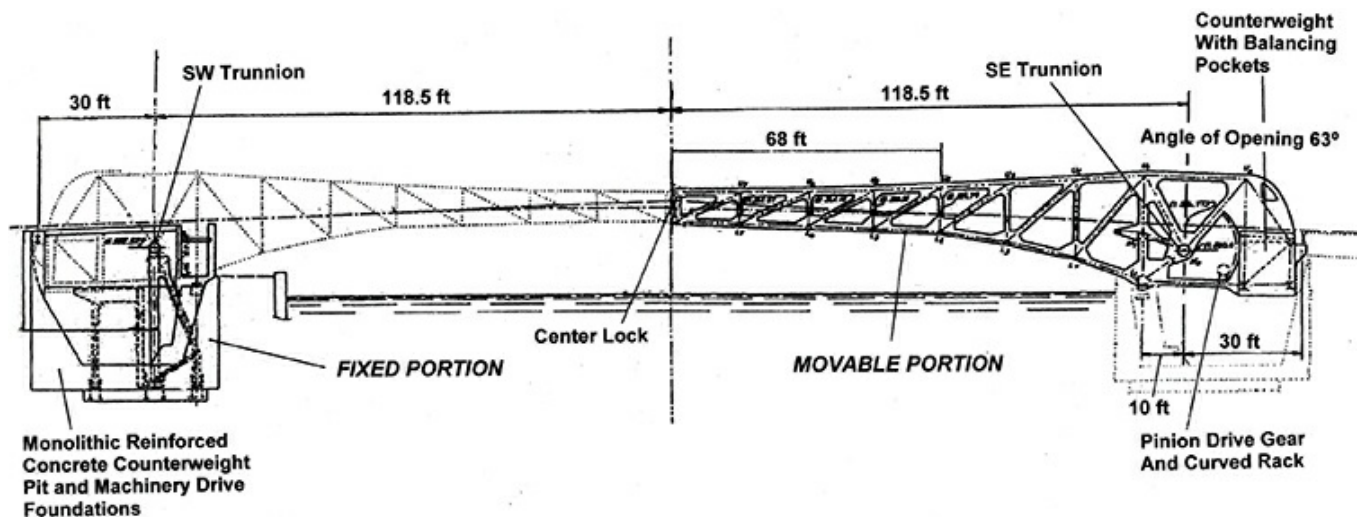
Figure 6: A composite diagram shows the fixed foundation and movable portions of a trunnion bascule bridge. All the weight of each span and counterweight are distributed over two large-diameter SAE 1045 steel trunnions attached to the movable structure.

A good example of a classic trunnion style design is found in the Ruby St. Bridge over the Des Plaines River located in Joliet, Ill. In Figure 6, a composite drawing taken from the original plans shows the fixed and movable portions of the bridge.

Alignment in this style of movable bridge is dependent on the transverse orientation of each trunnion bearing such that it is perfectly transverse by 90 degrees to the longitudinal truss axis of the bridge. When the Ruby St. Bridge was first constructed, the trunnion elevation of the west side of the bridge was 2 inches higher than that of the east side. This was apparently corrected by the use of shim plates on the live load anchors, but center lock problems still persist today because of this oversight at original construction.
