# Development and Evaluation of Longitudinal Joint Sealant in Illinois

**PHYSICAL RESEARCH REPORT NO. 168**

**Evaluation of Longitudinal Joint Sealant in Illinois**

**Illinois Department of Transportation**

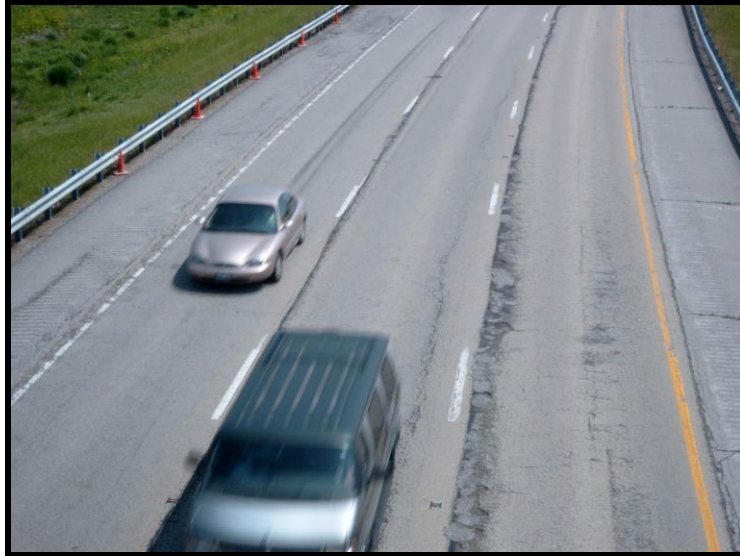
Figure 2: Cold Joint

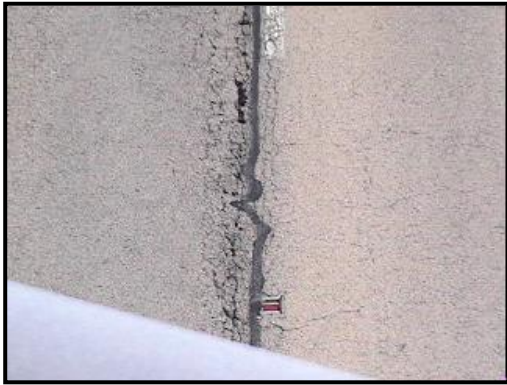
Figure 4: Joint Distress with Sealed Joint

The Illinois Department of Transportation (IDOT) has investigated the potential of using a joint sealant to decrease the permeability of HMA joints. Previously, IDOT looked at a joint tape that was placed at the cold joint interface. The problem was that the low density of the joint is not only concentrated at the joint but also propagates several inches on either side of the joint, as shown in Figures 4 and 5.

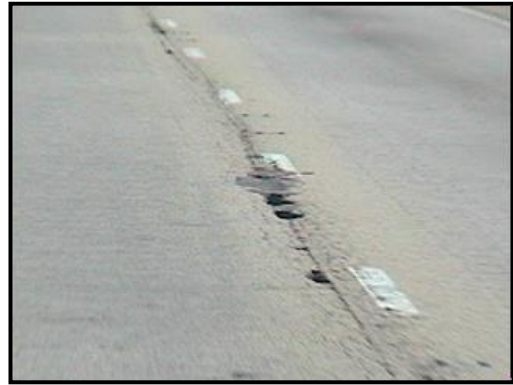
Figure 5: Low Joint Density Area

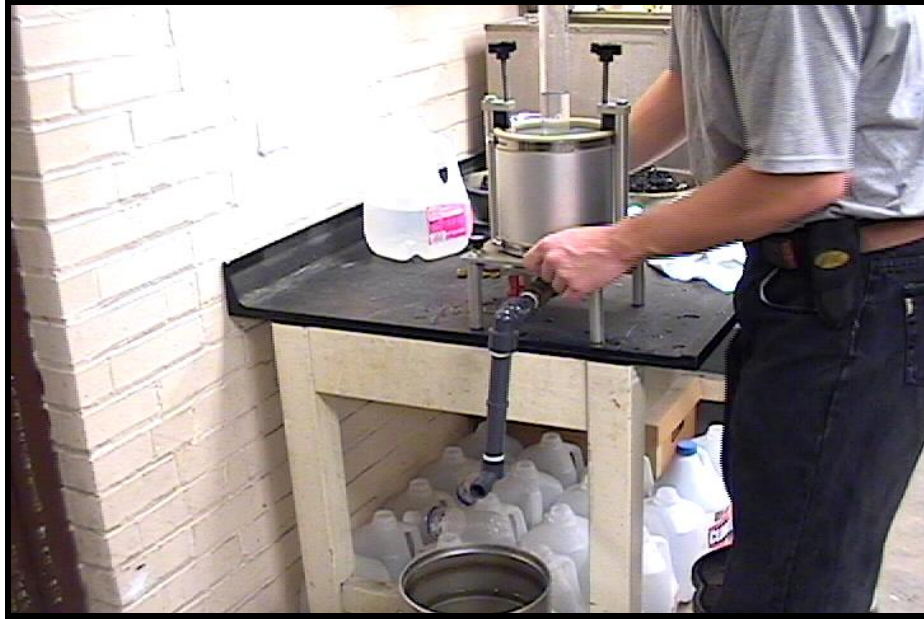
Figure 6: Preparing Lab Permeameter for Testing

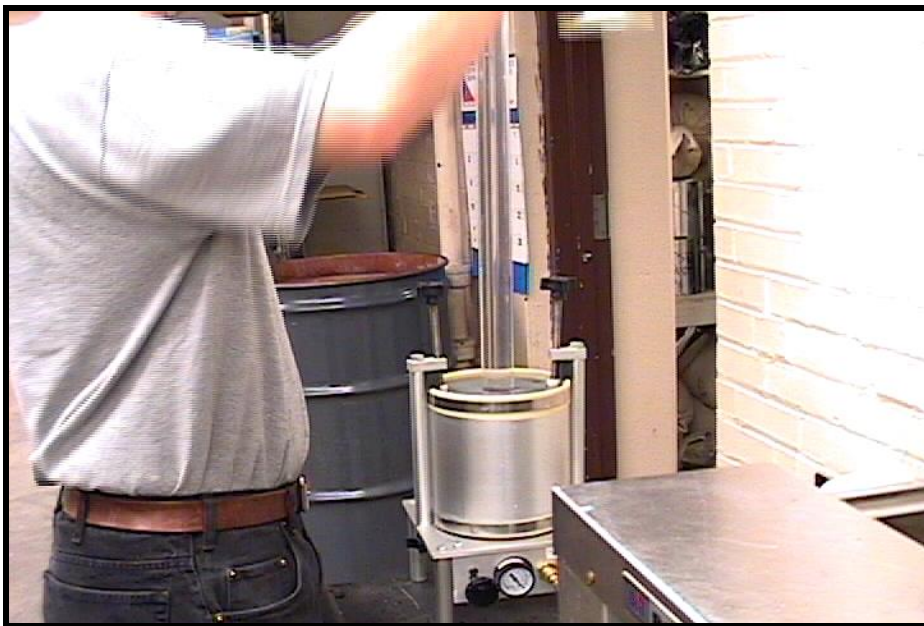
Figure 7: Timing Drop in Water Height of Lab Permeameter

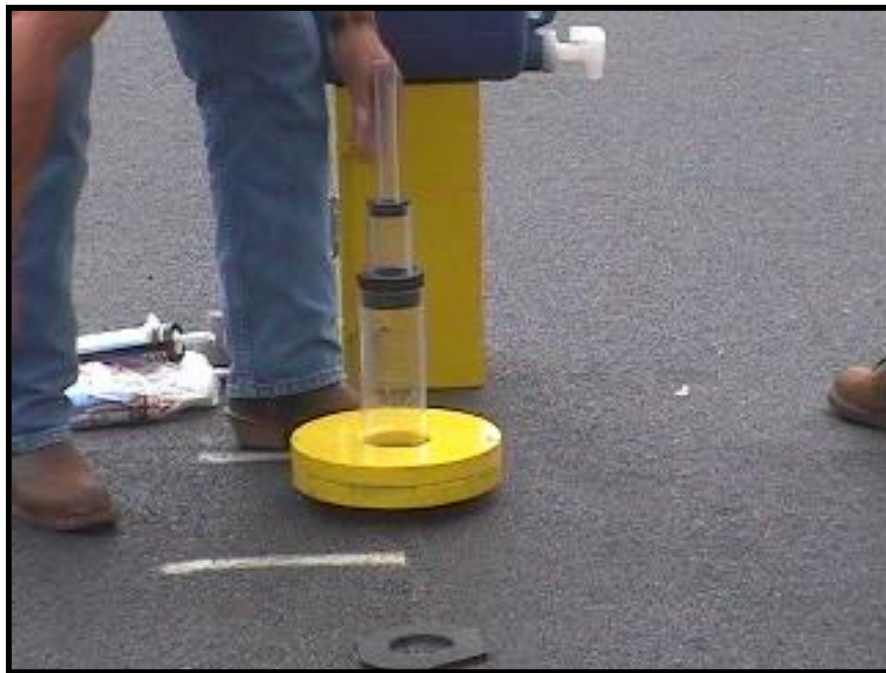
Figure 8: Illinois Field Permeameter

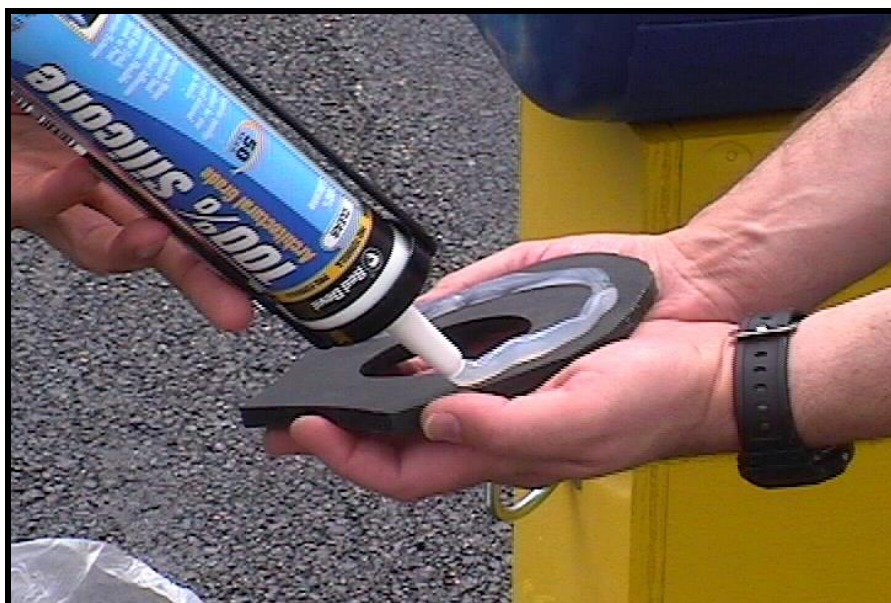
Figure 9: Applying Silicone

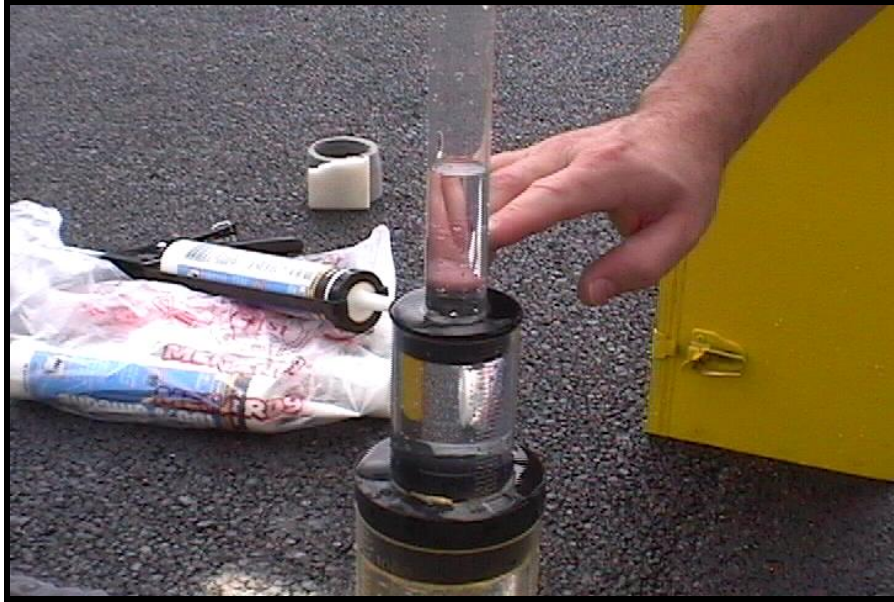
Figure 10: Measuring Water Fall in Standpipe

Figure 10 illustrates the top standpipe being used to determine permeability of a low permeability pavement. When the drop in height is too quick to measure in the top standpipe, the middle or bottom standpipe is used depending on the level of permeability. It is possible to use a larger standpipe than necessary, but it increases the time to run a test.

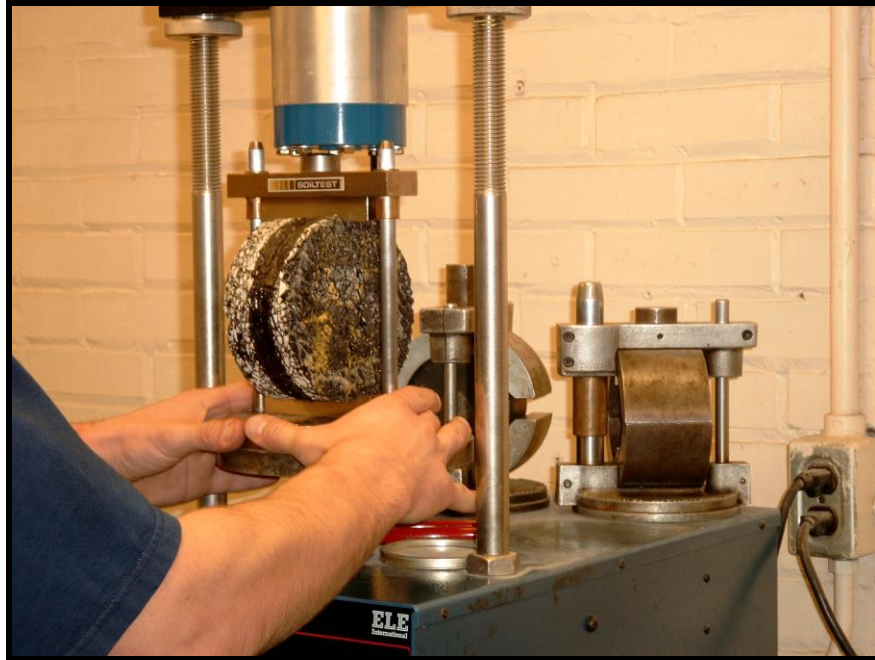
Figure 11: Breaking Cores

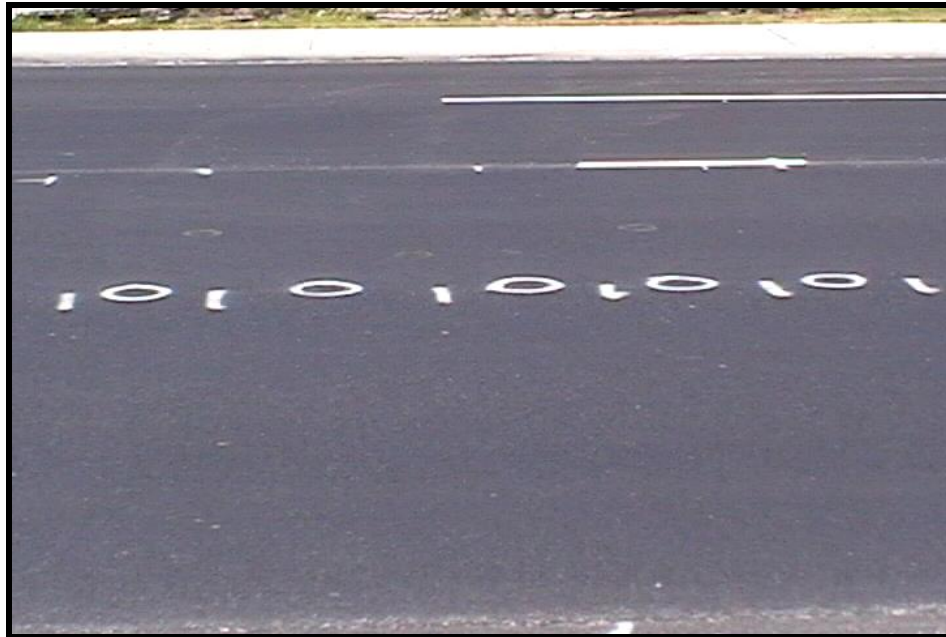
Figure 19: Final Mat Showing Sample Locations

The locations of the joint tape were marked on the pavement prior to paving the matching lane to ensure that the joint sealant samples could be located for testing and observations. After the second lane was placed, the area was marked for testing, as shown in Figure 19.

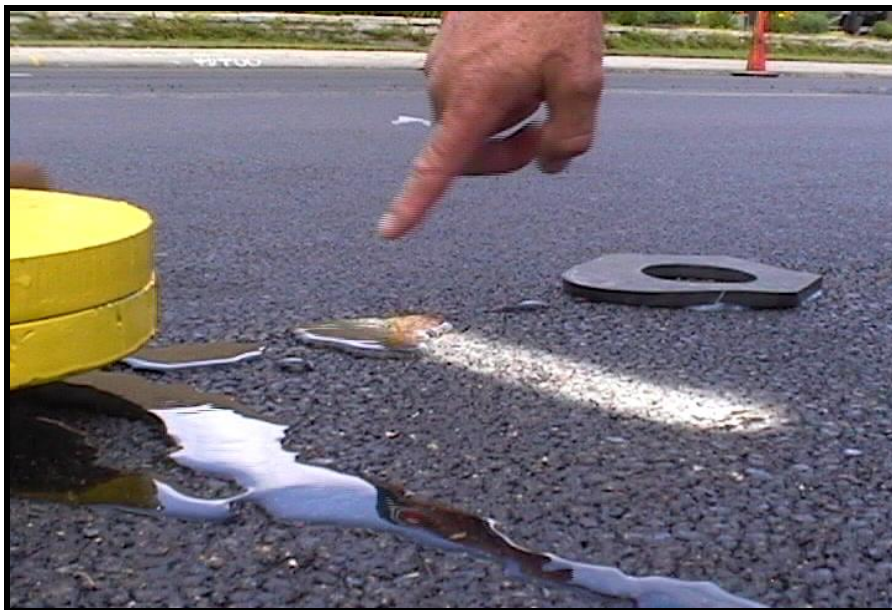
Figure 21: Field Permeameter Water Resurfaces along the Joint

When testing the joints, the water used for permeability testing was observed to disappear into the pavement, to flow rapidly from the pavement around the device, or to

resurface at various distances from the test site. Figure 21 demonstrates how the water can flow from the test site, as well as travel further out and resurface.

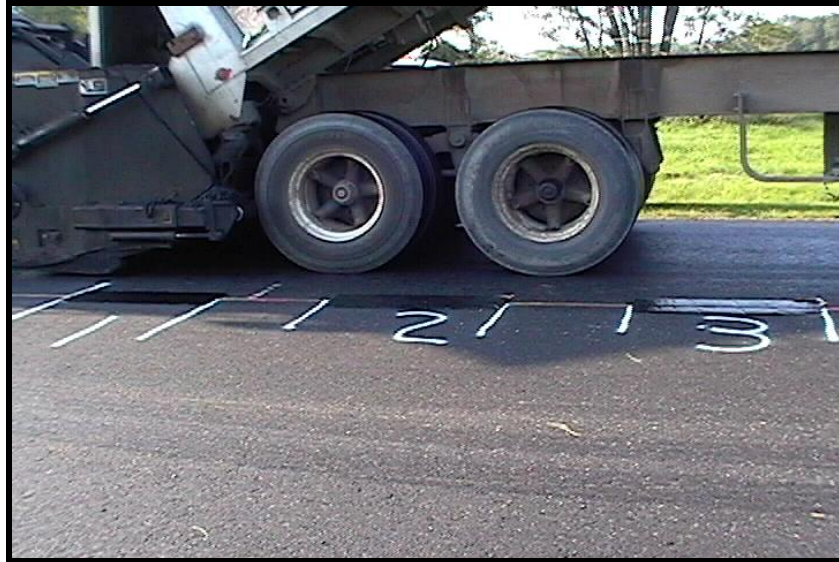
Figure 24: IL 40 Paving over Joint Sealant Formulations

involved looking at the migration of three different formulations fabricated by Quik Pavé Products Inc. The joint sealant strips measure 12 inches wide, 30 inches long, and 3/16 inch thick. The three formulations were evenly spaced at the test location and are shown being paved over in Figure 24.

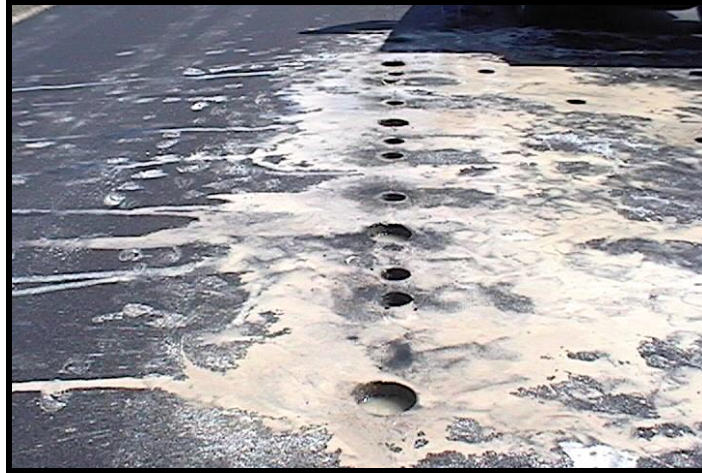
Figure 25: IL 40 after Coring Test Locations

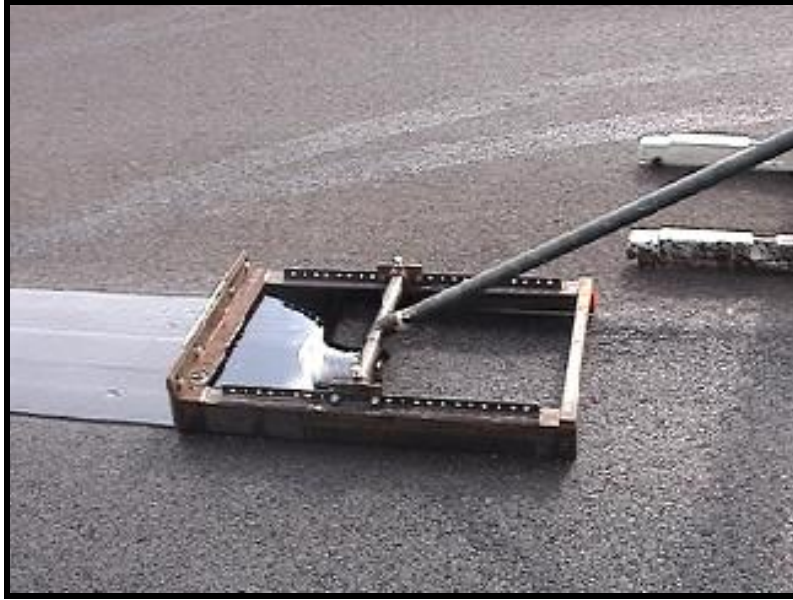
Figure 30: Jband Placement

This application process allows the freedom to make adjustments in thickness and width during placement. For example, if flushing occurs because of too much migration, then the amount of material placed can easily be decreased. After the material is placed, it cools to a solid so that traffic can pass over the material without causing damage to the JBand, as shown in Figure 31.

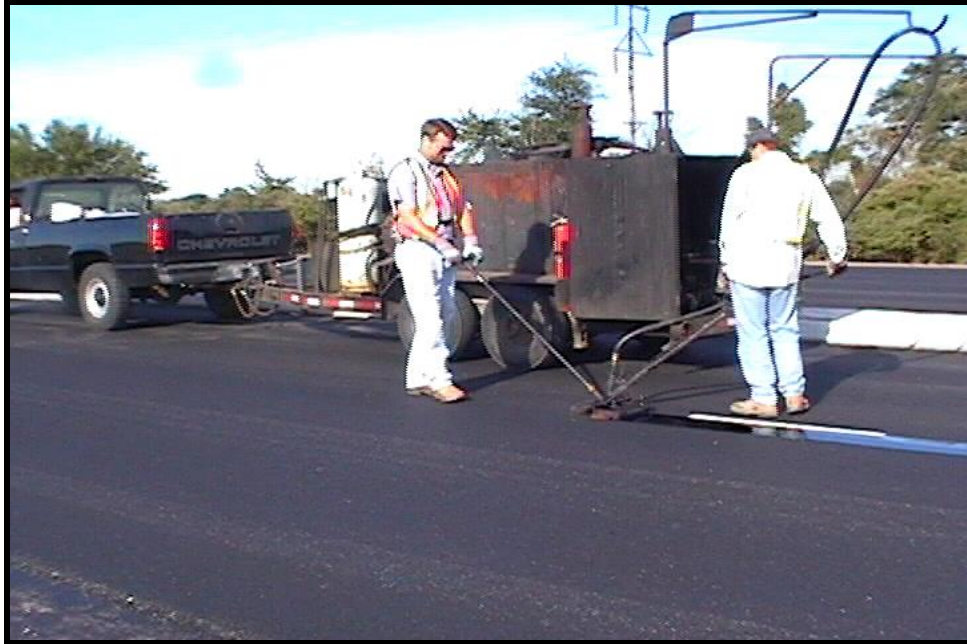
Figure 39: US 51 Jband Placement

The Jband was placed in one application prior to paving, as shown in Figures 39 and 40. The QuikSeam was placed in two applications. The first QuikSeam application consisted of placing a 9-inch strip so that approximately 2 inches of QuikSeam would remain exposed after the first lane was paved. The second application of QuikSeam was placed after the first lane was paved. The second application was placed adjacent to the first application and lapped up onto the edge of the first lane. The QuikSeam application is shown in Figures 41, 42, and 43.

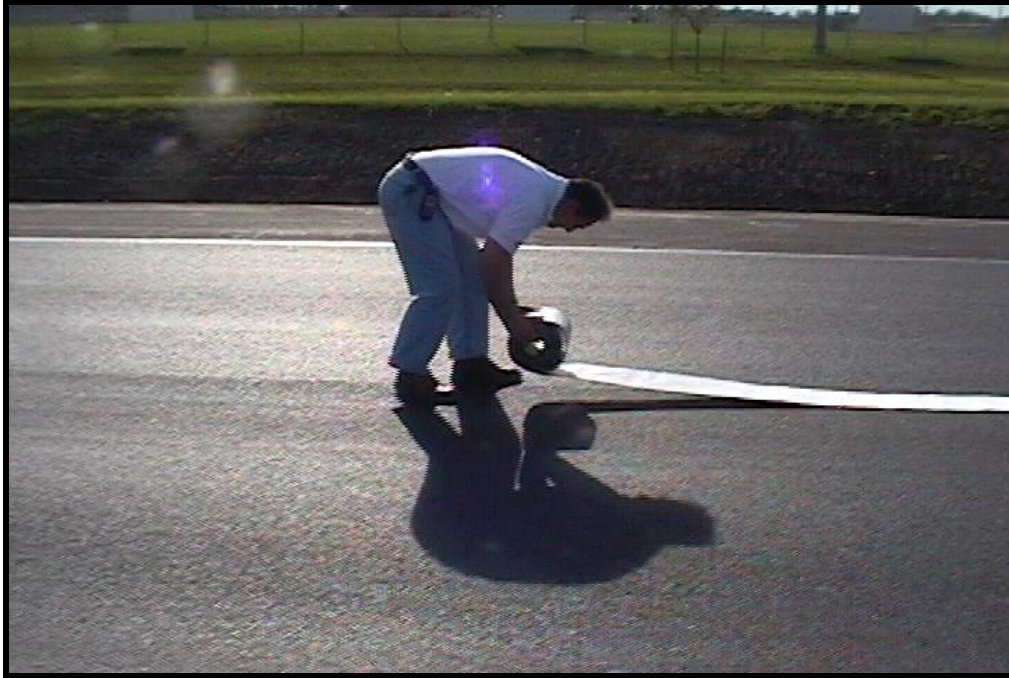
Figure 41: US 51 QuikSeam Placement

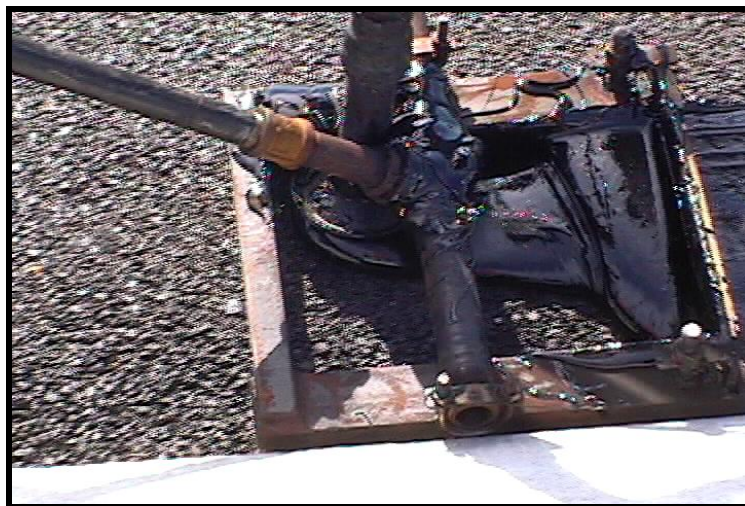
Figure 44: US 51 Jband Applied at Median

Figures 44 and 45 show the Jband being applied to the median in the RP-2 test section. It was observed that very little density was being obtained in this area. The vibratory rollers tended to stay far enough away to ensure that the concrete median would not be damaged.

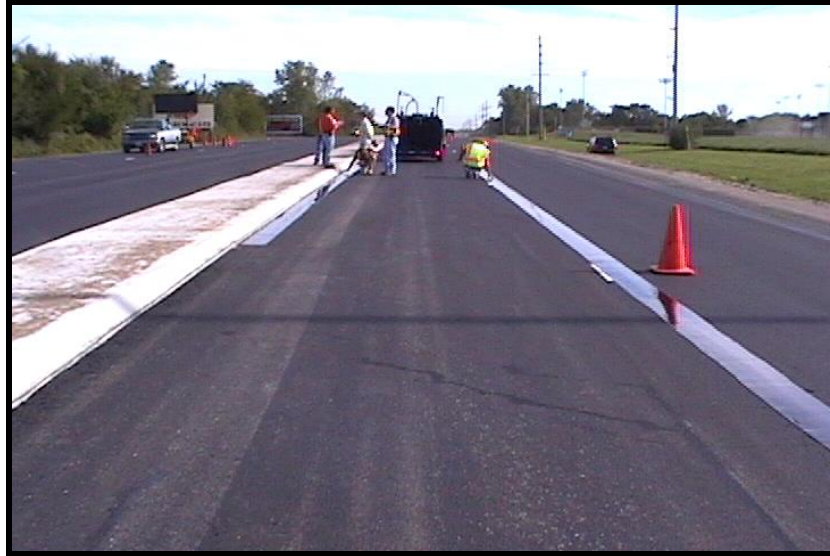
Figure 45: US 51 Jband Median Placement

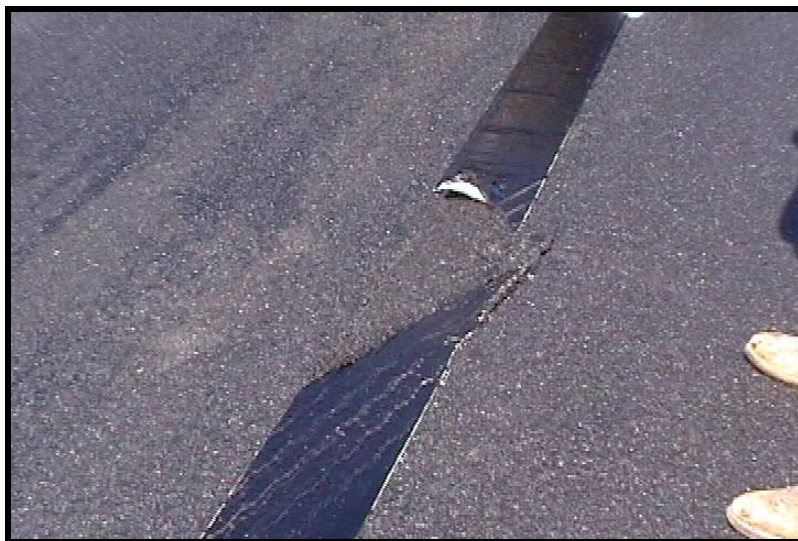
Figure 46: Joint Sealant Tracking

A main concern with the joint sealant material is that traffic should be able to drive over the material without picking up the joint sealant. For the US 51 project, the joint sealant was paved over with the bituminous surface the same day as it was applied. Since the test sections were only 100 feet in length, with control section between, there was little need for construction vehicles to pass over the joint sealant. However, as the temperature increased during the day, the material did become softer and tracking was observed, as shown in Figure 45.

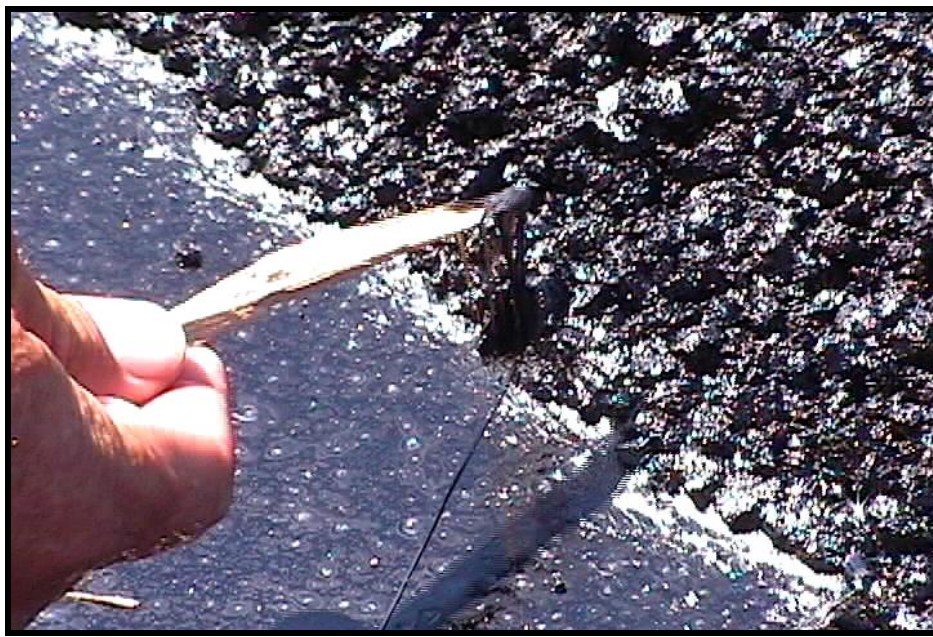
Figure 47: Joint Sealant Softens under HMA Surface

The joint sealants did soften more than what was observed in the past. Figure 46 demonstrates how the joint sealant softened after the first lane was paved. The softening of the material can also be seen by the glossy sheen along the joint sealant and HMA surface. The material is very elastic and contains polymers. The intent is that the polymers will help to prevent cracking. It was also noted when looking at the edge of the surface on the first lane paved that the material was migrating up into the surface. The intent is that the polymers will help to prevent cracking.

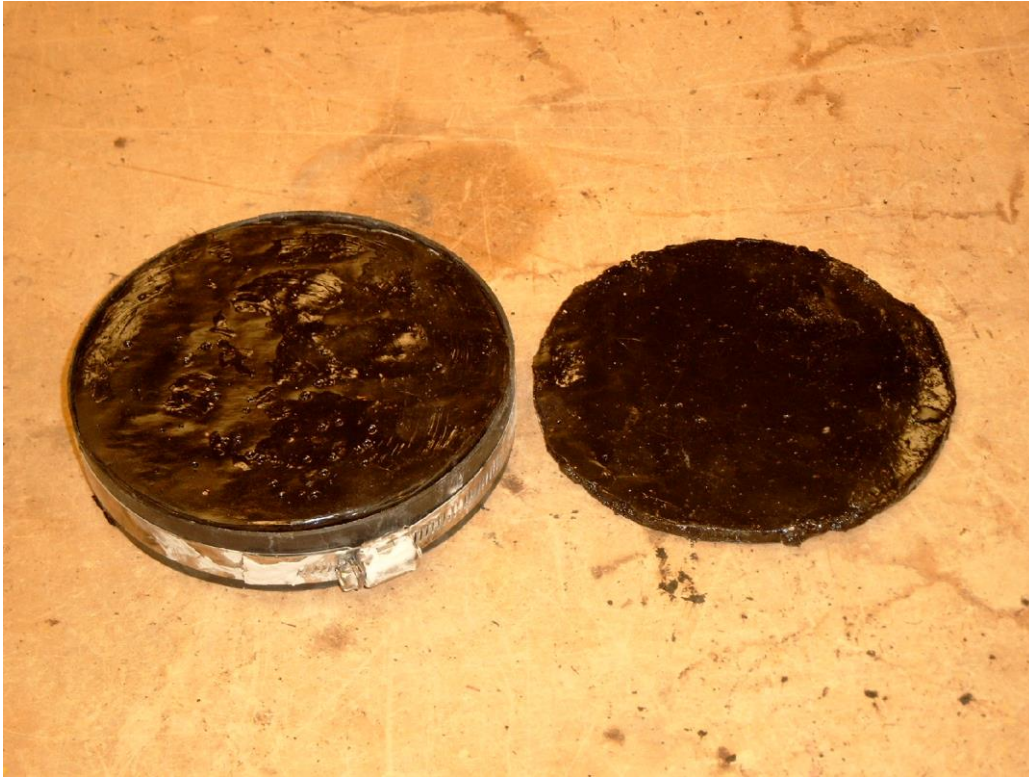
Figure 53: Joint Sealant Mold and Sample

The lab procedure utilizes the gyratory compactor to simulate field conditions. A filler specimen compacted to a height of 3 ½ inches (88.9mm) at 4% air voids is used to simulate a binder base. The filler specimen is then saw cut to a height of 3 inches (76.2mm) to ensure a flat, uniform surface. The filler specimen is placed into a room temperature gyratory mold with the sawed face up. Two paper discs are placed on the 3 inch filler face to prevent the material from migrating down. This is done so that the surface and sealant material can be easily removed for observation and allows the filler specimen to be used on multiple trials. A 6 inch diameter of joint seal at the desired thickness (typically 3/16 inch) is placed on the paper discs. Since the Emulsicoat Jband was sent in pint and quart cans, the joint sealant was heated, poured into a 6-inch mold, and cooled to room temperature (Figure 52).

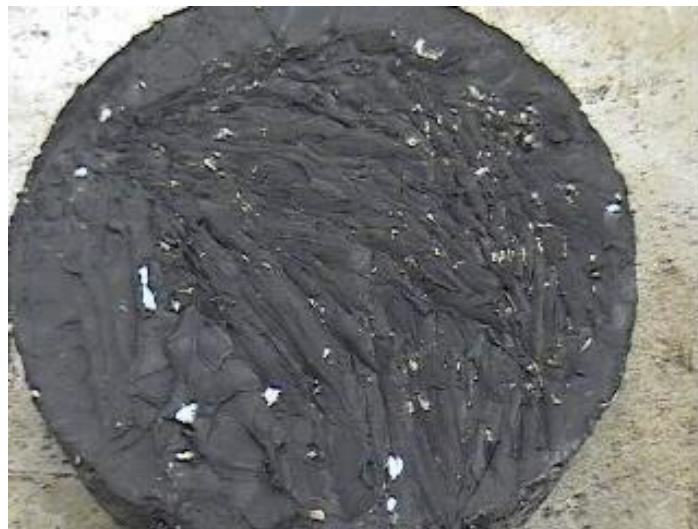
Figure 54: 5005 Bottom View

The lab procedure helped rule out several intermediate formulations before those that were finally used on US 51. Two such formulations were designated 5005 and 4004. The lab trials showed that the 5005 material did not soften much, thus not migrating up into the sample, as shown in Figures 53 - 55.

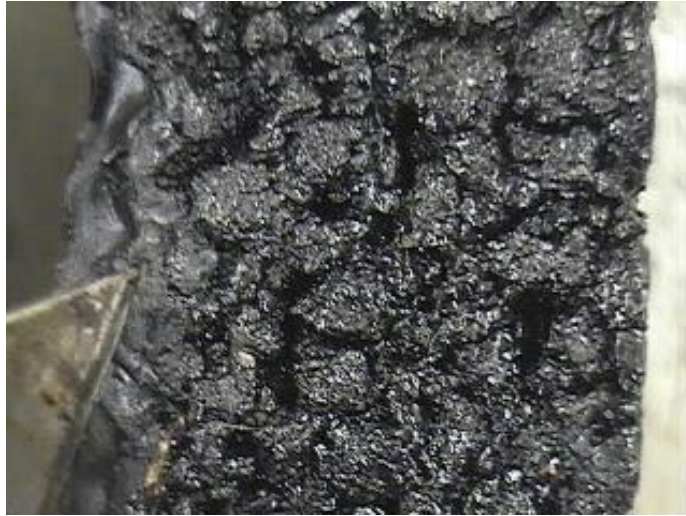
Figure 55: 5005 Side View

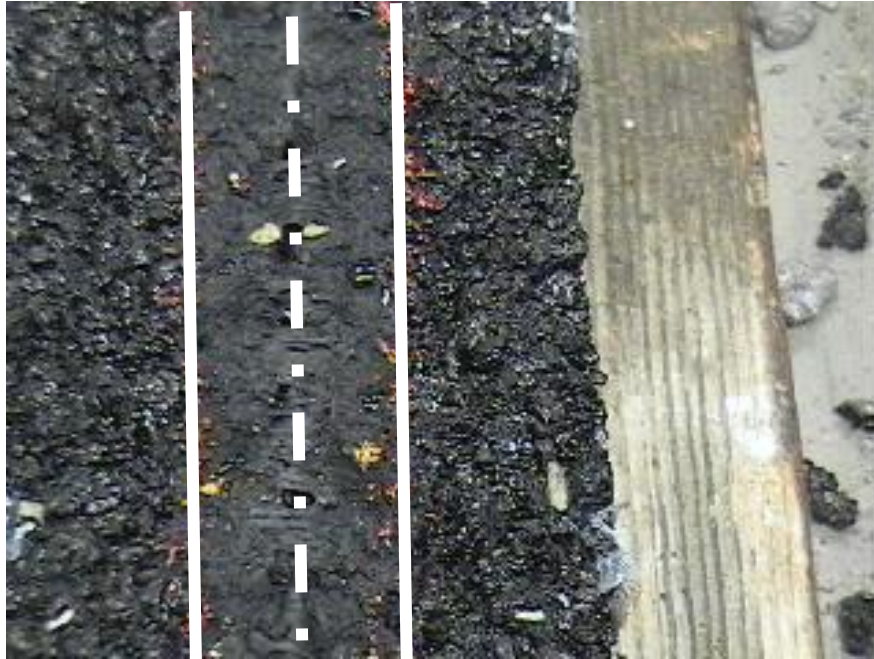
Figure 59: 4004 after Splitting

The 4004 softened more than the 5005 material, but was still not satisfactory, as shown in Figures 56-58. The picture showing both 4004 and 5005 shows that the 5005 material remained as a thick coating while the 4004 material is less detectable, since it did migrate more and had less build up at the interface.
