Evaluation of Service Life of Noise Barrier Walls in Illinois

Project IIB-H1, FY 1997

Report No. ITRC FR 97-3

November 1999

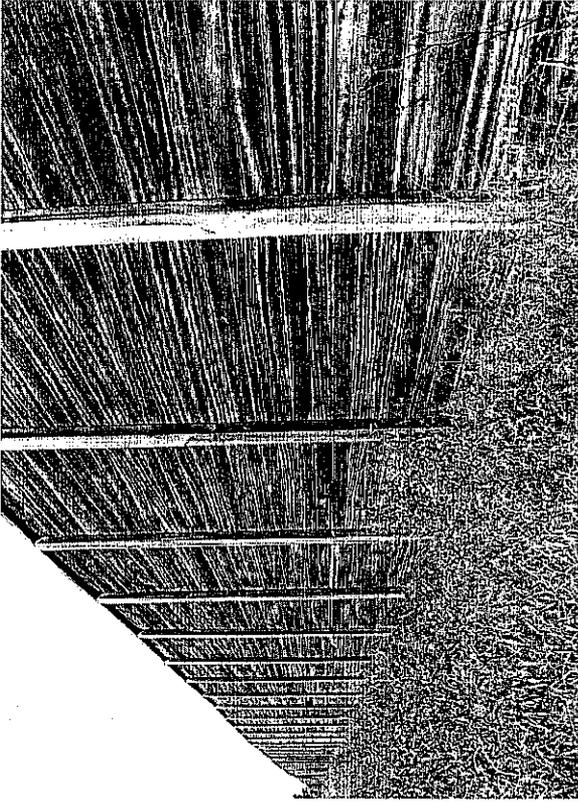
24. Tropical hardwood, I-355, north of Army Trail Road, highway side
built 1989

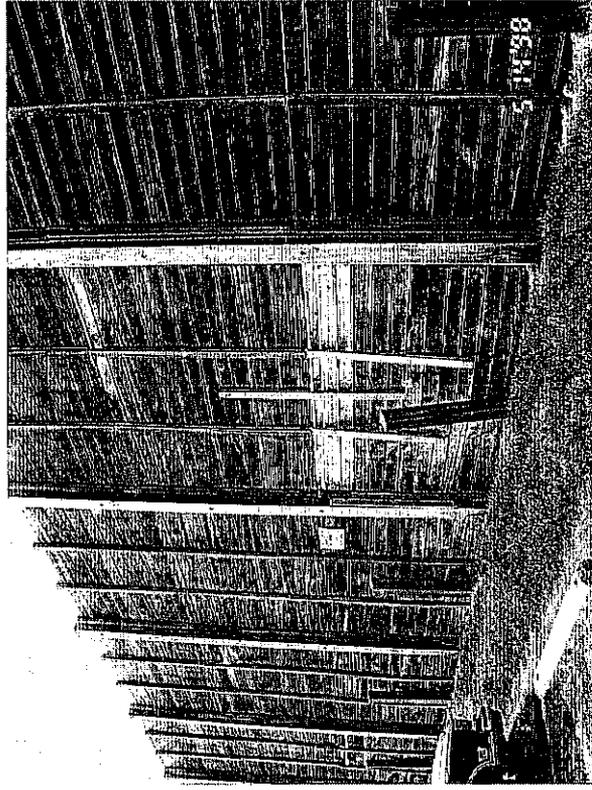
30. Tropical hardwood, east of IL 53 at Lake Cook Road, residents' side built 1990

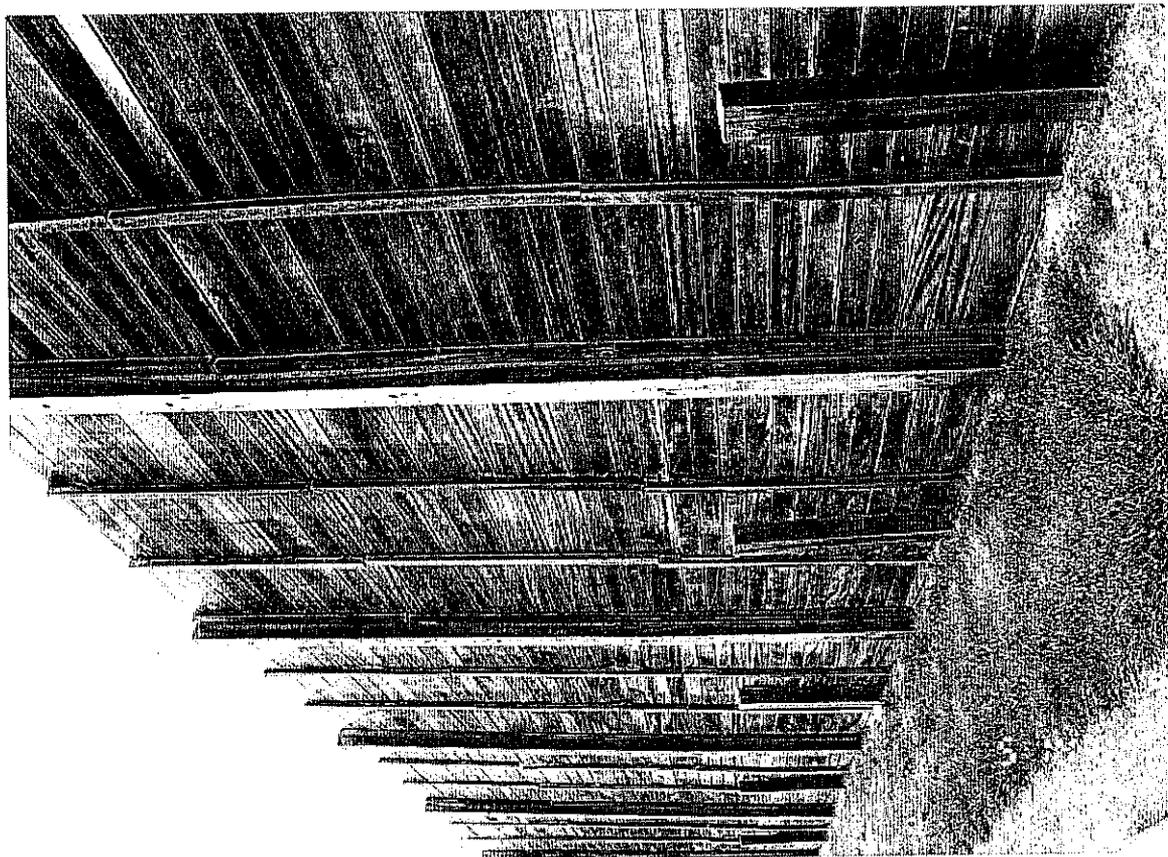
32. Tropical hardwood, east of IL 53 at Lake Cook Road, residents' side
built 1990

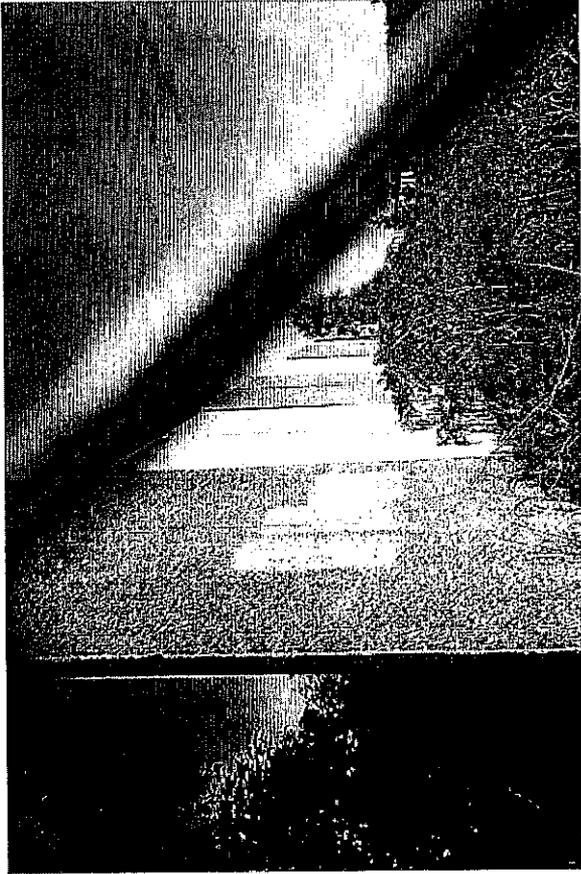
5. Precast concrete panels, IL 39/US 51, Rockford, graffiti paint-out
built 1980

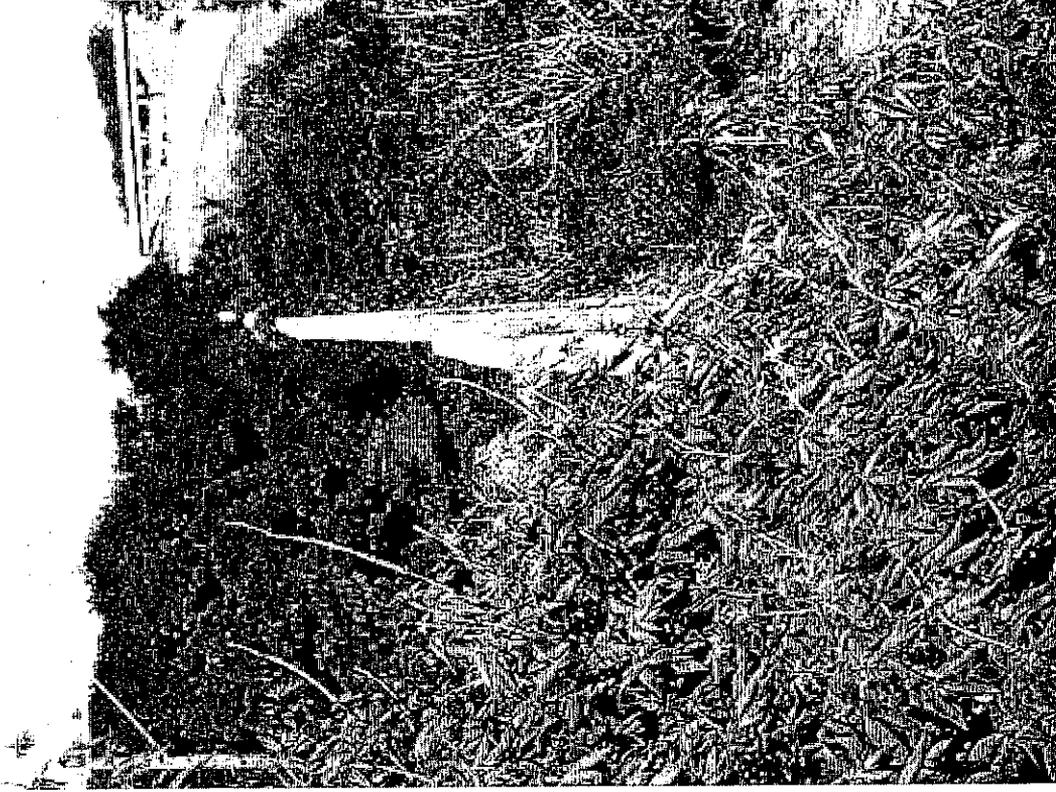
8. Precast concrete panels, Rockford, looking west on IL 39/US 51 from Milford Road overpass, showing some movement of wall panels built 1980

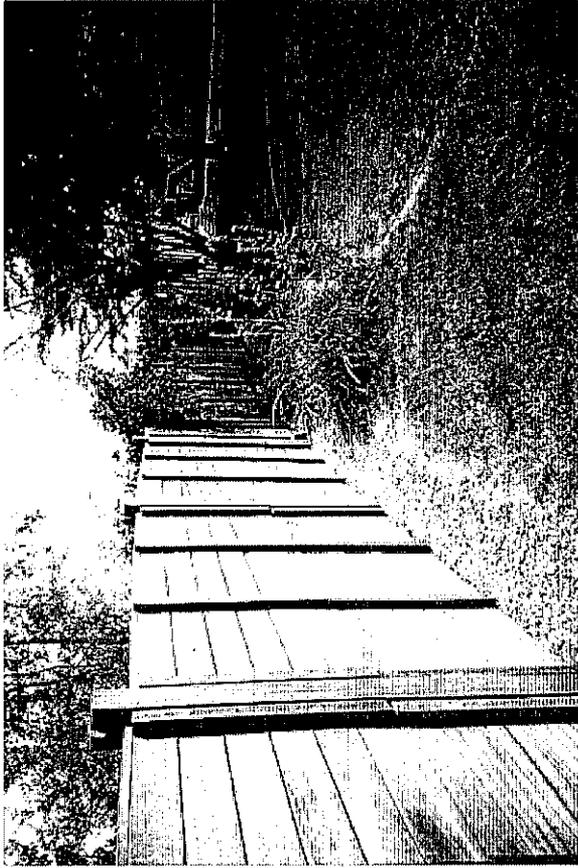
6. Bongossi barrier, I-474, Peoria, minor unevenness along top of barrier 1987-1998

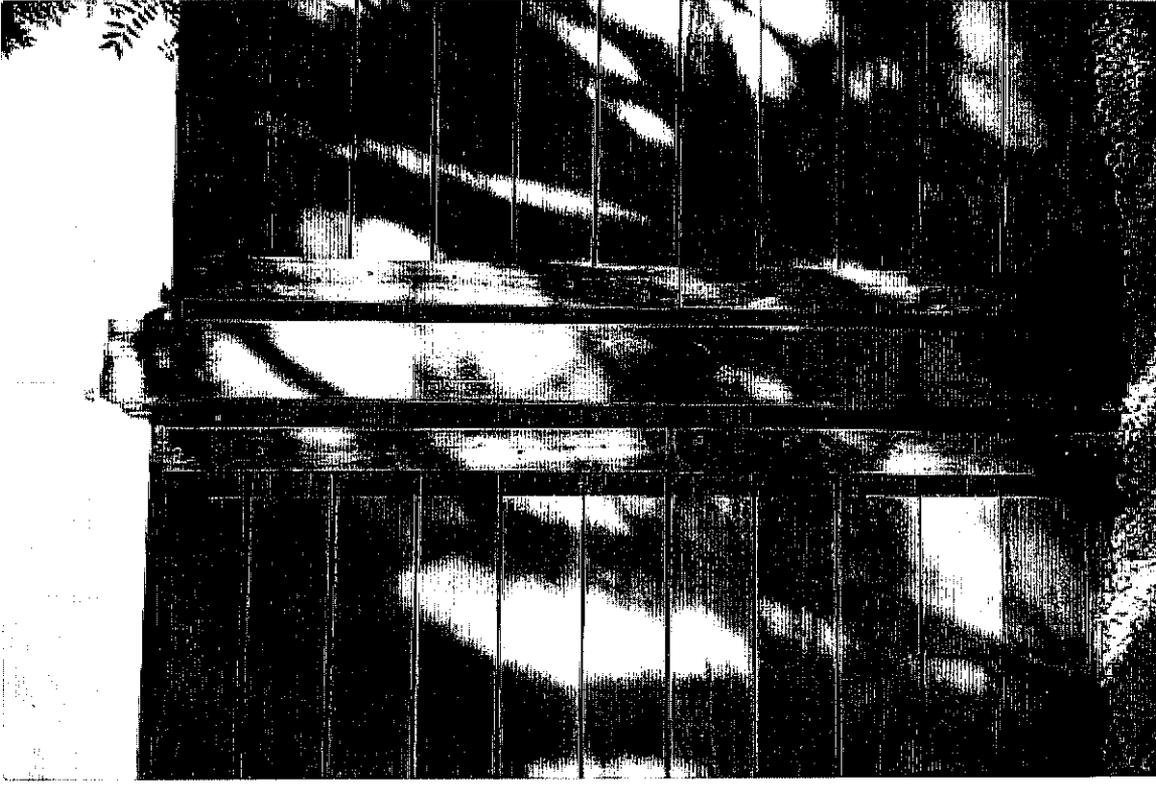
13. Bongossi barrier, I-474, Peoria, gravel drainage layer at base of barrier; gap between pre-assembled panels 1987-1998

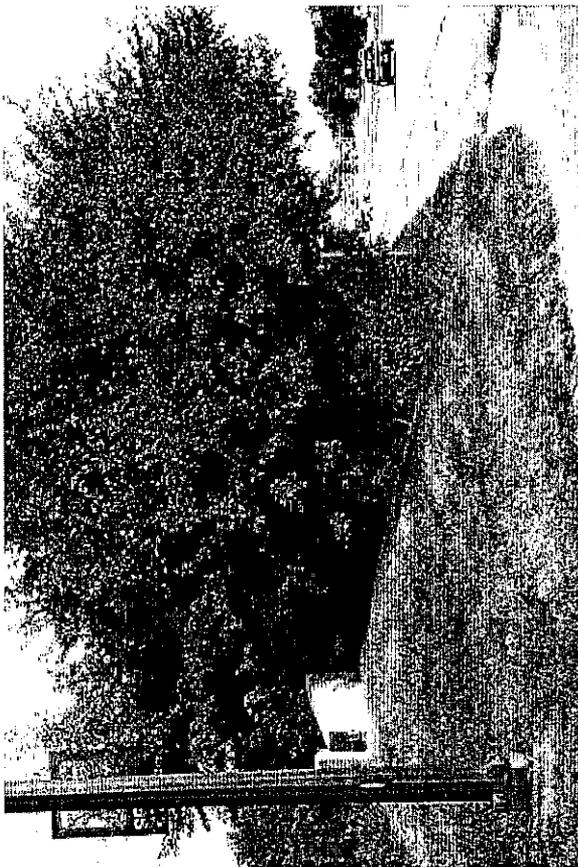
2. Combination berm/retaining wall, IL Rte. 4, Springfield, highway view at cross-street 1979-1998

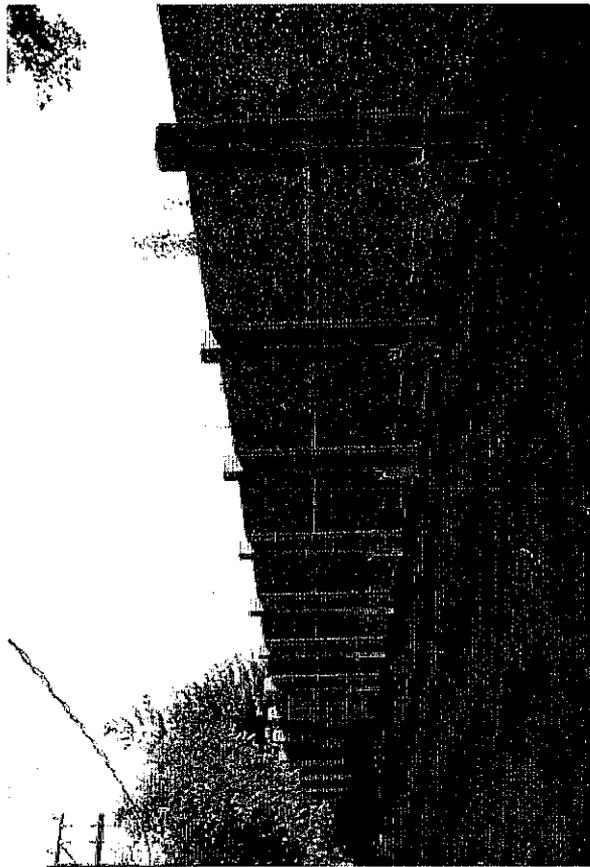
4. Residents' view of combination berm/retaining wall, IL Rte. 4, Springfield 1979-1998

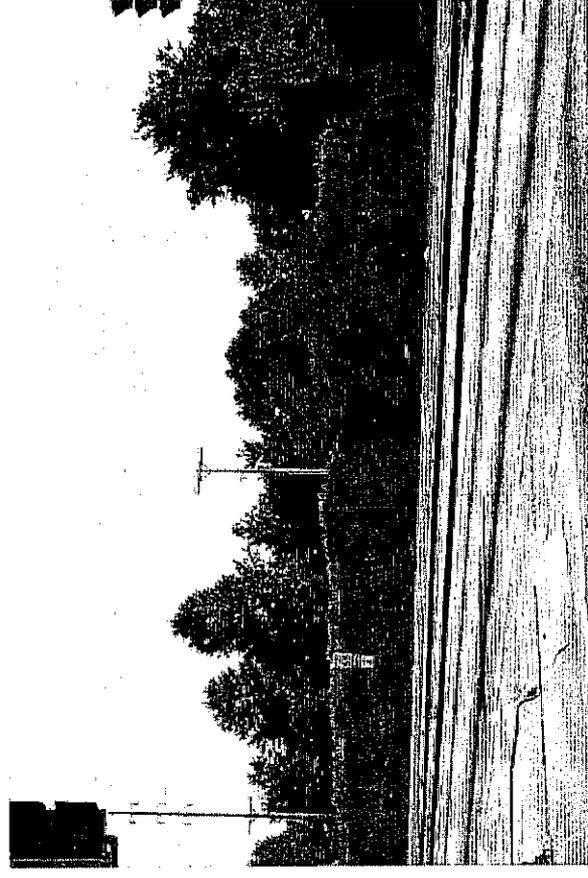
8. Earth berms, IL Rte. 4, Springfield, mowed near base only 1979-1998

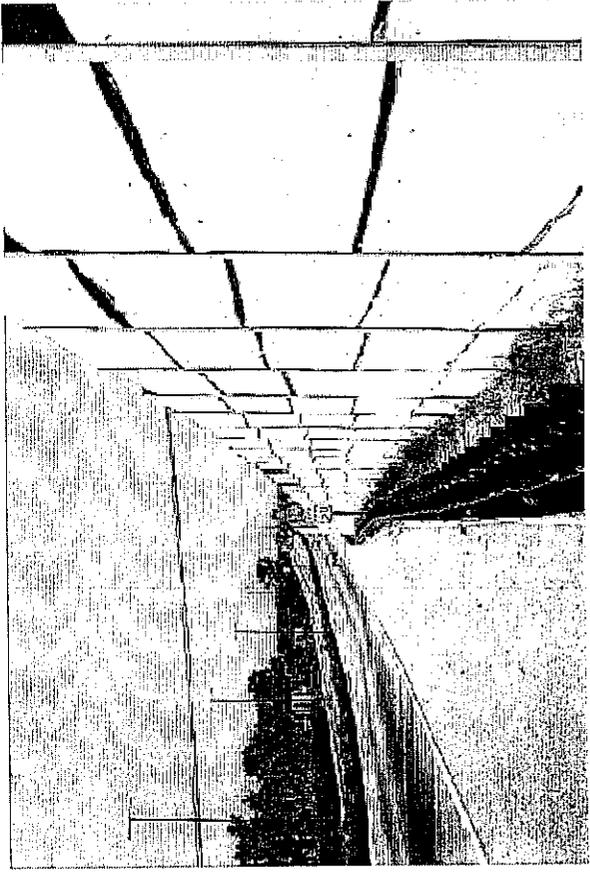
3. Fiberglass panels added over Noisfield wall, I-255 built 1984

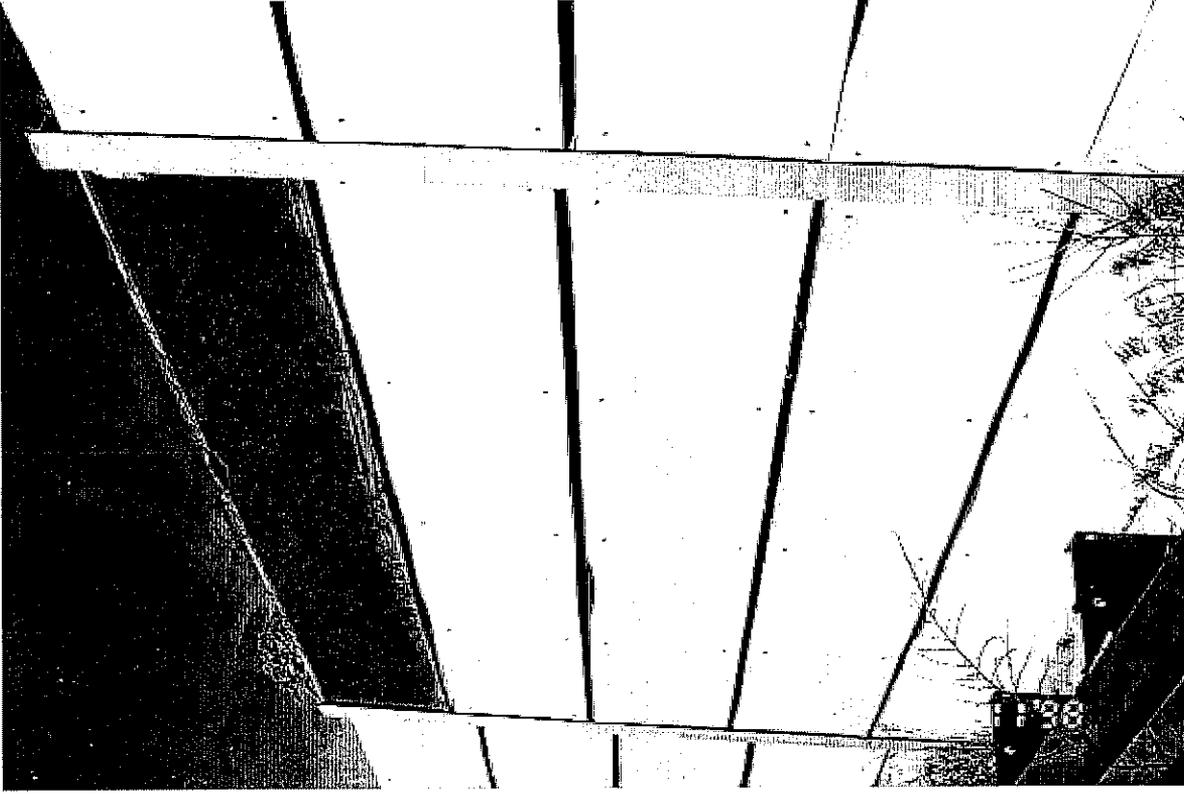
10. Exposed steel panel with fiberglass covering absent I-255, Centerville built 1984

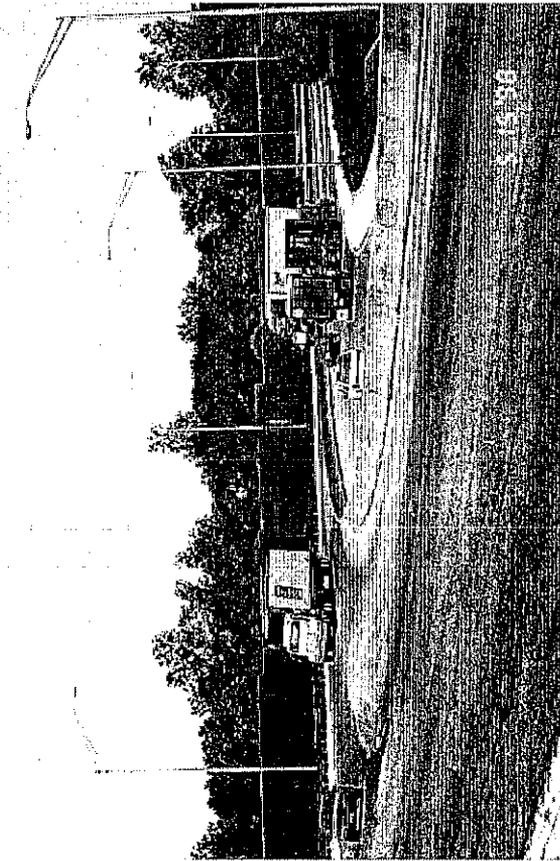
1. Carsonite, I-294, showing uneven coloration of panel components when viewed from a distance
1994-1998

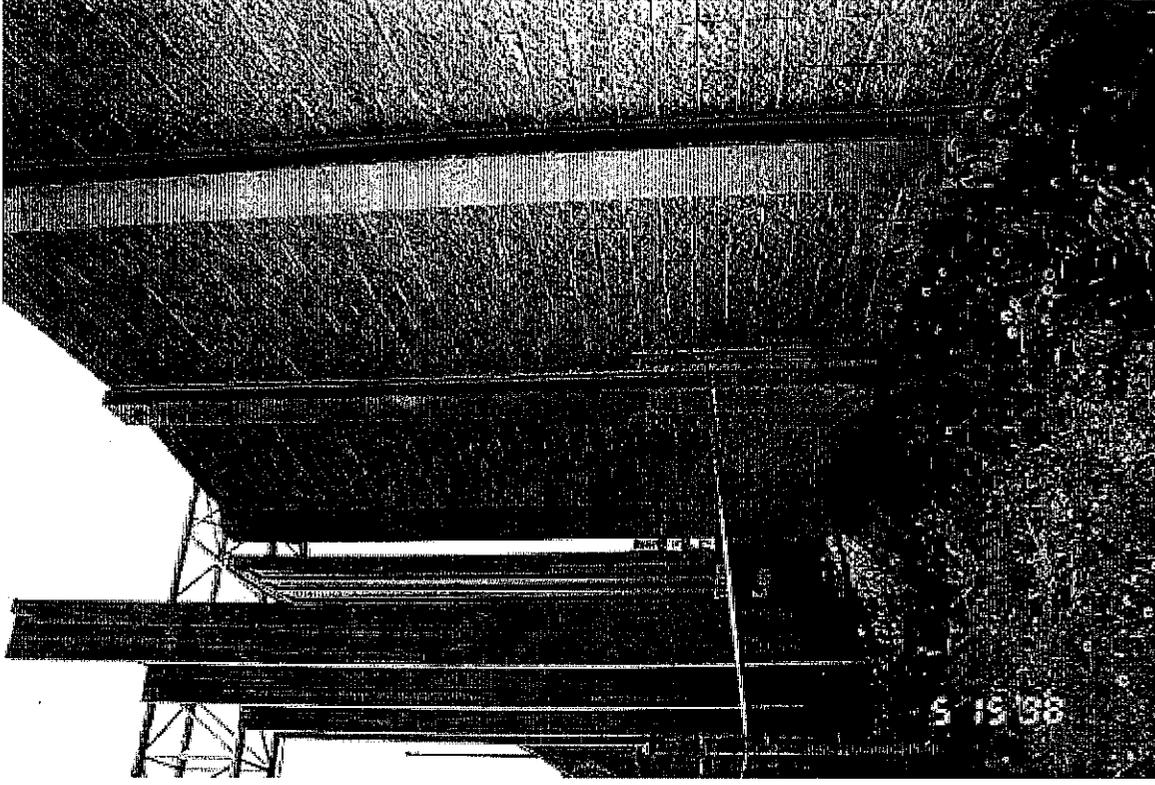
17. Precast concrete noise wall (foreground) transitioning to glue-laminated wood wall, I-294; note access gap in wall 1994-1998

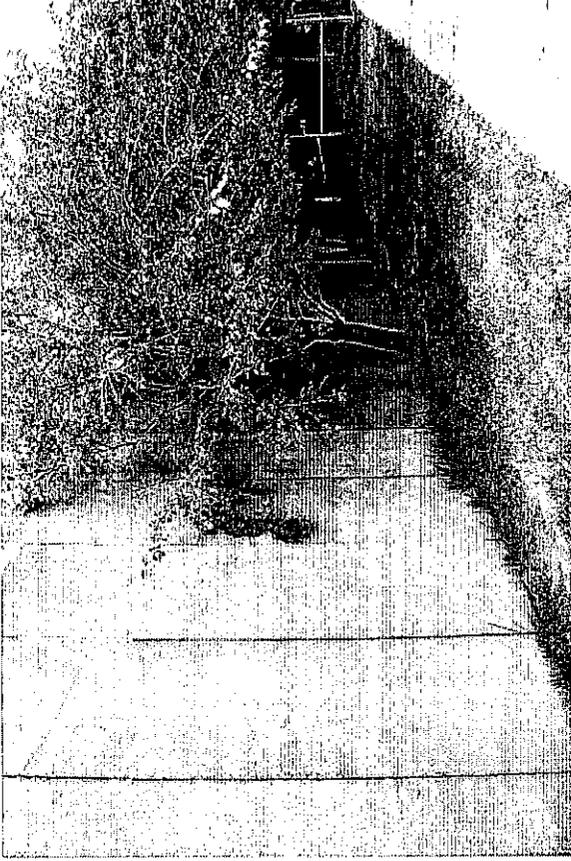
6. Precast/prestressed concrete barrier, I-170, St. Louis, with tree at base; wall leans toward roadway (left)

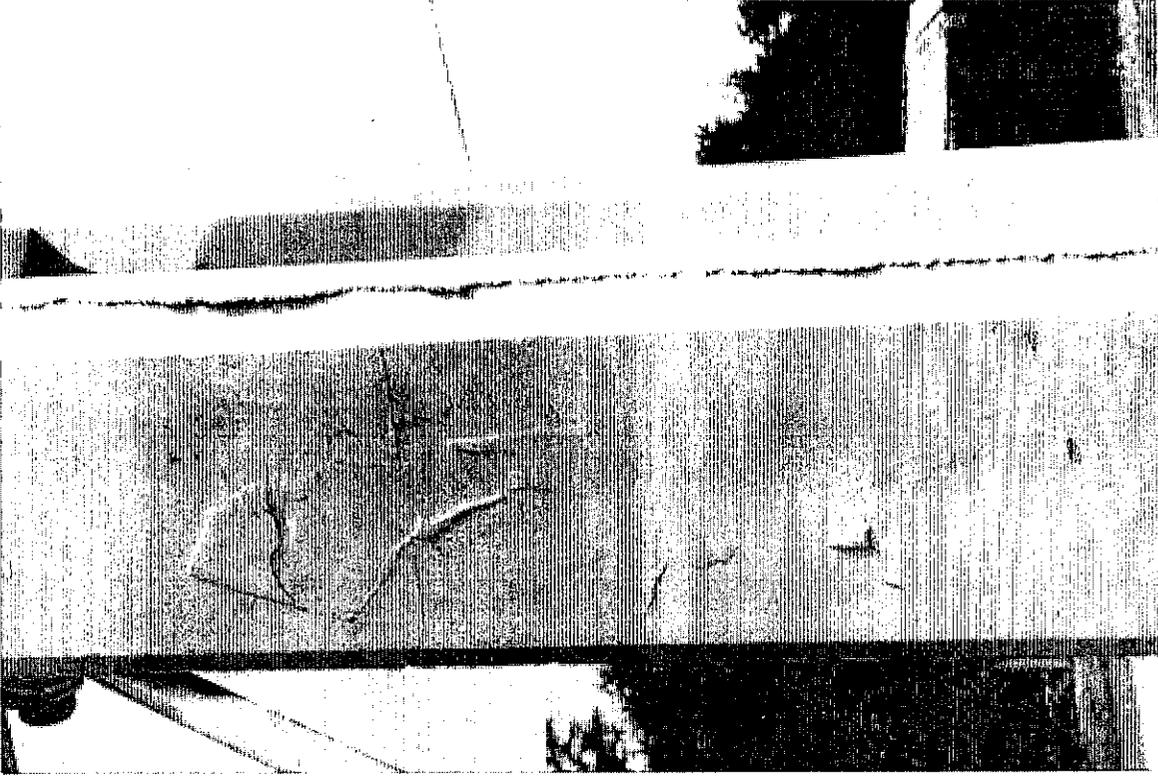
14. Precast concrete post, Manchester Road, St. Louis, isolated surface irregularities, new construction 1998

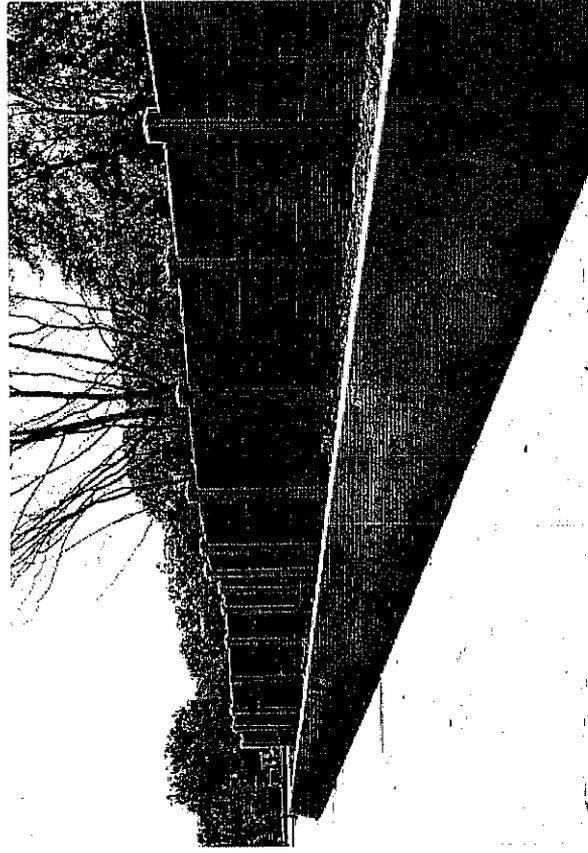
18. Precast concrete posts and stacked panels, Manchester Road, St. Louis, undulating wall section 1998
