# **IDNR – Office of Mines and Minerals Abandoned Mine Land Reclamation Division**

## **Emergency Unit**

# **Mine Grouting Emergency Projects**

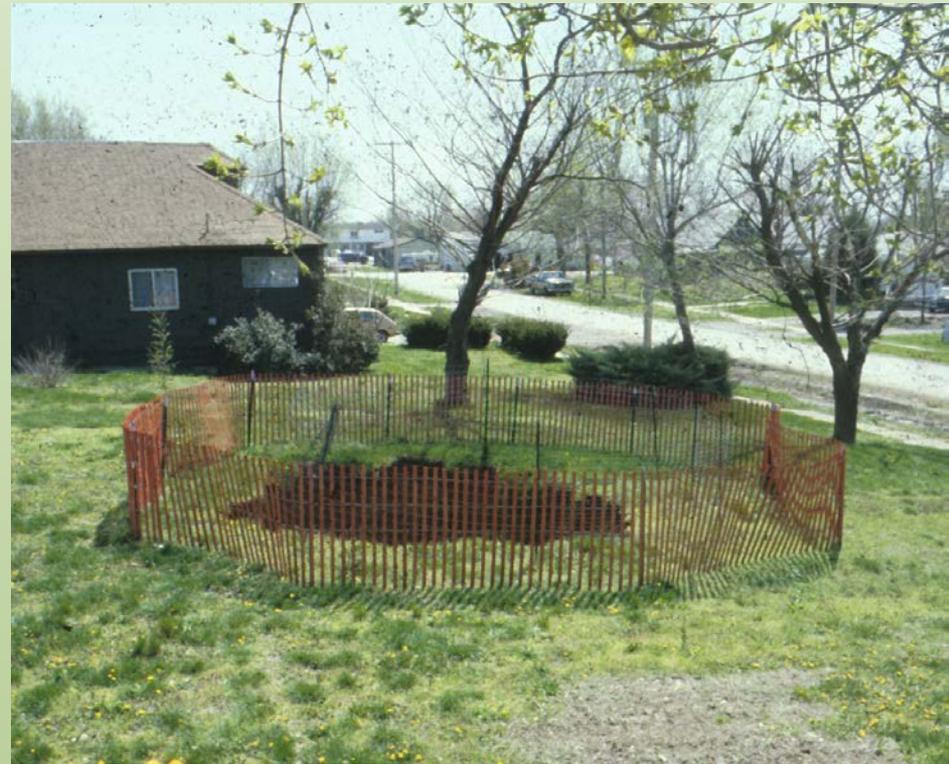
In shallow underground mining areas, falls of mine roof are frequently followed by surface subsidence causing pit holes or sinkholes.

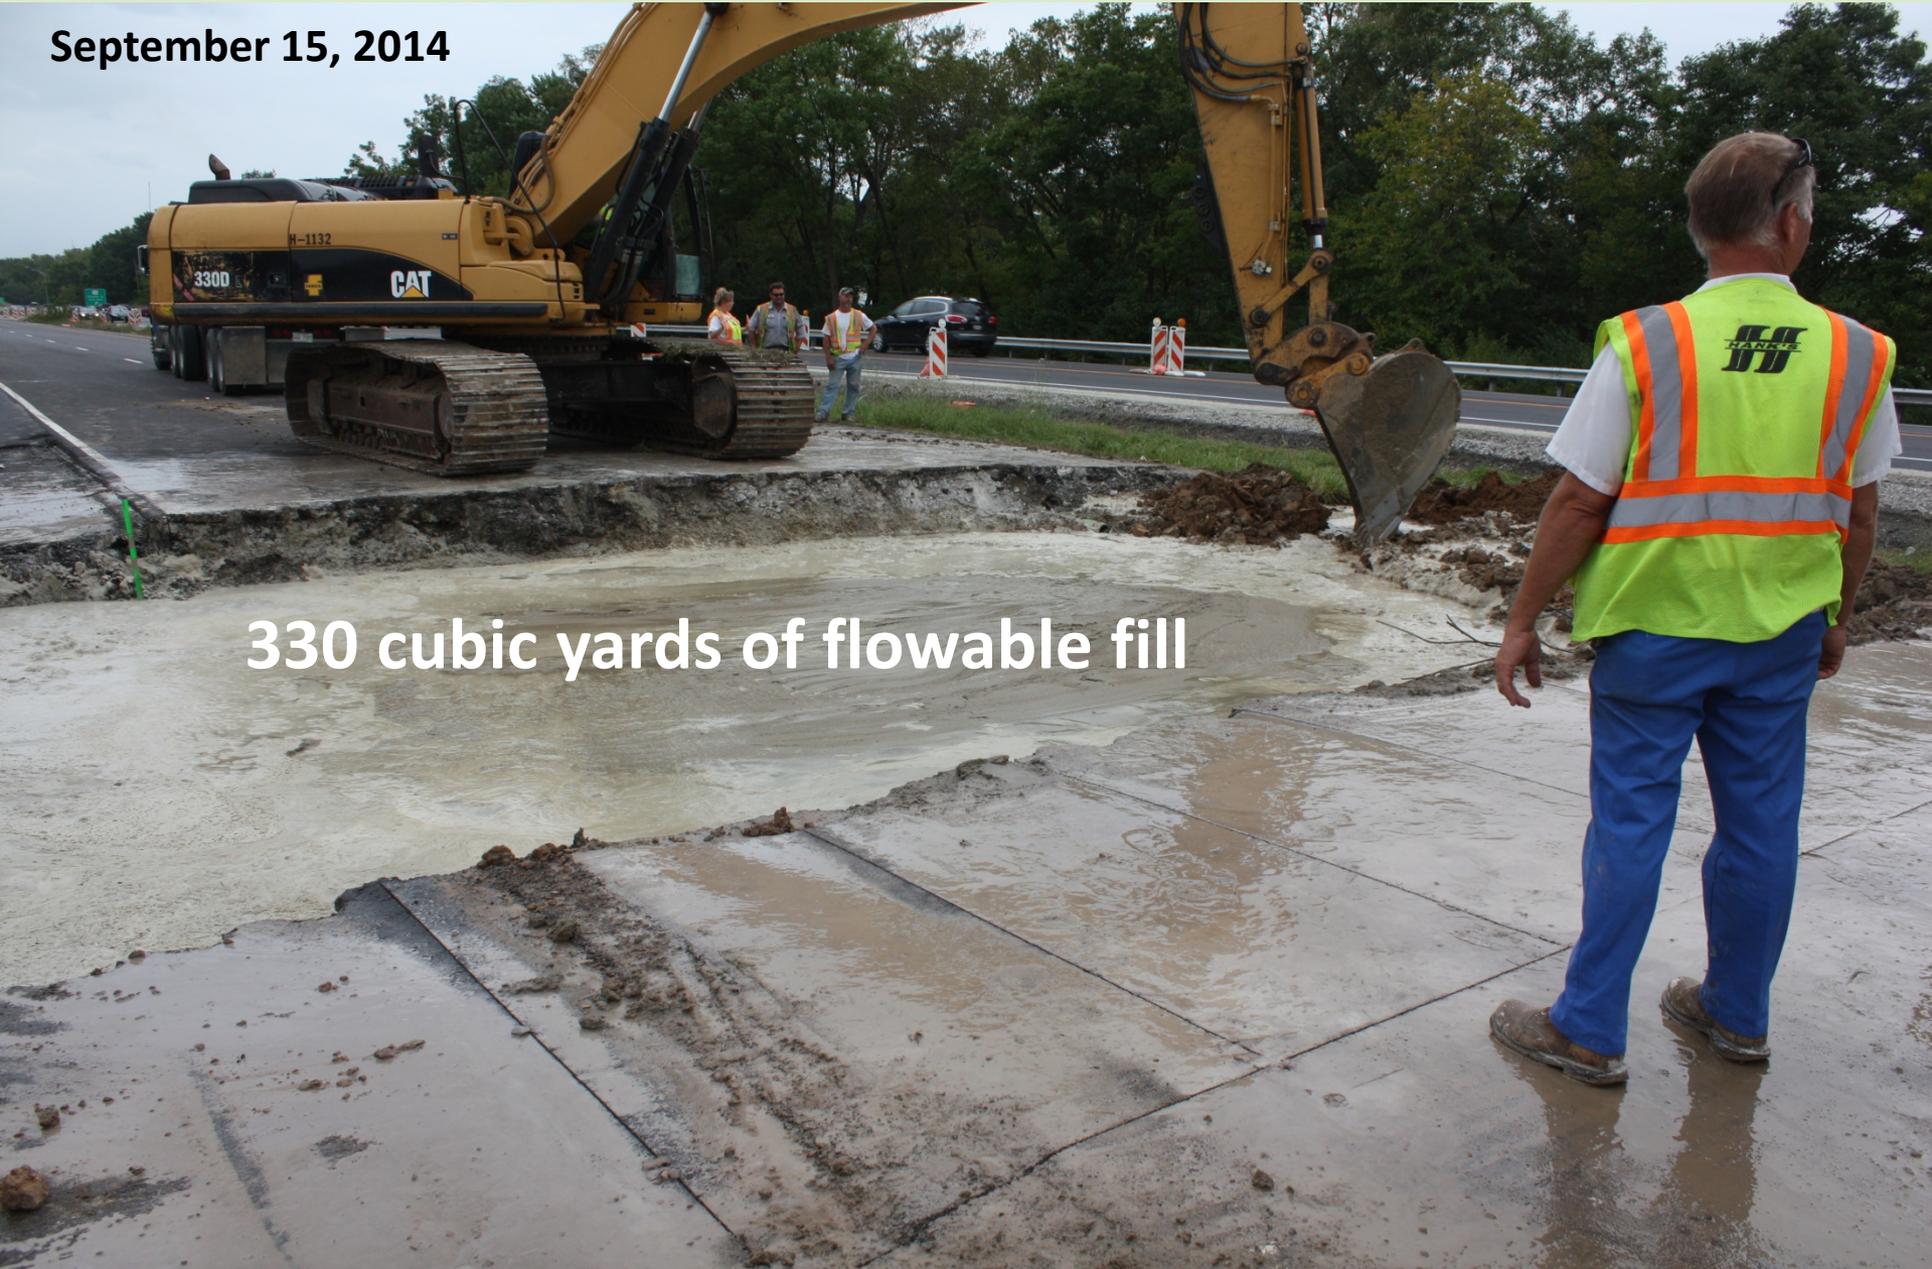
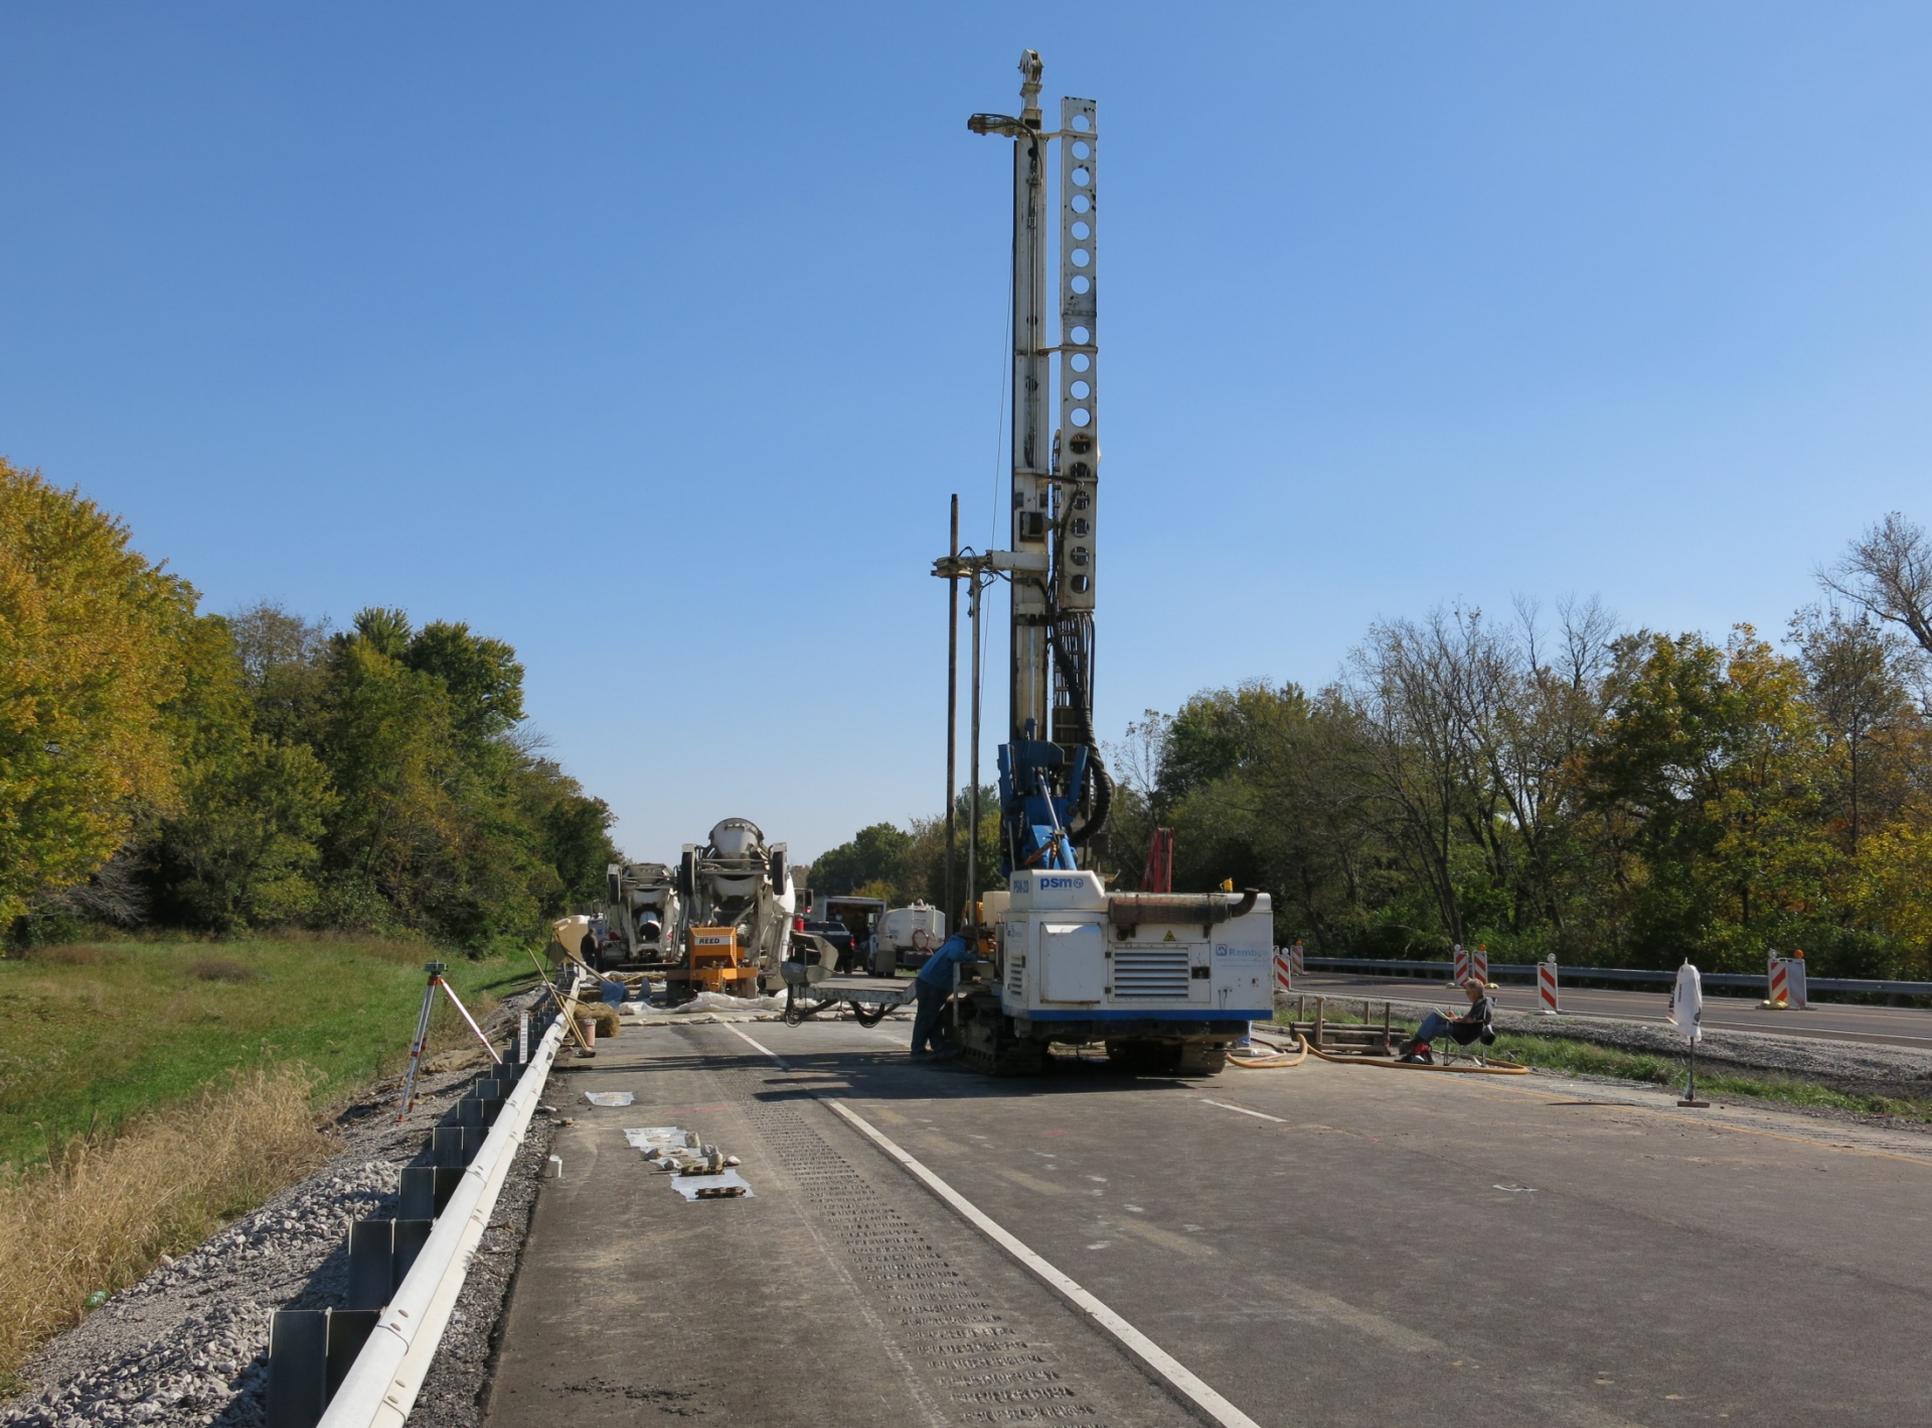
**Collapsed materials**

330 cubic yards of flowable fill

- 506 yds<sup>3</sup> of cement grout
- 100 yds<sup>3</sup> Mix A
- 406 yds<sup>3</sup> Mix B
- 7 day strength
  - Mix A: 930 – 1,010 psi (Ave = 965 psi)
  - Mix B: 710 -1,140 psi (Ave = 963 psi)

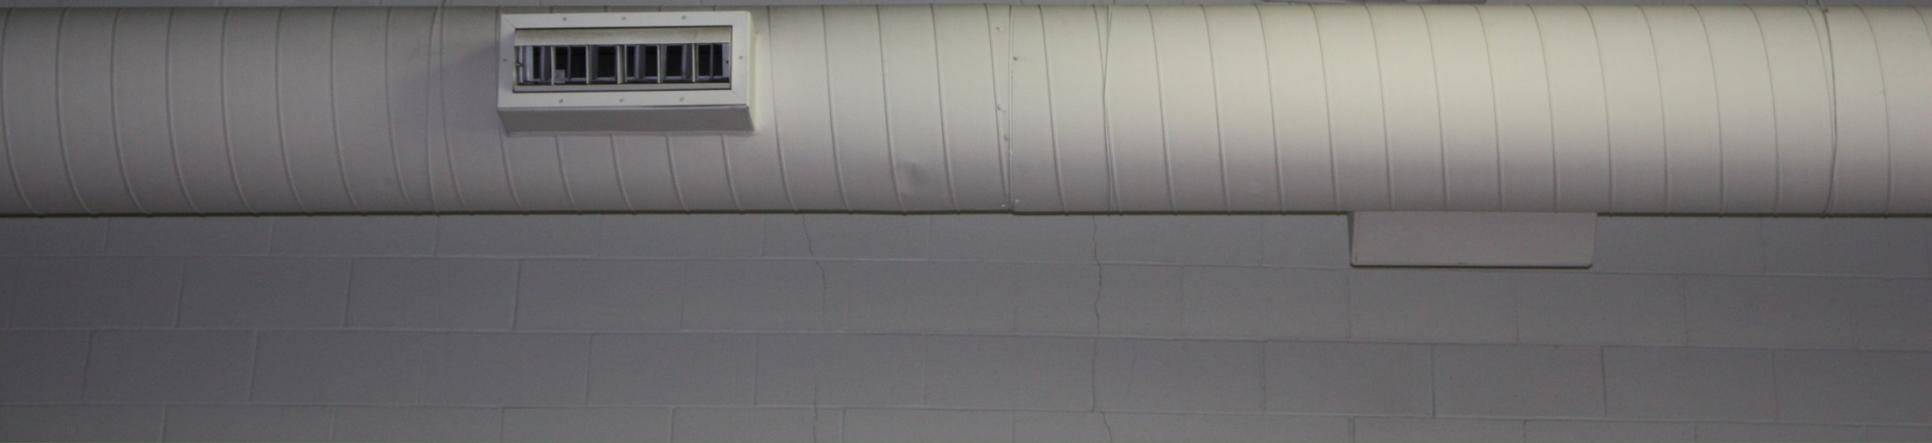
**North Gymnasium Wall  
- Roof Trusses Punching Through Load Bearing CMU**

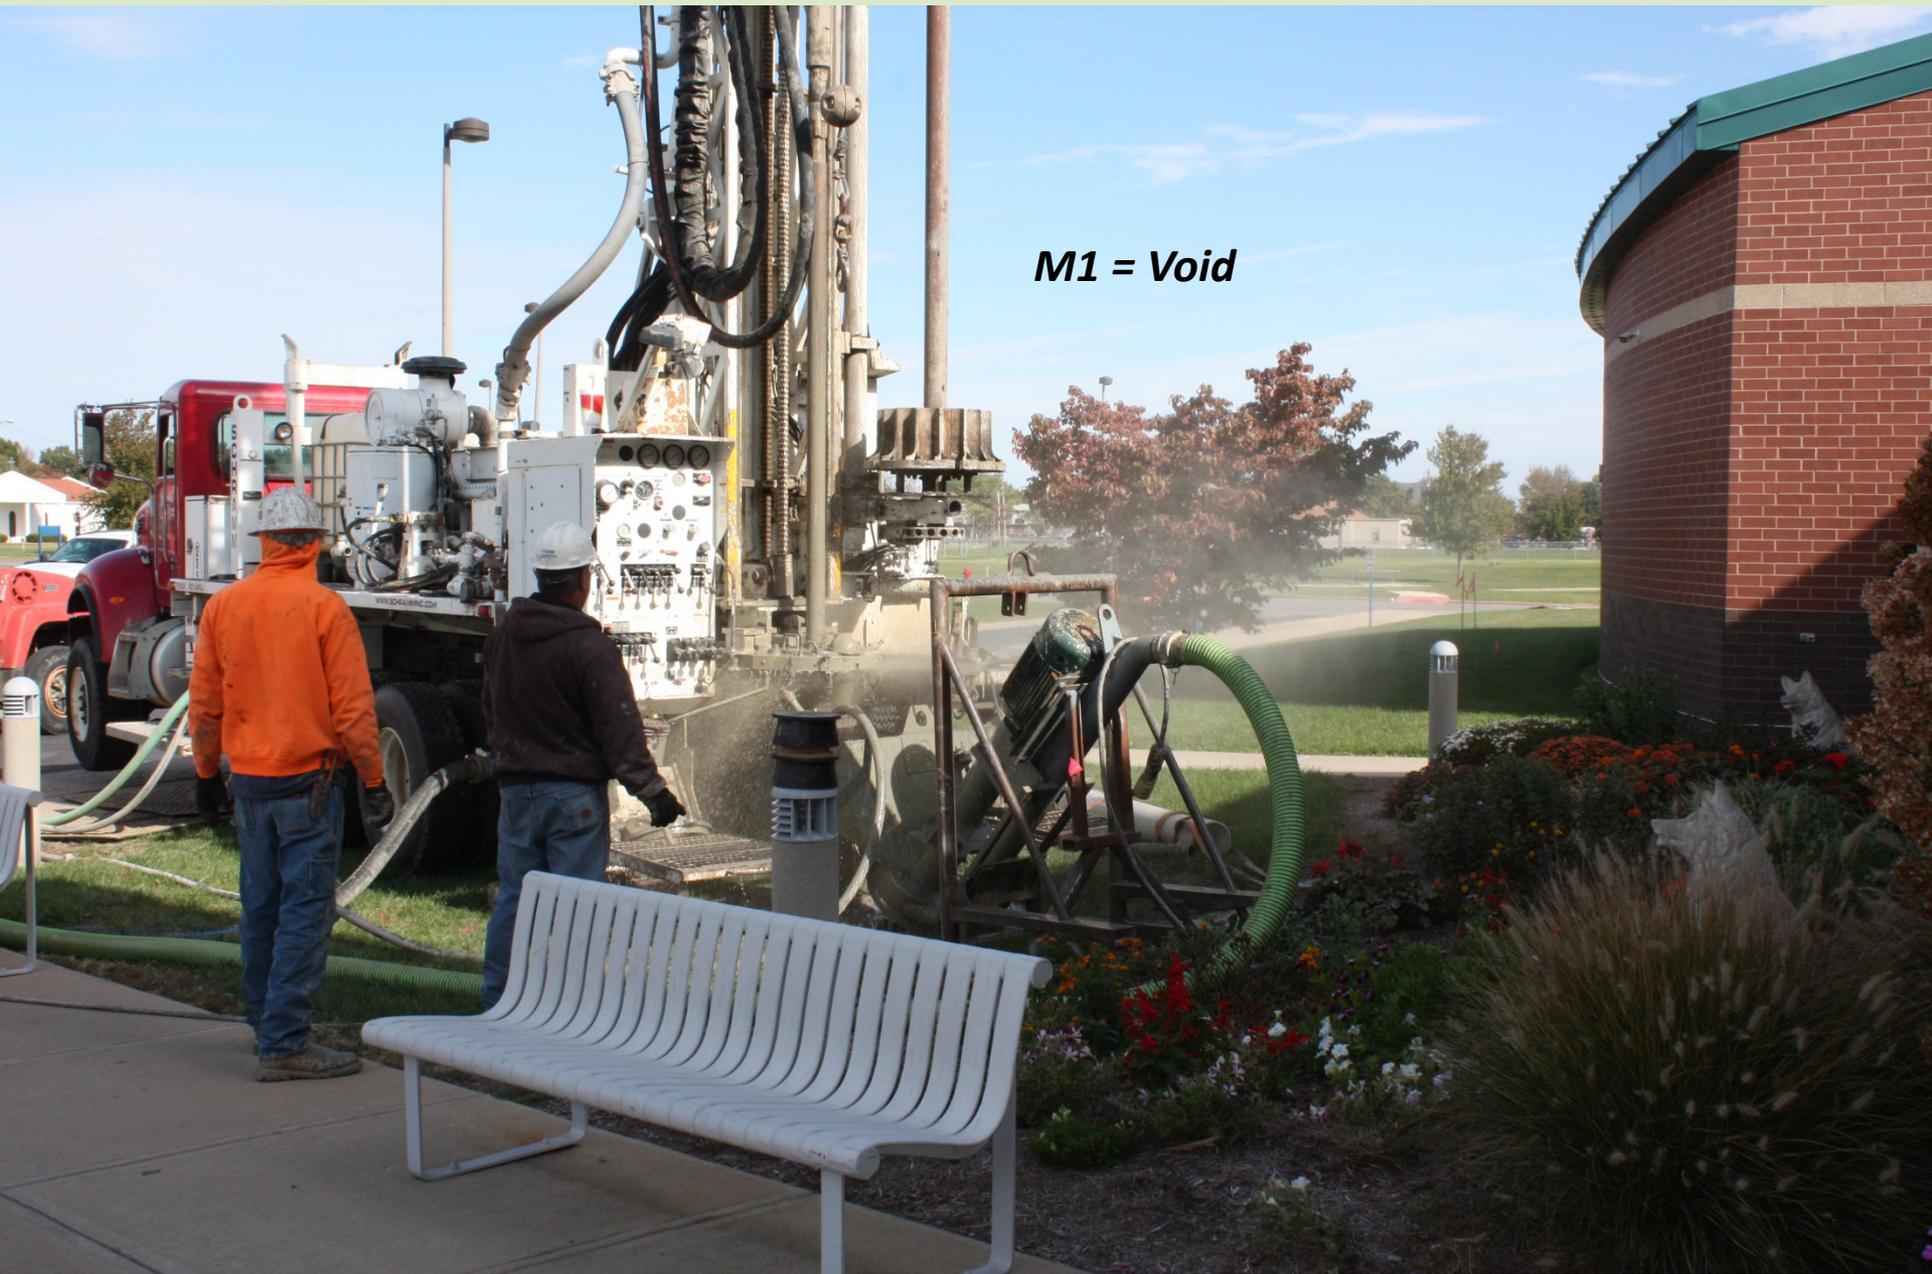
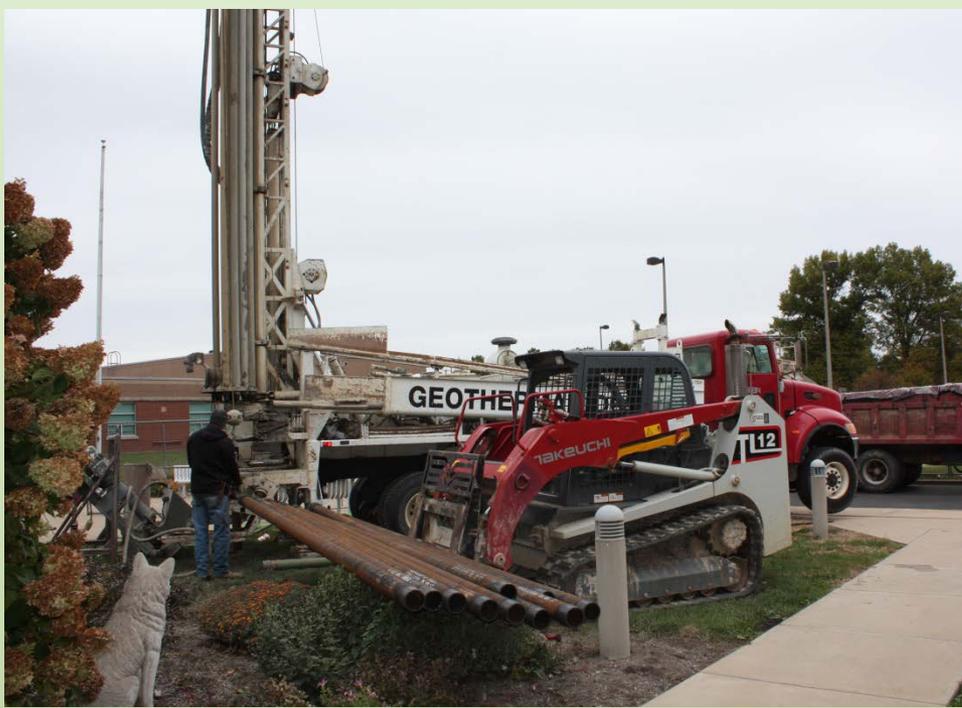
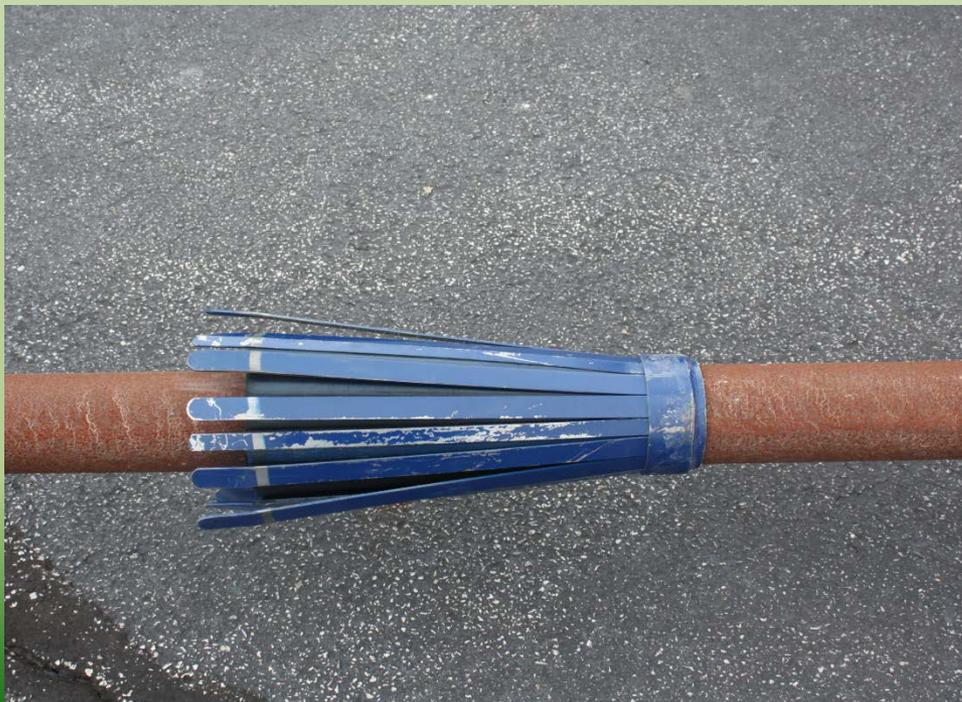
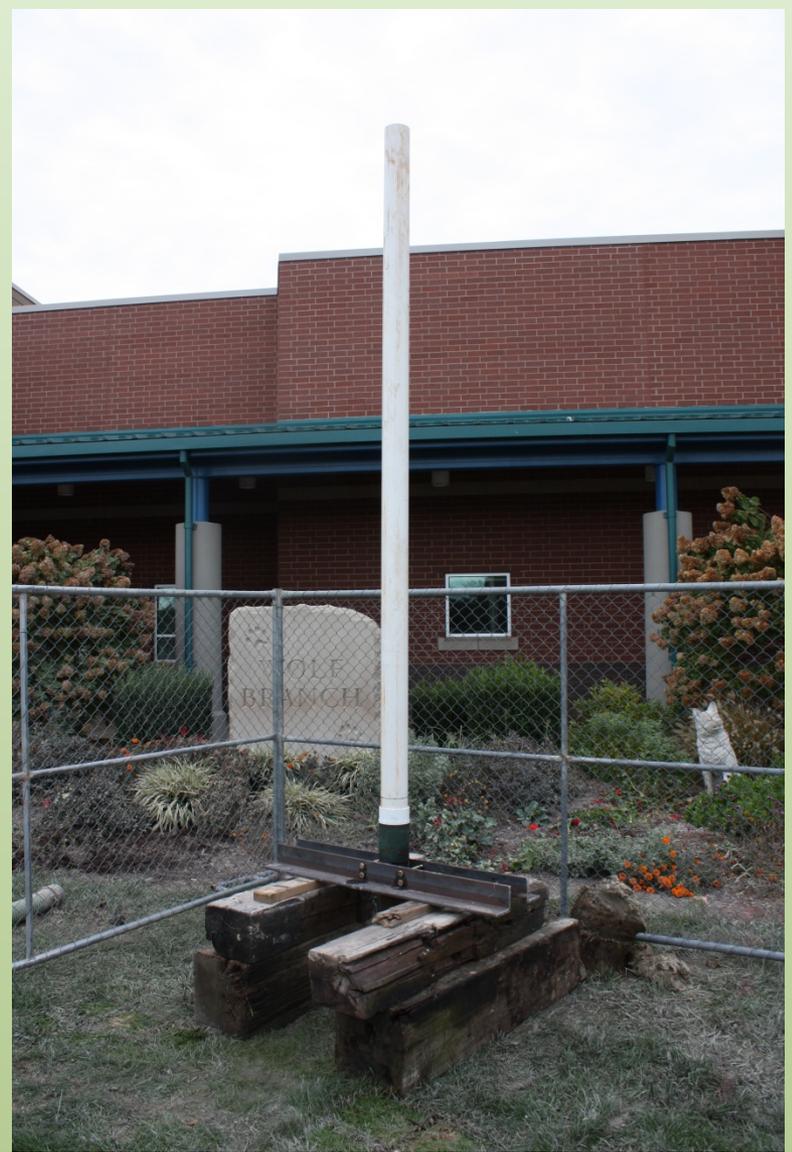
Figure 1

***M1 = Void***

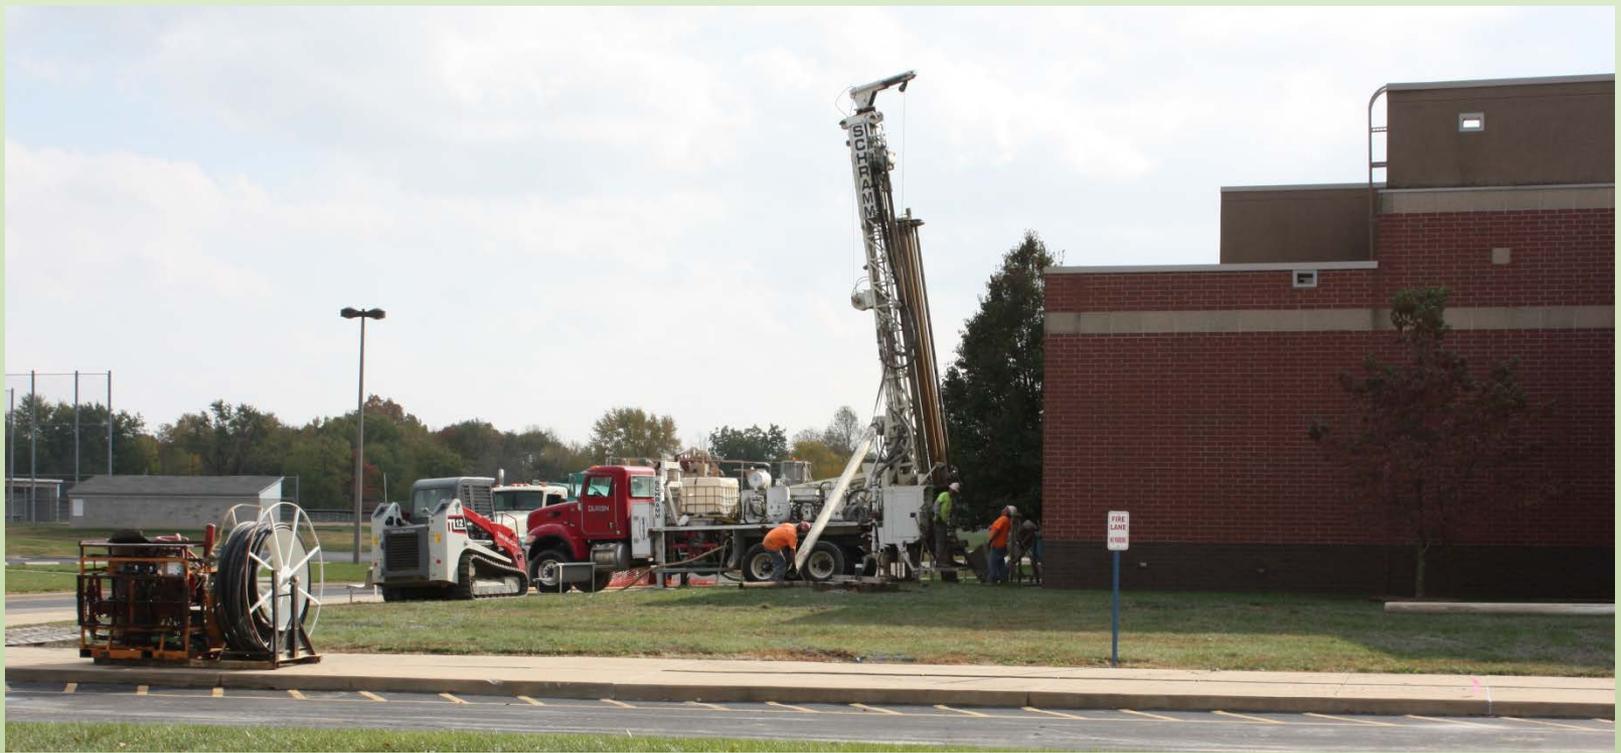
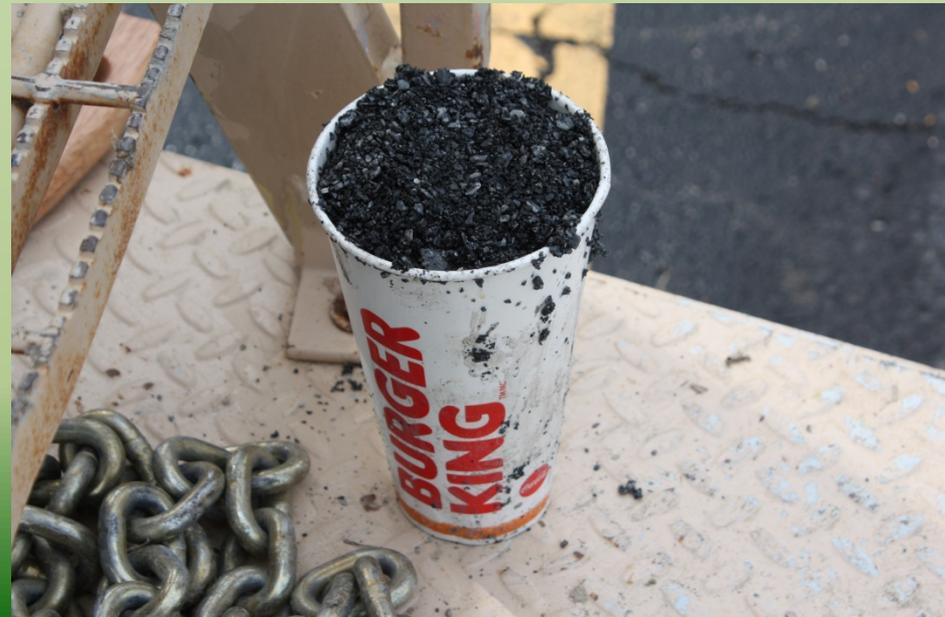
***M4 = Coal***

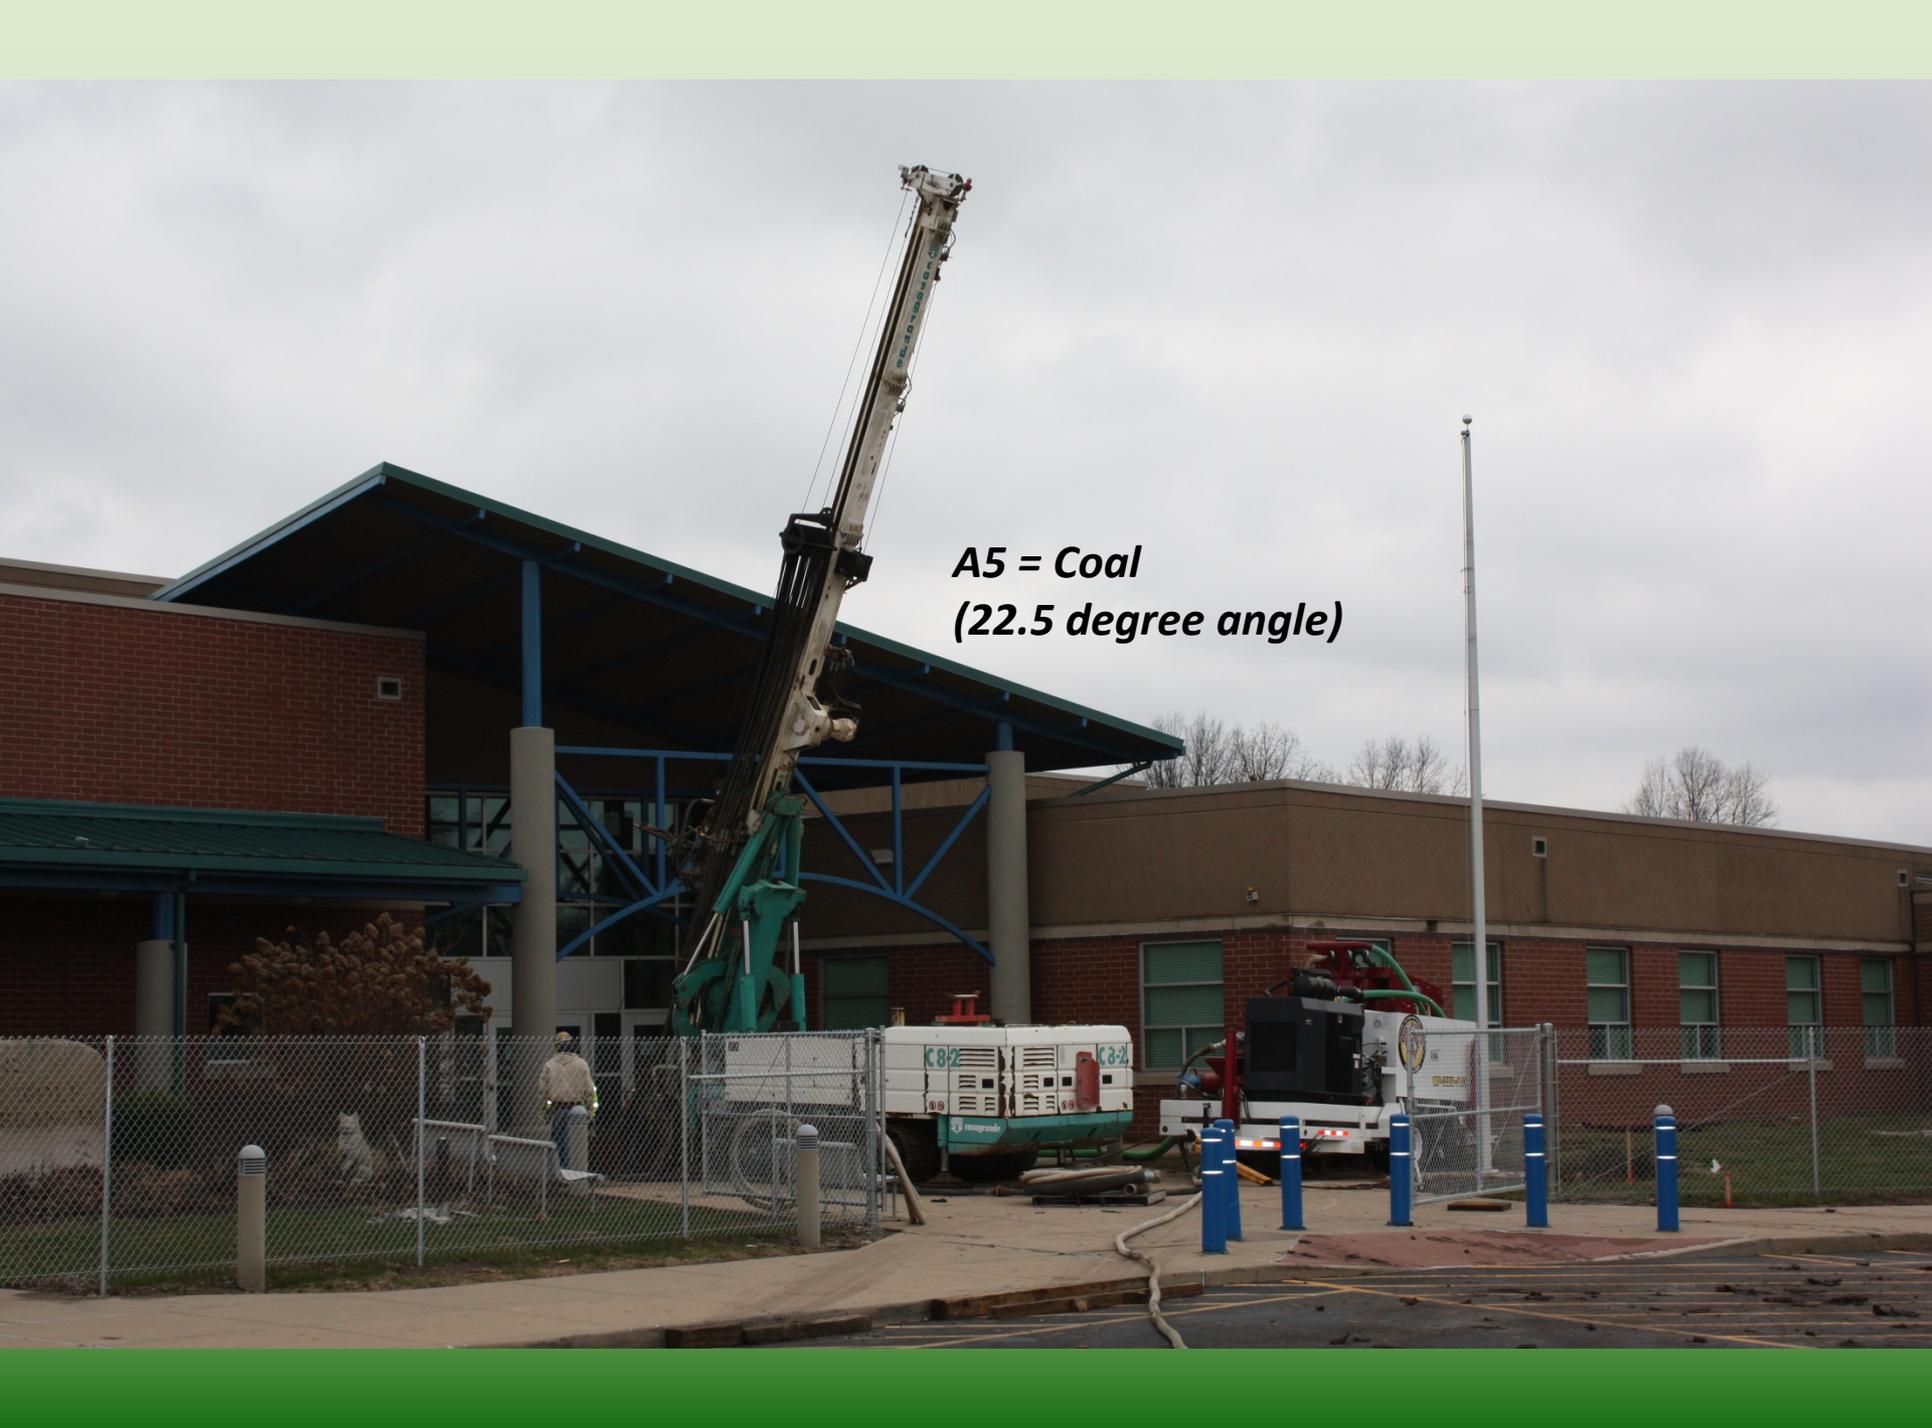
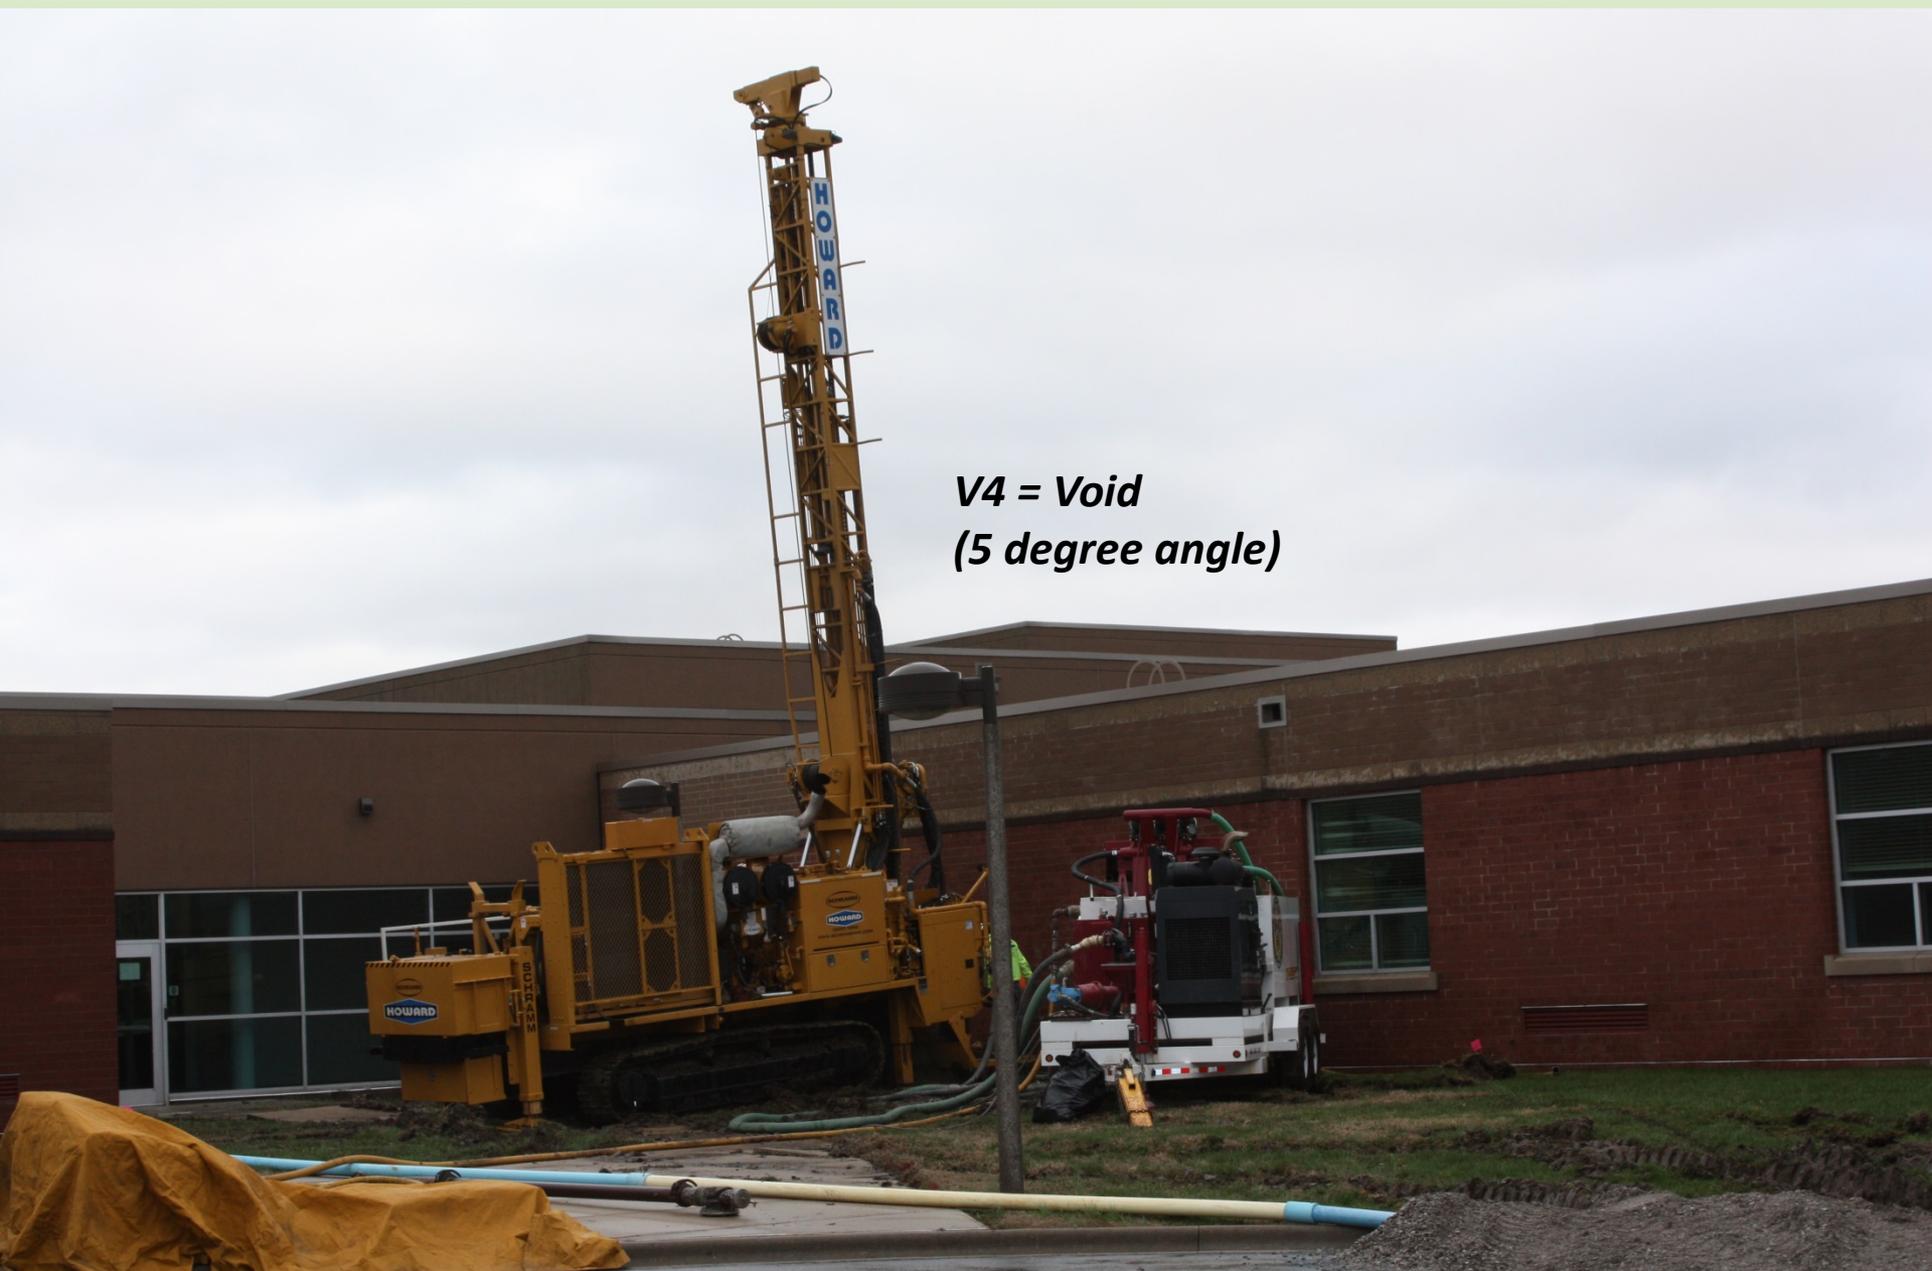
***A5 = Coal  
(22.5 degree angle)***

***V4 = Void  
(5 degree angle)***
