# **BRIDGE CONDITION REPORT**

**STRUCTURE NUMBER: 050-0058**

**LOCATION: US Route 52 over the Fox River in  
LaSalle County**

**DATE INSPECTED: November 28, 2016**

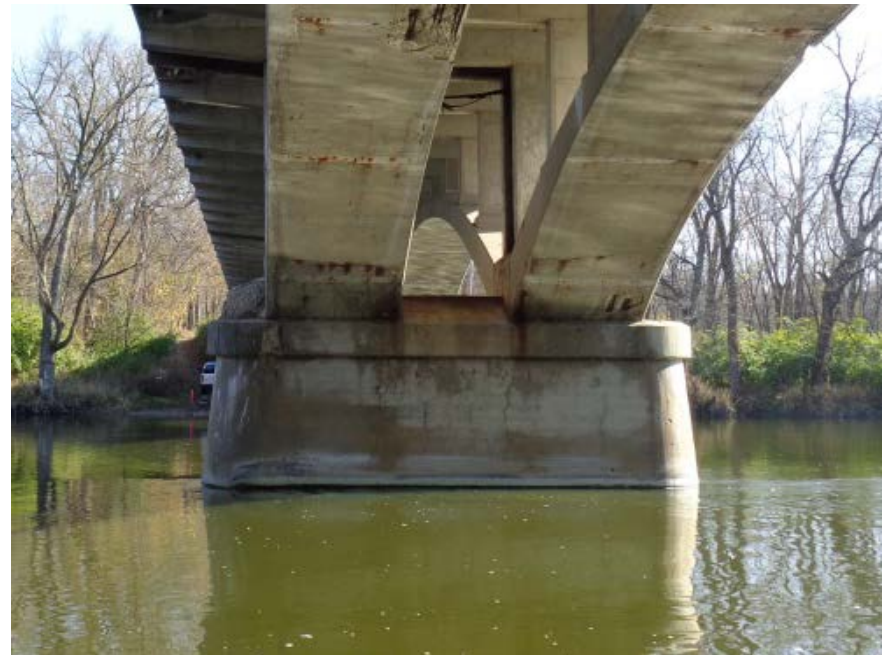
During the bridge inspection, the top of the footing at Pier 2 was found with a probe on each side near the pier centerline. The 1978 rehabilitation plans indicate that the footing at the pier face is 4'-3" thick and set on rock. The sandy river bottom was at the same level as the top of the exposed footing. The inspector was unable to push the probe through the river bottom below the top of the footing elevation.
